6th International Conference on Case Histories in Geotechnical Engineering, Arlington, VA, August 11-16, 2008

GOOGLE EARTH MAPPING OF DAMAGE FROM THE NIIGATA-KEN-CHUETSU M6.6 EARTHQUAKE OF 16 JULY 2007

We describe the use of Google Earth during and after a large damaging earthquake that struck the central Japan coast on 16 July 2007 to collect and organize damage information and guide the reconnaissance activities. This software enabled greater real-time collaboration among scientists and engineers. After the field investigation, the Google Earth map is used as a final reporting product that was directly linked to the more traditional research report document. Finally, we analyze the use of the software within the context of a post-disaster reconnaissance investigation, and link it to student use of Google Earth in field situations.

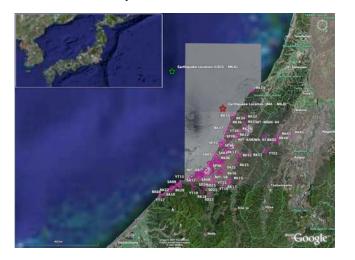
Figure 3. Google Earth Map of all sites in the Niigata-Chuetsu Japan earthquake reconnaissance area

The general site map of the reconnaissance area (Figure 3) is populated by several symbol types. Two epicenters (USGS and JMA) are determined with different data sets and posted as green and red stars respectively. Clicking on the stars opens a dialog box with detailed information about the earthquake magnitude, mechanism, and timing. The other sites are posted as sites visited (circles) or collapsed structures (arrows), along with the site identifier. The identifier is a combination of the initials of the observer team and the chronological order of the observation (e.g., YT20 was observed by the vehicle-team led by Yasuo Tanaka, and is their twentieth site formally logged). Double clicking on the symbols will let the viewer fly to the site, and single clicking opens up an information balloon.

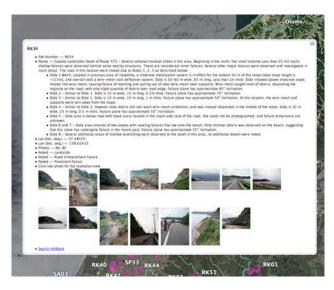
Figure 5. Detail of thumbnails of damage imagery and damage observations for a landslide damaged site.

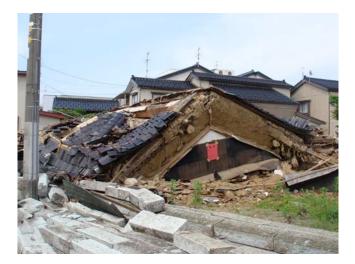
Figure 7. Photograph of house collapse at site NIT-55 that is linked to the thumbnail image in the balloon in Figure 6

An image of the home can be viewed clicking the thumbnail (Figure 7). Google earth is used here to correlate directional patterns of damage with the strong motion data recorded at several sites in the city. This is important if many of the collapses can be associated with one or several specific pulses of motion that
