Columnar Basalt – Vibration Study and Preservation Methods at Mumbai, India

COLUMNAR BASALT – VIBRATION STUDY AND PRESERVATION METHODS AT MUMBAI, INDIA

The Gilbert Hill is situated west of the Andheri railway station on western railway line in Mumbai, India. The present hill is practically a vertical monolith that rises about 60 meters (200 ft) above the surrounding ground level. The hill displays beautiful vertical columnar jointing that extends from the top to the bottom. Because of its rare and almost unique occurrence the hill with columnar joints is important geologically and historically. Hence, this hill needs to be preserved. The jointing is very well exposed in the western, northern and eastern parts. In the southern part there is rolled down debris that covers the exposure of the columnar jointing. The paper deals with the effect of vibrations caused by the construction equipment on the jointed rock body, for which vibration studies have been carried out. The propagation of waves (vibrations) at various locations (points) in the area resulting from use of heavy construction equipment like vibratory roller, rock breaker, etc was studied. The induced Peak Particle Velocit

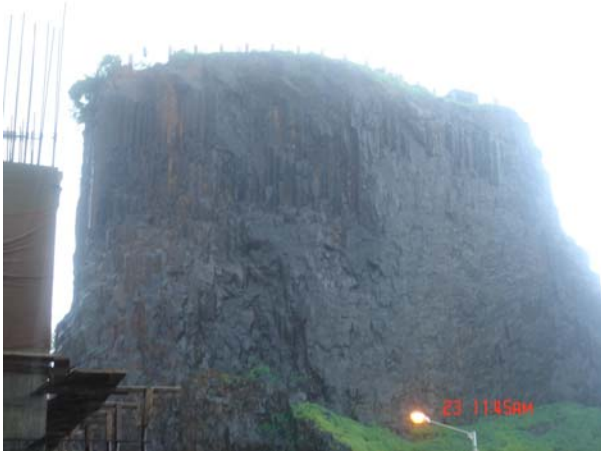
Fig. 1. View of Gilbert Hill

The Gilbert Hill is practically a vertical monolith that rises about 60 meters (200 ft) above the surrounding ground level. The hill displays beautiful vertical columnar jointing. Since columnar jointed structure is rare and only two to three such structures are present in the world, Gilbert hill can be considered as a geological monument worth preserving and may be made into a tourist attraction site. Because of its rare and almost unique occurrence the hill with columnar joints is important geologically and historically.

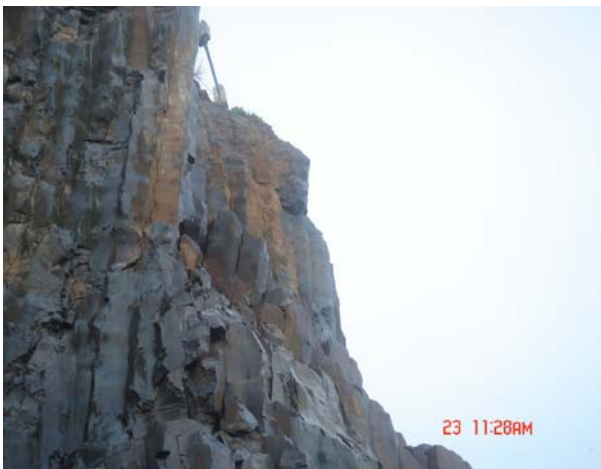
Fig. 2. View of columnar joints

The basalt plug of the Gilbert hill shows very distinct columnar jointing that extends from the top to the bottom of the hill. The jointing is very well exposed in the western, northern (Fig. 2) and eastern parts of the hill. In the southern part of the hill there is some amount of rolled down debris that covers the exposure of the columnar jointing (Fig. 3). The present extension of the basalt plug is restricted to the Gilbert hill while in the surrounding areas there are outcrops of the stratified tuffaceous breccia or hyaloclastite. The Gilbert Hill basalt has been dated by Dr. Mike Widdowson, of the Open University, Milton Kenys, U.K. and it is 60.5± 1.2 million years old.

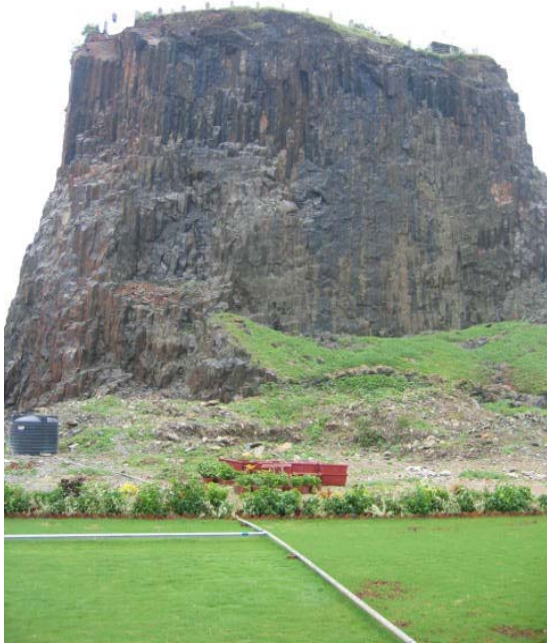
Fig. 3. Plug of basalt intrusion

The plot under investigation is situated in the west central part of Salsette Island, about 500 meters west of the Andheri railway station (suburban western railway). The rock type encountered in the Gilbert hill is mainly compact basalt which is intrusive into the stratified tuffaceous breccia that shows distinct westerly dip (Fig. 1 and Fig. 2). The basalt intrusion is in the form of a nearly circular body that was originally much larger in diameter as compared to what exists today. It is in the form of a practically vertical monolithic body that rises almost 60 meters above the surrounding ground (Fig. 3). Similar columnar jointed intrusive basalt also outcropped in Amboli Hill, west of Jogeshwari Railway Station. The latter intrusive body has been described by Tolia Nita & S. F. Sethna (1990) as a lopolithic intrusion. Unfortunately the entire basalt outcrop at Amboli Hill has been quarried and now there are only a few traces of the basalt seen in the area. There is no evidence of the Gilbert hill basalt being a lopolithic body, as we only see the vertical cylindrical body **which represents a volcanic plug.**

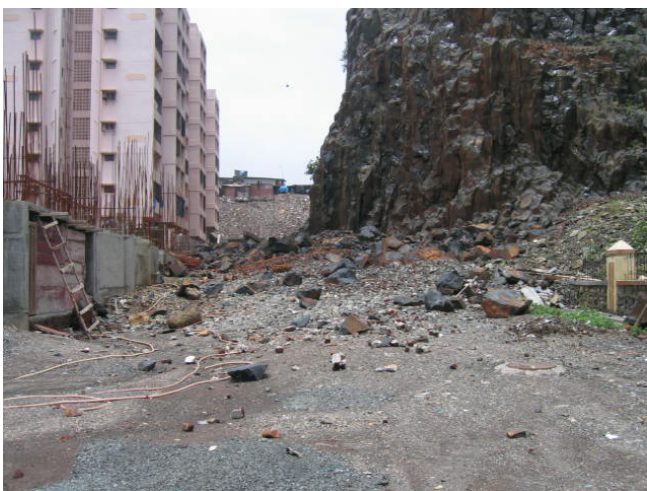
Fig. 4. Debris after heavy rain fall

Quarrying was permitted in the Gilbert Hill area during 1960s and the rock is cut without knowing its importance. Also the recent development and construction activity in the surrounding area may have endangered the stability of the remaining hill portion. The hill shows columnar jointing. Due to quarrying the joints may have opened out. Seepage of water in joints during rains would have enhanced the joint separation. Added to this, use of heavy construction equipment in the vicinity of the hill may induce vibrations thereby widening the joint aperture.

1. Pave the area at the top to prevent seepage of water in to joints which cause widening of joints and subsequent toppling.
2. Provide properly designed storm water drain (SWD) at the top of the hill. This should be done without cutting rock surface.

6. Gunite sides to prevent further erosion and weathering. However weep holes should be provided to facilitate drainage to prevent development pore pressure. This work is proposed on the South and South East side where there is soil overburden.

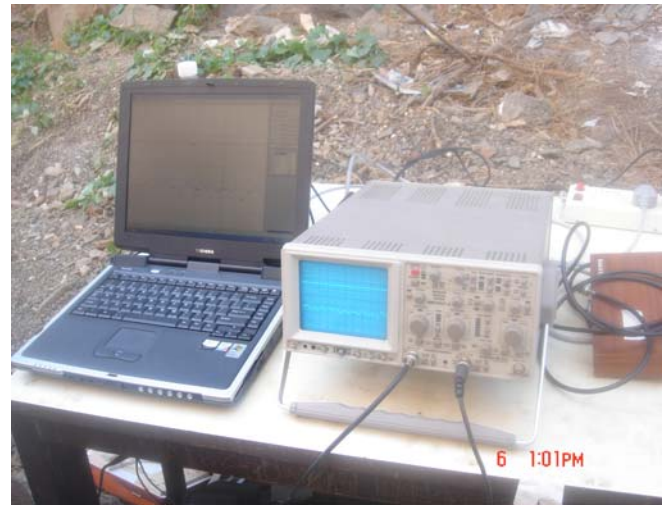
Fig. 5. Experimental set-up at site.

Figure 5 shows the experimental set-up and data recording at site. The location plan where the vibration study is conducted is shown in Fig. 6. Acceleration pick up mounted on rock is shown in Fig. 7. The acceleration pick ups are placed on either steel plate or well compacted concrete.

- The induced Peak Particle Velocity (PPV) is then compared with the tolerable/permisible PPV specified in the available literature.
- The induced particle velocity was measured with the help of pick-ups.
- The signal is then magnified using a charge amplifier (Fig. 8) and then recorded using software for the Digital Oscilloscope.
- The amplifier is connected to an oscilloscope (Fig 8.) which records the readings which are then recorded on a laptop directly connected to it.
- The software is used to exactly find the amplitude of vibrations from the graph.
- The maximum amplitude in each graph taken for every set of readings of vibrations is then recorded and tabulated.
- According to the safety limits the permissibility of vibrations is decided.
