Real-Time and On-Line Near-Field Microwave Inspection of Surface Defects in Rolled Steel

R. Zoughi et al., "Real-Time and On-Line Near-Field Microwave Inspection of Surface Defects in Rolled Steel," *Proceedings of the Asia-Pacific Microwave Conference (1997, Hong Kong)*, vol. 3, pp. 1081-1084, Institute of Electrical and Electronics Engineers (IEEE), Dec 1997.

REAL-TIME AND ON-LINE NEAR-FIELD MICROWAVE INSPECTION OF SURFACE DEFECTS IN ROLLED STEEL

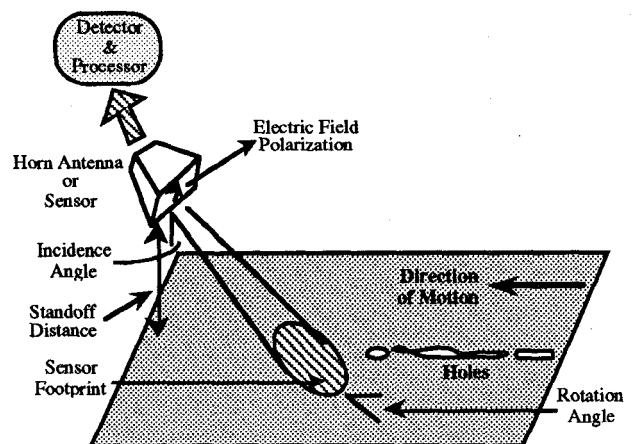
Fig. 1 shows the typical measurement setup used to conduct the majority of the measurements on all of the gross defects. A horn antenna radiates the microwave energy/signal onto the steel surface at a given frequency and polarization. Since there is a relative motion between the sensor and the defect, a voltage proportional to the phase or magnitude of the reflected signal is recorded as a function of the relative location of the strip. Fig. 1 also shows all of the important measurement parameters such as the standoff distance, the incidence angle, the rotation angle, etc.

Fig. 1 General schematic of the measurement setup.

Fig. 2 shows three typical detected signals as a function of the scanning distance for two adjacent holes (in the roll direction similar to those shown in Fig. 1) with diameters of about 6 mm and 3 mm at a frequency of 24 GHz, a standoff distance of 30 mm, an incidence angle of 45 degrees, at vertical polarization and with a horn antenna. The solid line shows the results when the holes are in the center of the antenna footprint and the dashed lines show the results while the defect is moved out of the center of the footprint by 10 mm and 30 mm, respectively.

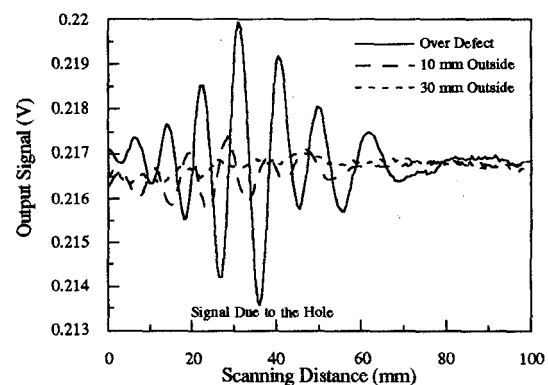
Fig. 2 Detected signals due to two small adjacent holes (in the roll direction), at a frequency of 24 GHz, vertical polarization, 30 mm standoff distance, 45° incidence angle with a small horn antenna [1].

The results indicate that the holes are clearly detected, in addition to the fact that if the defect is not exactly lined up with the antenna it may still be detected as long as the defect is within the antenna footprint. This indicates that the number of sensors needed to cover the entire width of a strip is reduced. This number will depend on the antenna dimensions with respect to the frequency of operation, the standoff distance and the incidence angle.

It is important to notice that the detected signal due to these two small holes is approximately 60 mm long (in the scan direction). This is as a direct result of the manner by which the measurements are conducted, namely the utilization of a horn antenna and an incidence angle. This "elongating" effect aids in increasing the detection sensitivity to small holes (and all other severe defects) since a hole is detected before it actually comes underneath the sensor. This is one of the inherent advantages of

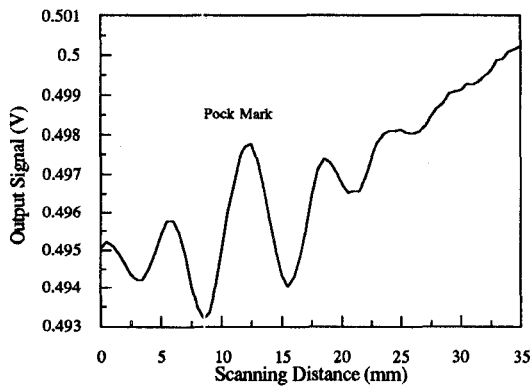
Pock marks are subtle surface defects which show up as very small humps on the strip surface. Fig. 3 shows the detected signal for a small pock mark at a frequency of 31.5 GHz, a standoff distance of 3 mm at nadir.

Fig. 3 Detected signal for a pock mark at a frequency of 31.5 GHz, and at 3 mm standoff distance (without a horn antenna) [1].

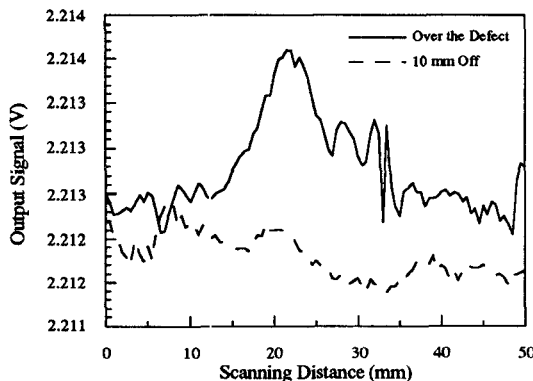
Wire marks are subtle defects elongated in one direction. However, as far as their subtlety is concerned they are similar to pock marks. Fig. 4 shows the detected signal due to a wire (mill) mark with a height of 0.05 mm, a width of 1 mm and a length of 8 mm at a frequency of 24 GHz, a standoff distance of 10 mm at nadir using a small horn antenna. Fig. 4 also shows the signal due to an area 10 mm outside of the wire mark.

Fig. 4 Detected signal due to a wire (mill) mark at a frequency of 24 GHz and a standoff distance of 10 mm using a small horn antenna when over the wire mark and when 10 mm outside of it [1].

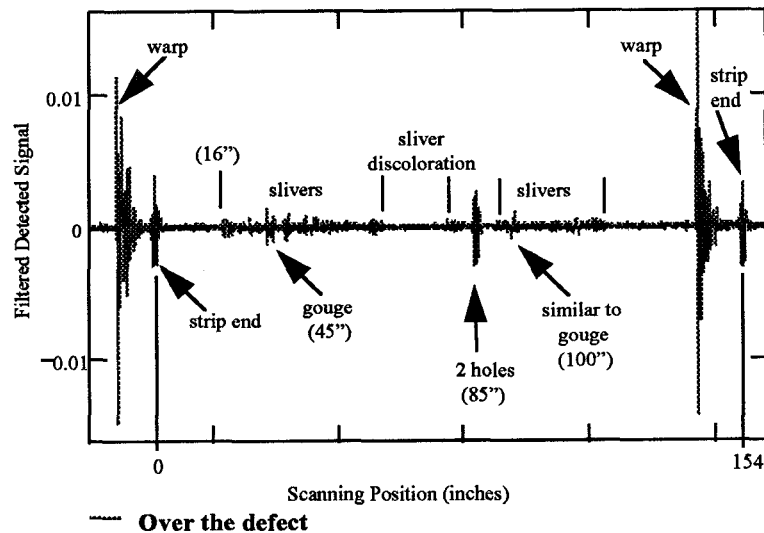
Several measurement runs were conducted, using this strip, during the time when we could not run the stand very fast (due to the mechanical difficulties as well as the excess flutter due to the warp in the strip) and for this investigation the strip speed was 30 ft/min. As an example, a full strip run is shown in Fig. 5 for which a 24 GHz sensor was used employing a small horn antenna at an incidence angle of 30 degrees and at a standoff distance of 53 mm. The vertical axis shows the output of the analog and the digital filters that pre- and post-processed the raw detected signal, and the horizontal axis shows the strip length, respectively. First, one sees a strong signal due to the warp followed by another strong signal due to the strip ends. Subsequent to a relatively smooth region the more rough sliver is clearly detected (rough means only to the touch, not similar to a lamination). After another smooth region due to a discoloration caused by the sliver, the holes are strongly detected followed by a relatively strong signal from the area similar to gouges. This is followed by some more sliver, discoloration and finally the warp and the strip ends are detected again. The compressed signal shown in Fig. 5, once expanded shows different signatures due to the holes, sliver and gouges. This is very important for future classification attempts.

Fig. 5 Detection of slivers, holes and pick ups using the test stand at 24 GHz, incidence angle of 30° , using a small horn antenna and at a standoff distance of 53 mm [1].

A test stand capable of simulating a small mill was manufactured. This piece of equipment allowed us to attach tin mill strips on it and be able to move the strip with a top speed of 1,100 ft/min. One of the strips that was supplied for inspection on the test stand was that of a continuous sliver consisting of two small holes adjacent to each other. The width of the sliver was 8.5 mm throughout, and in some places it had a rough surface while in some other places it was a mere discoloration (smooth). The holes were approximately 6 mm by 4.5 mm and 1.5 mm by 4.5 mm (in both cases the 4.5 mm is in the direction orthogonal to the strip roll direction). Immediately after the holes the sliver had a texture much similar to a few consecutive gouges. Furthermore, when attaching the strip to the test stand rolls, a crack where the strip ends come together was produced (e.g. *tape joint* on strip ends), plus the fact that there existed a warp on the strip near this crack as a result of the strip geometry and the manner by which it had been cut.
