Foundation Work of High TV Tower in Collapsible Loess

Evstatiev, Dimcho; Evlogiev, Yordan; and Nedelcheva, Mariana, "Foundation Work of High TV Tower in Collapsible Loess" (2008). *International Conference on Case Histories in Geotechnical Engineering*. 21. <https://scholarsmine.mst.edu/icchge/6icchge/session07/21>

FOUNDATION WORK OF HIGH TV TOWER IN COLLAPSIBLE LOESS

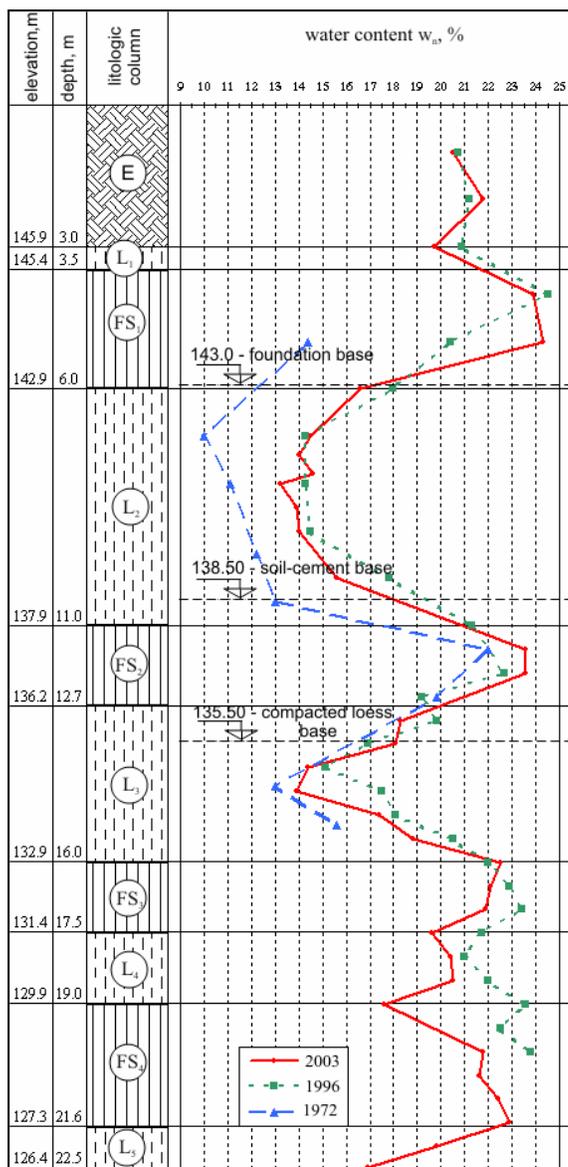
Fig. 2. Geological structure of the soil base
The curves of the moisture content investigated in 1972, 1996 and 2003 are presented in the right

The geological structure of the soil base is presented in Fig. 2. The thickness of the loess complex is about 30 m. After an artificial embankment (E) follow five loess horizons (L_1 to L_5) divided by four very well expressed fossil soils (FS_1 to FS_4). Thin loess horizons and fossil soils (FS_5 , FS_6 , FS_7 and maybe FS_8) with a total thickness of about 7 m follow in depth.

The 7-16 m interval (layers L_2 , FS_2 and L_3 in Fig. 2) possesses collapsibility under geological burden (unloaded collapsibility) of 2-3 %. Non-collapsible loess is found at a depth of 16 m with collapsibility tending to $\delta_{cv} = 0.00$ % under geological burden $p_{Bv} = 0.3$ MPa.

It increased with another 1 cm till 1987 and then slow attenuation started, increasing only with 0.5 cm in the course of 8 years, i.e. with about 0.62 mm annually till 1995. It may be presumed that this fading rate would have continued in the next years too, if the accidents in the WSS system did not occur. As a result of them, the non-compacted backfill embankment (Fig. 3) was over-moistened and irregular settlement of the built on it contiguous to the tower low structures occurred. Part of the water had permeated into the non-compacted part of the soil base (loess horizon L_3), provoking certain increase in its moisture content (Fig. 2).

The establishment of the degree of moistening of the loess base under the tower foundation and the tracing of these changes in the course of time is an important element of the monitoring (Fig. 2). As already mentioned, 2.60 m of collapsible loess remained under the heavy tamper compacted loess. The moisture content in it had increased from 2 to 4 % till 1996 (with respect to the recorded one in 1972), with a maximum in the lower part of the layer. Due to this moistening the settlement of the tower has not attenuated entirely. The main sources of moistening are the permeating surface water via the deformed vertical planning and the damaged WSS networks.

The effect of activities undertaken to 2003 consisted in reducing the moisture content of the collapsible layer with 1-2 % (Fig. 2). The entire stabilization of the backfill embankment completed in 2006 will lead to further attenuation of the settlement.

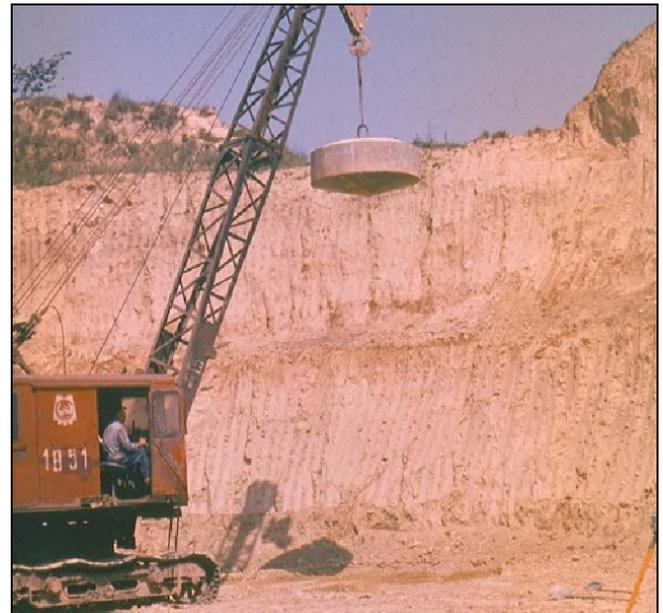
Photo 1. Heavy tamping of the excavation bottom - L₁, FS₁, L₂ and FS₂ can be distinguished on the vertical slope

- Excavation for the foundation to elevation -14.50 m (absolute elevation of 138.50 m), which was not difficult even for the vertical excavation slopes due to the low moisture content of loess $w_n=12-14\%$;
- Compaction of the excavation bottom using a 7 ton tamper (Photo 1), reaching $\rho_d > 1.50 \text{ g/cm}^3$ to a depth of 3 m and modulus of total deformation $E_o = 20 \text{ MPa}$;

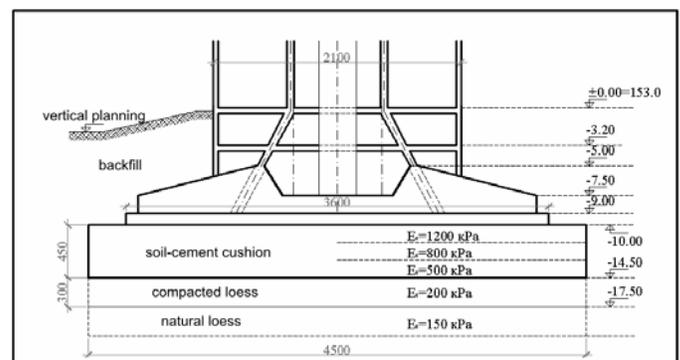
Fig. 3. Foundation scheme of the TV tower in Rousse city

Foundation with borehole piles of the “Benoto” type, with their lower end reaching 38 m, i.e. the basal gravels and sands, was initially considered. The method was abandoned due to its high cost. An alternative solution was accepted using loess improvement methods with the aim of avoiding the collapsibility hazard. This solution included deepening of the excavation, compaction of its bottom by means of a heavy tamper (Minkov et al., 1980) and construction of a thick soil-cement cushion, on top of which is built the reinforced concrete foundation (Fig. 3).

- Construction of a soil-cement cushion with a thickness 4.5 m and a diameter of 45 m. The cushion consists of three layers, 1.5 m each – with increasing cement content respectively 2, 4 and 6 % in an ascending direction and modulus of total deformation E_o 50, 80 and 120 MPa, measured *in-situ* with stamp testing. The layers were built of 15-cm thick strata by *in-situ* mixing of cement and soil and by roller compaction. Soil from the excavation was used, which was stored at the surface and then returned back in the pit with dump trucks along a ramp in the slope;
- The foundation was set at a depth of -10.0 m (absolute elevation of 143.0 m). It consists of two bodies – 1.5 m thick common reinforced concrete slab with a diameter of 36.0 m and radial reinforced concrete ribs on the top surface of the slab with varying cross-section – height of 1.0 m in the end and 3.5 m in the center.

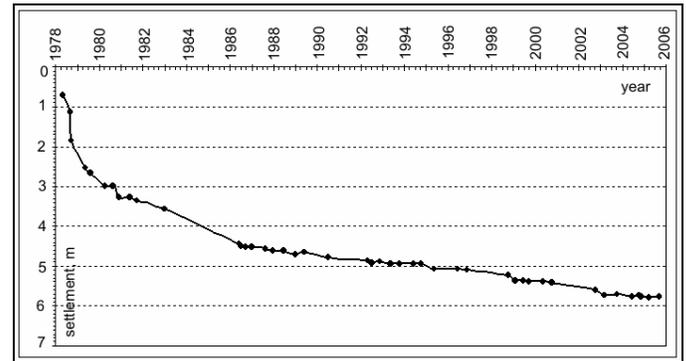
Fig. 4. Averaged graph “time – settlement” of the leveling marks

The settlement of the tower was measured after its construction to elevation 0.00, and after construction of $\frac{1}{4}$ part of it and with certain interruptions during its up to date operation (Fig. 4).

During the construction of the tower the settlement was relatively more intensive, reaching 3.57 cm after its completion in 1983.
