Need for Prior Geotechnical Engineering Studies for Foundation Design: Cases of Collapsed Buildings in Port Harcourt and Environs, Nigeria

NEED FOR PRIOR GEOTECHNICAL ENGINEERING STUDIES FOR FOUNDATION DESIGN: CASES OF COLLAPSED BUILDINGS IN PORT HARCOURT AND ENVIRONS, NIGERIA

Cases of collapsed buildings have been on the increase in the city of Port Harcourt and environs in Rivers State, in particular and other major cities in Nigeria in recent times. A critical evaluation of the modes of failures indicates that absence of and / or inadequate subsurface geotechnical investigations have been responsible for these building foundation failures. Case histories of four major building foundation failures within the municipality of Port Harcourt and environs in the southern Niger Delta sub-region of Nigeria in recent times are presented and discussed in this paper. The first case history involves a five-storey building that collapsed because it was constructed across a river channel that had sand and gravels as major subsurface materials beneath the building site. As a result of excessive increase in groundwater table during the rainy season and the attendant excessive pore water press

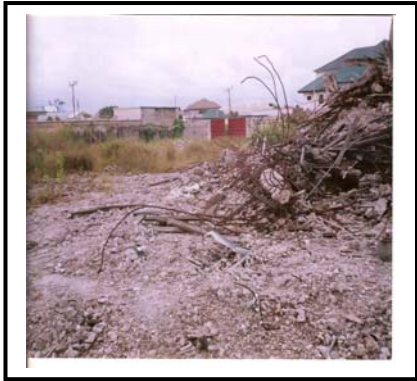
Fig. 6c: Remains of the collapsed building along the New Tombia Extension Road GRA III Port Harcourt.
