Temporary Support of Excavation System for 300 New Jersey Avenue

TEMPORARY SUPPORT OF EXCAVATION SYSTEM FOR 300 NEW JERSEY AVENUE

This paper discusses the design, construction, and performance of the support of excavation system used at 300 New Jersey Avenue jobsite. The temporary support of excavation system is more complicated than the typical urban site in Washington D.C. and had to be adaptable to many different and variable conditions surrounding the site. These conditions included support of a six and seven story office building, WMATA's Red Line Subway tunnel under D Street and the support of the 24 foot wide brick and stone Tiber Creek Sewer, which was built in the late 1800's to drain a major portion of Washington, DC.

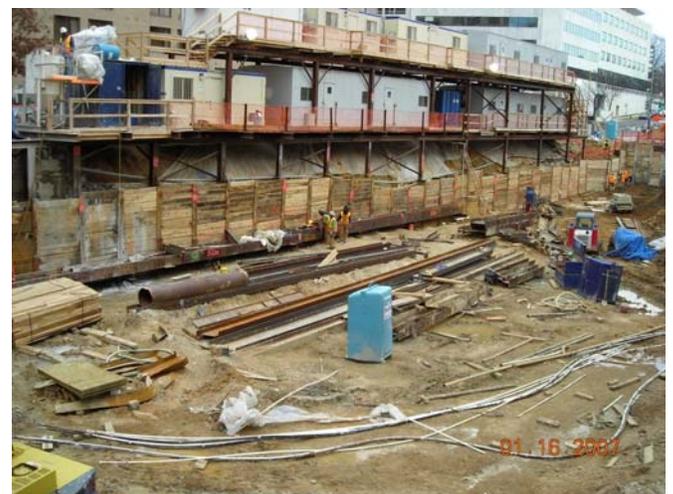
Fig. 1. Office Trailer Support Platform

Since the jobsite is located in the heart of D.C. (just blocks away from the Capitol Building) combined with the irregular and small shape of the site made the everyday site logistics very difficult and challenging. During the ground to grade phase of the job, trailers for the architect, the general contractor, the excavator, and Clark Foundations were required on site. Due to the limited real-estate available a double story trailer platform was designed and built by Clark Foundations along D Street. Since the north wall WMATA soldier beams, along D Street, needed a six foot slope cut at the top one side of the trailer platform had to be supported from the existing metro piles while the other side could bear on D Street (see fig. 1).

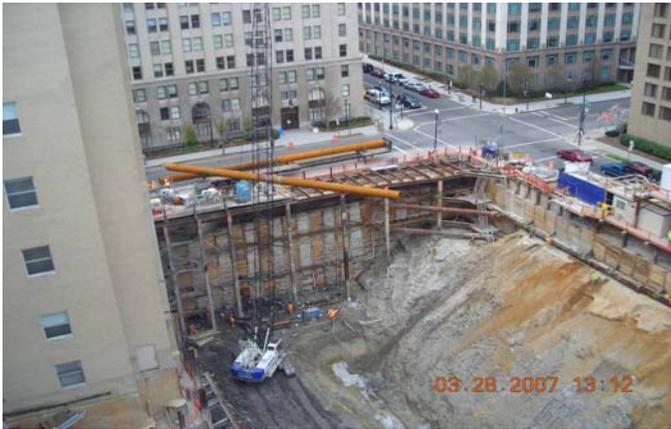
Fig. 2. Unloading of Raker Brace Steel Shipment

required to be unloaded from First Street N.W., which necessitated two flagmen to temporarily close off First Street while the shipments were unloaded (see fig. 2).

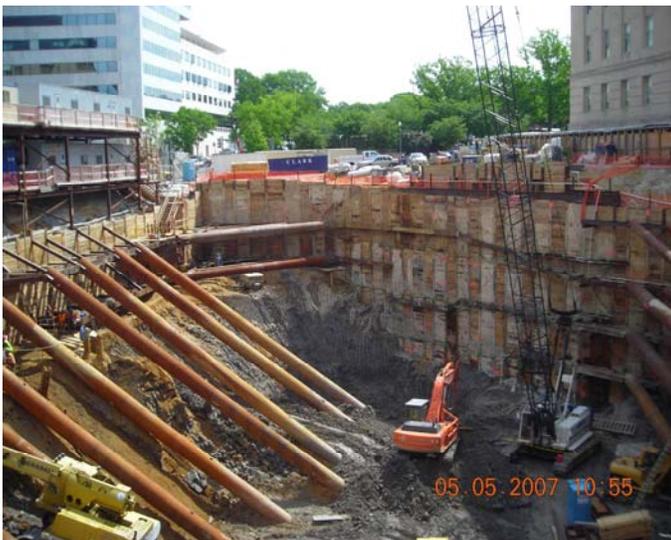
Fig. 3. Maneuvering of 75 Ton Link-Belt Service Crane

A 75 ton link belt service crane was required to remain on site to assist in the installation of the sheeting and shoring components. However, due to the space requirements around the perimeter of the job the service crane could not be situated outside the excavation. Having the service crane inside the excavation posed a unique set of conditions. Not only did our service crane have to maneuver around the excavator's equipment, that was constantly hauling dirt out of the hole, but half of the site was unavailable for any equipment to maneuver in as it was taken up by the first tier raker berm for a good portion of the excavation process (see fig. 3).

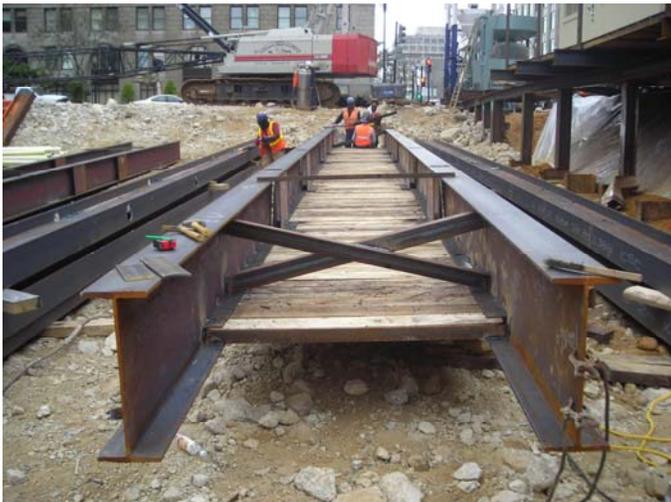
Fig 4. Fabrication of PSHG Wall Panel

In lieu of excavating a panel under slurry and displacing the slurry with tremie concrete and a reinforcing steel cage, the slurry is self hardening. The soldier beams and lagging are prefabricated as a panel and placed in the liquid slurry. Each panel once assembled weighed seven tons (see fig. 4). Conventional waterproofing is later applied to the face of the lagging, prior to construction of the building foundation wall.

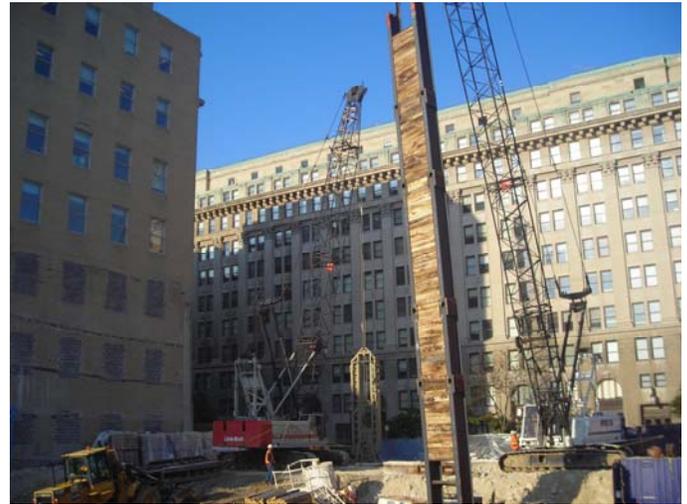
Fig. 5. PSHG Wall Clamming Operation With Service Crane Holding Panel To Be Set.

- A cement silo for bulk storage and a 4 cubic yard blender were used to batch the self hardening grout. The slurry is a mixture of Type III cement and attapulgate clay.
- Two crawler cranes were mobilized. One crane was for the clamming operations using our free hanging clam buckets and another service crane was for the setting of the pre-fabricated soldier beams with lagging panels.
- The clamming buckets are free hanging cable operated buckets that are 30 inch wide.
- The soldier beams were pre-fabricated with reservations for the future tiebacks, and paired together with wood lagging to make a panel.

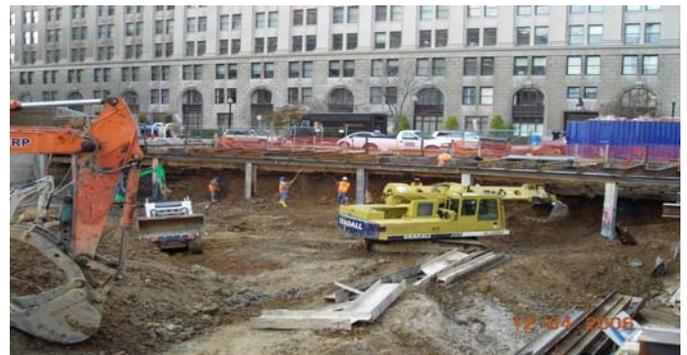
Fig. 6. Installation of Utility Support Structure

After completion of the PSHG Wall along First Street, we proceeded with excavation around and under the existing utilities. This required the use of small backhoes and plenty of handwork. As the utilities were exposed, a system of steel channels and hanger rods were installed across the top and bottom of the utilities and attached to a series of pin piles installed beforehand (see fig. 6).

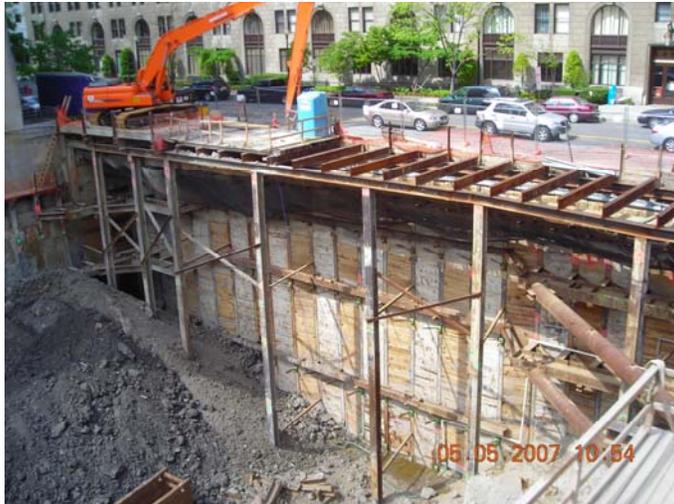
Fig. 7. Excavator's Long Stick Backhoe Platform and Utility Support Structure

Incorporated into the utility support was a 20ft long x 16ft wide platform for the excavator's long stick backhoe (see fig. 7). This platform was designed to overhang the excavation. Extra pin piles and steel beams were added to this area of the utility support to help reinforce the platform. Concrete mats that were 10ft long x 4ft wide x 12" thick were used for the decking of the platform.

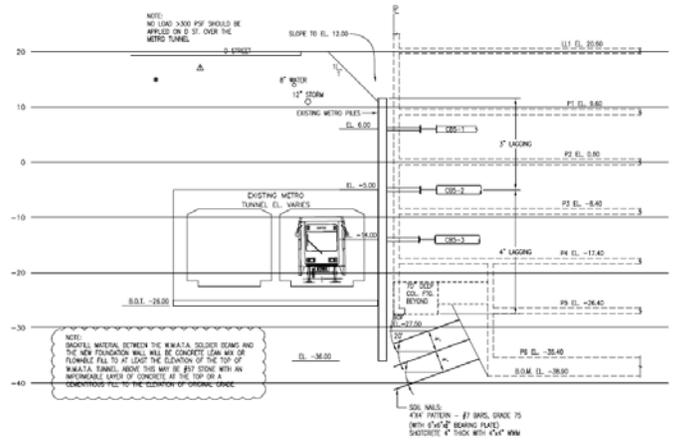
Fig. 8. Section at North Wall WMATA Piles

Under D Street is WMATA's Red Line subway tunnel. This tunnel was constructed in the 1970's using conventional soldier beams, wood lagging, and cut and cover construction. The soldier beams location varied from 6ft outside the new building line to encroaching into the new basement. The shoring system utilized the existing soldier beams by installing new wood lagging, three tiers of steel rakers and concrete heel blocks as the excavation progressed (see fig. 8).

Along the north wall, the new building slab on grade parking level stepped up a floor from P6 level to P5 level. This step was incorporated in the new building design so it would not be situated in the influence line of the WMATA metro tunnel. In order not to undermine the new building footings and the WMATA Tunnel where this transition occurs a system of soil nails and shotcrete were used to retain the earth in this area. The height of the shotcrete wall ranged from 20 feet to 6 feet and incorporated a 4 foot x 4 foot staggered soil nail pattern. The soil nails consisted of 75 ksi number 7 bars with 6inch x 6inch x 0.75inch thick bearing plates and the shotcrete was 4inches thick reinforced with 4inch x 4inch square wire meshing (see fig. 8).

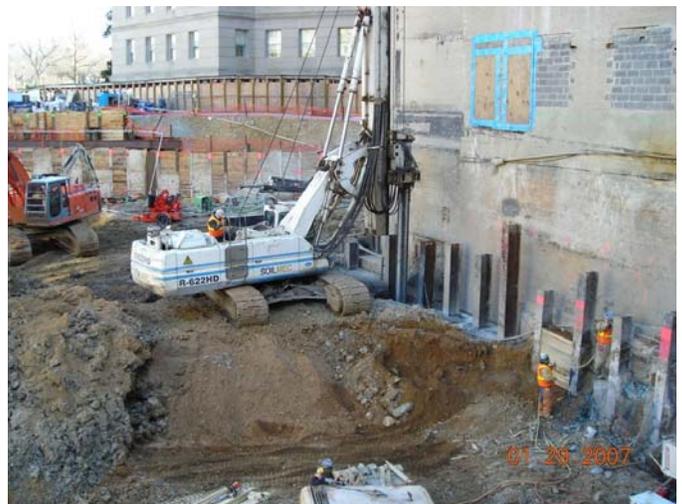
Fig. 9. Tangent Wall Drilling Operation

Along the south side is the existing six and seven story Acacia Building. The foundation of this building was concentric spread footings. A tangent pile wall was determined to be the best design to limit deflection of the shoring system adjacent to the building and to prevent the loss of fine soils from behind the wall. The system consisted of 30 inch diameter holes drilled directly adjacent to each other. The first series of "primary" holes are drilled 4feet-9inches on center and drilled to a depth 10 feet below sub-grade. A wide flange beam is inserted in the hole and then the hole is tremie filled with 3500 psi concrete to a height of 4ft below the underside of the existing building's footing. A series of "secondary" holes are drilled tangent between the primary holes and set back 4 inches. These holes are drilled to a depth of 2 feet below sub-grade and tremie filled with 3500 psi concrete in the same manner as the "primary" holes (see fig. 9). The concrete of the "primary" and "secondary" holes were purposely kept low to aid in the installation of the steel support brackets. In order to prevent loss of material the remainder of the annular space was filled with a cement bentonite mixture that hardens to the same consistency as the soil it is replacing.

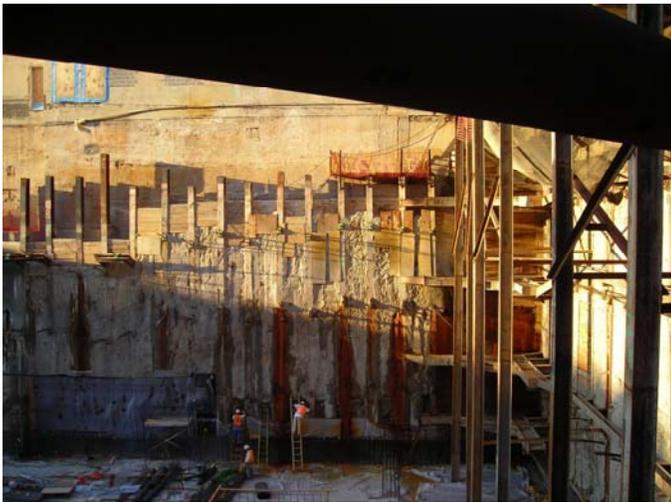
Fig. 10. Tangent Wall Scabbled Back to Face of Soldier Beams and Waterproofing Being Installed

During the excavation operation the concrete face of the tangent piles were scabbled back to the face of the soldier beams to provide a flush face. Any imperfections were shotcrete filled. This face was later covered with conventional waterproofing (see fig. 10).

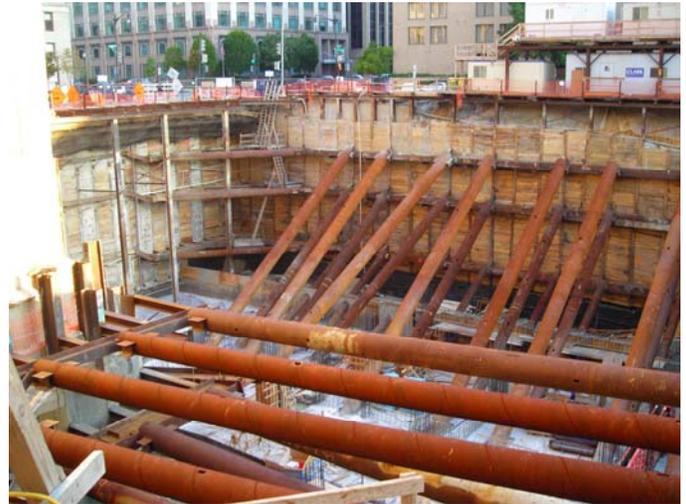
Fig. 11. Internal Steel Raker, Corner Braces, and Cross-Lot Bracing

The north side was braced with three tiers of steel wales, corner braces, and rakers with continuous 4 ft wide x 5 ft deep heel blocks per tier. Maintaining an earth berm against the WMATA tunnel was critical to limiting deflection of the existing soldier beams. Mass excavation had to be performed to sub-grade and the heel blocks excavated and concreted below sub-grade in a safe manner. After setting the steel corner braces and rakers, each brace was pre-loaded to 100 percent of the design load using hydraulic jacks (this was a WMATA requirement).

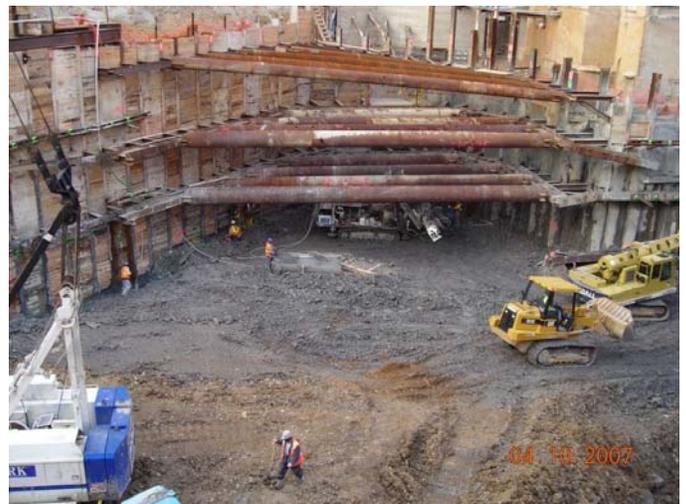
Fig. 12. Tieback Drill Rig Drilling Tiebacks Underneath Low Headroom Cross-Lots.

prefabricated in the soldier beams before installation. Coordination of access for tieback drilling while working through the cross-lots had to be thoroughly planned to provide enough space and headroom for the tieback drill rig (see fig. 12).
