Educating Students Through Understanding the Pathology of Geotechnical Projects

EDUCATING STUDENTS THROUGH UNDERSTANDING THE PATHOLOGY OF GEOTECHNICAL PROJECTS

ABSTRACT

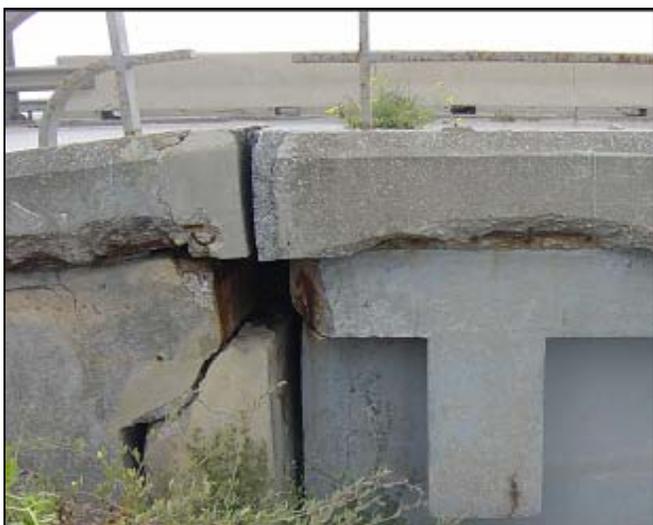
From visual observations on the access ramps of all structures, settlement is apparently the main cause of disorders and caused damages as illustrated by photo 3 and 4. As a matter of fact, very significant settlements were recorded respectively of about 50 cm for PK 0+200 structure and about 40 cm for PK 0+600 structure.

Rotation of access slabs is due to differential settlements between embankment of access resting on high compressible soil and abutments founded on deep end-bearing piles foundation. The same pathology was detected between adjacent piers from which resulted concrete surface bursting favoured by steel corrosion.

Photo 3. Rotation of approach slabs followed by structure damages.

To stop the evolution of disorders due essentially to continuous settlement of primary consolidation it revealed necessary the design of soil improvement (reinforcement) techniques aimed at substantial settlement reduction or acceleration of remaining consolidation. Then, two solutions were studied. First is the installation of rigid inclusions by means of metallic or concrete piles manufactured on site. Second are sands columns which play the role of vertical drains associated with light weight embankment material (unit weight equals 8 kN/m^3). The ground surface of improved soil is covered by a spreading mattress made up of drained sand to complete the outward drainage process from sand columns. This technique was finally approved because of moderate cost compared to rigid inclusions solution, (Bouassida et al, 2004).

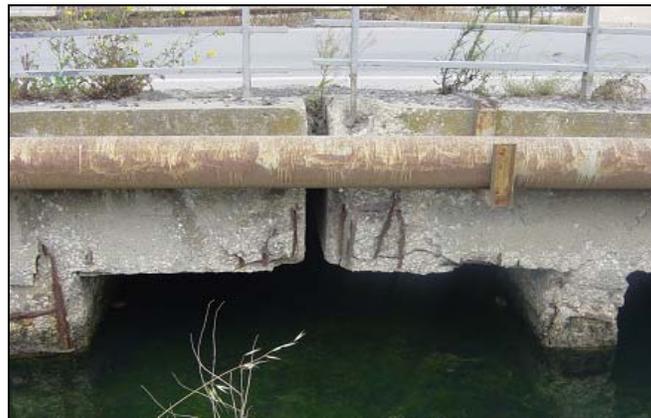
Photo 4. Rotation of piers
