## **CHACAO CHANNEL BRIDGE – THE DESIGN CHALLENGES**

The Chacao Channel bridge, a planned privatized/concession bridge project, is to link the island of Chiloé with continental Chile through the Chacao Channel. When completed, it will be the longest suspension bridge in South America (2,365 m) with two approximately equal spans linking three pylons. The location of the bridge presents a combination of unprecedented challenges in the design and construction making it very unique, including: extreme seismicity with the largest earthquake recorded to date anywhere in the world having occurred very close to the envisioned bridge location (the 1960 Valdivia Earthquake with a moment magnitude of 9.5!); extremely strong sea currents and tide fluctuations within the channel (up to 5-6 meters/sec and 6 meters, respectively); the general area being surrounded by active volcanoes; and a history of Tsunamis. The above extreme challenges resulted in construction cost escalations; inevitably, in 2006, after a significant portion of the investigations and design was completed, the Chilean ministry of Public Works put the project on hold. The above extreme physical challenges were the main reason

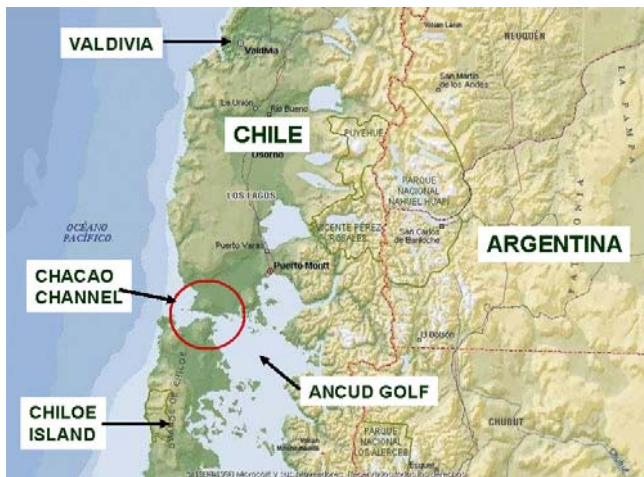
Fig. 1. Bridge Setting

The envisioned Chacao Channel bridge will be located in Southern Chile, Region 10, Los Lagos, Chiloé. The bridge will connect Route 5 South of Chile between the Continent and the Island of Chiloé, crossing the Chacao Channel (Figure 1).

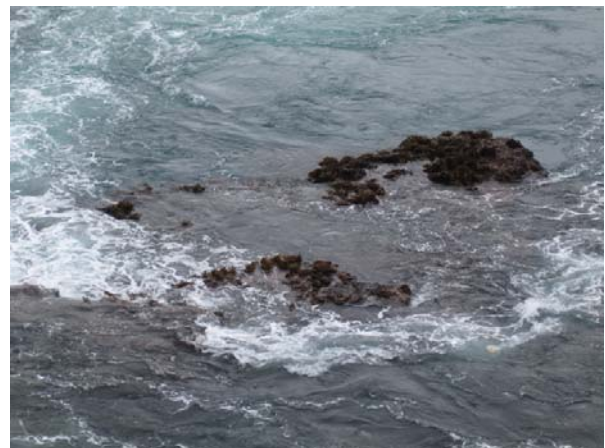
Fig. 3. Top of Roca Remolinos. Picture taken from a boat during low tide.

This very long span would drive the cost too high for the bridge to be built. However, roughly in the middle of the channel there is a submerged islet (called Roca Remolinos, see Figure 3) that could potentially be used to support a third pylon and cut the span in half. The biggest concern from the beginning of this project was if Roca Remolinos was strong enough to support a bridge pylon. Geotechnical investigations and several studies provided a design where the bridge with three pylons could be constructed.

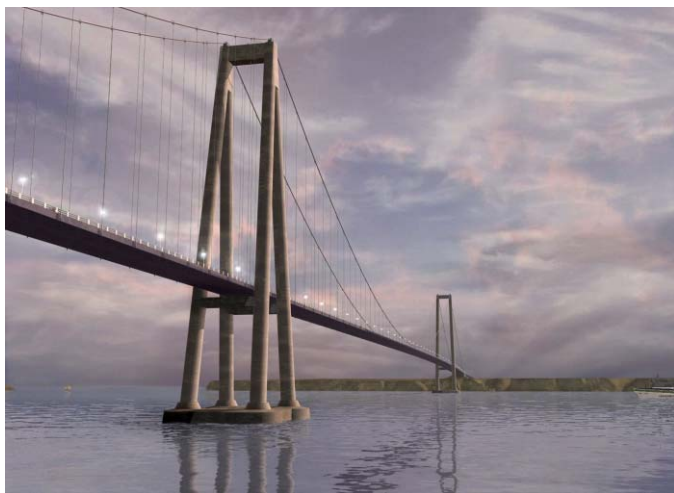
Fig. 5. Rendering of Final Bridge Concept (Ingenieria Cuatro/Cowi, 2001)

The bridge scheme is a suspension bridge, with two main spans supported by three Pylons (North, Central and South) and having a continuous deck. The North (Continent) and South (Island of Chiloe) Pylons are to have a distance of about 1050 m and 1100 m from the Central Pylon. The three Pylons will rise about 180 m above the mean sea level (Figure 4 and 5). The positioning of the central pylon has to be in the middle to provide the symmetry necessary for the design (equal spans), and symmetry is what drove the positioning of the North Pylon in the water. If Roca Remolinos was closer to either shore a different scheme would be needed.

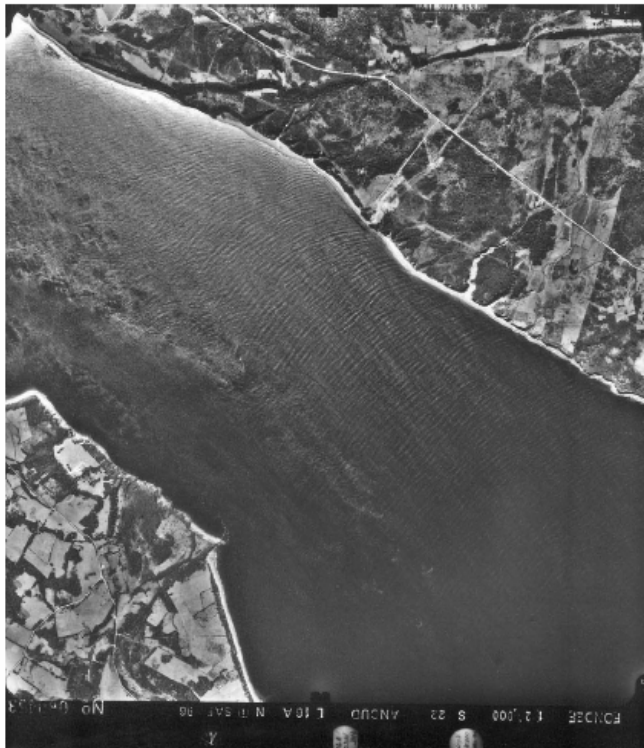
*Fig.6. Aerial photo SAF-060453-Fondef of the Chacao Channel above Roca Remolinos (GDS, 2006)*

Regarding the genesis of Roca Remolinos, Roca Remolinos corresponds to glacial deposits of unknown age but probably older than the last Llanquihue glaciation found on both banks of the channel. The cementation agent in the Roca Remolinos samples is described as ferric oxides, and could be created due to a pozzolanic reaction. The project was put on hold before the origin of the cementation was fully understood. Once the project is reactivated, a cement specialist will be needed to give an expert opinion on the stipulated process.

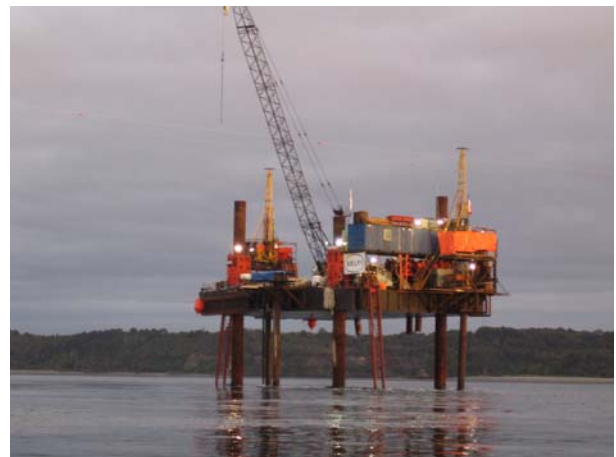
*Fig. 7. Jack-up Platform on top of Roca Remolinos*

The borings were drilled using state-of-the-art drilling equipment from a jack-up platform (Figure 7). Two different core barrels were used, the NQ 3 (required for the pressuremeter tests), and the GEBOR S with an inner diameter of 101 mm. The GEBOR S was chosen for increased core recovery to identify the different soil layers. This larger diameter of sampling, together with the use of a jack-up platform were the two critical improved factors over the preliminary investigation, and proved that the soil cementation in Roca Remolinos is generally higher, and consistently so, than presented in the preliminary investigation.

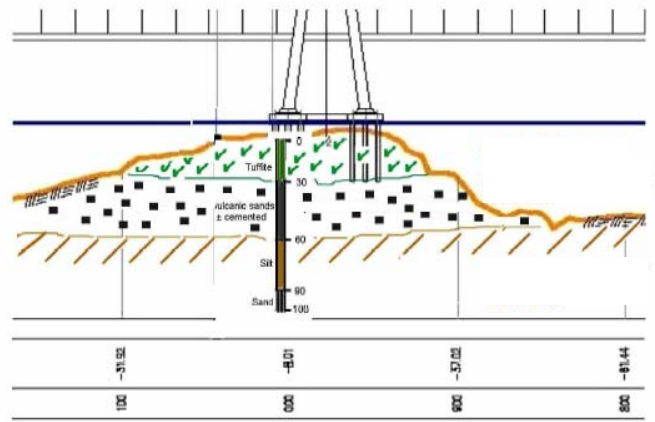
Fig. 8. Roca Remolinos soil layers (W. Romberg, 2006)

Roca Remolinos. Based on the sample visual inspection and test results, four different layers were identified (W. Romberg, 18 January 2005, Figure 8). All elevations given herein are below the Mean Sea Level, in meters.

1. A Tuffite (Caprock) layer exists (grey color), about 40-meter-thick, comprising of fine to medium sands, well to highly cemented, with low to medium silt content.
2. Below the Tuffite layer is a layer comprising of Pleistocene Sands about 35-meter-thick, comprising of medium sand, well to low cemented, with a few layers of gravel. Within the same layer are sublayers with concentrated gravel and low silt content. The layer colors vary from medium to dark grey and grey-brown.
3. Below the Pleistocene Sand layer, there is a layer of Pliocene/Pleistocene Silt about 30-meter-thick, comprising of hard or cemented Silt, with light brown to yellow color.
4. Below the Pliocene/Pleistocene Silt there is a layer of Pliocene/Pleistocene Sands, comprising of very densely compacted, partly cemented medium sands. The soil investigation was terminated about 20 meters inside this layer.

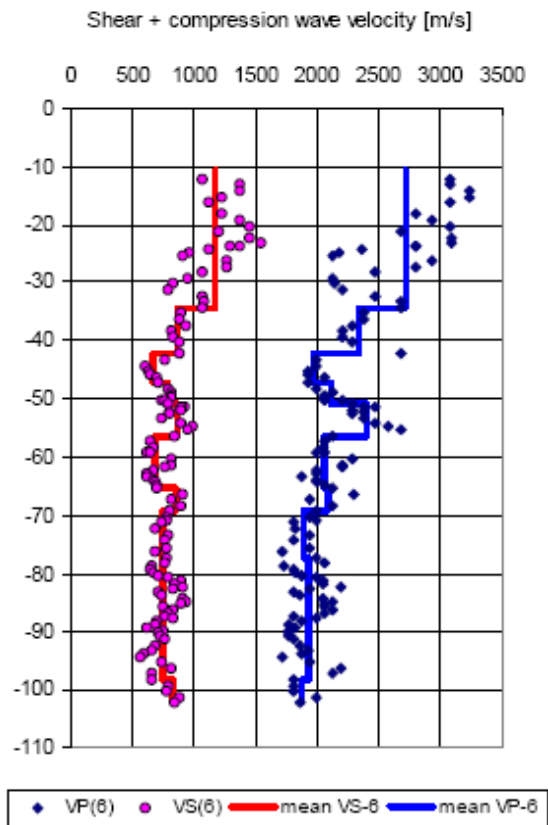
Fig. 9. Shear and compressional wave velocity profile at Roca Remolinos from suspension logging (boring A.SM-6, W. Romberg, 2006)

- The P-S suspension logging results showed shear wave velocities with typical values between 1000 and 1400 m/s for the Caprock layer, between 600 and 800 m/s for the Upper-Sand layer, and about 700 m/s for the Silt layer. No measurements were taken for the Lower-Sand layer (see Figure 9). The high shear wave velocities for the Caprock layer are indicative of a rock material. It is noted, however, that the material cementation varies (see below) and once broken the material behaves like soil rather than rock.
- The mass density varied from about 1.7 to about 2.5 gr/cm<sup>3</sup> with typical values of about 2.1 gr/cm<sup>3</sup> for the whole depth.

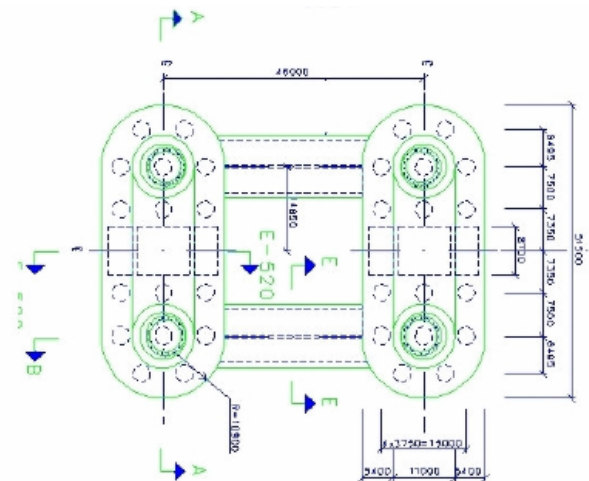
Fig.10. Plan view of Central Pylon foundation (COWI, 2006)

The Central Pylon foundation is to be placed on a combined pile cap, with each pile cap being supported by 16 piles (Figure 10). The combined pile cap consists of two separate pile caps connected with two transverse beams. These beams are hollow with dimensions 4 m deep by 11 m wide by 24.2 m long. The piles are cast-in-place concrete piles, 3 m in diameter at the top with an external steel casing, 70-mm-thick. The pile diameter is reduced to 2.7 m after the top 13.5 m and continues for another 28 m. The total length is about 42 m.

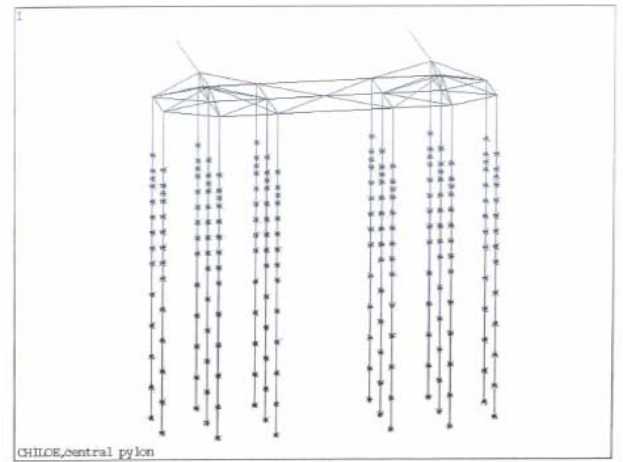
Fig.11. SASSI finite element model of Central Pylon (GDS, 2006)

design spectra at each foundation location. The rock design spectra for the subduction event were defined at the referential study (ICUATRO-COWI 2001). GDS estimated the acceleration time histories that matched the rock spectra and using wave propagation theory estimated the acceleration time histories at the surface of the shallow foundations. Using SASSI (Lysmer et al., 2000), a finite element computer program, the designer accounted for soil-foundation interaction and estimated the acceleration time histories at the center of the pile caps (central and north pylon) and at the top of the anchor blocks. Figures 11 and 12 show the finite element models of the central pylon foundation and the anchor blocks. Figure 13 shows one of the many design response spectra at the top of the foundation level (central pylon) accounting for soil-foundation interaction. GDS used SASSI to estimate the acceleration time histories, spectra and foundation impedances (springs and dashpots) and provided them to the bridge designer to be used in a global finite element bridge model and identify the seismic forces at the bridge.

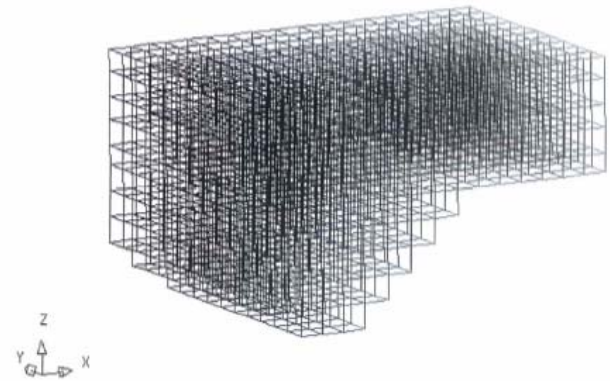
Fig. 12. SASSI finite element model of south anchor block (GDS, 2006)

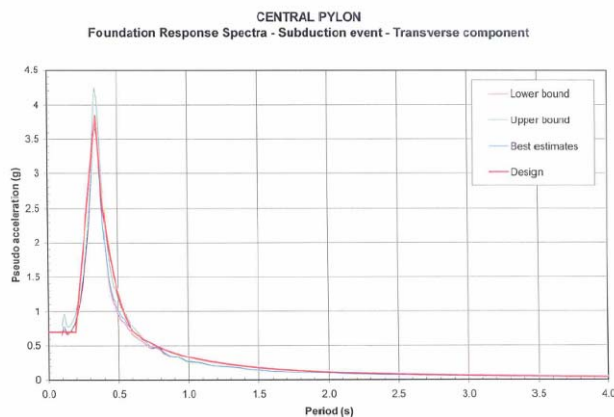
Fig. 13. Indicative design acceleration response spectrum at foundation level of the Central Pylon, accounting for soil-structure interaction (GDS, 2006)

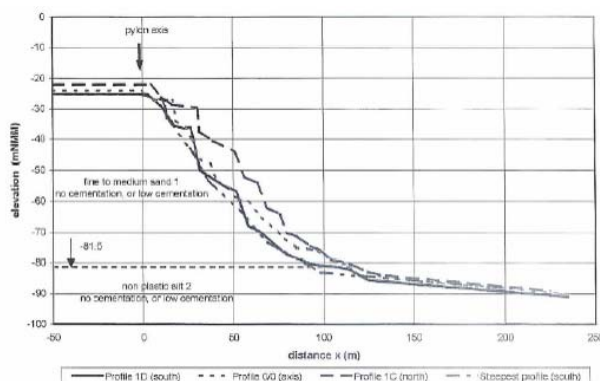
Fig.14. North pylon- longitudinal profiles (GDS, 2006)

As mentioned earlier, the north pylon was placed close to a relatively steep slope at the north bank (Figure 14) and the slope stability and slope displacements during the design seismic event were estimated.

Limit equilibrium methods were used to estimate the factor of safety for static conditions. The assumptions and methods used were simple and conservative given that the static slope failure was not a driving factor in the design. This is true for the static and seismic stability as well as the calculation of permanent displacements. A slope of about 35.5 degrees was considered in the calculations.

For the analyses, a  $\phi$  angle of 40 degrees and zero cohesion were used and were deemed reasonably conservative. The overall factor of safety for a slope failure was approximately 1.2. A factor of safety of 1.5 was achieved by moving the north pylon foundation 20 m to the north.

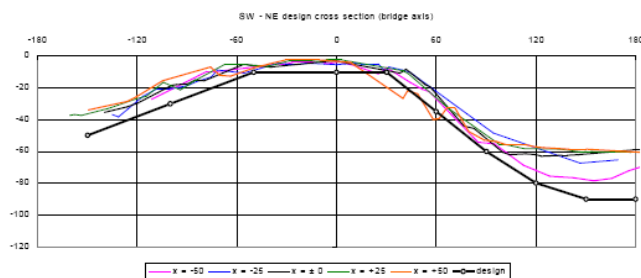
Fig. 15. Cross-sections with the steepest slopes at Roca Remolinos (W. Romberg, 2006)

The Central Pylon is envisioned relatively close (30 to 40 m) to a relatively steep slope at Roca Remolinos (Figure 8 and 15). The lateral capacity of the foundation was estimated conservatively during the design. The stability of the steep slope of Roca Remolinos was not examined in such detail as for the North Pylon mostly because of the generally high cementation of the caprock material. However, during the final design, a more complete study will be carried out to assess the slope stability given that in a case of a slope failure, the cantilevering length of the piles will increase, along with the scour susceptibility of the foundation. Such a situation would worsen in case of repeated lateral loading before or after a potential slope failure. The interconnection of slope stability, large cantilevering lengths and scouring is further discussed later in the "future steps" section.

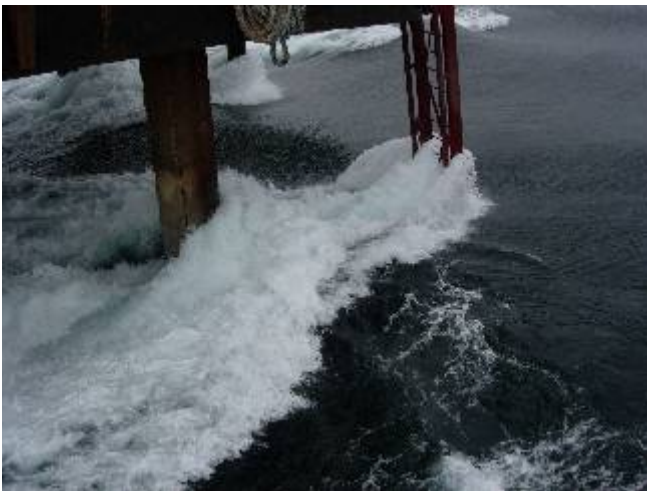
*Fig.16. Currents at the legs of the jack-up platform at Roca Remolinos*

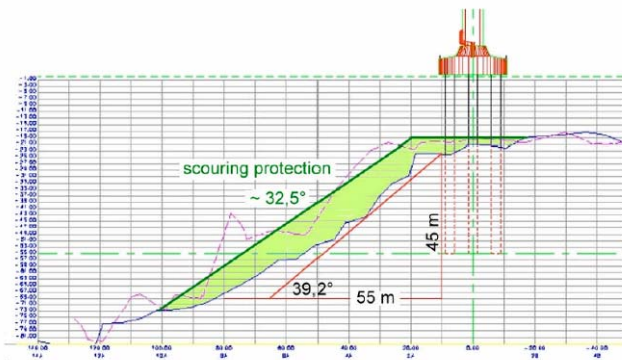
*Fig.17. Recommended scouring protection measures for the North Pylon (W. Romberg, 2006)*

the north pylon location. Based on the above data and the north pylon soil material information collected during the geotechnical investigation, it was estimated that the rate of material loss the North shore will suffer in the next 100 years, is about 0.2 to 0.5 m per year. Changes in the bathymetries taken in 2000 and 2005 suggest that 0.5 m per year is the more reasonable value to follow. Figure 16 is representative of the strong currents in the channel. These findings suggested moving the North Pylon 50 m to the North. This 50-m displacement due to scour considerations is independent of the 25-m displacement due to the slope stability considerations. However, since both displacements consider extreme events that will not occur simultaneously, a 50-m displacement of the north pylon to the north was decided. This distance would provide adequate factors of safety at all times for slope stability and give the necessary time to repair the scour protection when necessary. Figure 17 shows a recommendation for the scouring protection measures.
