Geotechnical Aspects of Recent Pakistan Earthquakes

GEOTECHNICAL ASPECTS OF RECENT PAKISTAN EARTHQUAKES

ABSTRACT

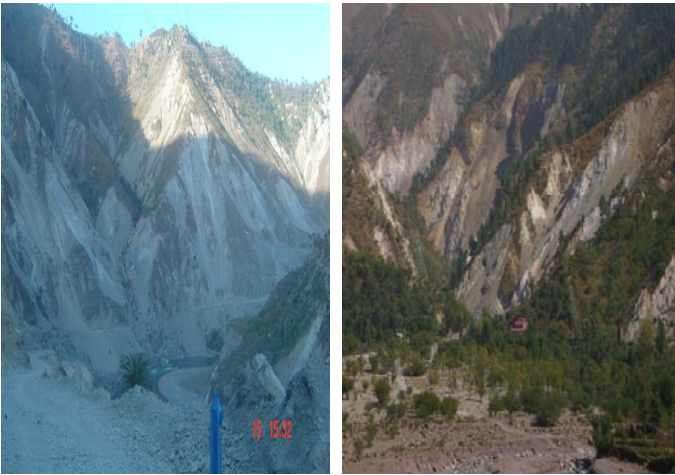
Figure 3. Views of slope failures in Balakot and Muzaffarabad affected areas.

The earthquake produced all kinds of slope failures and landslides ranging from rock fall to deep-seated slope failures, see Figure 3 and 4. This aspect was the most obvious and damaging. The earthquake also left many slopes in meta-stable state. During an aerial reconnaissance immediately after the earthquake, more landslides were noted on the hanging wall side than foot wall of the fault (Bilham et al., 2005). The concentration of the slides was much more along the mid slopes and on slopes which had roads built along them. A series of landslides noted from Balakot to southeast of Muzafarabad, indicate probable surface expression of the causal fault.

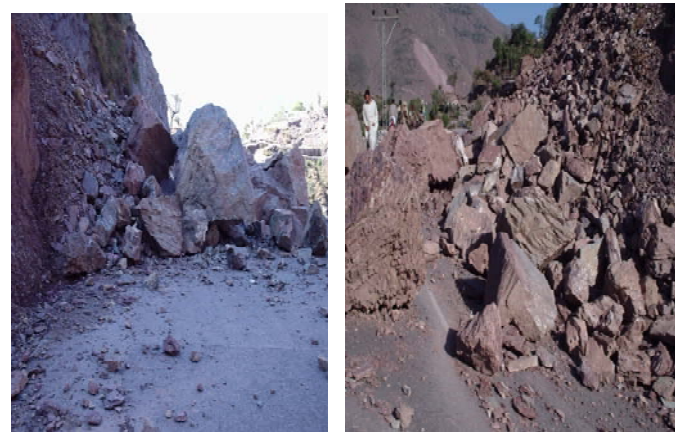
Figure 4. Views of rock falls that blocked the roads at many places.

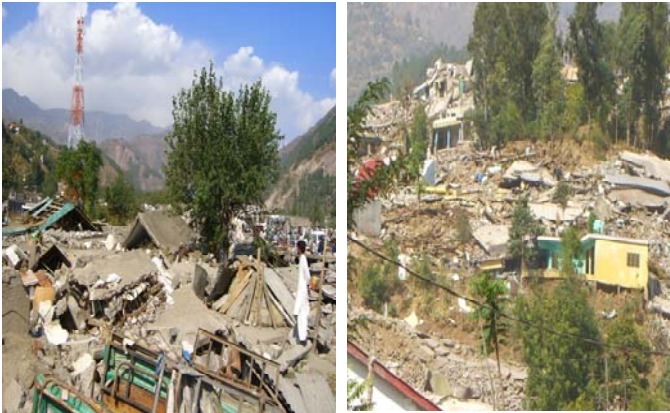
Figure 7. Masonry buildings on slopes were razed to ground in Balakot area.

Ground shaking and deformation adversely affected the typical strip foundations in the entire area. Some concrete brided supported on pile foundations also suffered damages. In rural areas of earthquake affected area, houses were made of stone masonry with mud used as mortar and for plaster. Most of these houses did not have proper foundations. The roofs comprised of metal sheets laid over timber beams supported on stone masonry walls. From all aspects, all these buildings were liable to get collapsed under dynamic loads. In

Damage to structures was lesser around Muzaffarabad and least around Bagh area. Severity of damage to various types and quality of structures is shown in Figure 7 through 12.

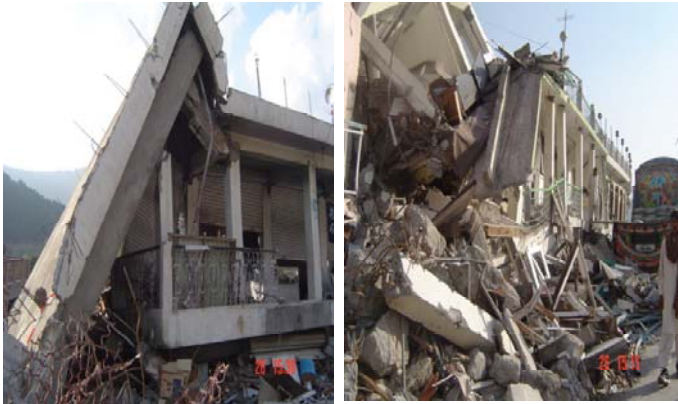
Figure 10. Visible reinforcement; an indication of very poor construction practices.

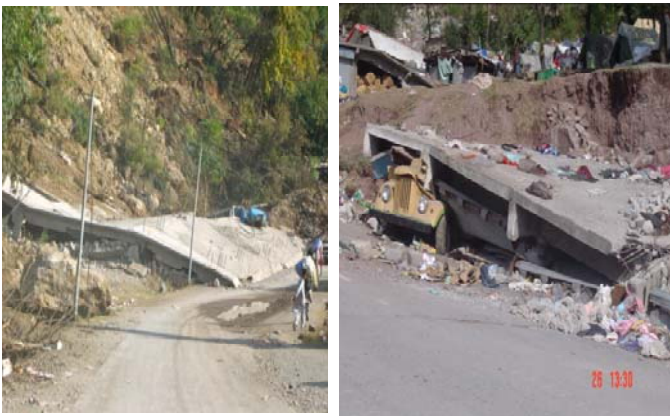
Figure 8. Concrete buildings with poor foundation and construction were collapsed in Balakot area.

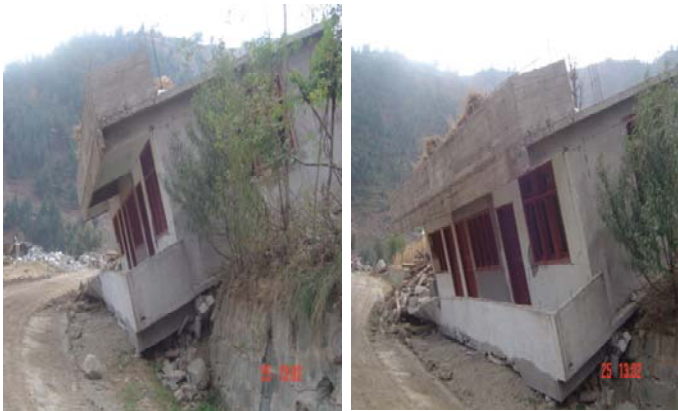
Figure 11. A building displaced laterally but stayed intact; an evidence of good construction.

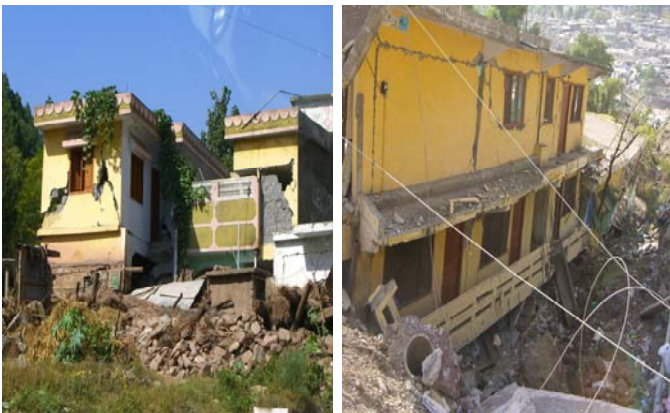
Figure 9. Some buildings with relatively better construction though damaged but withstood the earthquake shaking.

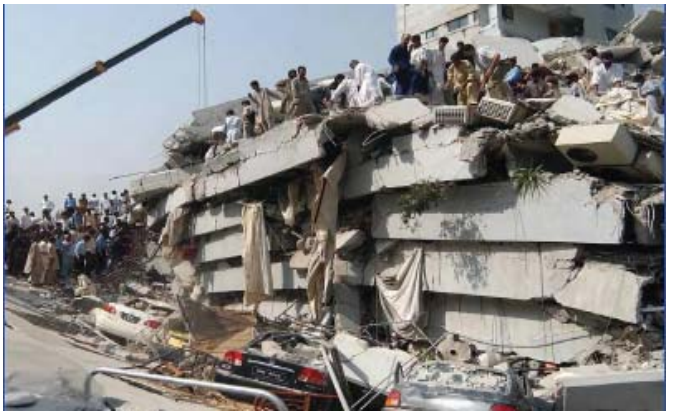
Figure 12. View of a collapsed multi storey building in Islamabad.

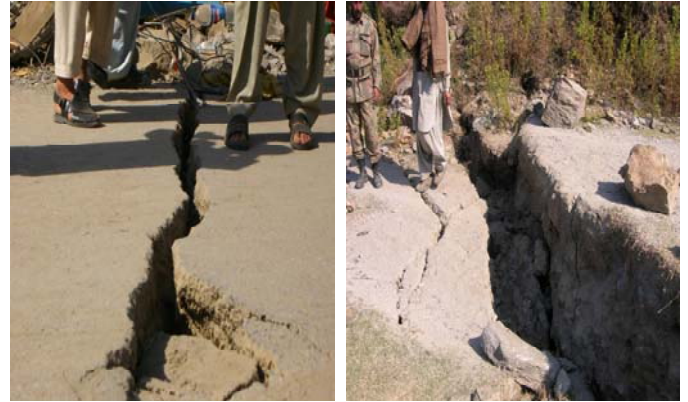
Figure 14. Transverse cracks on roads showing tension cracks.

Most the roads in Kashmir area are made in cut. The slopes are maintained with the help of retaining and toe walls. Most of the retaining structures were razed along with the roads while at other places where roads were holding on, the retaining walls were severely damaged, Figure 13. At places, retaining structures were damaged due to rock falls. On many roads, longitudinal and transverse deep cracks were observed, Figure 14 and 15. Most of the culverts were either collapsed or partially damaged, Figure 16.

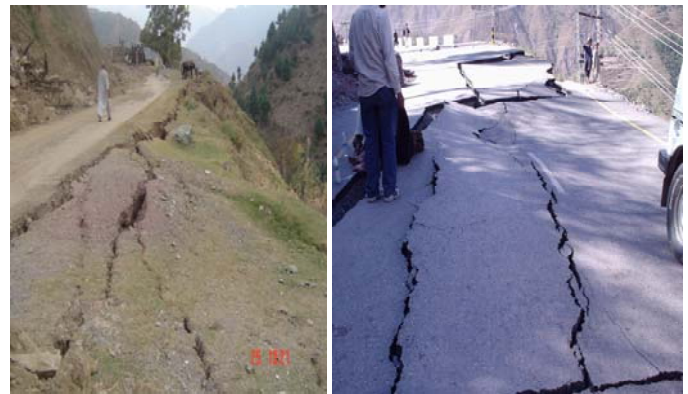
Figure 15. Longitudinal cracks on roads aligned parallel to slopes.

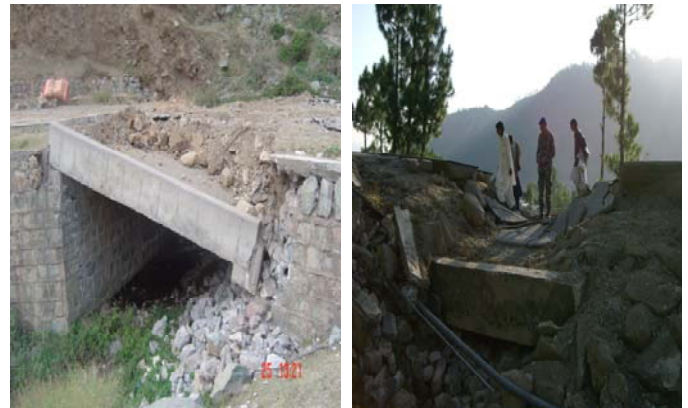
Figure 16. Most of the culverts in most affected area were damaged.

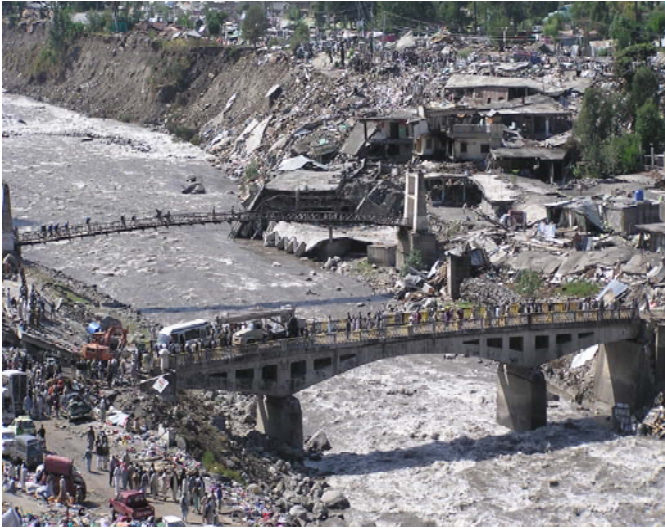
Figure 17. Though buildings on either side of the bridges were destroyed; the concrete and suspension bridge

When compared with other structures, the damage to bridges was minimal except at few places. Lateral displacement of bridges near Balakot and Muzaffarabad was observed, see Figure 17 and 18. Abutment of one of the bridge near Balakot moved almost 8 feet from its original position. Many bridges suffered damages at the joints due to improper joints. Suspension bridges suffered least damage except one located near Muzaffarabad. A landslide washed away its one of the towers along with its anchors, Figure 19. Electric supply lines were extensively disrupted in Balakot and Muzaffarabad, Figure 20.

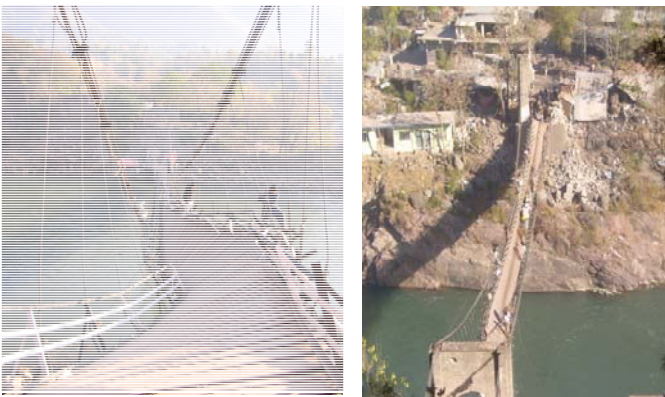
Figure 19. Damage to suspension bridges.

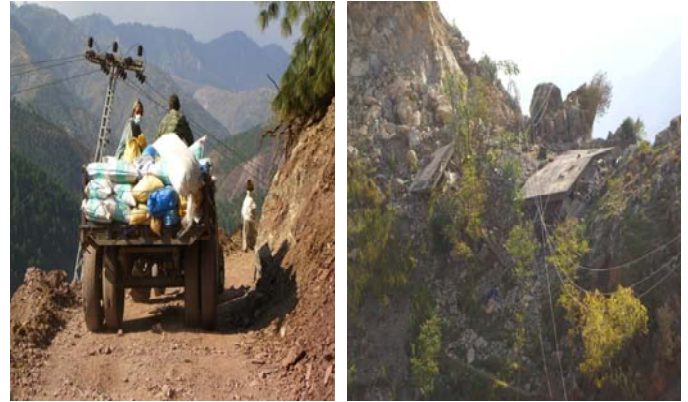
Figure 20. Electric supply lines were severely disrupted.

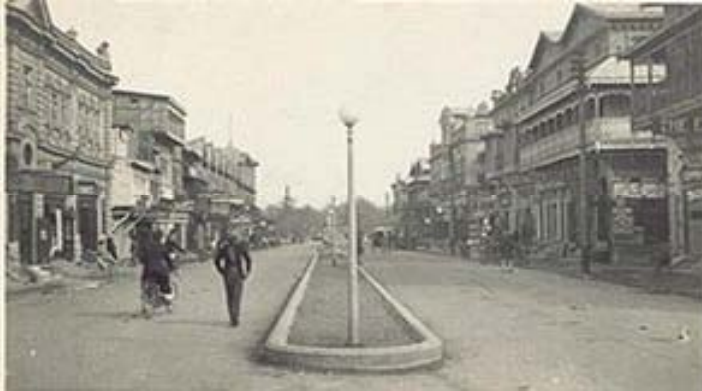
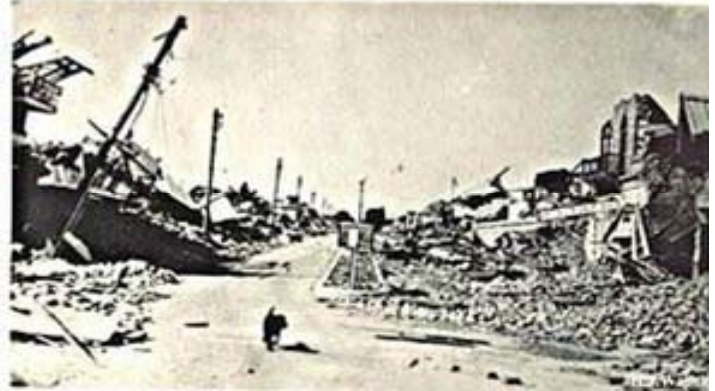
Figure 21. A view of Bruce market before (left) and after (right) the earthquake (Wikipedia.org).

earthquake completely devastated the city of Quetta, leaving 35000-60000 dead and injuring thousands of people in affected areas. The entire infrastructure of Quetta city including roads, railway lines, residential buildings and other lifelines were completely disrupted, see Figure 21.
