Differential Settlements of Cylindrical Steel Storage Tanks: Case of the Marine Terminal of Bejaia

DIFFERENTIAL SETTLEMENTS OF CYLINDRICAL STEEL STORAGE TANKS: CASE OF THE MARINE TERMINAL OF BEJAIA

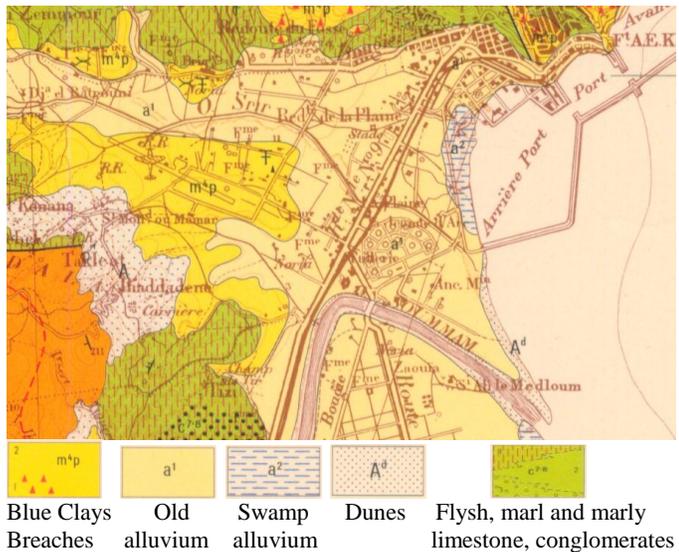
Fig. 1. Extracted of geological map of Bejaia n° 26 (1/50000).

nape basins of the Tell (Roth, 1950). The depression between the mountains of Gouraya, to the north, and Sidi Boudraham to the southwest, has been filled by fine alluvium of the Soummam and Seghir rivers and interpenetrated in transgressive marine deposits (Fig. 1). It consists of sedimentary soil deposits of Quaternary age. The geologic formations found in the region are:

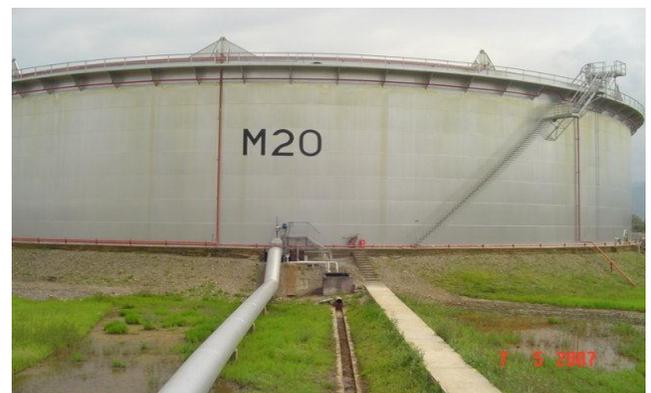
Fig. 3. Oil storage tank.

The marine terminal of Bejaia is a zone of storage of hydrocarbon liquids. It consists of sixteen cylindrical floating roof steel tanks (Fig. 2). The tanks range in capacity from 30 000 to 50 000 m³ with varying diameter ranging from 56 m to 67 m. All the tanks had a height of 16 m (Fig. 3). The tanks were built in 1957. Their structure consists of an assemblage of metallic shells of varying thickness from 8 to 32 mm welded to a flexible foundation made of metallic sheets of 12 mm thick. Inside them slides a steel floating roof weighting approximately 430 tons (Sonatrach, 1991). The tanks were founded on a reconstituted and compacted granular fill, raised from 2 to 3 m above the natural ground level (Fig. 4). The main operating load for structures is the internal pressure of the stored petroleum product whose average density is 0.9. This pressure may change in the process of operation. The operating loads are cyclical. For the serviceability limit state (SLS), when the tank is filled, it transmits to the floor an average stress of approximately 120 kPa.

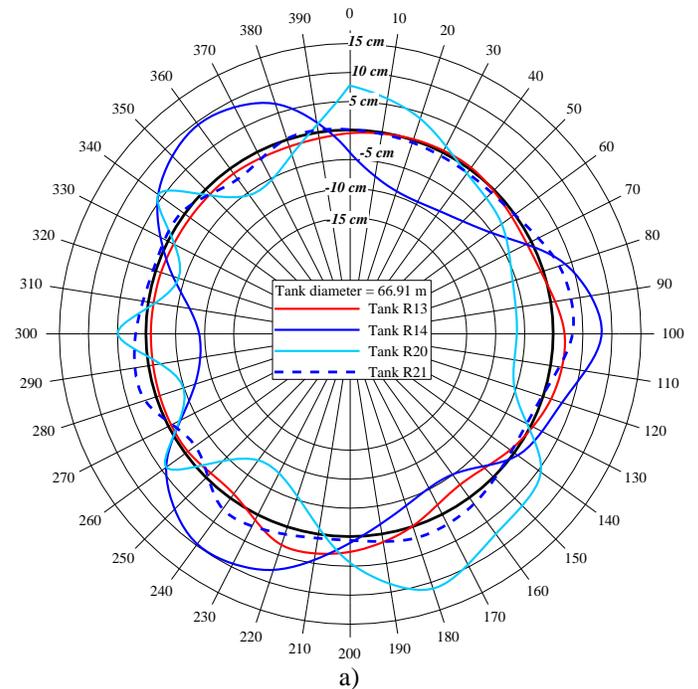
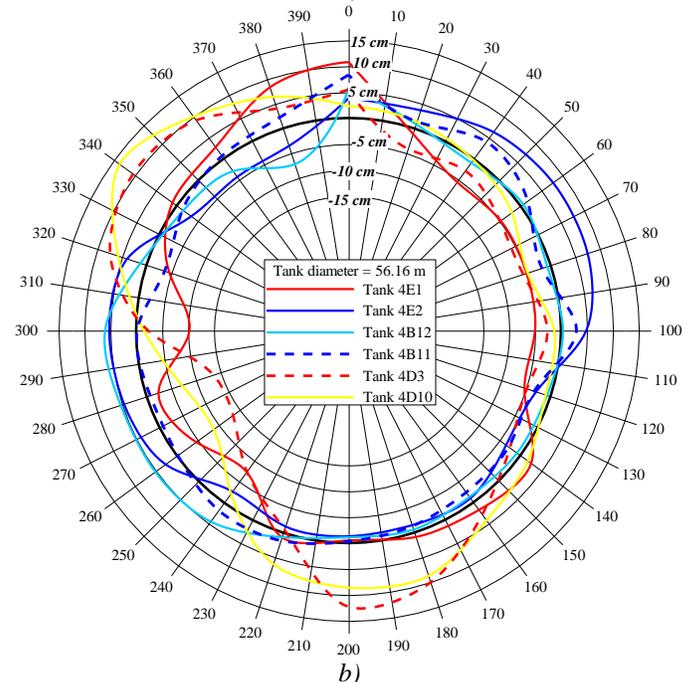
Fig. 6. Ovalisation of tanks (december 1994).

At the end of 1980s, after about 25 years of satisfactory service, the tanks of marine terminal Béjaia were subjected to settlements, ovalization and tilting. Figures 5a and 5b show the ovalisation of some tanks with diameter of 66.91 m and 56.16 m respectively measured in December, 1994. The settlements observed along the perimeter of the three tanks R13, R21, and C9 are shown in Figures 6, 7 and 8. The measured differential settlements reached maximum values of 28 cm, 22 cm and 18 cm for the tanks C9, R13 and R21 respectively (Sonatrach, 2004).

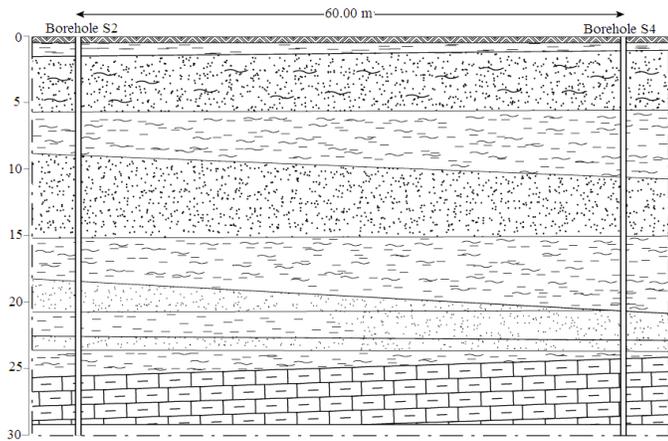
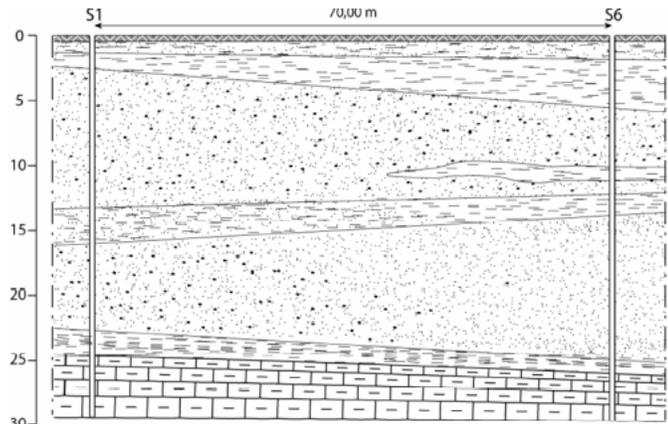
Fig. 9. Typical soil profiles.

Stratigraphy over the sites of the fourth tanks was typically composed of fill about 1.5 m thick, overlying 24 to 28 m thick alluvium clay-sand dominated layers impregnated by muds at the northern marine terminal to sandy and gravelly with intercalation of layers of silty and muddy sand at the Southern Terminal, which is close to the marine environment. All these sedimentary layers are rest on a substratum of gray very stiff to hard marl found to a depth between 25 and 30 m. At the time of the geotechnical investigation, groundwater was encountered at a depth of about 2 m. The ground water level is tidally influenced and at certain times of the year, the groundwater level was just below the ground surface. Typical soil profiles are shown in Figures 9a and 9b. The engineering properties of the soil layers are summarized in table 1 and Figures 10, 11 and 12.

It shows also a lateral heterogeneity of alluvium layers below the tank locations (Fig. 9). This heterogeneity and the compression of soft soil layers underlying the site seem to be responsible for the large differential settlements and tilting experienced by these tanks. The tanks were founded on difficult soil conditions.

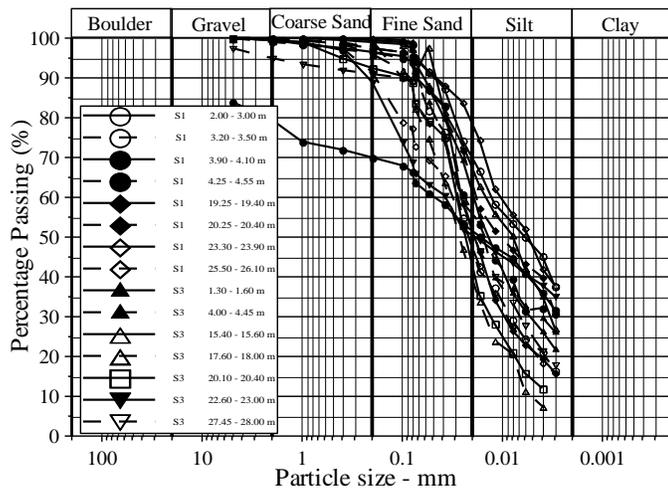
Fig. 10. Size grain distribution.

Grain size distributions (Fig. 10) show that 93 to 100% of the elements have a diameter lower than 0.2 mm and 77 to 100% elements have a diameter lower than 80 μ m (fine sand, silt and clay). The water levels are high; they vary between 21 and 48%. The wet and dry weight volume (γ_d and γ_h) are respectively variables from 11.8 to 17 kN/m³ and 17.5 to 20.8 respectively. The degree of saturation generally varies from 95 to 100%. The clay layers have high plasticity, the plasticity index varies between 27 and 42%, and the liquid limit varies between 53 and 88%. This investigation indicates a low soil consolidation and a high compressibility of the soil layers, the index compression varies between 0.10 to 0.55 (Fig. 12). The results of direct shear and triaxial tests (UU) show dispersion due to the heterogeneity of soils. The friction angles, ϕ , and cohesions, c , obtained by shear tests are respectively variable from 3 to 25° and 10 to 100 kPa. Cohesions are low up to 25 m depth, corresponding to the alluvial and marine deposit and then an increase in the layer of gray marl. From triaxial tests, these values are generally low, ranging between 15 and 75 kPa for the cohesion and 0 to 5° for the friction angle. The tangent modulus E_i and the secant modulus E_{50} , corresponding to a level of 50% of the deviator of rupture most commonly used in geotechnical behavior laws, obtained from triaxial tests are given in table 1.

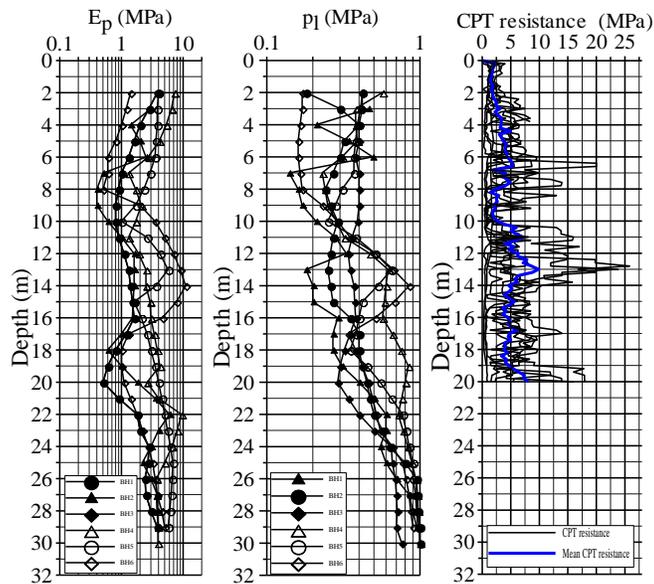
Fig. 13. In situ soil characteristics.

The results of the static penetrometer tests (CPT) show a large variation in tip resistance q_c . Peak strength of 10 to 30 MPa were measured in layers of coarse alluvium (sand and gravel), and between 1 to 2 MPa in layers of silty sands and soft clays (Fig. 13). According to the pressuremeter tests, the limit pressure (p_l) and pressuremeter modulus (E_p) varies between 0.15 and 0.8 MPa and 0.5 to 10 MPa in the first twenty meters (Fig.13). The relative density (D_r) of the layers obtained by different means is given in table 2.

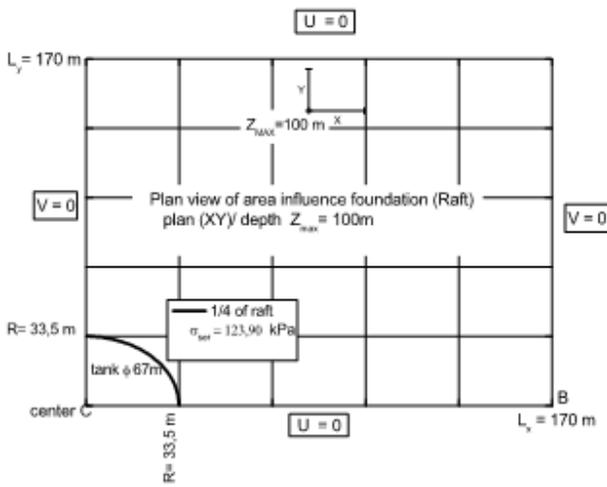
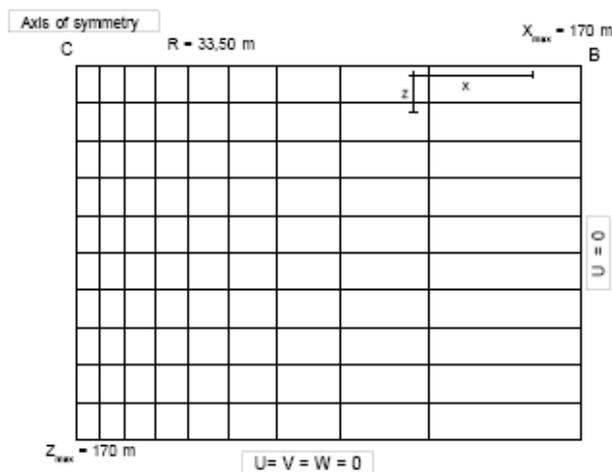
Fig. 17. Geometry and boundary conditions of 2D and 3D models.

four models were considered: linear elasticity, elastoplastic model with Mohr-Coulomb criterion, elastoplastic model with Drucker-Prager criterion and elastoplastic modified Cam-Clay model. Axisymmetric deformation (2D problem) calculations with reasonable assumptions were performed and will be compared with the three dimensional (3D) analysis. It can be expected that the settlements obtained in 2D cross sections would overestimate the settlements. To reduce the complexity and size of the 3D models symmetry axes were defined. Then, only one quarter of the construction is modelled. This is possible because the loaded area is almost symmetric and the influence of the non symmetric outer part of the tank is expected to be negligible. Figures 17a and 17b show the geometry and boundary conditions of 2D and 3D models. Considering the influence of tank of 67 m diameter, the model radius and depth are 170 m and 100 m respectively. The tanks were modeled as structures having a completely flexible base.

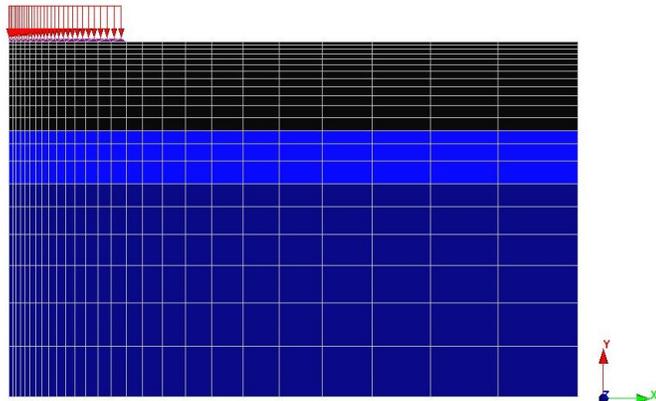
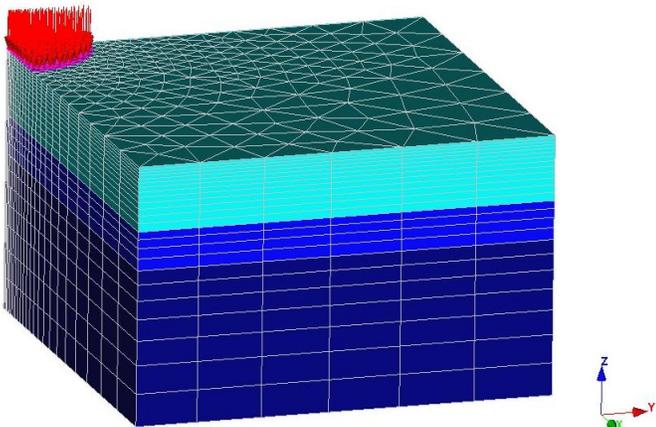
Fig. 19. Finite element mesh.

For the axisymmetric model, 8-node quadrilateral elements were used to model the soil domain and the flexible base of the tank. The 2D model consists of 1795 nodes and 576 isoparametric elements. The 3D model mesh comprised 17002 elements and 46299 nodes. Figures 18a and 18b show a typical finite-element mesh used in the analyses. The serviceability limit state (SLS) is about 120 kPa; it represents the weight of dress, floating roof and the stored crude oil. The input model parameters of each layers used to perform the calculations are summarized in tables 3 and 4.

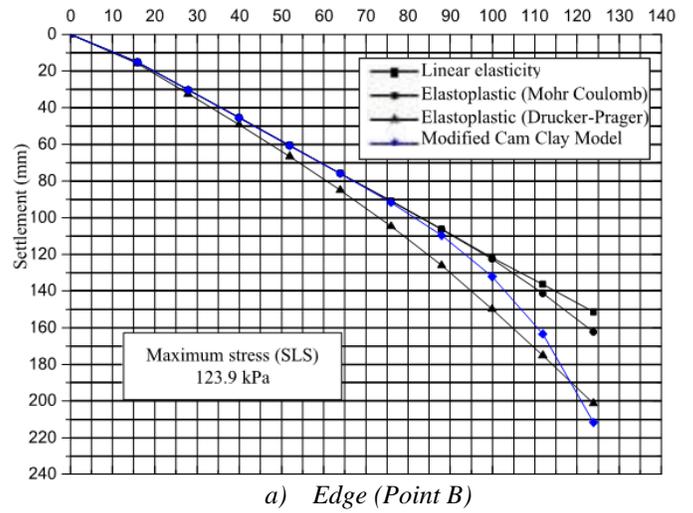
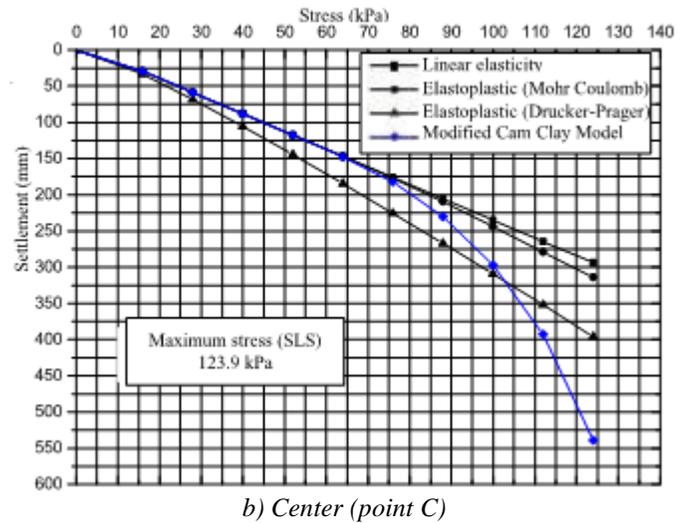
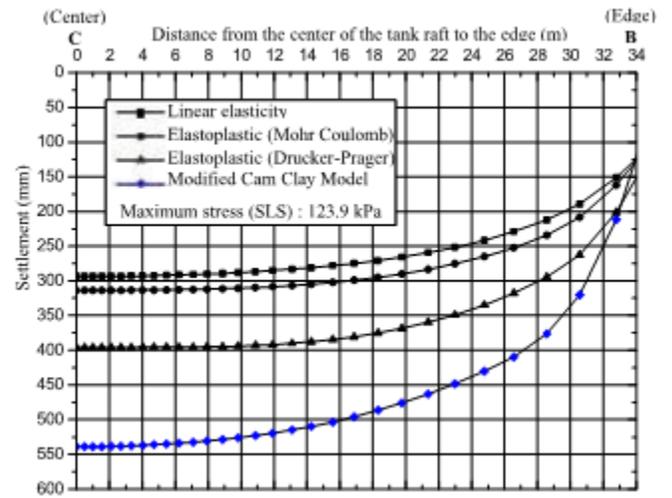
Fig. 19. 2D (axisymmetric) computed settlement.

The calculated settlements under serviceability loads are shown in Figures 19 and 20 for 2D and 3D models. Figures 21a and 21b show the deformed mesh for the two models. Considering the modified Cam Clay model and 3D model, the vertical settlements calculated are about 480 mm at point C (center) and 155 mm at point B (edge). Between point B and C about 325 mm and 332 mm of differential settlements are expected for 3D and 2D model respectively. The predicted differential settlements are excessive. These results are in fairly good agreement with the measured differential settlements, which reached maximum values of 280 mm, 220 mm and 180 mm for the tanks C9, R13 and R21 respectively (Sonatrach, 2004). Taking into account the linear elastic model and the elastoplastic models with Mohr-Coulomb and Drucker-Prager criteria, the predicted differential settlement is approximately about 140 to 200 mm between the edge and the center of the tank for the two considering problems.
