## EVALUATION OF TREATMENT METHODS USED FOR CONSTRUCTION ON EXPANSIVE SOILS IN EGYPT

### ABSTRACT

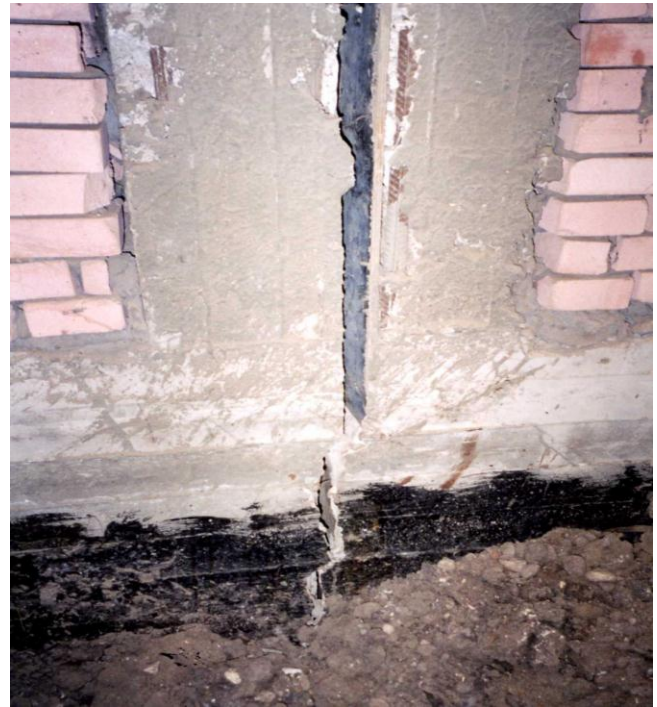
Photo 1: Cracks observed at foundation elements.

were observed at the different structure elements as showed in photo 1.  
 By investigating the expansive soil under and around the main governmental building, it was found in a wet condition, and this was due to water leakage from the nearest groundwater tanks and the irrigation around the building directly. Also it was found that the location of the main building was in a depressed location of the whole site, which enable the rain water and leakage ground water tank to be collected under its footings which was not surrounded with enough replacement soil.

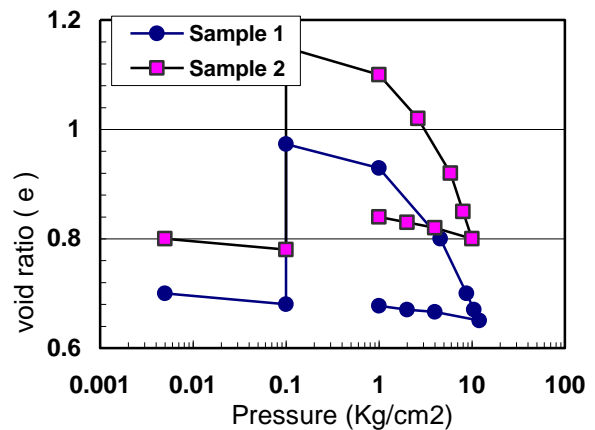
Fig.4. Swelling pressure test for soil, site 3

The tests for soil samples in the laboratory showed that the swelling pressure was very high and was ranged from 8-16 kg/cm<sup>2</sup> for dry soil and the soil bulk density was ranged from 1.97–2.03 t/m<sup>3</sup>. Free swelling index readings were in the range of 100% to 160%, as shown in Fig. 4.

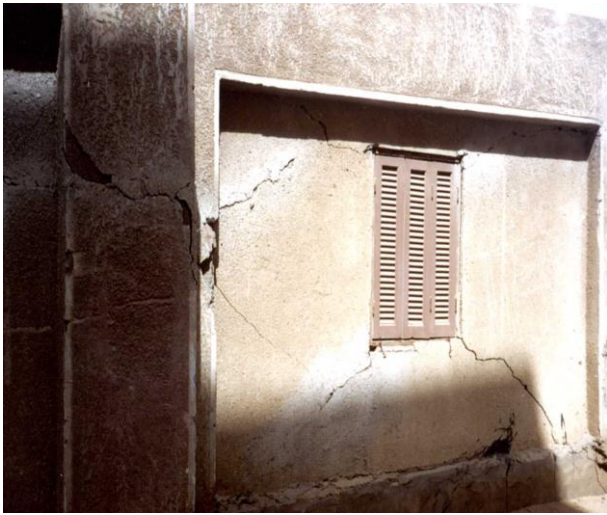
Photo 2. Cracks observed at light structures

The defects were shown at first as cracks in the outer and interior walls and then cracks propagate with time until effect on the concrete members. Photo 2 shows the cracks observed in a light weight building in its outer walls and concrete members.

(5) Making sure that, for light weight structures established on such expansive soils, a more careful should be considered to using the suitable thickness and type of soil replacement and in the same time, making sure that the foundation is more rigid.
