GEOTECHNICAL ISSUES ASSOCIATED WITH THE DESIGN AND CONSTRUCTION OF THE MIDDLE RIVER BRIDGE

Vishnu Diyaljee, Ph.D, P.Eng, F.ASCE
Managing Director, GAEA Engineering Ltd
33 Ashby Field Road, Brampton, Ontario
Canada, L6X 0R4

The existing short single span, single lane, concrete bridge constructed in 1930 across the Middle River in the Town of Mc Kellar, Ontario required replacement as a result of age and sub-standard approach roadway geometrics. In 1986, a geotechnical investigation was undertaken to upgrade the existing bridge. This investigation was undertaken primarily within the river since the new bridge structure was contemplated on an alignment with improved geometrics. The proposed structure was designed but was never constructed. In 2009, the need for a new structure was revived with the idea of placing it on the existing alignment with minor alignment modifications. However, as a result of buried timber being encountered during the geotechnical investigation, conventional drilling had to be abandoned and an air track rig used to ascertain the nature of the subsurface conditions. Thirty two (32) probe holes/boreholes were undertaken to define the preferred location of the

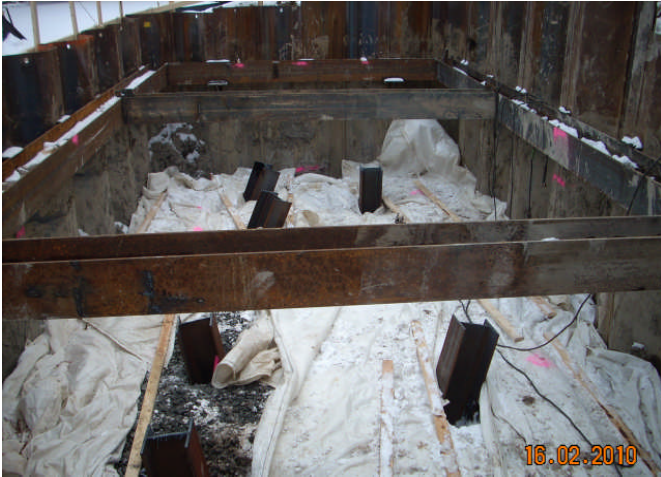
Fig.7. Installation of Abutment Piles some with Reverse Batter

At the west abutment where the rock was inclined approximately 45 degrees the batter of the piles had to be reversed and driven toward the rock face. As a result of loosing horizontal resistance by virtue of reversing the batter a massive concrete dead man had to be constructed and tied to the piles with four dywidag bars. Although some piles slipped at the east abutment, the situation did not require the same treatment as in the case of the west abutment in the case treatment No photos are available showing the remedial work undertaken.
