CONSTRUCTIVE SOLUTIONS TO THE CONSERVATION OF CULTURAL HERITAGE

Miroslav Todorov

University of Architecture, Civil Engineering
and Geodesy (UACEG)
1 Hristo Smirnenski Blvd, Sofia 1046, Bulgaria

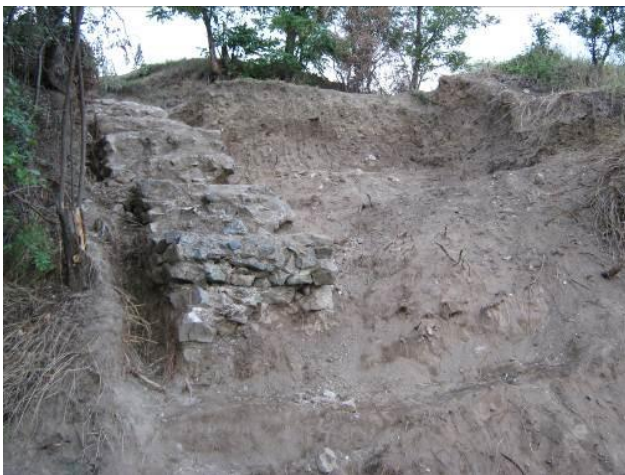
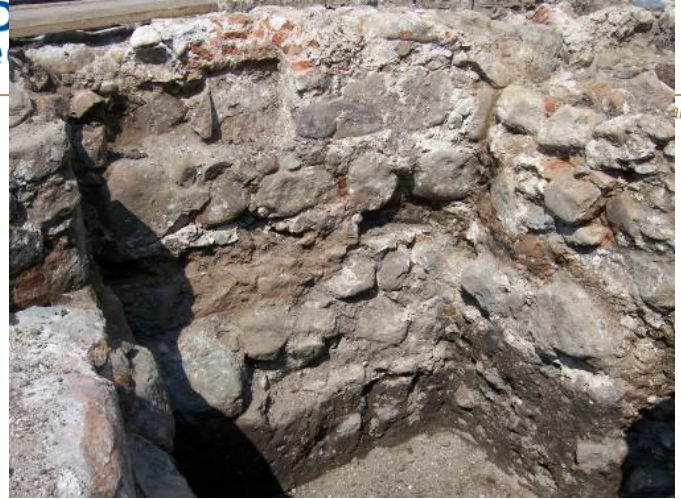
Fig. 1. View of basic wall

The foundations as primary element usually are the most typical reason for destruction of immovable monuments. The foundations in the ancient and medieval monuments are developed as stripes from dry masonry. Mortar, lead brackets and clay substances have been used in some of the monuments. Masonry materials consisted of rough, as well as processed stone (Fig. 1).

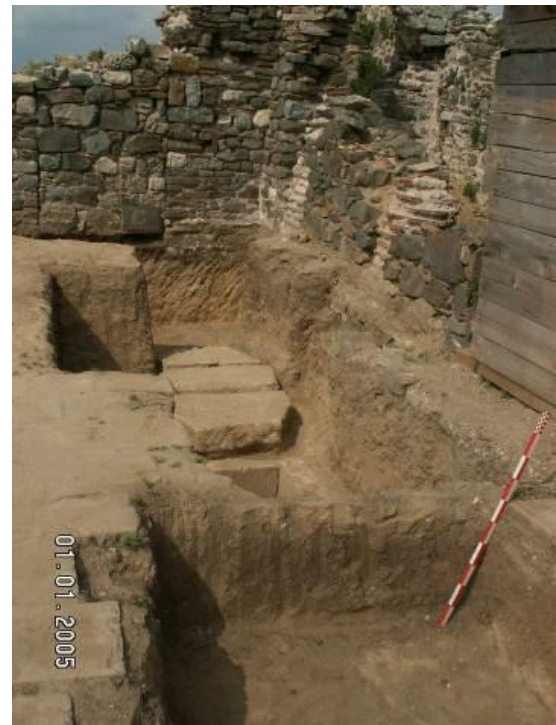
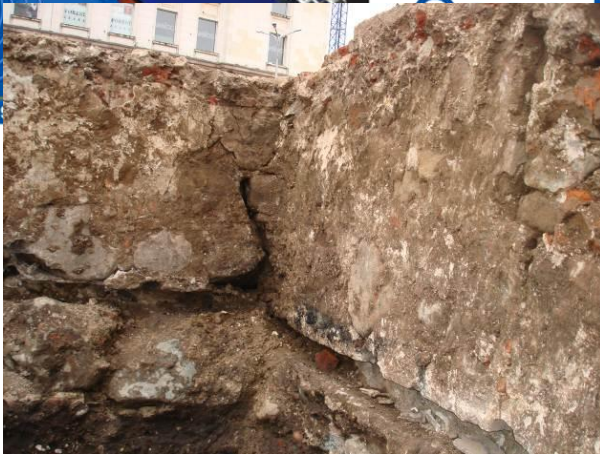
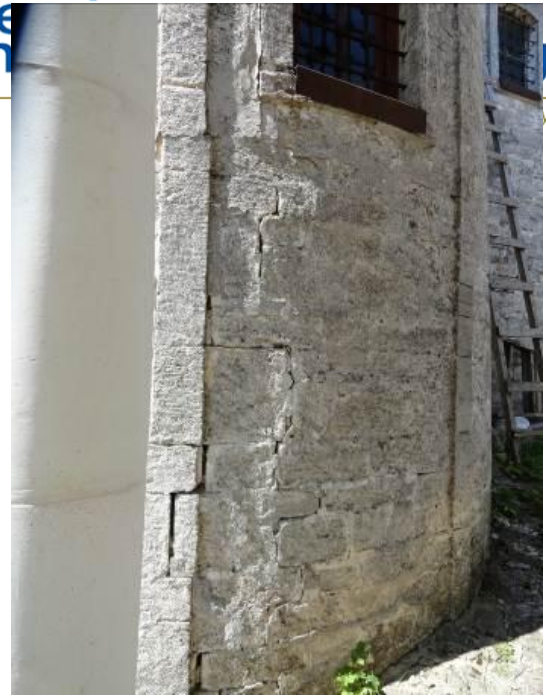
Fig. 2. View of naos (sanctuary) of an ancient temple - addition of secondary building elements

Continuous exploitation of a large part of religious and fortificational buildings has led to numerous reconstructions and additional building. In most cases these reconstructions are substantially different from the original masonry and even more often are not properly implanted in it (Fig. 2).

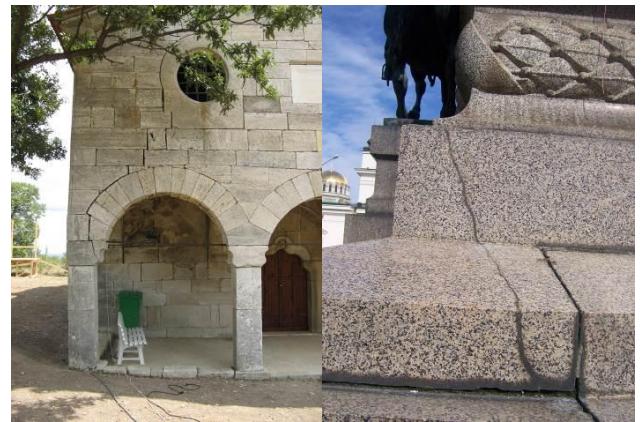
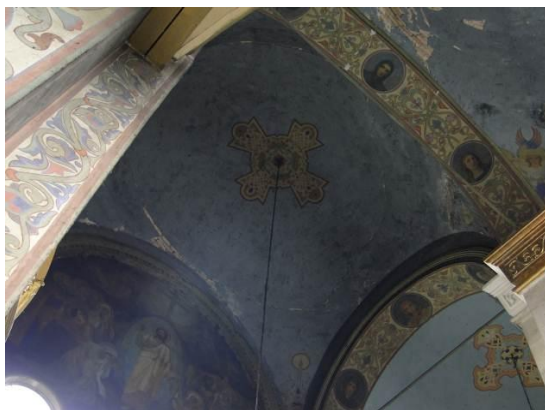
Fig. 3. Characteristic cracks and damages in masonry

On Fig.3 are presented some of the most characteristic defects and damages of masonry structures. Fig.3a illustrates a particularly interesting crack in a church dome as a result from vertical seismic movements. Fig.3b shows the typical cracks in the apse of a church. And Fig. 3c and Fig.3d show characteristic horizontal displacements of the construction, resulting from continuous deformations of the ground.

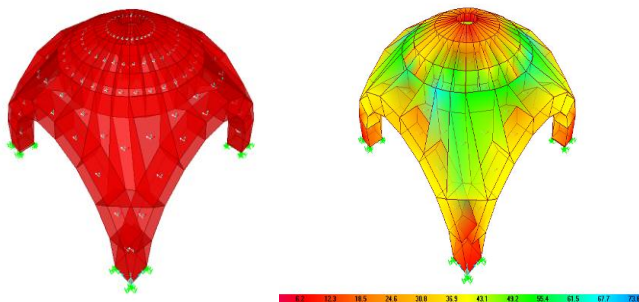
Fig. 4. Model of the dome and tangential stress distribution

The model examining a dome of a temple uses volumetric elastic elements (Solid) with the help of SAP2000 software. Through it was sought a description of the stress and strength conditions under different possible loads during the time. At first sight the presence of the crack running along its entire periphery had no reasonable explanation.

The tensioners of the dome system didn't show any defects in the anchoring zones. The second possible assumption was that the entire vertical pivot system supporting the domes has suffered major horizontal deformations also wasn't confirmed. The research and analysis gave a picture of tangential stress along the entire periphery (cyan coloured zones on Fig.4), which surprised us and this effect occurred after the vertical component of the seismic influence was taken into account.

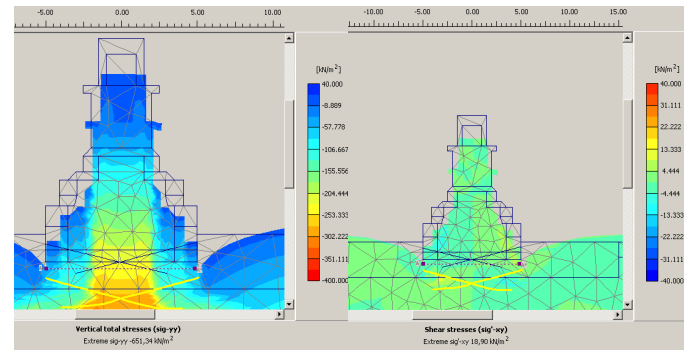
Fig. 5. Normal and tangential stresses in the structure

The second basic defect – wall splitting – was analyzed and studied using another software product - Plaxis. The modelling of the elements was conducted using different soil models, mainly MC, HSM и JRM. These models were used in different combinations, depending on the sufficient amount of parameters, obtained in the study of the materials. The models and part of the results are presented on Fig.5. In the study of this model the zones of concentration of the main tensile stresses, which were the reason for the cracks, were clearly defined. In the zones with high tangential stresses are observed mostly horizontal displacements between two blocks of the masonry.

This two simplified models have given us an opportunity to explain the developing processes. Consequently they allowed future solutions, implemented at the moment.

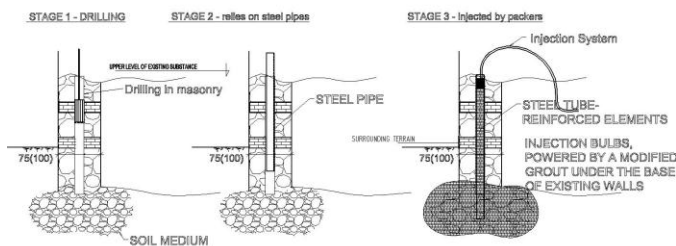
Fig. 6. Schematic diagram of injection

Schematic diagrams for integration of new construction with the old, combined with additional fortification of the base are presented on Fig.6. This solution is used in the reconstruction of numerous (late antiquity, medieval and modern) Orthodox Christian temples and partially some fortificational constructions.

This technique is also successfully used with various diameter of drilling for stabilization of brick walls. It is also successful when using injection solutions, mainly polymeric and in combination with steel and fiberglass rebar. Often it was used for rebaring of highly artistic stone masonry. This technique allows the preservation of both interior and exterior sides of the substance and gives an opportunity to upgrade and conserve it with almost no noticeable effect. The modelling and study, aiming at evaluation of the constructions behaviour,
