## Investigating the Performance of Ground Anchor Through The Failure Slope Disaster in Taiwan

## INVESTIGATING THE PERFORMANCE OF GROUND ANCHOR THROUGH THE FAILURE SLOPE DISASTER IN TAIWAN

At milestone 3.1 km of the Formosa Freeway in northern Taiwan, a landslide occurred on April 25, 2000, causing nearly 200,000 m<sup>3</sup> of earth and rock to slump down onto the freeway below. Four people trapped in cars beneath the collapsed slope died. How such a tremendous slope failure could happen in dry weather without advanced warning is attributed to two key factors: (1) Long-term groundwater infiltration resulting in the softening of thin interlayer between sandstone and shale; (2) Ground anchor corrosion resulting in a decrease in slope stability. Together these two factors caused the slope to reach a critical limit resulting in a collapse. In Taiwan ground anchors have been widely used to improve slope stability along roadways for more than 40 years. After the Formosa Freeway slope collapse the government began a comprehensive survey to examine anchors on the slopes along all freeways. This paper uses finding from this survey as well as information from other slope failure invest

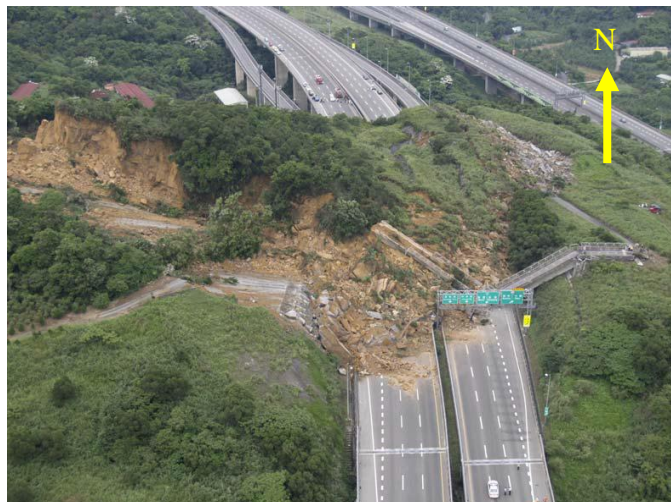
below. Four people trapped in cars beneath the collapsed slope died, as shown in Fig. 1. That slope is 50 meters height cut dip-slope and reinforced by ground anchors.

Fig.1 Photos of slope failure on Formosa Freeway in Taiwan

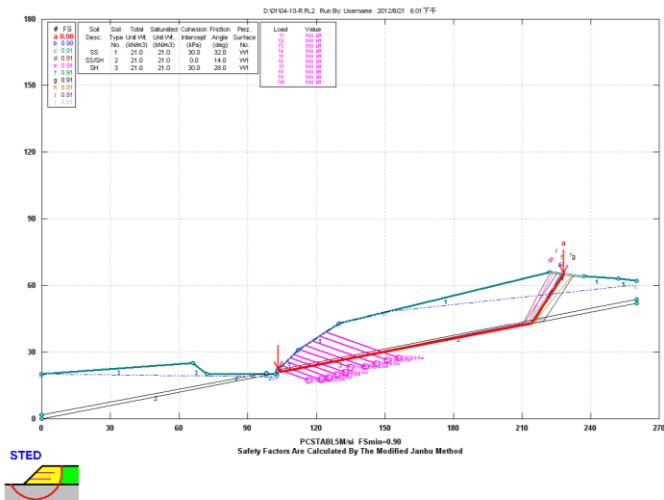
Fig. 3 Slope stability 2D analysis results

Figure 2 shows the photo of original ground anchor slope condition. A 2D slope stability analysis was performed after the slope failure. The soil parameters are referring to the original design report and the investigation works of the disaster and modified by back analysis. Figure 3 shows one of output section of the slope stability analysis results. The softening effect of sliding rock (sandstone and shale rock layer) caused by ground water was taken into consideration by reducing the cohesive strength value (C) from 10 kPa to zero and friction angle value ( $\psi$ ) from  $20^\circ$  to  $14^\circ$ . Figures 4 to 6 are the slope stability analysis results for normal, earthquake and rainfall conditions, respectively. According to these stability analysis results, the 3m layer of sandstone/shale sitting above the rising groundwater level, significantly influences stability conditions and reduce the factor of safety from 1.55 to 0.9, which is below the stability specification requirement. In addition, the possible cases of tendon prestress lose in different percentage because of anchor corrosion or other defects with respect to the slope stability are analysis as shown in Table 1.

The analysis results indicate the mechanism of slope failure to be attributed to two main factors. Surface water runoff seeping into existing cracks of the weathered sandstone weakened the sandstone/shale layers over time eventually contributed to the landslide. Also, corrosion of the ground anchor tendons compromised the strength of the system. Investigative results obtained after the slope failure showed that the tendons were degraded which would have inhibited their strength and durability under stress. However, the case of design earthquake condition may play another role on its slope stability, even though no such large earthquake was happen just before this slope failure, the past earthquakes could be gradually reduced the prestress of the ground anchors. Ultimately the runoff seepage compromised the rock strength in the interface of the sliding plane and then corroded tendons not able to withstand the sliding force allowed the slope to become unstable resulting in a landslide.

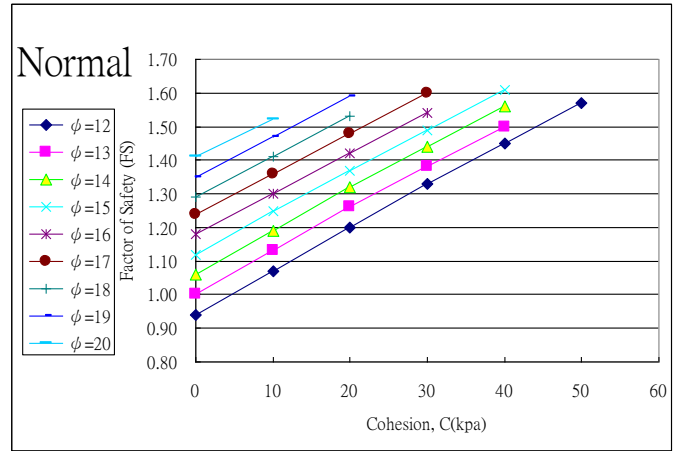
Fig. 4 Slope stability analysis results by reducing the strength value for Normal condition

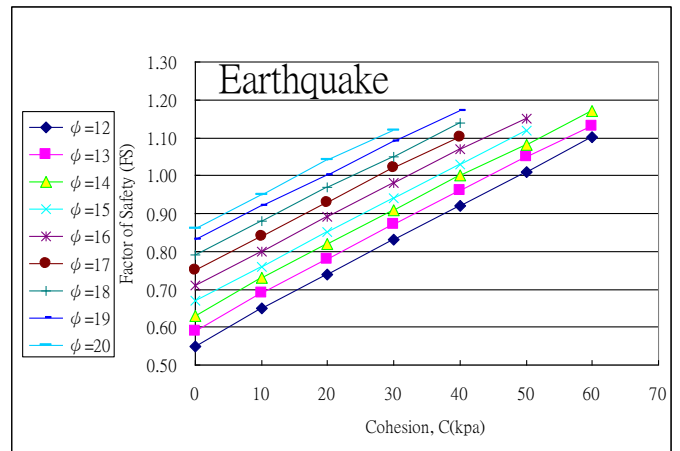
Fig. 5 Slope stability analysis results by reducing the strength value for Earthquake condition

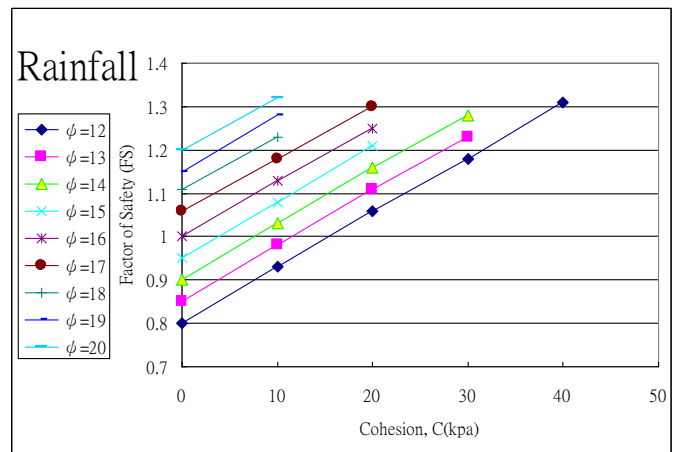
Fig. 6 Slope stability analysis results by reducing the strength value for Rainfall condition

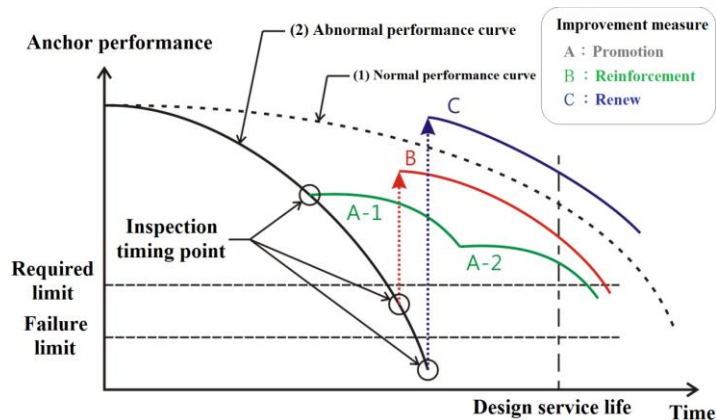
Due to the creep of the ground anchor system, the load capacity of the tendon decreased during its lifetime. Creep is generally evaluated by the cyclic loading test. Figure 7 shows the schematic diagram of the ground anchor performance curve for its life cycle. It indicates that under normal conditions the performance of permanent ground anchors should remain higher than the required limit for the duration of its life. To meet this requirement the ground anchor needs to be inspected periodically and maintained as needed. If results indicated that the anchor has a decreased performance, measures should be taken to remedy this, as in curve A, Fig. 7. If the anchor is performing below the required limit, reinforcement is necessary, like curve B in Fig.7. Lastly, if performance is below the failure limit, the anchor should be replaced, shown in curve C, Fig. 7.

Fig. 7 Relationship between anchor performance and design service life (Modify from Public Works Research Institute , 2008)

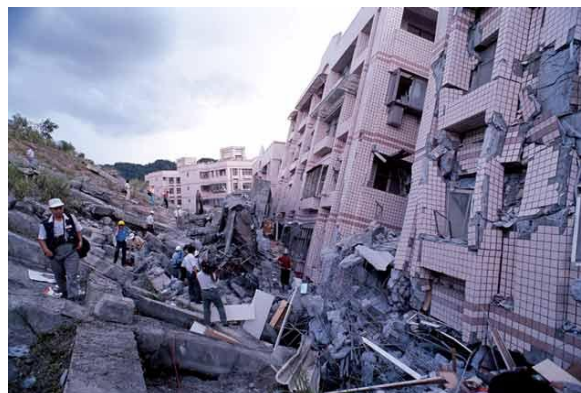
After the landslide at Lincoln Mansion in 1997 claimed the lives of civilians, shown in Fig. 8, Taiwan took note of ground anchors. Requirements became more stringent for inspections, design and construction, and the use of ground anchors on permanent retaining structures were debated. Then, on April 25, 2000, tragedy struck again with the slope collapse on the Formosa Freeway. After a thorough inspection of the ground anchors on the freeway slope, several problems were discovered including insufficient inspections, inappropriate construction methods, and maintenance defects. The sources of the failures and inspection techniques are given as follows:

Fig. 8 Landslide of Lincoln Mansion in 1997

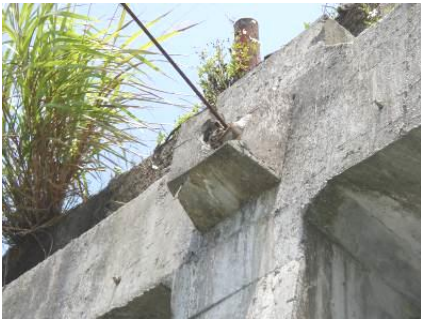
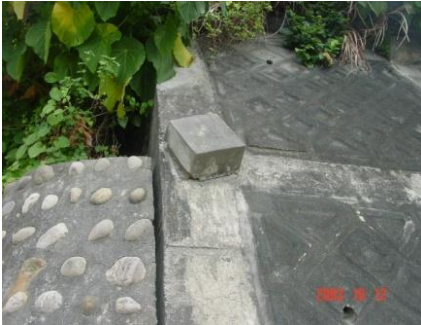
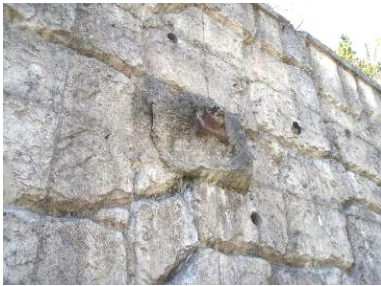
(1) Failure of anchor head: visual inspection for cracks or flaking of the concrete blocks, tendons shifted up, and departure or rotation of the anchor head, shown in Fig. 9. Efflorescence or groundwater seepage, rupture of the bearing structure and topsoil hollowed, along with other signs of disturbance.

Fig. 9 (a) Tendon fracture and shoot out

Fig. 9 (b) Depart or rotate of the anchor head

Fig. 9 (c) Cracks or flake off of the concrete blocks

Fig. 9 Failure of anchor head and concrete blocks

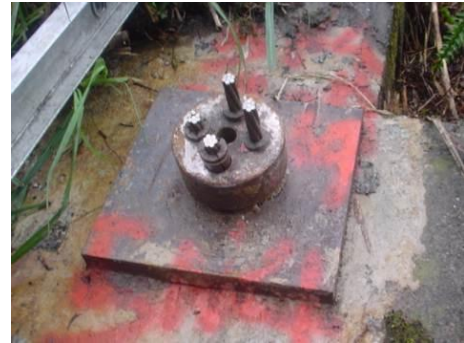
tendons behind the head, an endoscope is used to observe the corrosion and breaking condition of the tendons behind the anchor head and the free length. Common problems include tendons with angular bending, shown in Fig. 10. Other conditions to look for include tendon shrinkage, corrosion of anchor heads and wedges, lack of grout in the free length, corrosion and breaking of tendons, shown in Fig. 11.

Fig. 10 (a) Schematic diagram of tendons angular bending

Fig. 10 (b) Tendons uneven shrink caused by angular bending

Fig. 10 Tendons angular bending conditions

orthogonal. In addition, the embedded casing in the retaining structure should sit in the correct angle and be fixed together with an end plate; this is usually conducted by welding them together to the rebar of the retaining structure before the structure concrete grouting. For non-orthogonal conditions, an unexpected angular bending will form in the tendon and reduce the performance of ground anchor.

(4) If the angle between the surface of earth retaining structures and ground anchors is not orthogonal, or the angle plate is not fixed in the retaining structures, then ground anchors will produce angular bending or loss of function, and may cause serious damage. It is recommended that the bearing plate and trumpet be welded and put together with the embedded hole pipe, to avoid angle offset and produce angular bending after the anchor stressing.

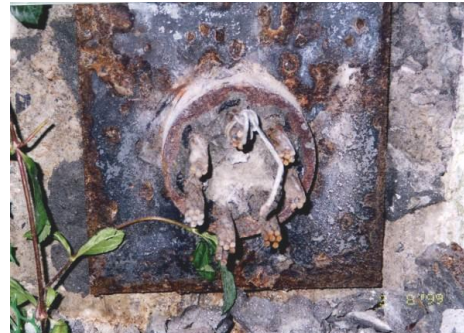
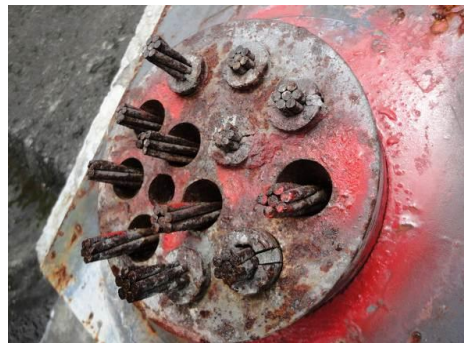
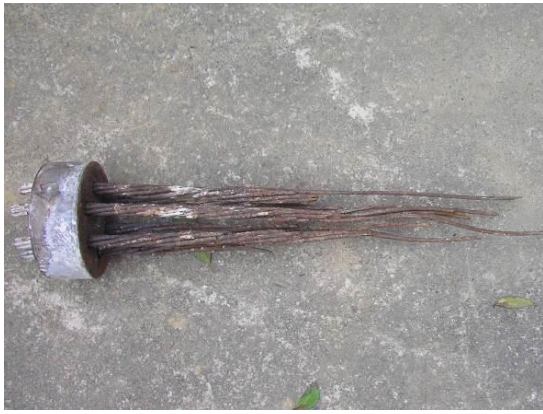
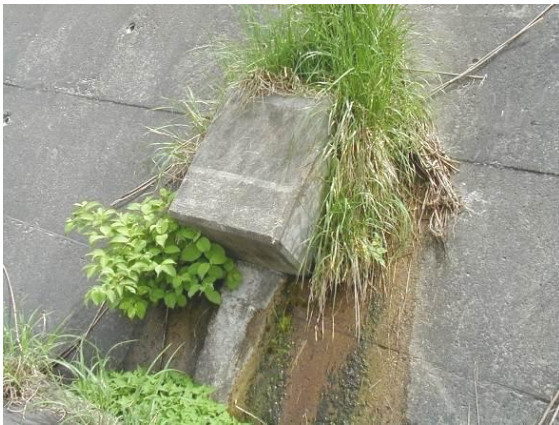
Fig. 11 (a) Anchor head corrosion

Fig. 11 (b) Tendons shrink ; Corrosion of anchor head and the wedges slip

Fig. 11 (c) Corrosion and breaking of free length tendons

Fig. 11 (d) Efflorescence or groundwater seeping out  
Fig. 11 Anchor head corrosion and wedges slip and breaking of tendons

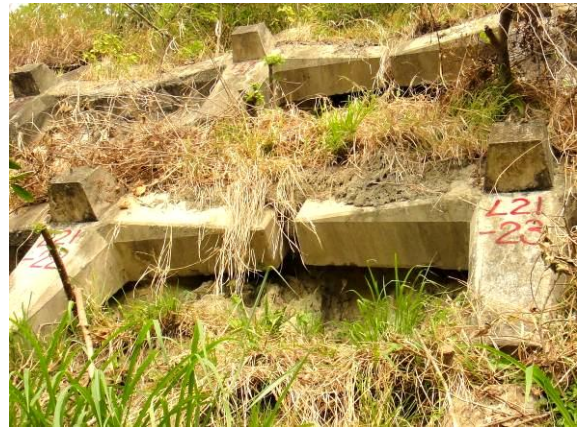
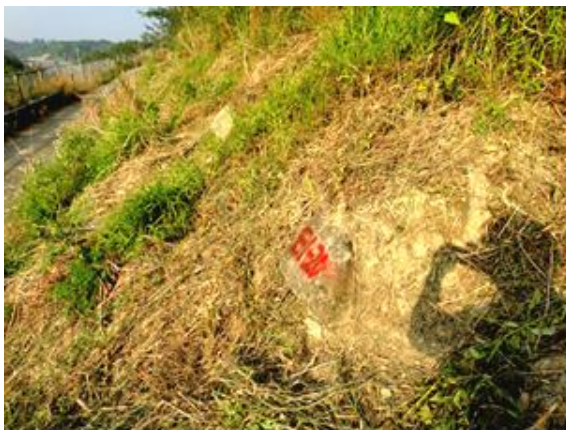
Fig. 12 (b) Topsoil hollowed  
Fig. 12 Prestressing lose conditions

Fig. 12 (a) Anchor head sink in creep soil

the design loads. However, the prestressing load may decrease because of soil creep, tendon corrosion and hollowed topsoil, shown in Fig. 12. On the contrary, the prestressing load may increase because of slope sliding, increased ground water pressure or swelling of the slope material, shown in Fig. 13.

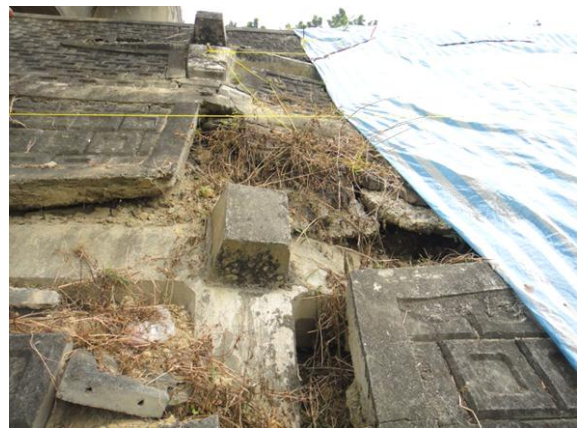
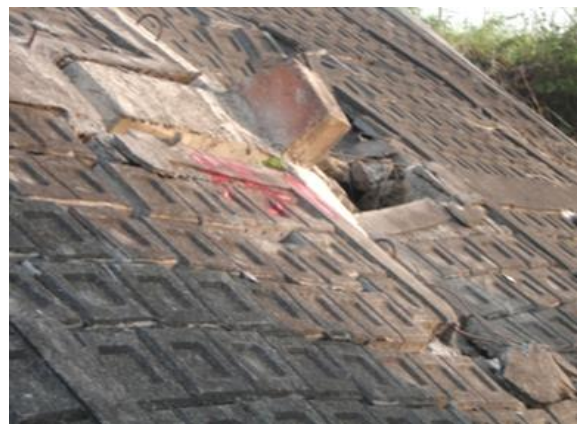
Fig. 13 (a) Prestressing load increase because of slope sliding

Fig. 13 (b) Anchor head sink  
Fig. 13 Failure conditions of anchor head

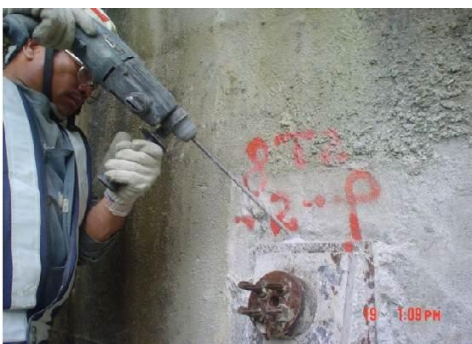
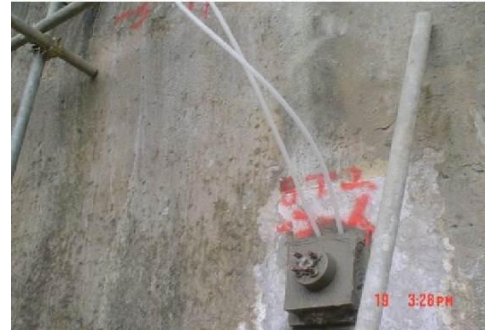
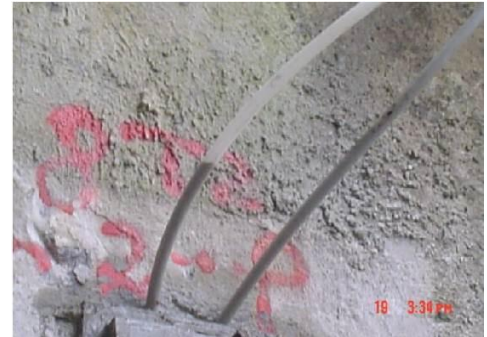
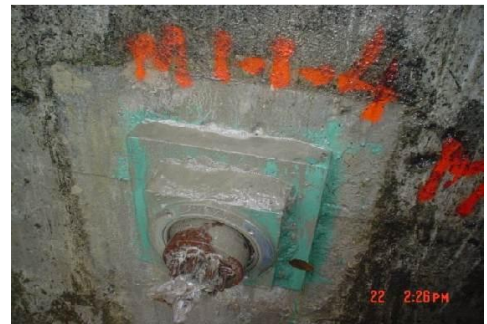
To conquer this problem of uncompleted grout, there were two methods proposed for a case in northern Taiwan before comprehensive construction work commenced. These two methods consisted of performing tests of ground anchors in the field and grouting by gravity type and pressure type, respectively. The grouting effectiveness can be check by grubbing the ground anchor out and cutting the grouting block to observe the cross sections. Based on the observation results, the grouting sections were found to be full of grout. Even the most difficult dead space for grouting, just behind the anchorage head, was full. The reasons for this successful grouting can be attributed to three key points. (1) Setting air vent holes (grout exit when overflow) on top of the anchor hole; (2) Exclusion of air bubbles and draining of water while grouting; (3) Supplemental grout during shrinkage, this can be applied by gravity or pressure methods. Figure 15 shows the construction process for improved grouting for the corrosion protection in unbounded length.

Fig. 15 (a) Drilling grout exit or air vent hole

Fig. 15 (b) Setting grouting pipe and air vent pipe

Fig. 15 (c) Exclude air bubbles and bleeding water in process of grouting

Fig. 15 (d) Grouting Completed

Fig. 15 Construction process of improve grouting for the corrosion protection in unbound length

(3) For effective grout that prevents corrosion in the free length of ground anchor, at least three key points are relevant: setting up the vent near the highest point of the anchor hole; keeping the grouting process in a fully exhaust condition; let the slurry be mutually complementary at any time during the bleeding and shrinkage process of the grout. Ground anchor free length corrosion grouting should achieve full grouting conditions. Respecting whether or not such corrosion performance can fit the expected function in design life is still worth discussing.

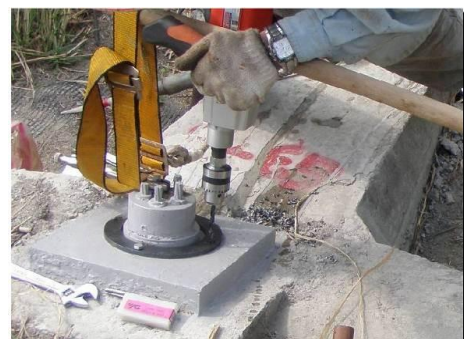
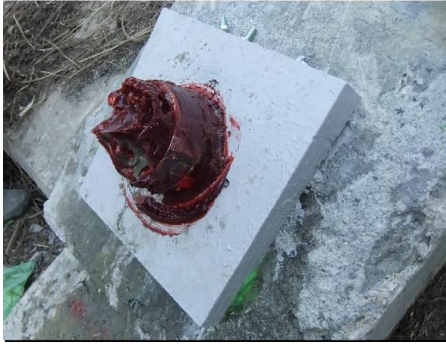
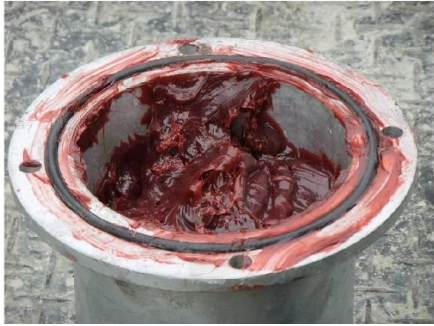
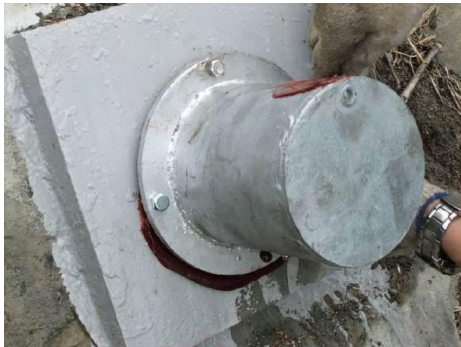
Once the anchor head is corroded, it is very difficult to protect the wedges and tendons. To improve corrosion of the anchor head the rusts on the surface of the tendons and wedges must be cleaned out and coated with anti-rust paint. Finally, the cover is replaced after being filled with a corrosion-inhibiting compound, as shown in Fig. 16.

Fig. 16 (a) drilling screw hole on bearing plate

Fig. 16 (b) filled anchor head with corrosion-inhibiting compound

Fig. 16 (c) cover filled with 1/3~1/2 corrosion-inhibiting compound

Fig. 16 (d) fixed galvanized cover with bolts  
Fig. 16 Construction process of corrosion-inhibiting cover
