A New Look at Landslides of the Vermilion and Echo Cliffs, Northern Arizona

Conor M. Watkins

J. David Rogers

C. M. Watkins and J. D. Rogers, "A New Look at Landslides of the Vermilion and Echo Cliffs, Northern Arizona," *Environmental and Engineering Geoscience*, vol. 28, no. 2, pp. 173 - 192, Geological Society of America, May 2022.

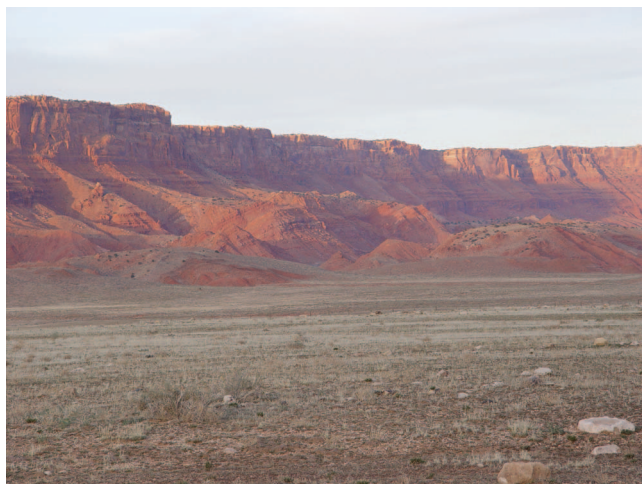
Figure 2. Hummocky landslides mantle much of the Vermilion and Echo Cliffs escarpments. This shows the rotational slumps (Toreva blocks) that typify the western Vermilion Cliffs.

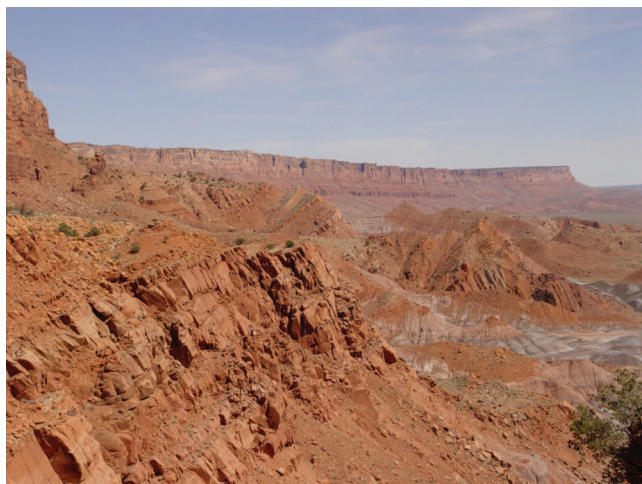
Figure 7. The rotational slumps of the western Vermilion Cliffs were first described by Davis (1901) and Strahler (1940). Multiple sequences of landslides are present along the escarpment, suggesting a sustained history of cliff retreat via retrogressive mass wasting.

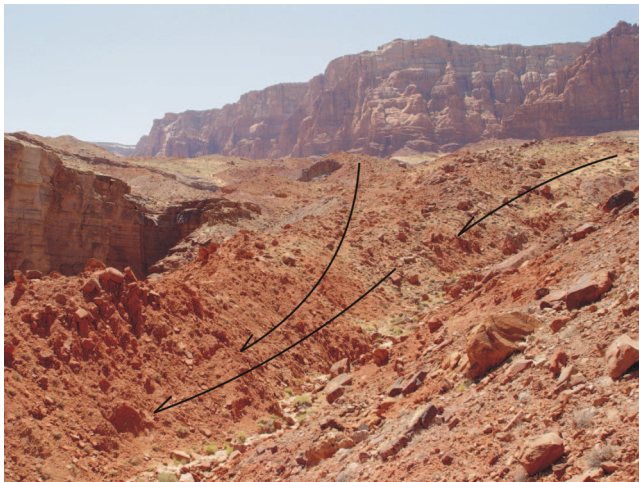
Figure 13. Disaggregated landslide debris mantling the Vermilion and Echo Cliffs, above and below the prominent Shinarump Bench near Lee's Ferry. These landslides are strikingly different from those observed elsewhere along the Vermilion Cliffs, which are much further from the Colorado River. The clasts are angular and chaotic, without organized structure.

Bench (Figures 12 and 13), suggest that different mechanisms of mass wasting were once operative in this area, closer to the Colorado River (Figure 14). The rapid draining of the temporary reservoirs impounded behind the lava dams could have triggered landslides flooded in the overconsolidated Chinle shale, which is exposed along the eastern Vermilion and northern Echo Cliff escarpments. The concept of slope failures triggered by rapid drawdown was introduced by Casagrande (1950).

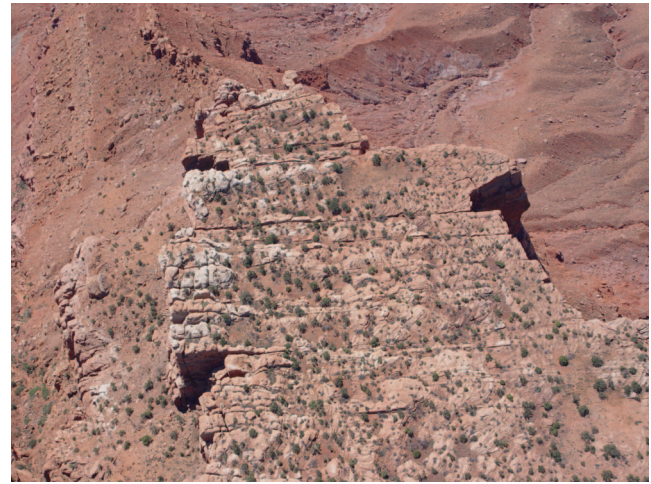
Figure 14. Aerial oblique view of the crest of the Vermilion Cliffs showing increasing dilation of regional joints (up to 1.5 m) in the Navajo Sandstone at the precipice of the escarpment. This is likely caused by creep of the softer Chinle beds, lying below the Jurassic section. Strain softening likely precedes landsliding along the escarpment.

The Navajo Sandstone is permeable and systematically jointed, with at least two major sets being nearly vertical (Rogers, 1982; see Figure 14, above). These characteristics allow precipitation falling on the Paria Plateau to easily infiltrate the sandstone and the underlying formations. However, the underlying shales of the

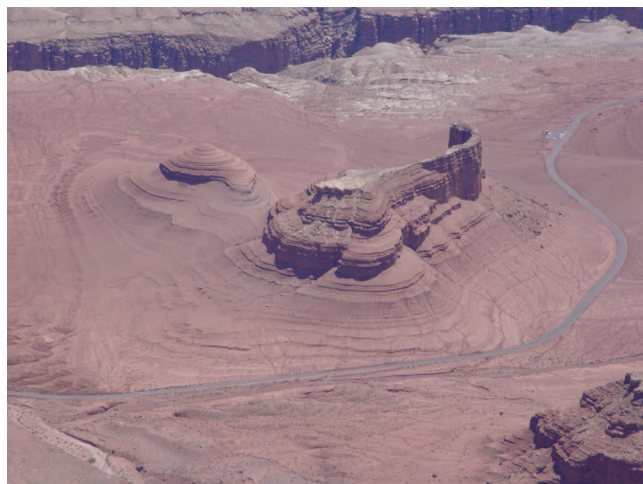
Figure 16. Rounded topography near Lee's Ferry resembles that of modern-day dry lake beds. This shows the smoothed bedding of the Moenkopi outcrops unique to this area.
