## **LESSONS FROM THE SEISMIC PERFORMANCE OF PILE-SUPPORTED BRIDGES AFFECTED BY LIQUEFACTION DURING THE M8.8 2010 MAULE CHILE EARTHQUAKE**

### **ABSTRACT**

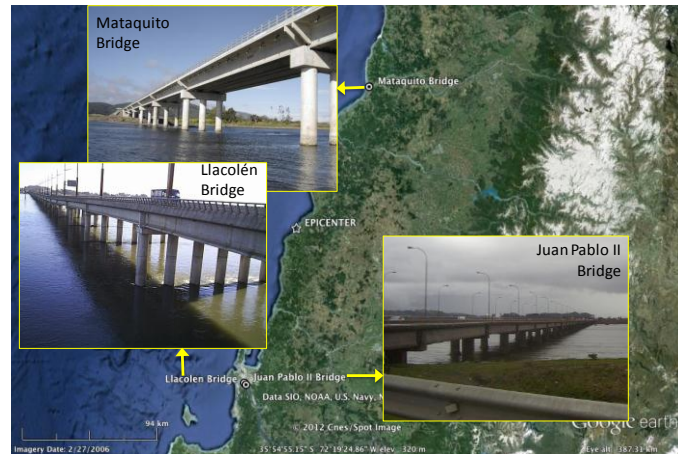
Fig. 1. Location and pre-earthquake photos of the three selected bridges.

in 2000), Juan Pablo II Bridge (1973), La Mochita Bridge (2005), Puente Viejo Bridge (Old Bío-Bío Bridge, 1942) and Bío-Bío Railroad Bridge (1889). During the 2010 Maule earthquake, all of these bridges experienced different levels of structural damage, compromising normal business activities in the region. The most common geotechnical failure mechanism observed at these bridges was liquefaction-induced lateral spreading that occurred along both shores of the Bío-Bío River. Lateral spreading contributed to approach fill deformations. The most extensive lateral spreading-induced damage occurred on the Concepción end of Llacolén and Juan Pablo II bridges. These two cases, along with the case of Mataquito Bridge, near Iloca (to the north of the epicenter area), are described and analyzed in this paper (Fig. 1).

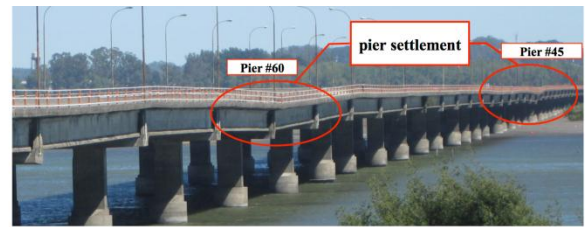
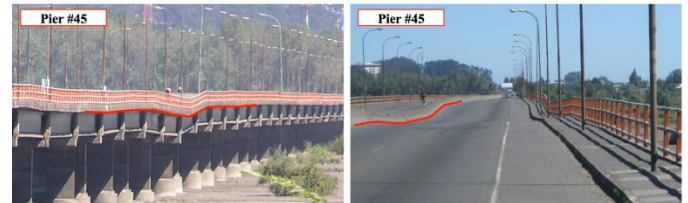
Fig. 8. Liquefaction-induced vertical settlement along the Juan Pablo II Bridge.

Column shear failure, vertical displacements of the bridge deck of up to 1 m, and rotation of the bridge bent of  $1^\circ$  to  $3^\circ$  occurred at the northeast approach (Fig. 9). In contrast with the damage observed at the northeast approach, the southwest approach suffered minor damage. This may be due to a combination of different soils conditions and more gentle slopes observed at the southwest approach.

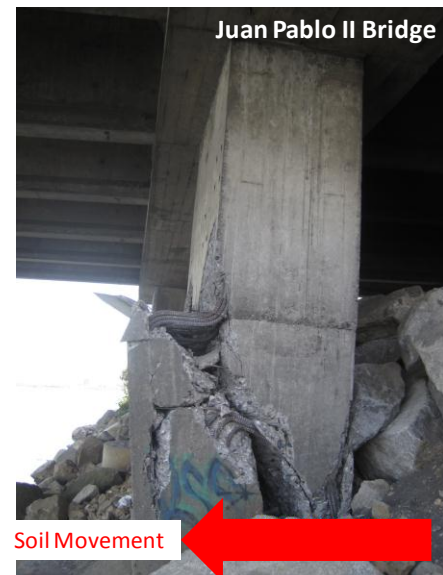
Fig. 9. Failed pier at the north end of the Juan Pablo II Bridge.

The result of this analysis is shown with a black line in Fig. 13. This simplified analysis shows that the expected lateral displacement at this abutment ( $>20$  cm) is consistent with the shear failure of the supporting column (Fig. 9).

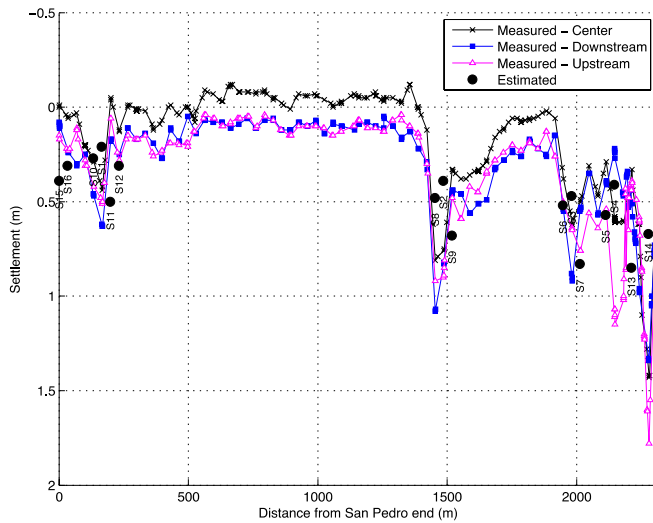
Fig. 10. Measured and estimated settlements along the Juan Pablo II Bridge.

Pier settlements of 0.4 m to 1.5 m were observed at several locations along the bridge (Fig. 10). The bridge deck accommodated these settlements with large vertical deformations, however relatively minor damage of the asphaltic layer was observed. As Fig. 10 shows, settlements of some piers were sometimes larger on the upstream or downstream side, indicating rotation of these bents about the longitudinal axis of the bridge. Soil in the vicinity of the piers showed evidence of ejected water and sand, while soil immediately surrounding the pier was depressed with standing water covering an annular zone around the pier.

The resultant profile of average estimated settlements is also depicted in Figure 10 using black circles. The reasonably good agreement between the estimated and measured deformations suggests that the vertical settlement profile along the Juan Pablo II Bridge can be partially explained by a combination of insufficient end bearing support of the piles and a down-drag effect of the liquefied material that surrounded the piles.
