## **CLOSURE AND POST-CLOSURE REDEVELOPMENT OF THE McCOLL SUPERFUND SITE**

**Edward Kavazanjian, Jr.**

### **ABSTRACT**

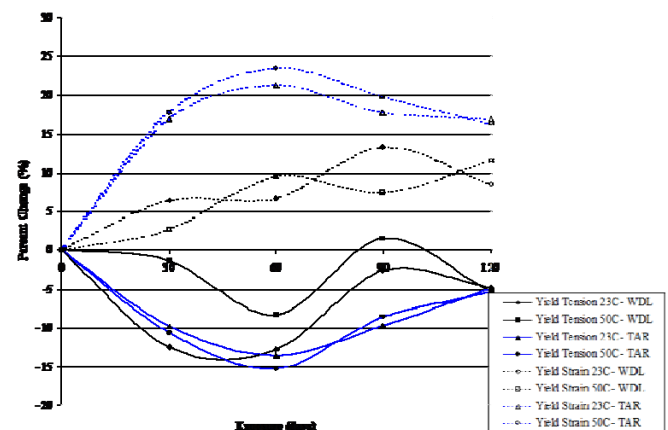
Fig. 4. Chemical compatibility testing of HDPE geomembrane using viscous waste (TAR) and waste-derived liquid (WDL).

In the compatibility testing program (Hendricker et al., 1998), conducted in accordance with EPA 9090 protocols, coupons of the geocell and geomembrane materials were immersed in viscous waste (TAR) and a waste-derived liquid (WDL) at two temperatures, 23° C and 50° C, for periods of up to 4 months and periodically removed and subjected to testing for mass, thickness, puncture resistance, trapezoidal tear strength, and stress crack resistance. The waste derived liquid, generated by agitating tar and distilled water together for over an hour and then siphoning off the liquid, was employed to model potential contact with gas condensate from the waste. This liquid

actually had a lower pH (pH on the order of 0.6) than the waste itself. The principle of time-temperature superposition, i.e. Arrhenius modeling (Koerner, 2005), was used to project test results out over the 100-year design life. Figure 4 shows some of the results of the testing on the HDPE geomembrane. These results suggest some softening of the HDPE materials upon initial contact with the waste but no time dependent trend was observed. Similar results were obtained on geocell specimens. Notched constant tensile load environmental stress crack resistance tests using a load equal to 30 percent of the yield strength of the material were conducted on specimens exposed to waste and waste-derived liquid for 120 days. These tests were terminated after 400 hours with no tensile breaks. Based upon the results of the chemical compatibility testing, a reduction factor of fifty percent was applied to HDPE materials deemed likely to come in contact with waste or waste by-products.

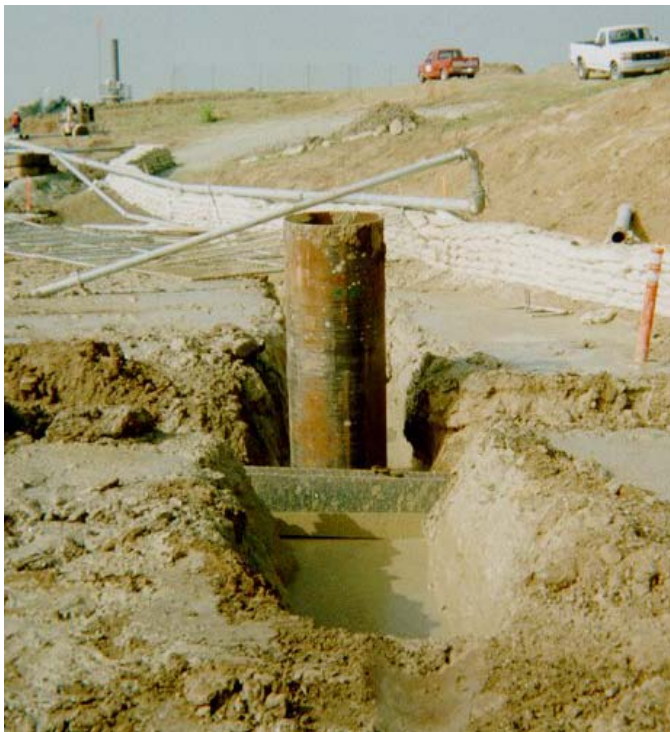
Fig. 7. Slurry wall construction between Upper and Lower Ramparts.

An important consideration in design of the soil-bentonite slurry wall subsurface barrier was constructability of the wall. Constructability concerns included construction of the wall up the 3H:1V slope separating Upper and Lower Ramparts as well as construction along the south boundary of the site adjacent to the Lower Ramparts area and east boundary adjacent to the Los Coyotes area. Provisions were made to use earthen berms along the wall alignment on the slope between Upper and Lower Ramparts in order to build up the wall above grade and then trim it back after the soil-bentonite backfill had consolidated. However, by using the large pipe "stop logs" like the one shown in Fig. 7 to partition the wall into short sections and allowing the backfill time to set up before proceeding, the slurry wall contractor was able to construct the slurry wall up the slope without using the berms.

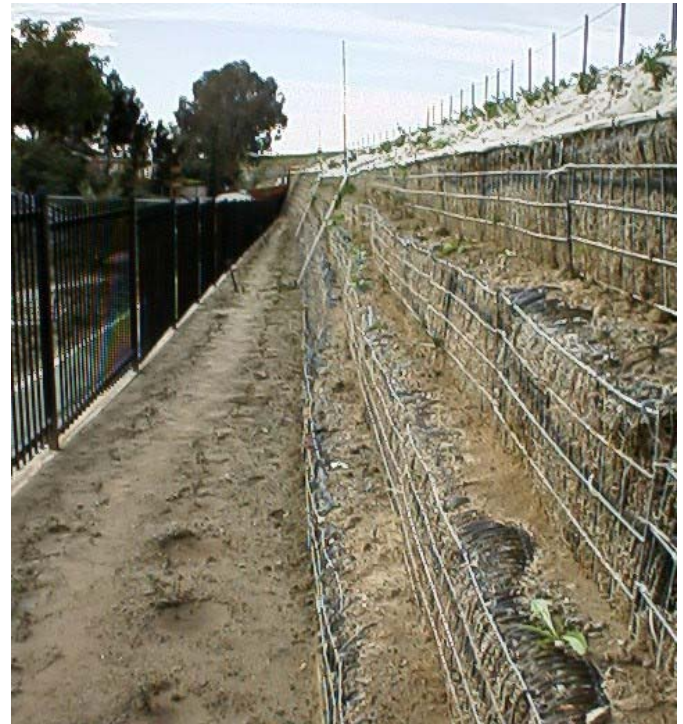
*Fig. 12. MSE wall on the south side of Lower Ramparts immediately following the end of construction.*

The facing for the MSE walls was constructed using wire frames lined with geosynthetics and filled with top soil to facilitate establishment of vegetation on the face of the wall. Figure 12 shows the facing for the MSE wall along the east side of Lower Ramparts immediately after the end of wall construction.

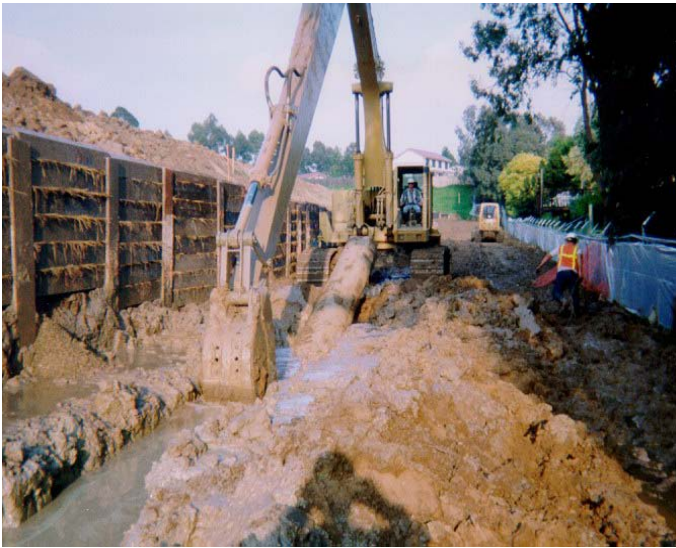
*Fig. 11. Slurry wall construction along the south side of Lower Ramparts.*

were relocated at the expense of the responsible parties for construction of the remedy. The fenced construction zone occupied about half of the backyards of the adjacent homes, which were typically 40 to 50 ft in width. Figure 10 illustrates the slurry wall construction scheme along the south side of the Lower Ramparts area and Figure 11 shows construction of the slurry wall in this area.

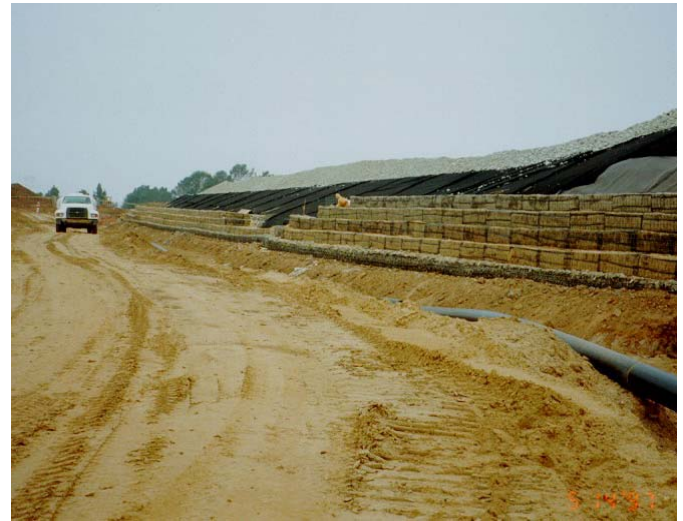
*Fig. 13. The MSE wall between Lower and Upper Ramparts under construction.*
