Predictive geohazard mapping using LiDAR and satellite imagery in Missouri and Oklahoma, USA

PREDICTIVE GEOHAZARD MAPPING USING LIDAR AND SATELLITE
IMAGERY IN MISSOURI AND OKLAHOMA, USA

A DISSERTATION

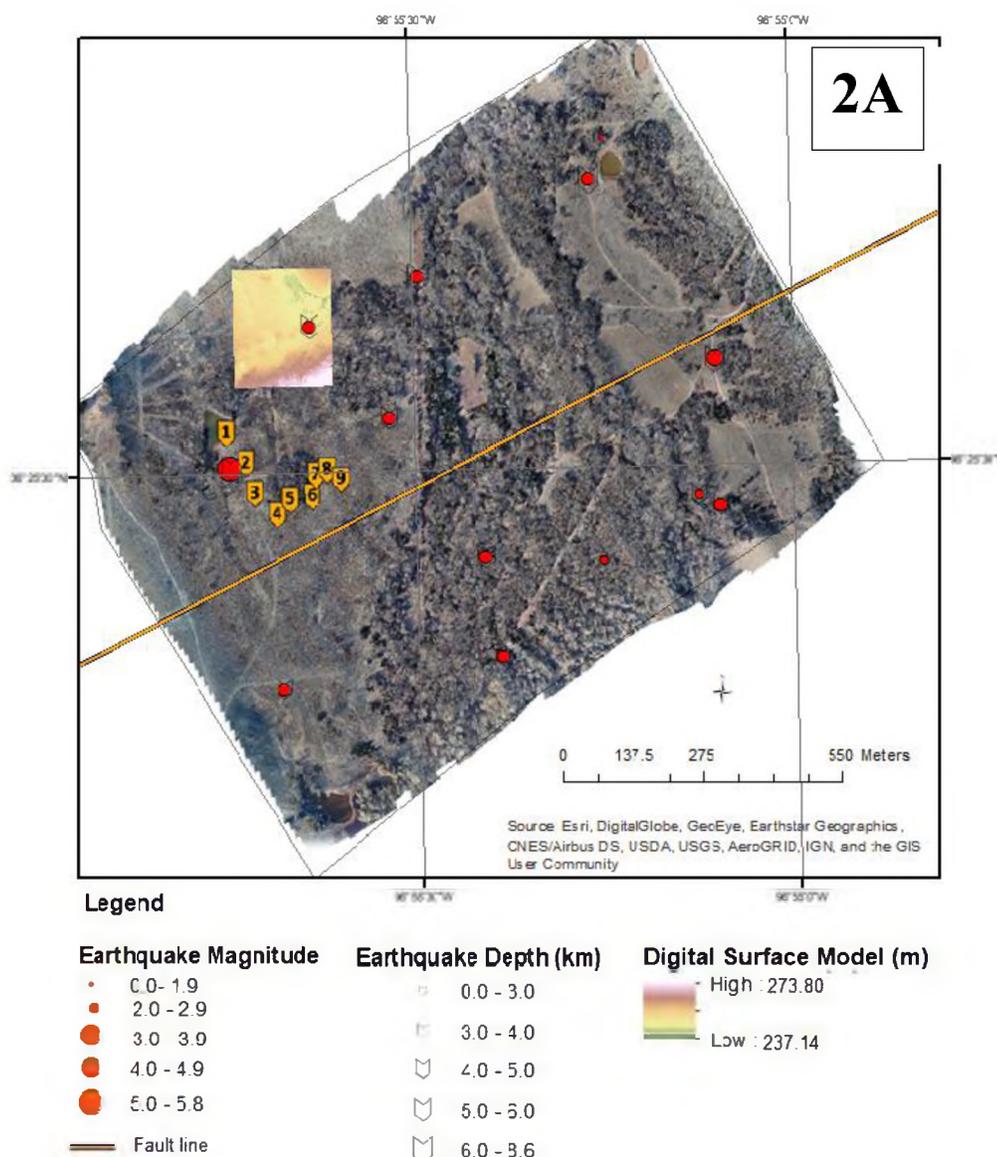
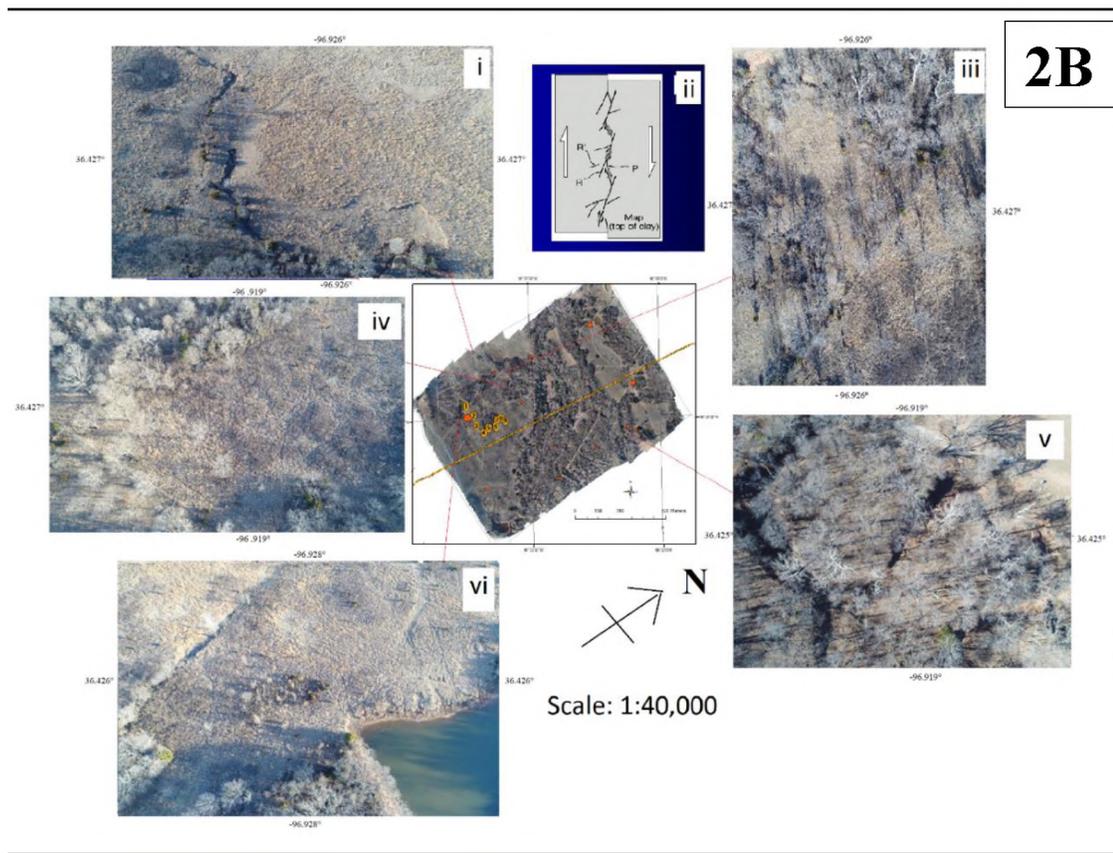
Figure 2. A. Processed photogrammetric image of the study area showing nine ground control point placements collected using handheld GPS unit (Trimble Geo Explorer 7X Rugged GPS Handheld W/ GNSS Rangefinder TerraFlex.AS). Images were collected during a flight in February 2019; the red dots indicate the magnitudes of the earthquakes and the arrows reflect the depths of earthquake epicenters. The colored rectangular box shows the digital surface model reflecting en-echelon fractures and the geospatial relationship of earthquake magnitude and the depth of epicenter. B. Details of locations of deformation structures: (i) En-echelon pattern; (ii) Strike-slip fault pattern from Riedel experiment (after Dooley and Schreurs, 2012); (iii– iv) Sections of the UAS mapped areas with denser vegetation showing conjugate joint sets; (v) Pull-apart wrench fault pattern; (vi) Strike-slip fault at the location of the Mw 5.8 earthquake. The geographic coordinates of each of the photos can be found in Appendix B.

The UAS aerial images exposed distinct linear patterns after the extraction of tree cover (Figure 2A).

However, Figure 2B shows the areas covered by dense vegetation, but after processing, a group of what are believed to be conjugate systematic regional joints were revealed. The tree cover camouflaged some of the en-echelon separation patterns (a set of parallel or subparallel, closely-spaced, overlapping, or step-like minor structural features) that recently opened up. The en-echelon graben-like features were oriented in a northwest-southeast direction, parallel to the regional systematic joints.

In addition, Figure 2B illustrates recent strain observed at the ground surface. Figure 3a shows another en-echelon set of graben-like joints spaced at approximately 2.63 m displacements that also appears to be synonymous with the regional systematic joint pattern. Studies associated with wrench-fault tectonics have described similar features using Riedel shear experiment (*Wilcox et al., 1973; Moustafa and Abd-Allah, 1992; Cunningham and Mann, 2007*). This type of extension faulting can often occur in fracture zones above offset or lateral spreading centers, and a M_w 5.8 would generate up to 5 -10 cm displacement.

The Riedel shear experiment documented that smaller en-echelon patterns formed at low amplitude and approximately perpendicular to σ_1 (*Dooley and Schreurs, 2012*). The behavior of high density (low water content) clay and sandstone in the Riedel experiment provides a suitable analog for the clay-rich beds and sandstone of the Northern Oklahoma Permian Red Beds (*Eisenstadt and Sims, 2005; Withjack et al., 2007; Dooley and Schreurs, 2012*). The density of the clay increases the brittleness of fracturing in the upper crust, resulting in discrete and planar patterns similar to the en-echelon patterns in Figure 2b (*Arch et al., 1988, Dooley and Schreurs, 2012*).

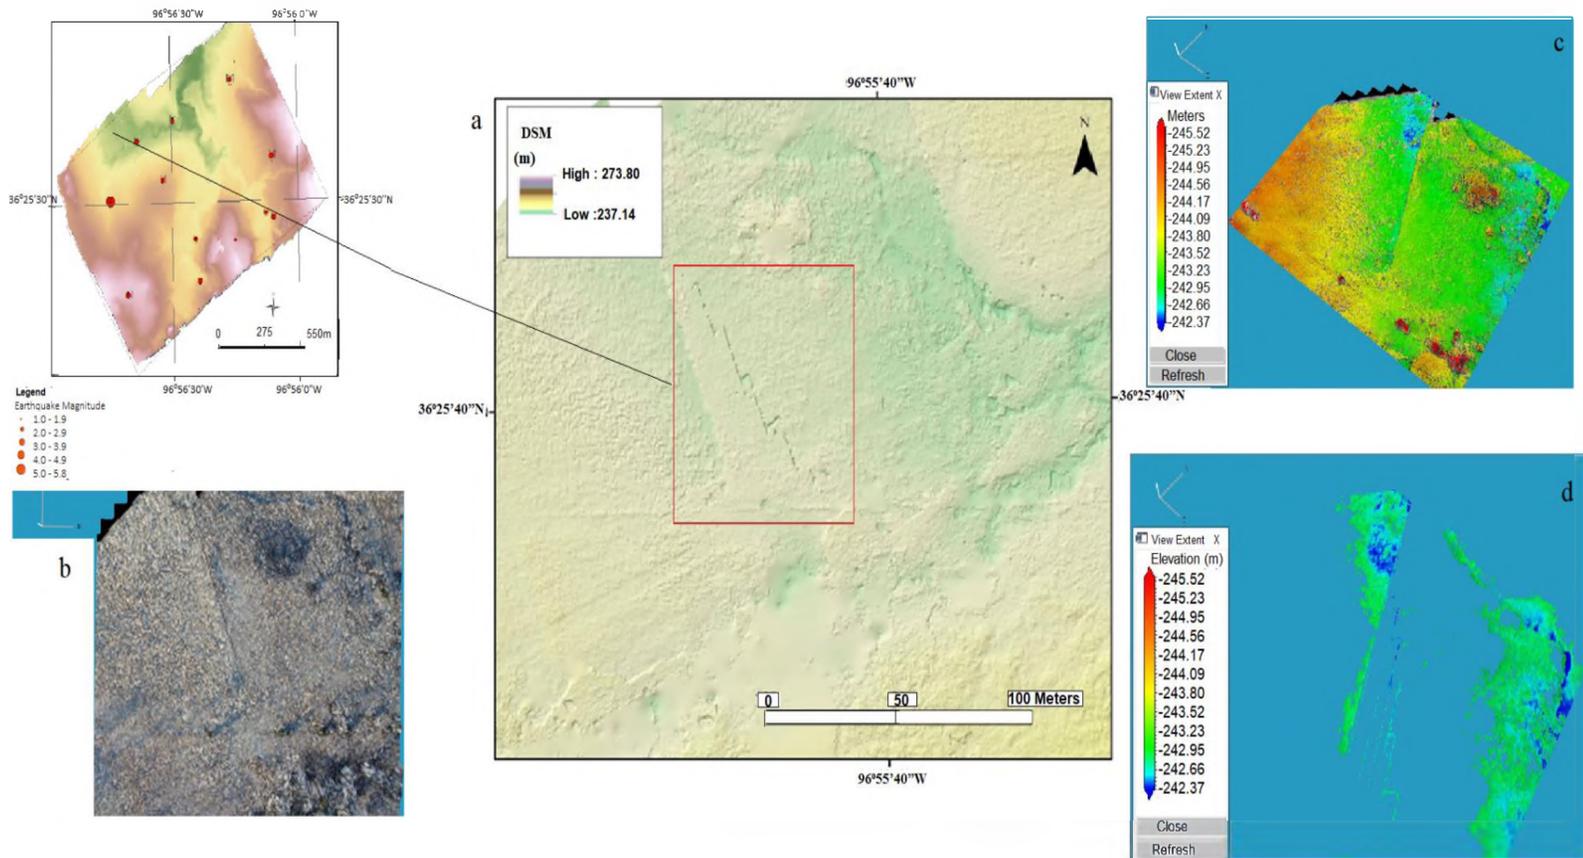
Figure 3. (a) The DSM with the vegetation extracted was produced in Agisoft photoscan for the Pawnee area, Oklahoma. This exposed a regular fracture pattern typical of en-echelon joints or left-lateral strike-slip fault; (b) Orthoimagery of the same location with shrubs growing in the opening of the en-echelon shear; (c) The processed cloud point of the oblique angle (30°) image processed in ENVI; (d) The cloud points higher than 243 m above sea level were filtered out in ENVI exposing the last ground returns with the same shearing pattern shown in the DSM image.

The DSM image in Figure 3 suggests three water-filled depressions (or "subsidence ponds") and an en-echelon fault pattern that likely projects from the underlying basement rock. The USGS seismic data for the study area indicates that there were 61 M_w 1.0 – 2.0 earthquakes, twelve $> M_w$ 2.5 earthquakes, and five $> M_w$ 3.0 earthquakes between 2000 and 2017. According to *Hawthorne et al. (2019)*, low magnitude earthquakes can deliver slow tremors that produce finite rupture patterns over time. The presence of these finite rupture patterns predisposes the higher magnitude earthquakes to inherit deformation patterns that are likely controlled by pre-existing discontinuities.

The en-echelon fissures identified in Figure 3 illustrate how pre-existing structures tend to channel dynamic energy pulses and more likely to experience plastic (permanent) deformations or sudden changes in effective stress at any depth (*Kearey et al.* 2009; *Zoback et al.*, 2013). En-echelon and wrench structures are usually associated with strike-slip faulting (*Wilcox et al.*, 1973). Earthquake shaking can also result in crustal deformation from a possible sudden release of stored elastic strain energy radiating outward, diminishing with the square of the radial distance traveled (*Davies et al.*, 2012; *King et al.*, 2014). Given that the epicenter is the shortest linear distance from the hypocenter to the earth's surface, the energy released at the epicenter assumed to be the locus of the earliest p-wave arrival.

The UAS aerial images appear to have delineated an extensional conjugate set of regional systematic joints for about 70 m (Figure 3). One possible mechanism is that these linear separations reflect the structure of the underlying metamorphic rocks projecting into the alluvial cover. Given the increasing seismicity over a ten-year period, extensional strain caused the conjugate joint sets to expand. It is likely that as more ground shaking occurred, soil or detritus filled the existing joints.

Given that the regional patterns of seismic energy decrease as the waves travel away from the hypocenter in non-tectonic regions (*Hovius and Meunier, 2012*), low energy release from deep hypocenters can be attenuated by soil moisture and associated pore fluid pressure variations (*Ishac and Heidebrecht, 1982*) in clay-rich alluvial overburden. This energy decrease might account for lower magnitudes felt along the river courses and highly vegetated areas (*Ishac and Heidebrecht, 1982*). As a result, the extraction of the vegetation in the DSM images (Figure 3) provided a better view of the en-echelon faults detected in the study area. The seismic surface wave energy dispersion also exhibited zones of overlap and created zones of possible amplification, which increased the potential for localized geomorphic expression (Figure 2b). This result was consistent with the effects of cumulative low energy faulting, like those that likely generated the joint-controlled en-echelon patterns imaged in the photogrammetry (Figures 3d and 3e).

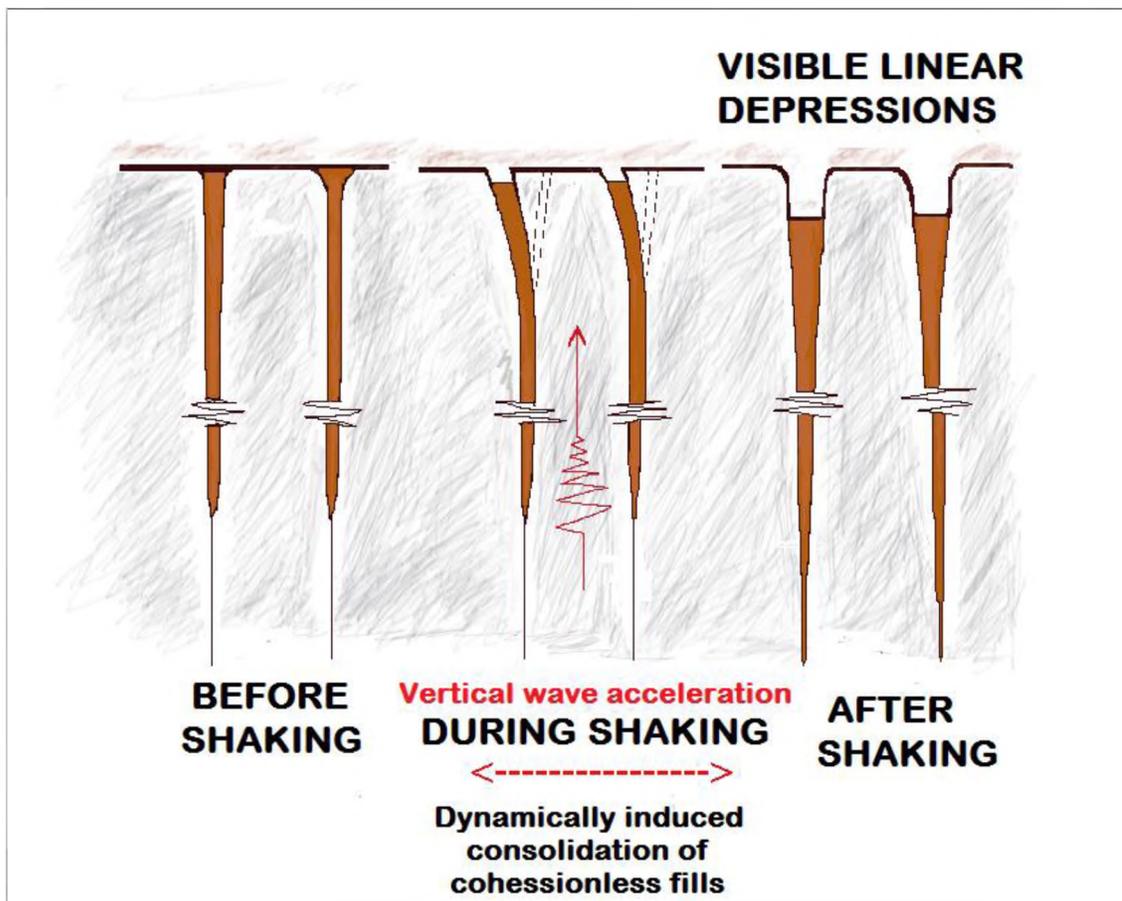
Figure 4. A schematic illustration of the development of visible linear depressions along parallel joint sets after seismic excitation engenders dilation that allows cohesionless-fill to consolidate, leaving shallow linear depressions.

Thus, the strain energy released by earthquake rupture and transmitted by the body waves propagated by elastic deformation of the rock through which the energy pulses travel is the moment magnitude (M_w) (*Miller, 1987*). As these body waves travel through the earth's interior, seismic excitation engenders dilation in both horizontal and vertical movements, leaving shallow linear depressions that are now filled with cohesionless soils (Figure 4).

Later, the vertical and horizontal shear waves allowed the weathered infilling to consolidate and drop into widened joints during strong shaking cycles (Figure 4). The open joints probably continued to experience additional settlement of infill during aftershocks. After the shaking ceased, the dilated joints exhibited linear depressions within the alluvial cover.

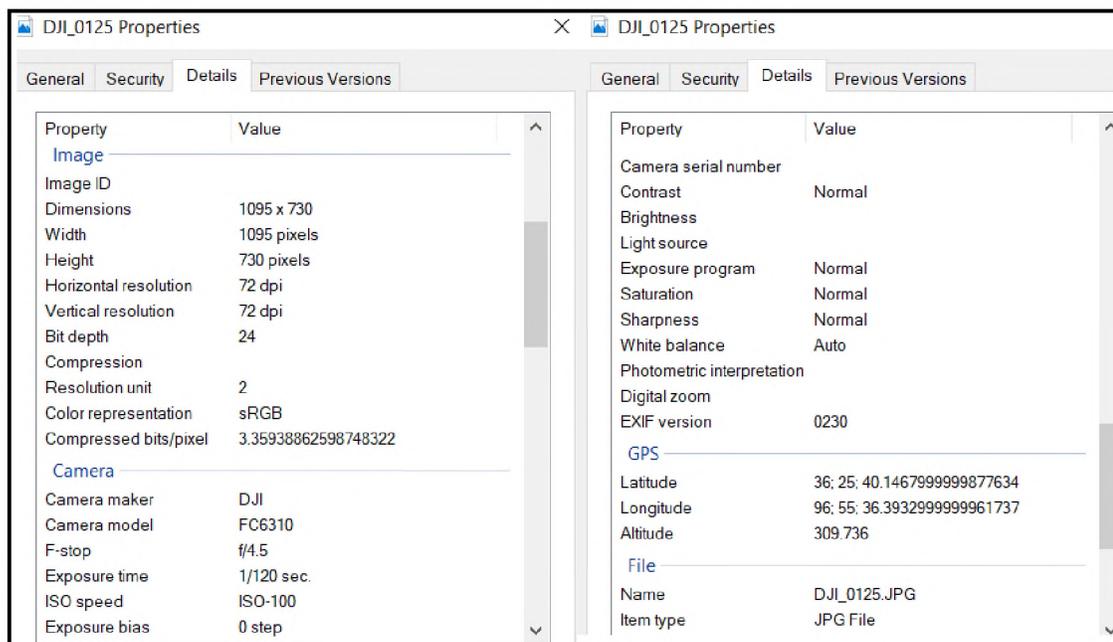
Figure S1. The metadata of UAS image DJI_0125 providing information about the camera used, the location, flight altitude, and quality of the captured data.

The significant variables considered before developing the flight plan for this study were the aircraft altitude, forward and side overlap, aircraft speed, and access to standard mission planning software. Using the basic principles of photogrammetry for DJI GS Pro and Pix4D capture, a ground sampling distance (GSD) of 2.5 cm/pixel was selected based on the expected scale of the faults within the study area. The resulting flight altitude was determined to be 30 m. The overlap was set to 80% forward and 60% side based on the recommendations in *Rosnell and Honkavaara* (2012). The aircraft ground speed was 9.2 m/s, calculated from the shutter speed of the camera and GSD. From these specifications, the optimal pixel size of 1095 by 730 used along with the GSD to adjust for the actual flight altitude (Figure S1).

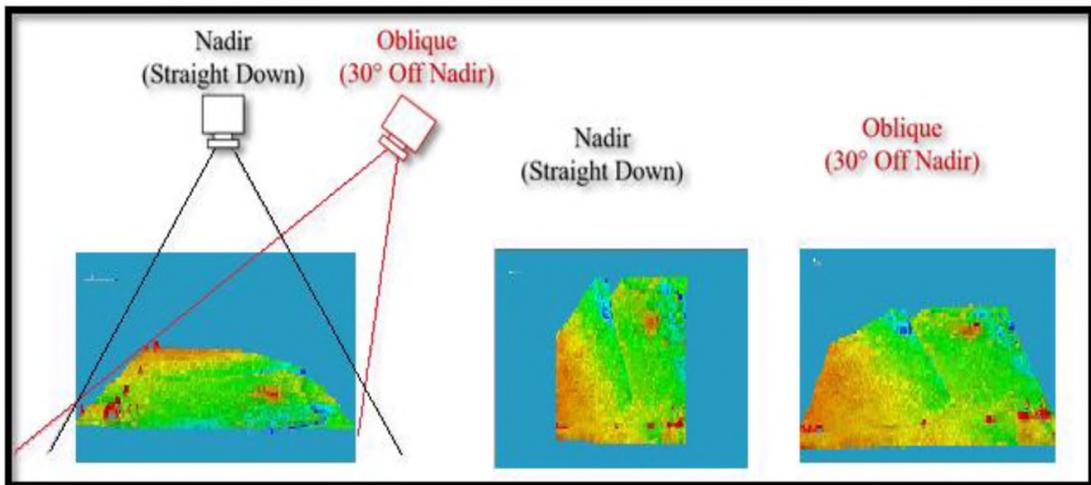
Figure S2. Impacts of sensor obliquity with camera angle (modified from James and Robson, 2014)

Two camera orientations were considered, nadir (0° , downward-facing) and oblique (30° from nadir). These angles were chosen based on the overlap coverage and orientation of the camera with respect to the ground plane. The nadir photographs were the principal set used in our mapping, based on the recommendations of *James and Robson* (2014), which afforded variability in the camera orientation and reduced the error values. These are shown in Figure S2 below.

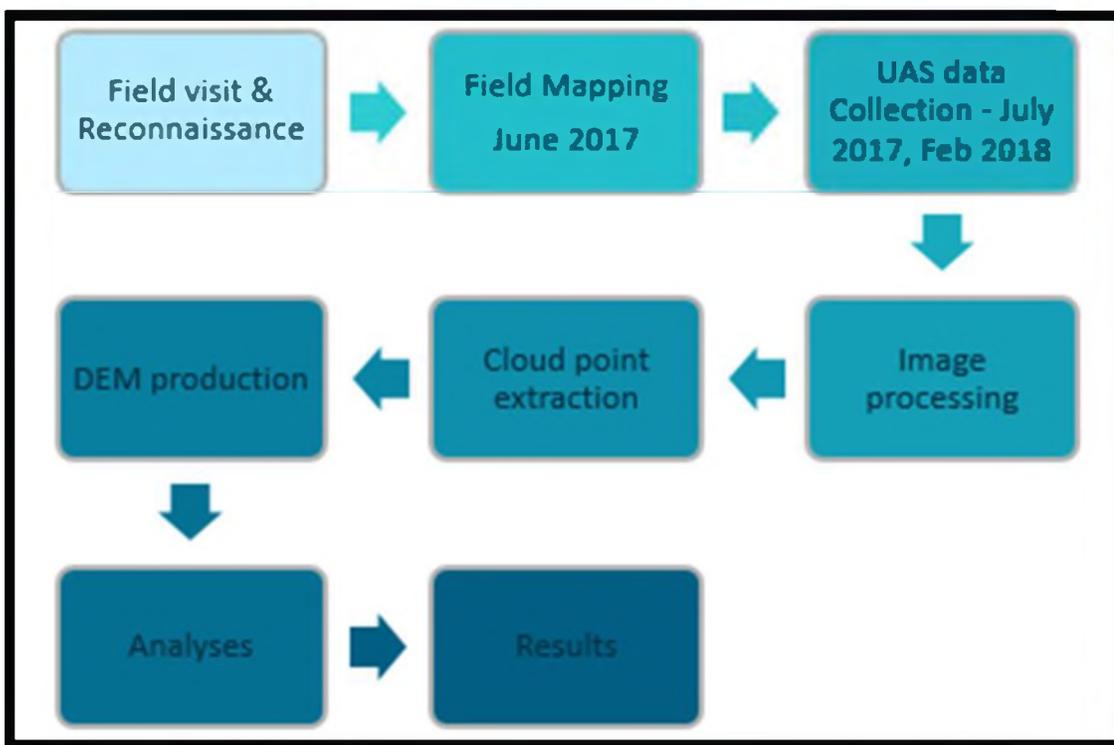
Figure 3. Summary of field methodology for UAS data acquisition, processing and interpretation for study areas

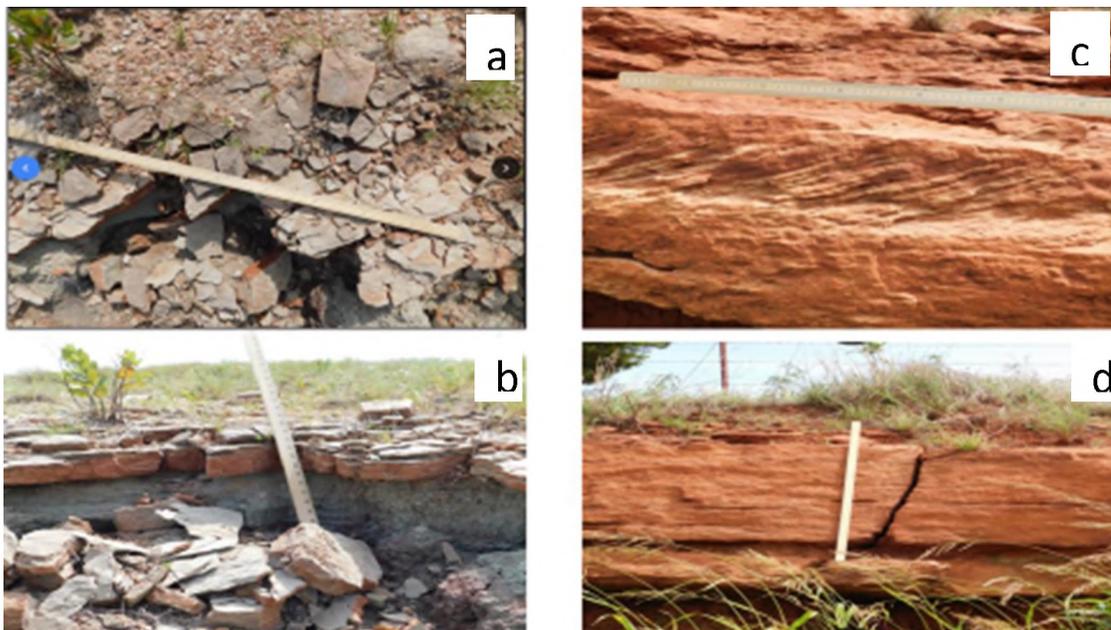
Figure 4. (a–b) Chevron pattern joints exposed on road cuts. (c–d) Exposed road cut in Noble and West Payne counties, exhibit cyclic red beds sequences of clay and sand stone (Johnson, 2008).

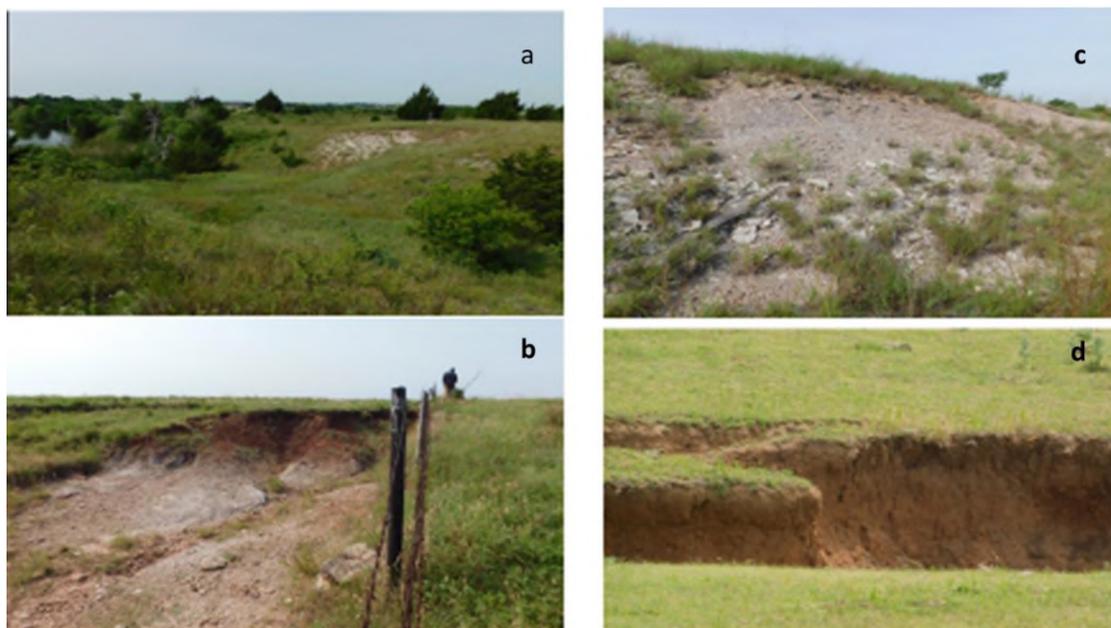
Figure 5. Field pictures from Perry, Oklahoma showing (a) showing pond collapse and mass wasting along sides of hills into the adjoining Willis Lake, Perry OK, (b–c) mass wastage on slopes; (d) subsidence in a freshly developing fault exposure.

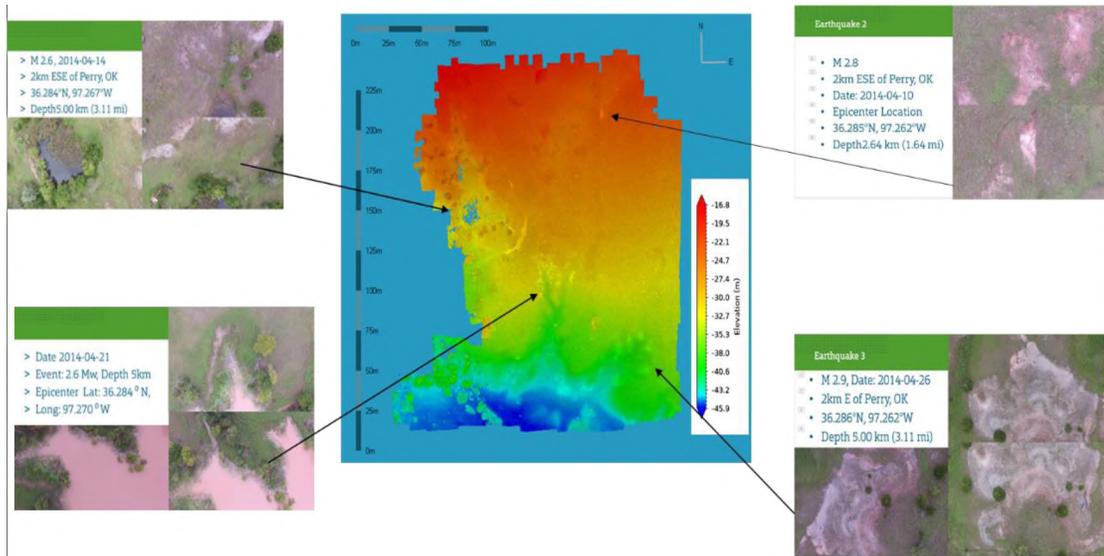
Figure 6. Perry ESE cloud point showing: (a) Depression around the earthquake filled with water; (b) collapse of larger pond edge from 5 events of earthquakes and aftershocks between April 1 and 30, 2014; (c) Slope creep proximal to Mw 2.9 earthquake; and (d) slope creep evident in the UAS imageries

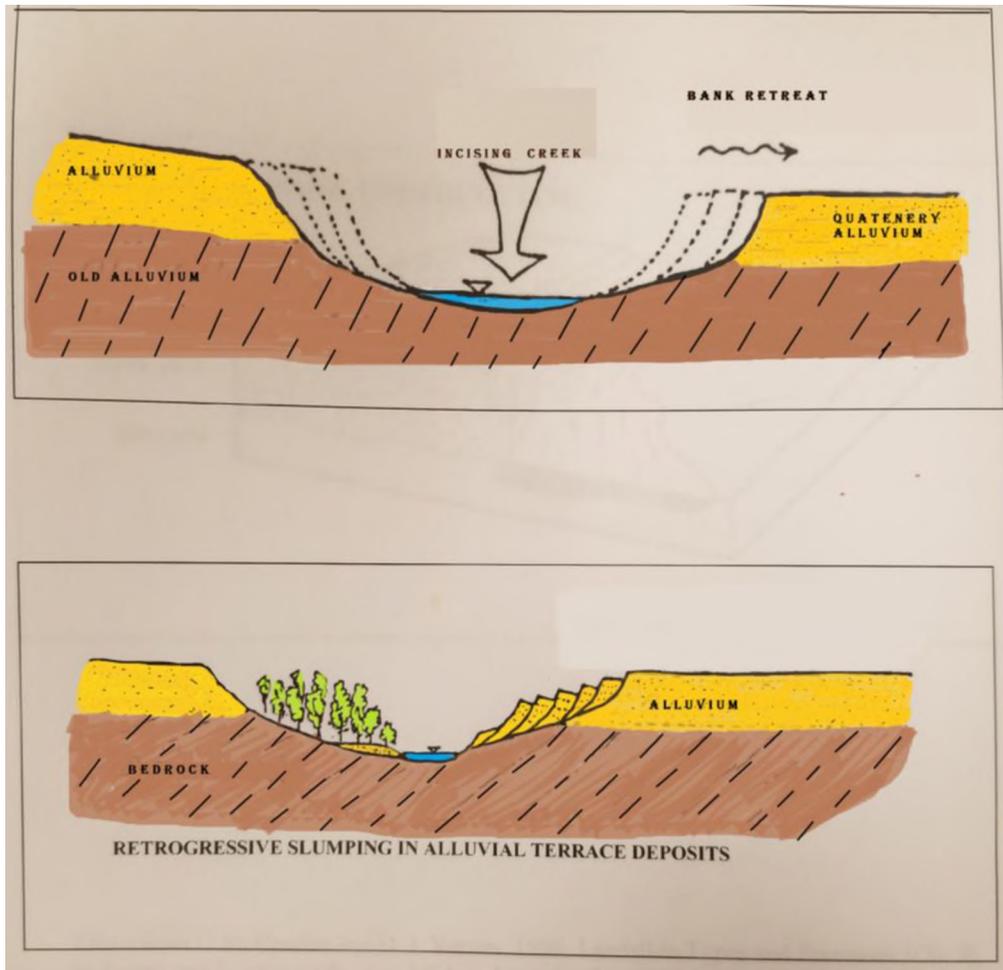
Figure 9. The schematic diagram showing river bank creep: (a) incising creek causing the bank to retreat in quaternary alluvium overlying older alluvium; (b) showing retrogressive slumping in alluvial terrace deposits river bank creep over laying bedrock.

The height of the vertical slope ranges between a few centimeters to about 2.0 meters (Figure 9). The geological condition in the river cut area that enables slope failure by spreading is characterized by clay and sandstone deposition, changes in pore water levels in the formation (Terzaghi and Peck, 1948). The critical height of the vertical slope is determined by the stability of shearing resistance of stable coarse-grained sand to gravelly material in a well-drained terrain.

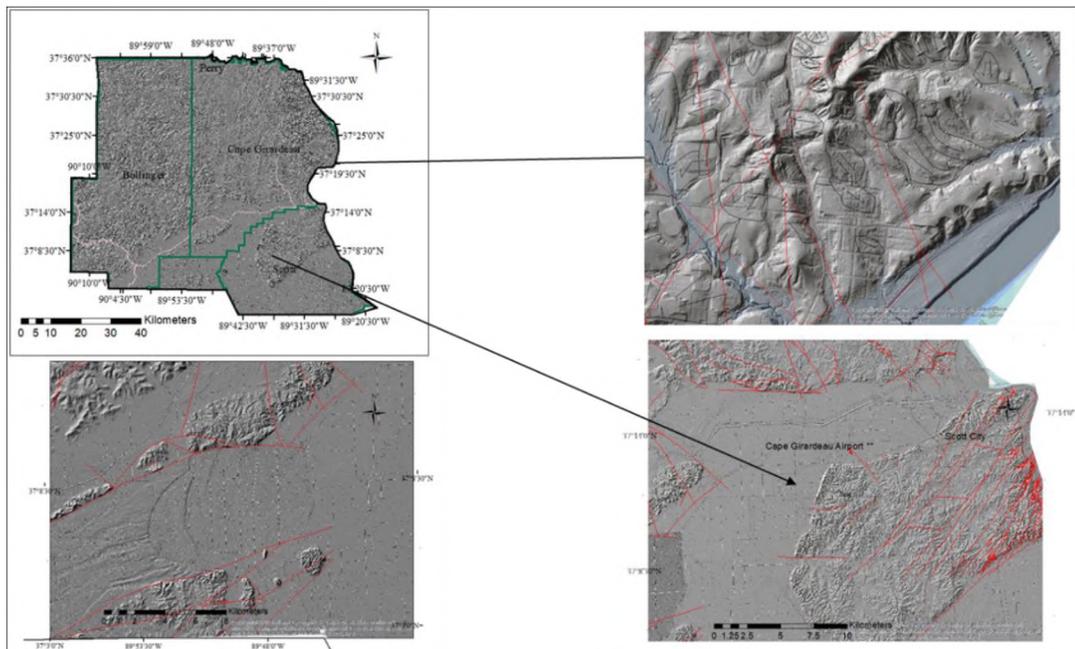
Figure 4. The hillshade map of the study area with snap shots of areas reflecting different types of landslides produced from LiDAR derived DEM maps. The red lines are mapped faults while the light gray lines are landslide mapped land slide areas.

The hillshade map provides the input for delineating the DEM, azimuth altitude, and scaling for the z-factor and is a distinct expression of landslide morphology. The visualization of DEM allows the interpolation of the z-factor for image analysis. The hillshade extraction exposes the unique expressions of landslides as they exist. The image analysis simplifies the identification of anomalous topographic patterns that are commonly related to landslides and other mass movements. Hillshade measures the values for a topographic surface described as the illumination angle, and shadows in each raster, with the raster output values ranging from 0 to 255.

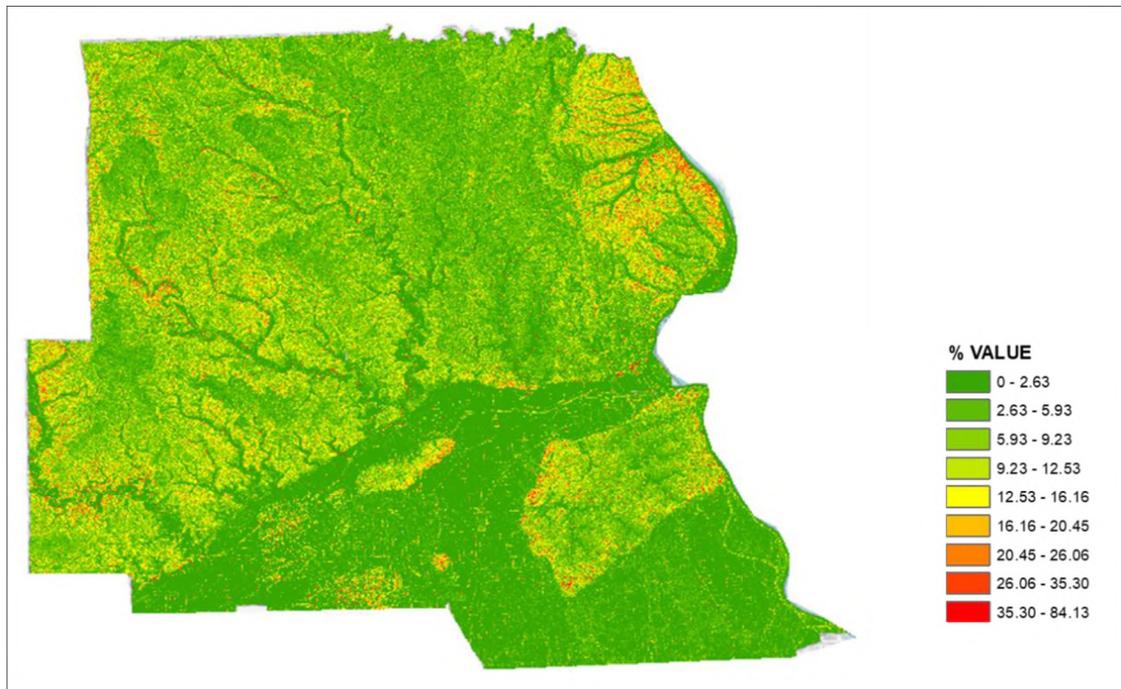
Figure 5. The slope analysis for the study area; the steepest areas in the map are coincidental with the river banks and the watersheds. The lowest areas are shown in green covering flat-lying cultivated areas.

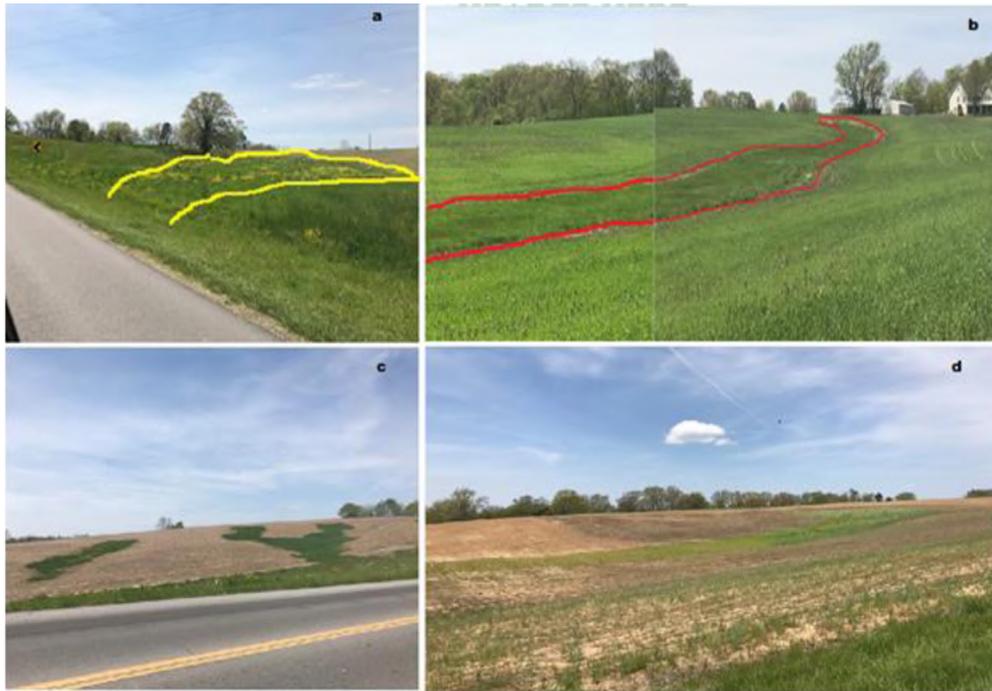
Figure 6. Field pictures showing observations during the field trip in May 2018. Image: (a) shows changes in vegetation with yellow flowers due to the change in soil characteristics and moisture resulting from shallow mass wasting on slope sides; (b) showed grasses with a deeper green coloration which is distinctly different from the surrounding grasses; (c and d) showed hillsides with vegetated patches indicative of a different adiabatic conditions.

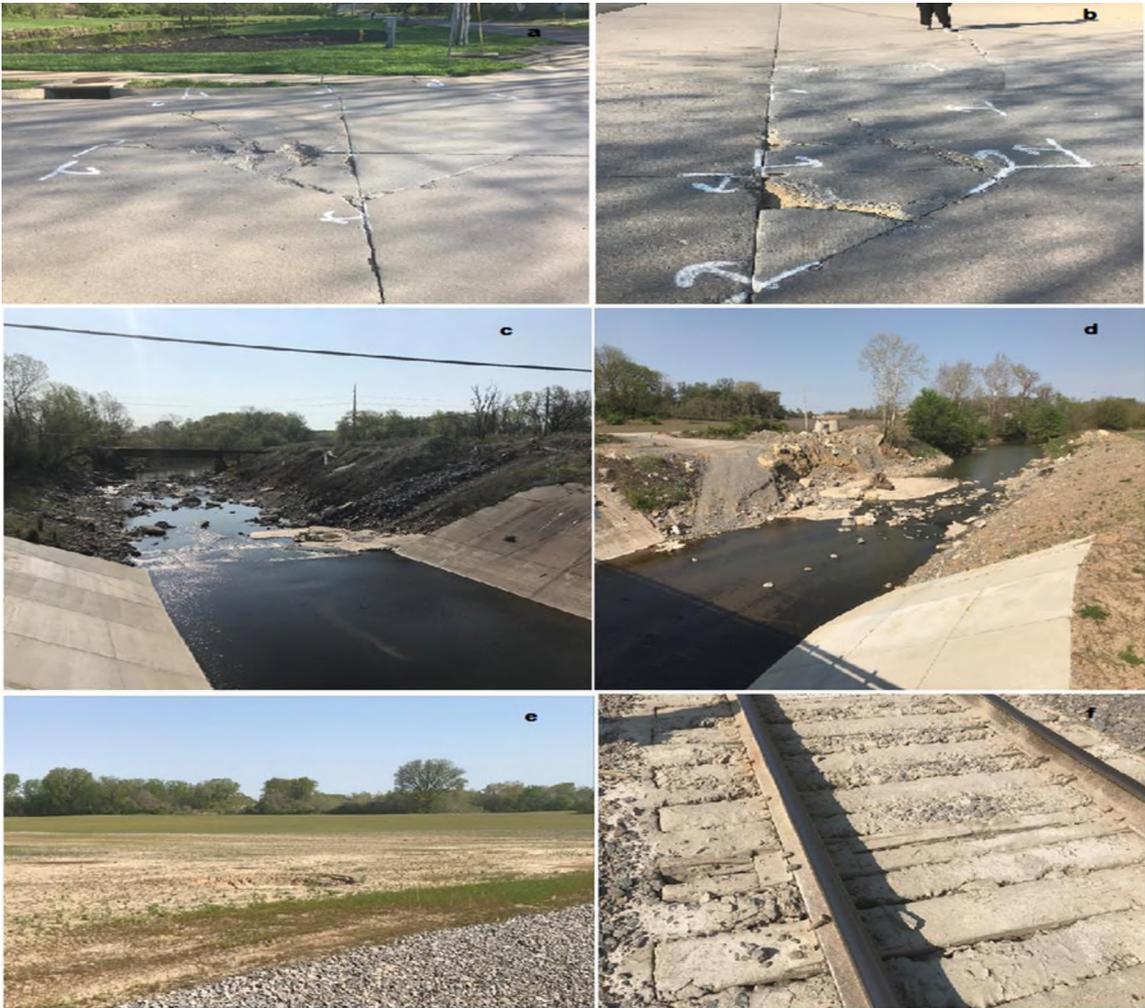
Figure 7. Field photos showing mass wasting in limestone terrain. (a and b) the pavements show the crack on the pavement as a result of differential settlement of the compacted soils; (c and d) show sides of the river channel falling into the river; (e) Sink hole shows subsidence in the topsoil which is indicative of an incompetent subsurface layer. (f) mud cracks evident along the Buzzi Cem rail tracks evidencing flooding of tracks.

The limestone bedrock in southern Cape Girardeau exhibits a rapid response to flooding and supports a high water table, which enhance dissolution of the rocks (Figure 9) (Roberts 1964; Lolcama 2003; Palmer 2004; Lolcama and Gauffreau 2008; Lolcama 2009; Bansah 2018). In 2007, the North-South BNSF Railroad line paralleling the Mississippi River, south of Cape Girardeau, was threatened by multiple sinkhole collapses adjacent to the Buzzi-Unicem Limestone Quarry. The impacted zone has been fitted with telemetered downhole monitors to measure settlement and provide real-time warnings to the railroad and local officials (Figures 7e and 9).

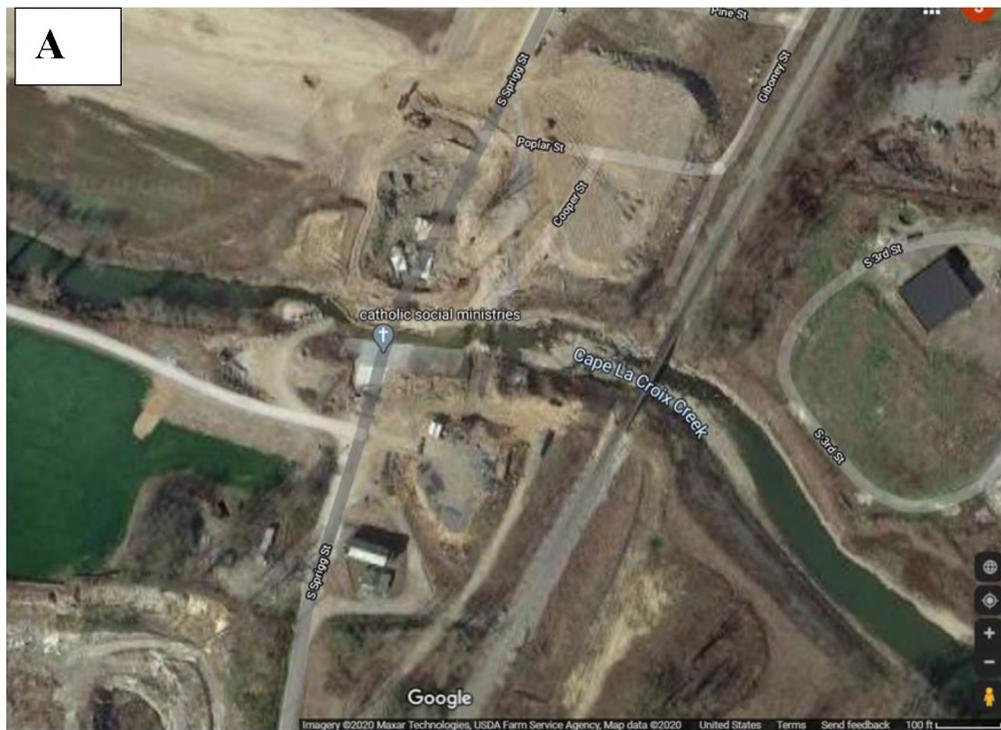
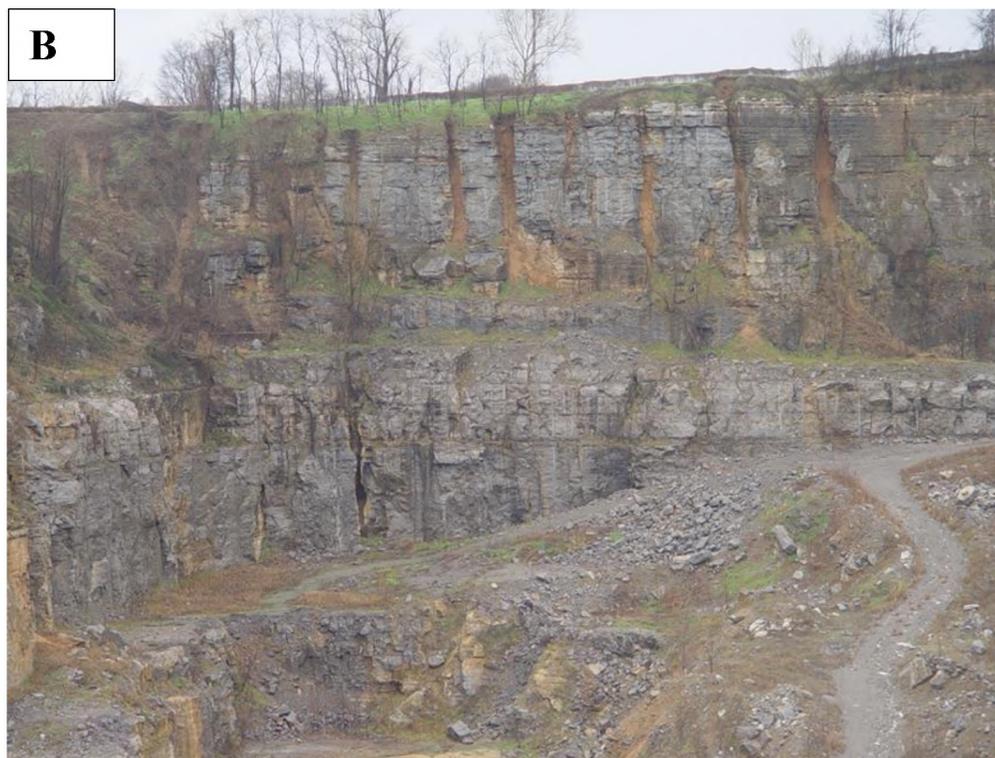
Figure 8A. The google map imagery of Cape La Croix River by Buzzi Unicem; B. Natural conduits for selective point recharge leading to a series of sinkholes around the northeastern corner of Buzzi Unicem mine pit.

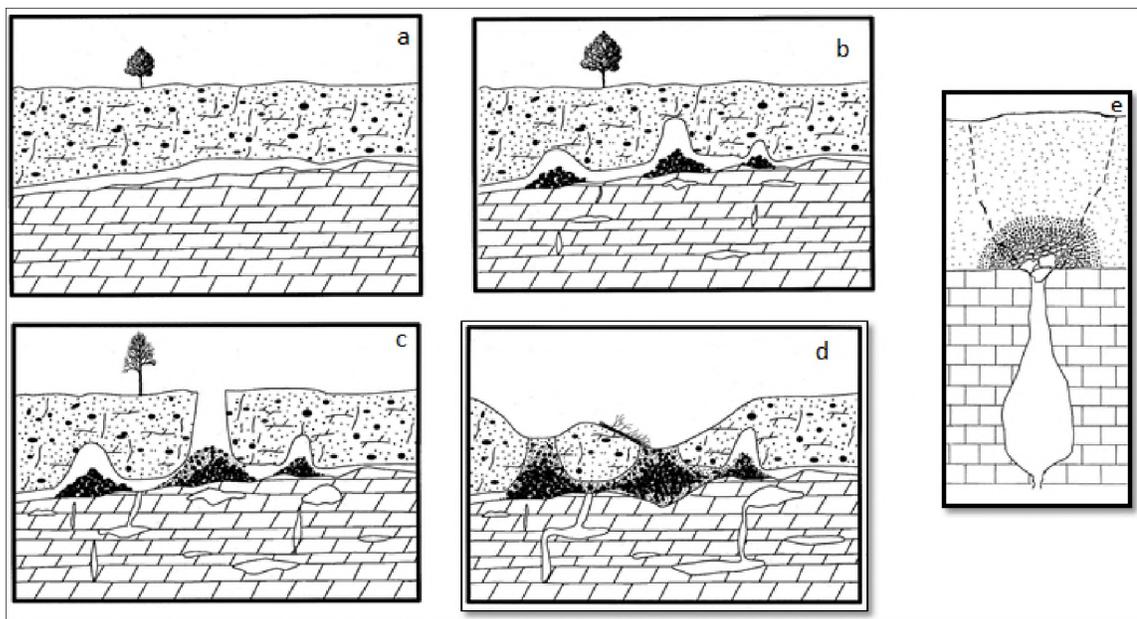
Figure 9. Stages of sinkhole formation in carbonate environment; (a) Dissolution by groundwater circulating through the rock; (b) As the rock dissolves, spaces and caverns develop underground; (c) After the underground support for the topsoil has being dissolved, it loses support, and sudden collapse occurs; (d) Multiple collapse can result in shapes like shallow bowls or saucers, while others have vertical walls, and some hold water, forming natural ponds; (e) inverse filter used in reversing the hydraulic piping in sinkholes (source: Missouri Geological Survey)

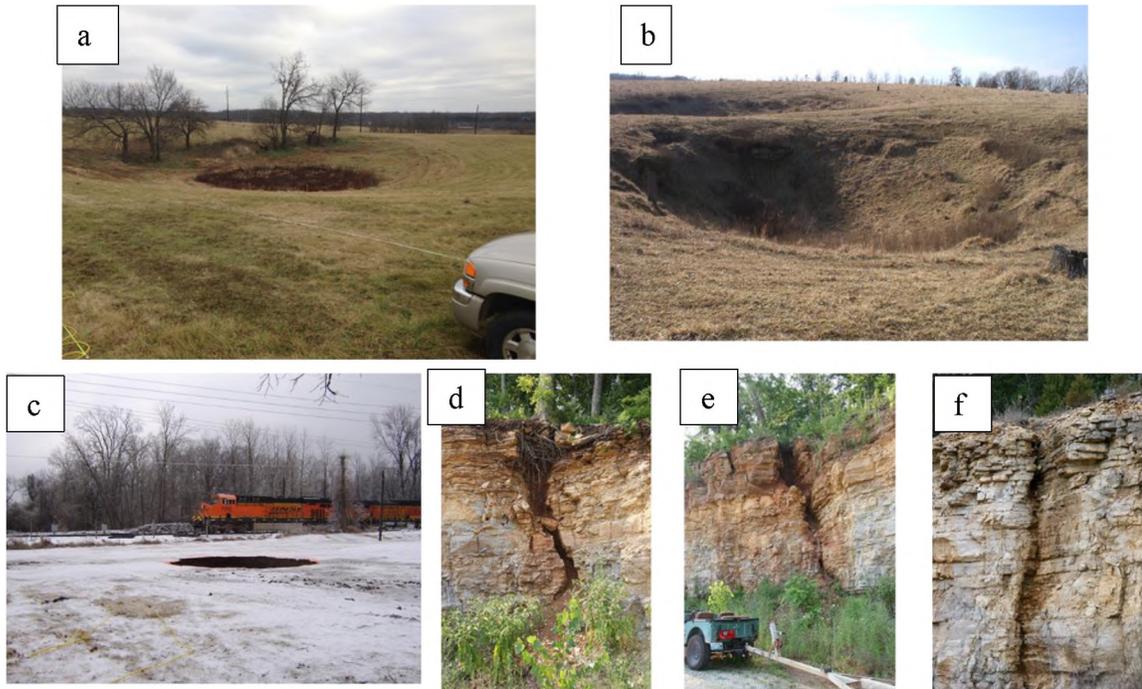
Figure 10. (a-b) Sinkhole formation in the Bootheel region; (c) shows sinkhole beside the Buzzi Cem rail facility; (d-f) Vertical section shows the early stages of sinkhole formation, as solution widening occurs.

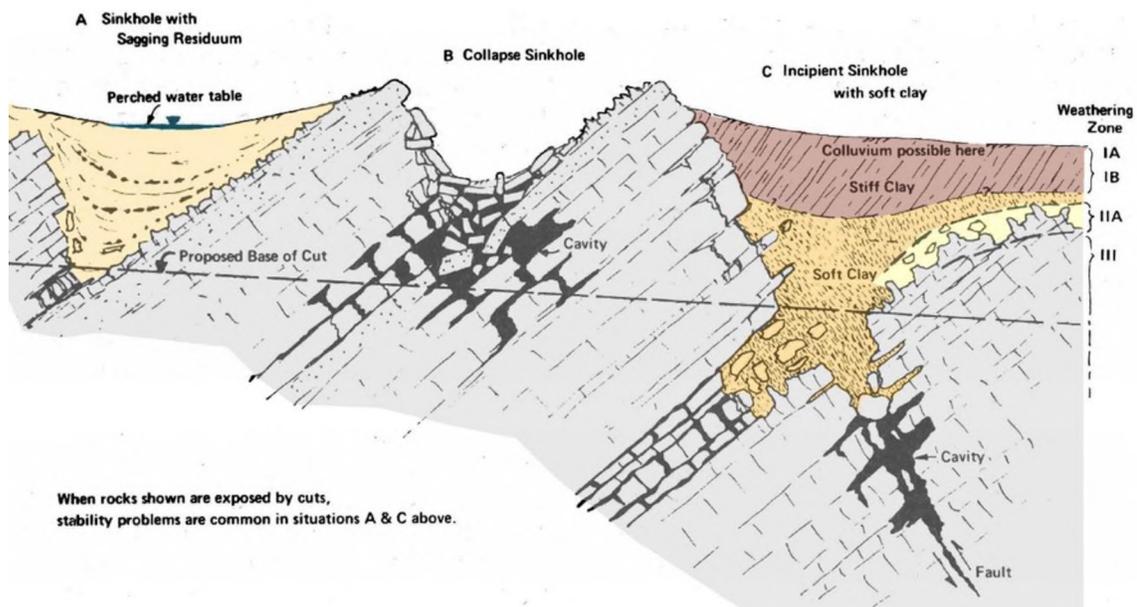
Figure 11. Schematic view of the reconstruction of a series of sinkholes in the same area.

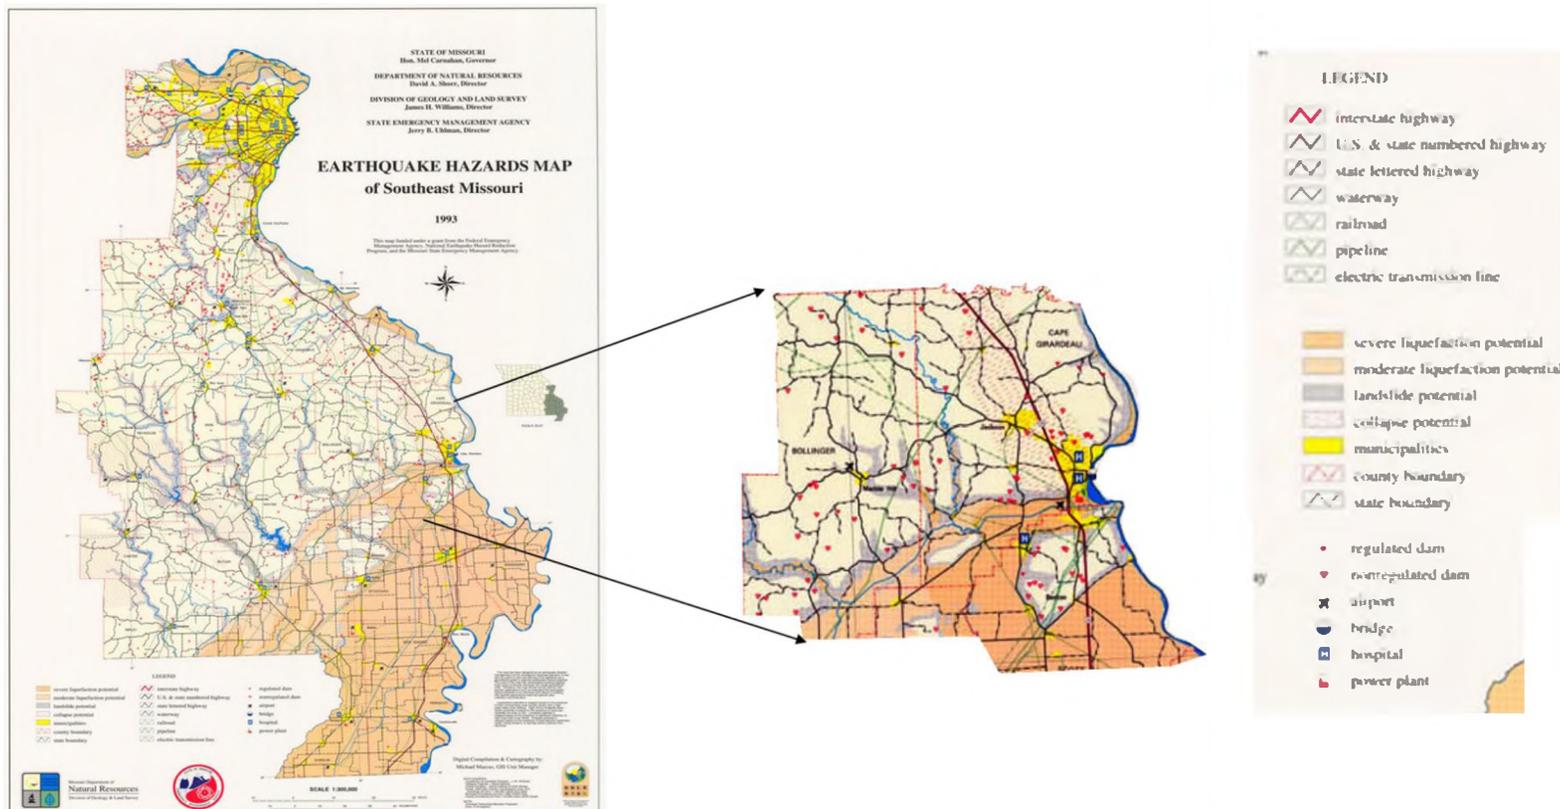
Figure 12. Earthquake Hazards Map of SE Missouri (1993) with detailed map of the study area extracted for analysis. The study area indicates severe liquefaction in the Mississippi embayment. While the collapse potential is projected along the interstate Highway 55. This zone falls within the high volume Ordovician limestone, dolomite, and sandstone perturbed by high-angle, interconnected faults (Figure 1). The landslide potential is higher along river courses due to down cutting river actions along hills.
