Predictive geohazard mapping using LiDAR and satellite imagery in Missouri and Oklahoma, USA

PREDICTIVE GEOHAZARD MAPPING USING LIDAR AND SATELLITE
IMAGERY IN MISSOURI AND OKLAHOMA, USA

A DISSERTATION

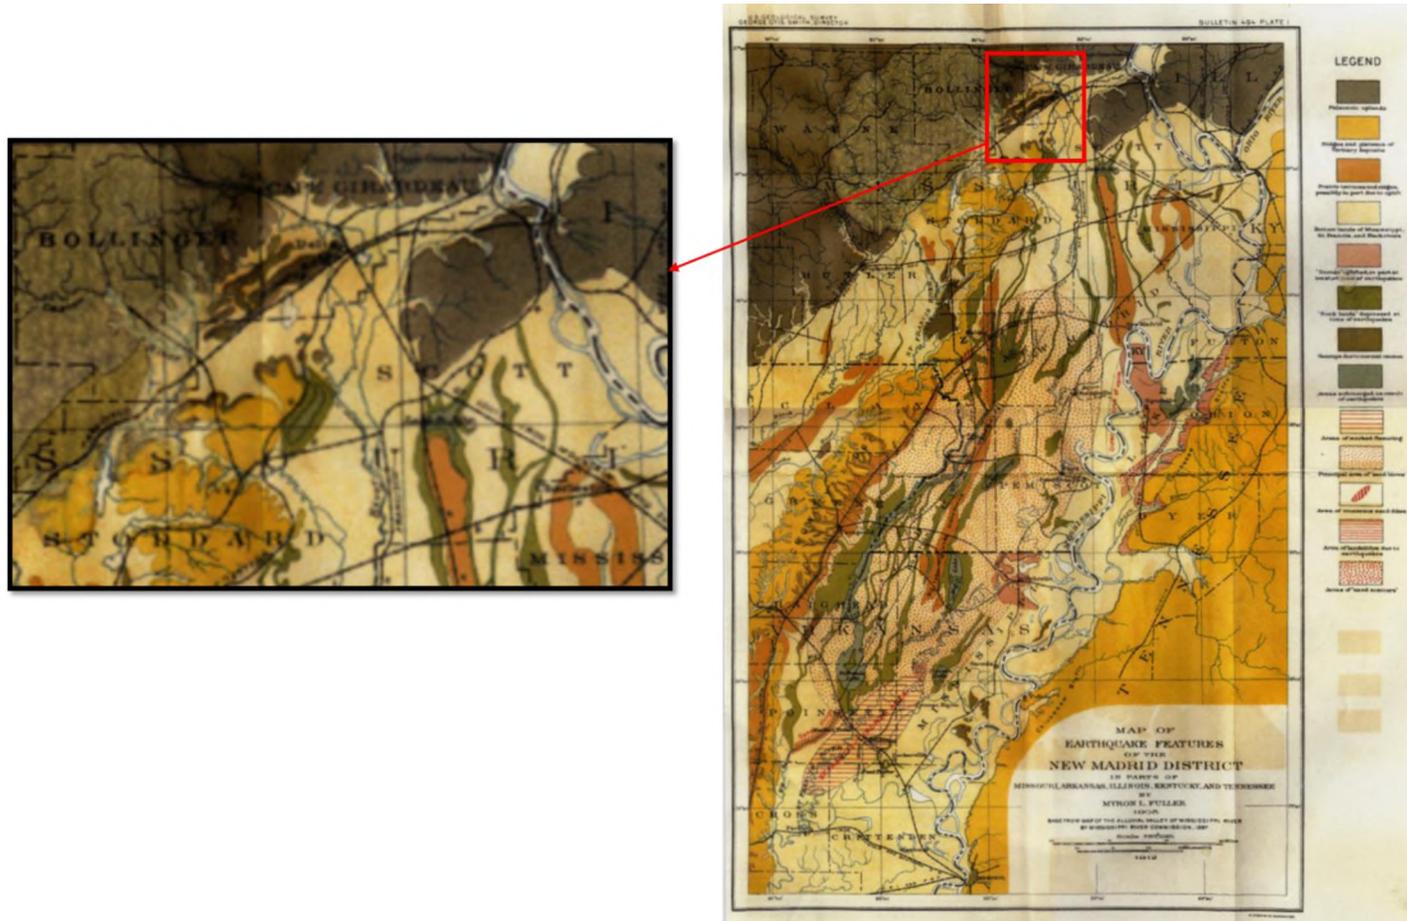
Figure 13. Map of Earthquake Features of the New Madrid District (1912) in Parts of Missouri, Arkansas, Illinois, Kentucky and Tennessee (Fuller 1912). The subset shows the parts of the study area with a detailed map of the study area showing Paleozoic uplands and Paleo landslides of tertiary deposits.

Agricultural dams are typically situated in areas of low population density. The largest threat category in Southeast Missouri is liquefaction potential, which encompasses the entire Missouri Bootheel, except for portions of Crowley's Ridge (the Benton and Bloomfield Hills). The liquefaction potential is moderate to high because of the high water table and preponderance of cohesionless sands beneath a surficial layer of overbank silts that create a semi-confined aquifer at shallow depth (Chung and Rogers 2015). The region also exhibits evidence of lateral spread features triggered by the 1811-1812 earthquakes (Figure 13).

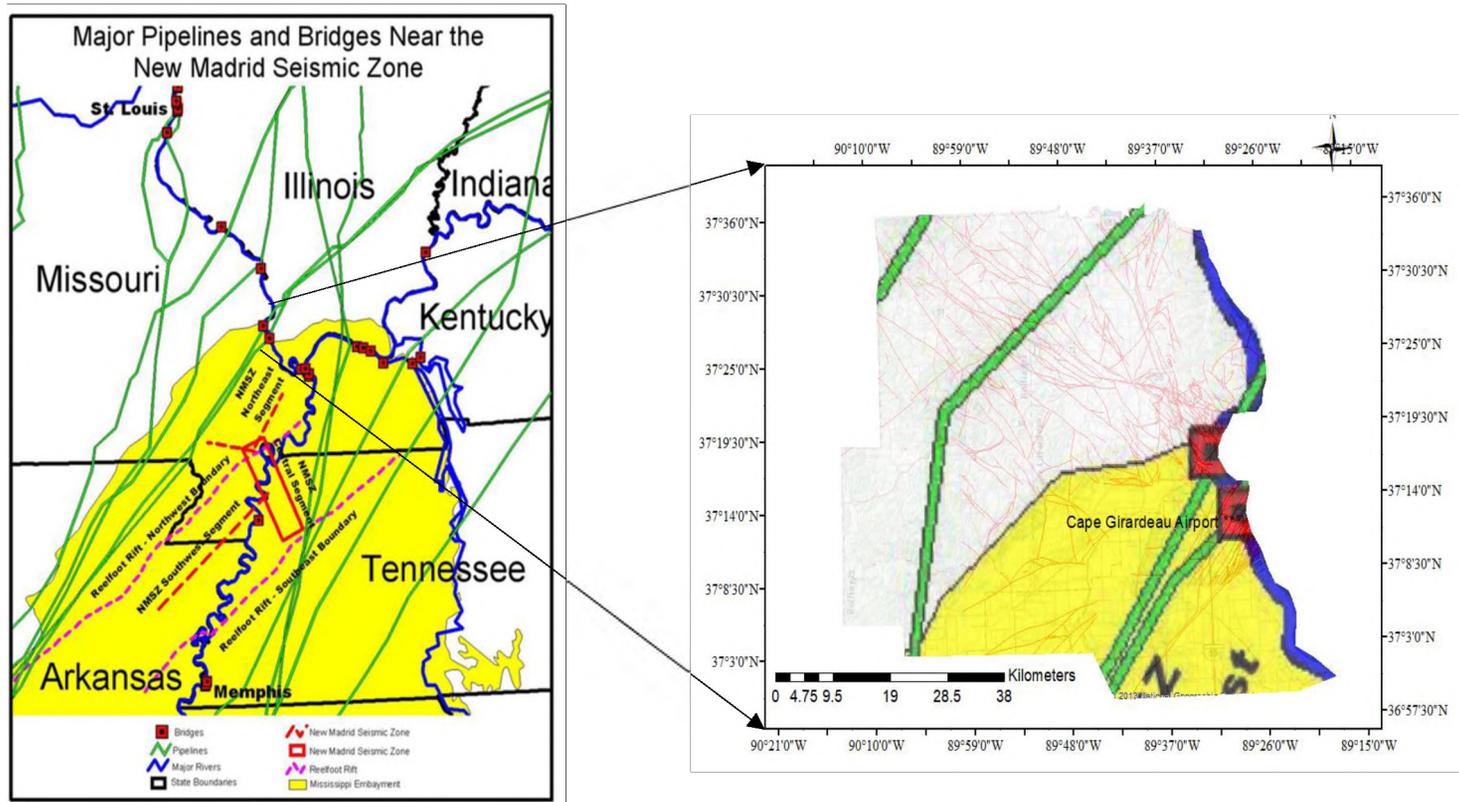
Figure 14. L - New Madrid Seismic Zone map showing major pipeline and bridges crossing through the Mississippi embayment, the Reelfoot Rift. R- Map of study area showing rock bearing faults (lines in red) that run almost parallel to the major oil pipelines in the study area. Southwest portions of the map in the Mississippi embayment are at risk of liquefaction given enough earthquake loading that occurs in the NMSZ.
