## Behavior of staged externally bonded carbon fiber reinforced polymer sheets for improved ductility

BEHAVIOR OF STAGED EXTERNALLY BONDED CARBON FIBER  
REINFORCED POLYMER SHEETS FOR IMPROVED DUCTILITY

MASTER OF SCIENCE IN CIVIL ENGINEERING

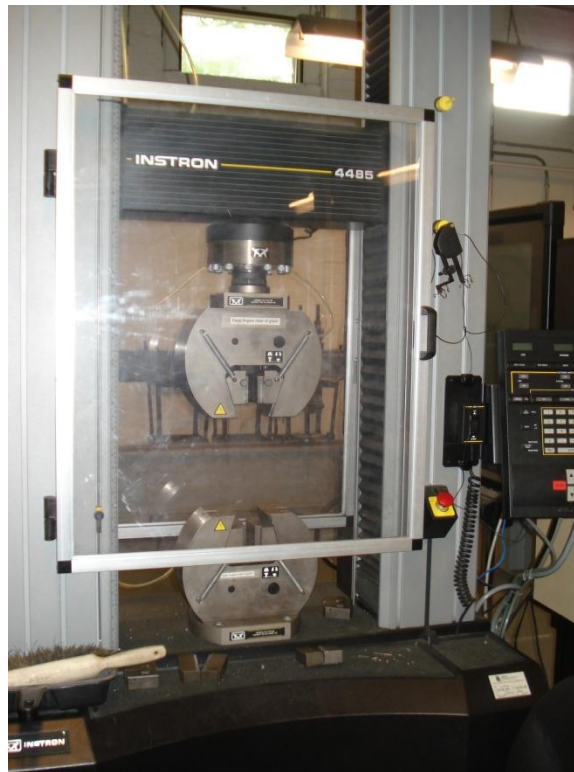
Figure 3.2. Instron 4485 Machine

Using an Instron 4485 as shown in Figure 3.2, preloading in the FRP was achieved by putting the steel coupon into tension. The FRP could then be applied to the surface so that when the load was released the FRP would be in compression. The

Instron 4485 uses an electric motor that provided a more constant load over the duration of the curing process opposed to a machine using hydraulics. This was important to ensure that the preloaded FRP would cure to a correct final load so the appropriate starting compressive strain was reached. The coupons were loaded to either 1.65 k or 3.2 k. The loading of 1.65 k represents 30% of yielding of the steel coupon while 3.2 k represents 60% of the yielding of steel. These values were based on a set of control coupons that was tested prior to the FRP application process. A coupon during the application phase is shown in Figure 3.3.

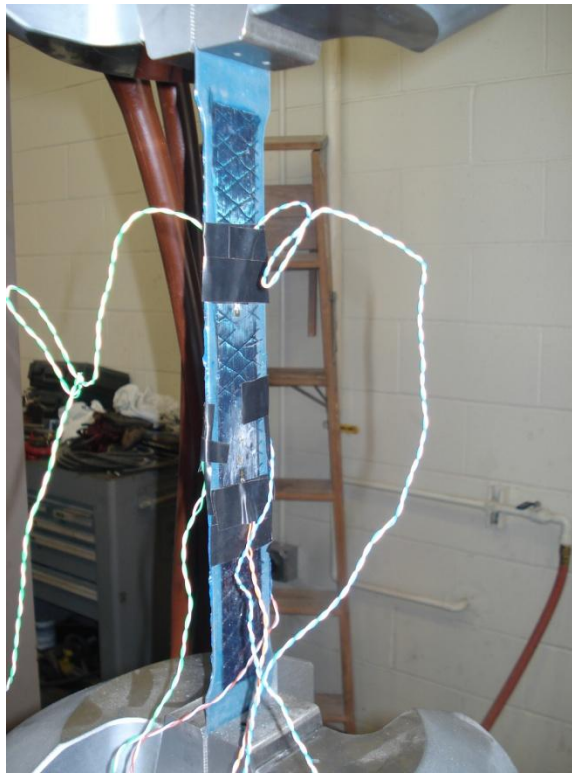
Figure 3.4. Coupon during Testing

The FRP coupons were tested to failure in a MTS 880 machine. The grips provided about 2500 lbs of force. The machine was set to displacement control with a rate of 0.063 in/min. Strain gages were hooked up so the strain can be constantly measured and recorded. Force and displacement were also logged during the test. An example of a coupon being tested is shown in Figure 3.4. Individual results are discussed below.

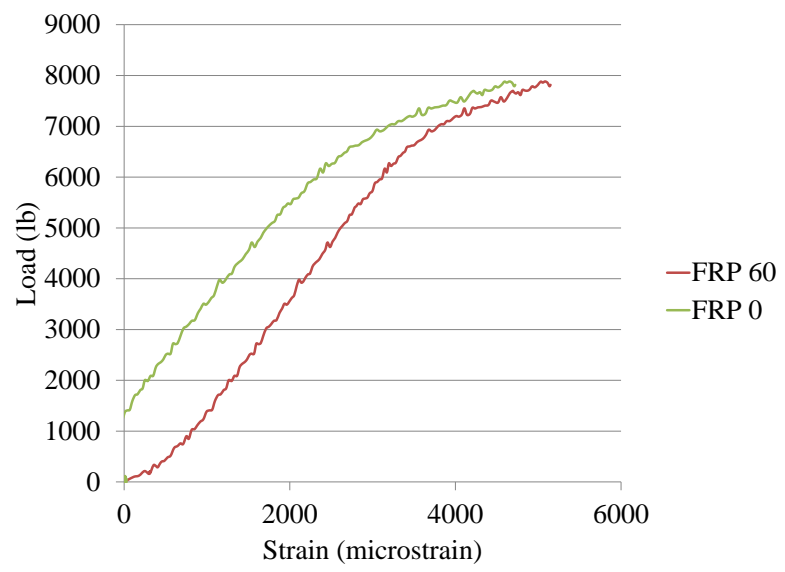
Figure 3.11. Load-Strain: FRP 60,0 #3

For FRP 60,0 #3 as shown in Figure 3.11, the non-preloaded layer appears to have supported more load after the initial drop than the preloaded layer. Again, both layers of FRP debonded, which may have been part of the reason for the reversal. This curve also shows the preloaded FRP layer engaged as soon as the test starts. These curves were not as expected. Only one of three had the preloaded layers taking load after the non-preloaded layer.

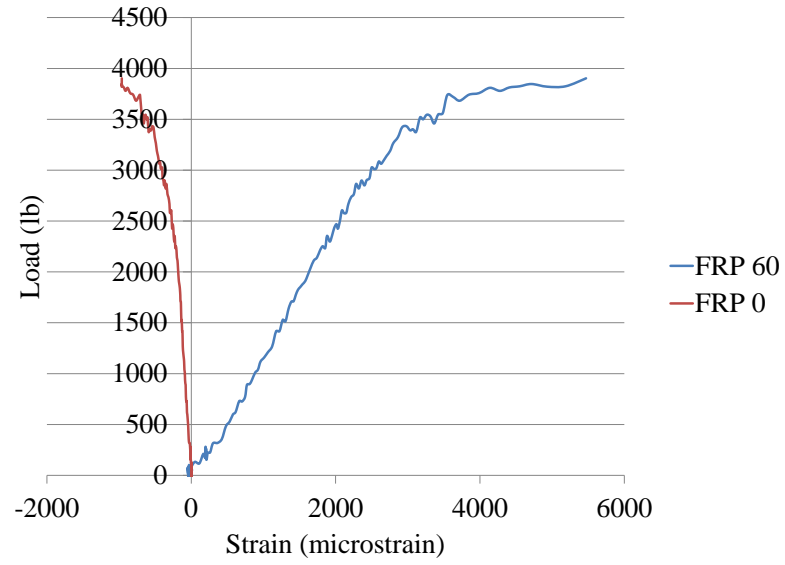
Figure 3.25. Load-Strain: W FRP 60,0 #3

Using the load strain graphs as shown in Figures 3.23-3.25, the cause of the drop and recovery was discovered. For W FRP 60,0 #1, the preloaded layer was actually the one to break first. The non-preloaded layer picked up the load before finally failing. The preloaded layer becomes engaged as soon as the load is added, which is not ideal. W FRP 60,0 #2 appears to have the same situation. The preloaded level fails first followed by the non-preloaded level. In this case, it even appears that the non-preloaded layer does not initially engage instead of the preloaded FRP. The non-preloaded FRP is acting like the preloaded FRP. For W FRP 60,0 #3, the non-preloaded layer was the one to fail first. It had some recovery from the preloaded layer before finally failing. Again, the preloaded FRP becomes engaged as soon as load is added. Out of 3 specimens tested, only one produced positive results. The implementation of wrinkles was not very successful.

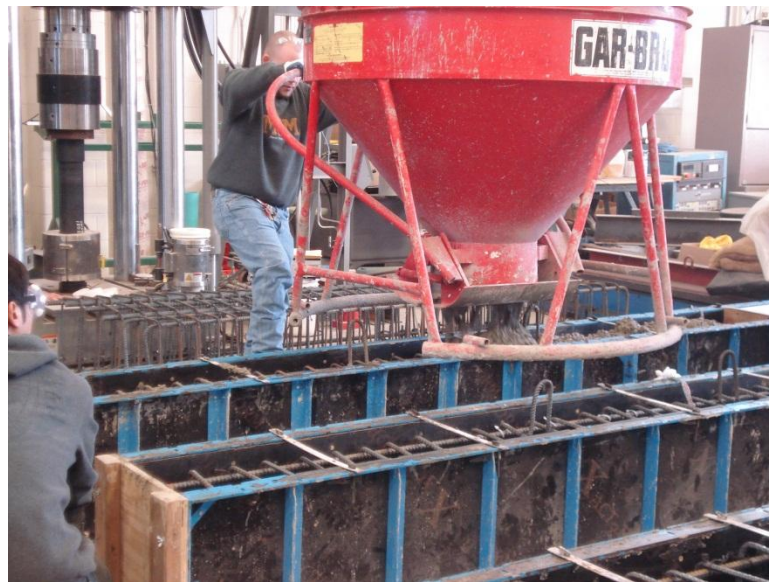
Figure 4.4. Concrete Placement

The concrete placement is shown in Figure 4.4. Concrete was delivered from Rolla Ready Mix. Slump was measured to ensure proper workability. Once the concrete produced a slump around 4.5 in, it was placed in the forms and vibrated internally. The vibration, shown in Figure 4.5, is done to achieve consolidation and ensure no voids occurred. The beams were allowed to cure covered with wet burlap and plastic sheeting for the first day. The beams were then deformed and allowed to cure the rest of the time in the lab until they were used for FRP application.

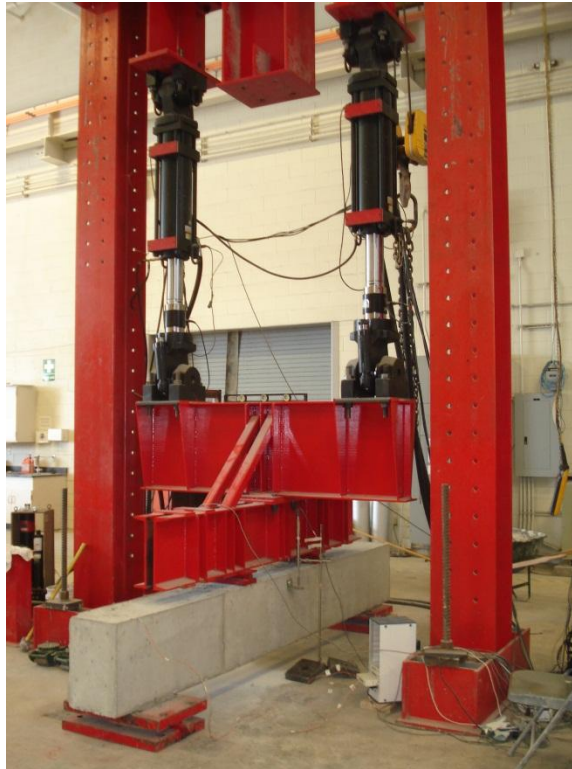
Figure 4.6. Beam Test Setup

center to center and the load points were 3 ft center to center. Two actuators provided the loading rate of 0.05 in/min. All of the strain gages on the steel rebar and FRP sheets were recorded throughout the test. In addition to the strain gages, 2 DCVTs measured deflection at the center of the beam. At various levels of loading, cracks were marked on the beams to show the progression over time.

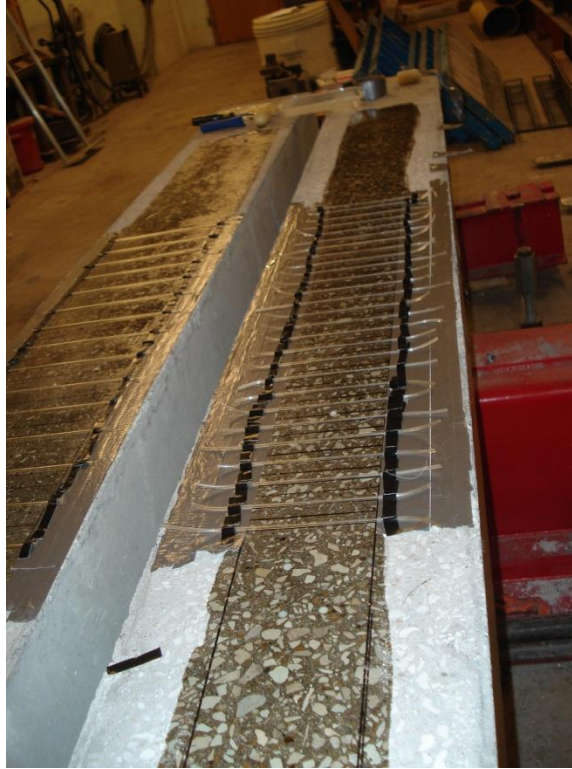
Figure 4.8. During FRP Application

The strips were placed on the beam in order of staging levels. The levels were installed on separate days to ease application. The middle strip was first applied and allowed to dry then the plastic wires were removed. This allowed the FRP to retain the predetermined arches locally. The wire was removed to leave space for the FRP as it was put into tension. A picture of the application of the middle strip of FRP is shown in Figure 4.8. The FRP was allowed to fully cure before the next stage was applied.

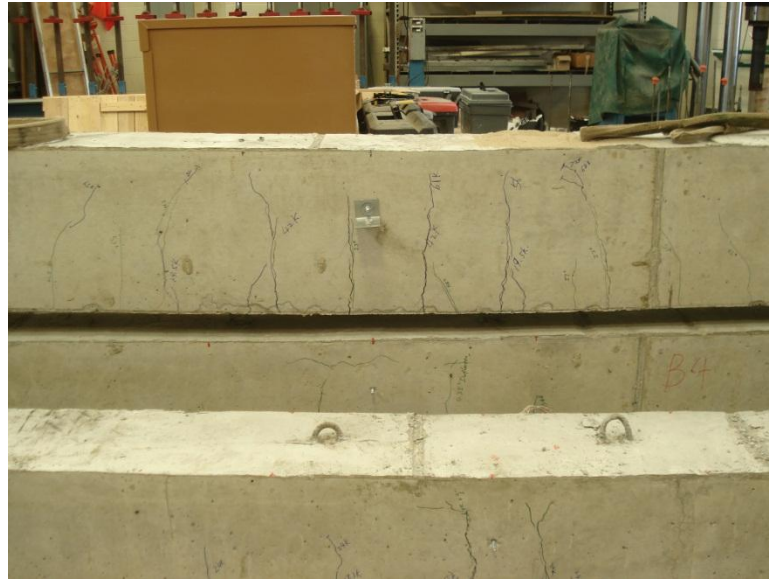
Figure 4.10. Failure of Beam 1

**4.6.1. Control Beam.** Beam 1 was the control beam without FRP. The failure is seen in Figure 4.10. The load-displacement curve, Figure 4.11, shows that the beam was cracked around 15 k and began yielding around 54 k. The maximum load reached was 73 k. The load-strain graph for the steel rebar in the control beam is found in Figure 4.12.

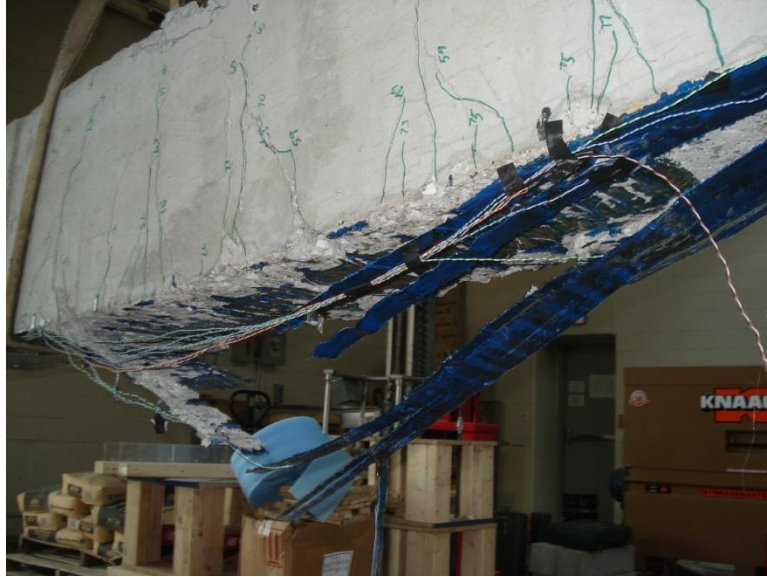
Figure 4.18. Failure of Beam 3

**4.6.3. Three Stage FRP.** The final beam of this set was Beam 3. This FRP had fracture as the main failure mode seen in Figure 4.18. Although debonding was observed near the flexural cracks, it did not reach to end of the beam. This showed an excellent bond at the end of the FRP sheets. The load-displacement curve can be seen in Figure 4.19. The curve shows that the beam reached a maximum load of 80 k. This is 5 k less than the last beam with two staged levels of FRP. This could be due to the arrangement of the FRP. When FRP fractures it does so perpendicular to the direction of the fibers so the smaller the width, the smaller the number of fibers needed to fracture before complete failure.

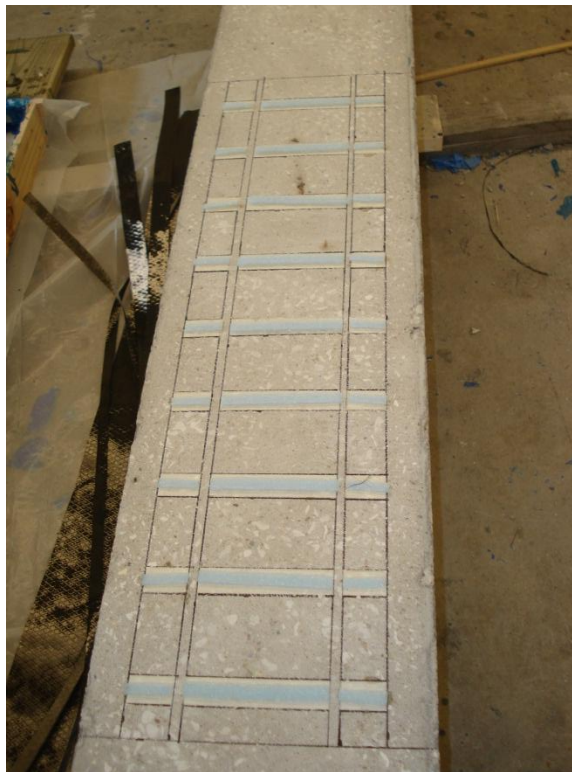
Figure 4.28. Layout of Foam Prior to FRP Application

The FRP application involved labeling the beam at locations of the debonded and foam sections before the primer was applied but after the surface preparation was finished. The tape was then laid out and the foam was glued to the top of the tape, shown in Figure 4.28. This prevented it from shifting during the application of the FRP sheet. The primer was then rolled over the surface of the concrete, tape, and foam. A bath of saturant was made to pre-impregnate the sheets of FRP. This ensured that the fibers were fully saturated without flattening the foam, already in place on the beam. Sheets were saturated and then laid in the proper locations. A grooved roller was used to ensure proper bonding between the concrete and FRP sheets. An area of concern was between each of the foam pieces. Extra care was given to roll the fibers here to aid in bonding, shown in Figure 4.29.

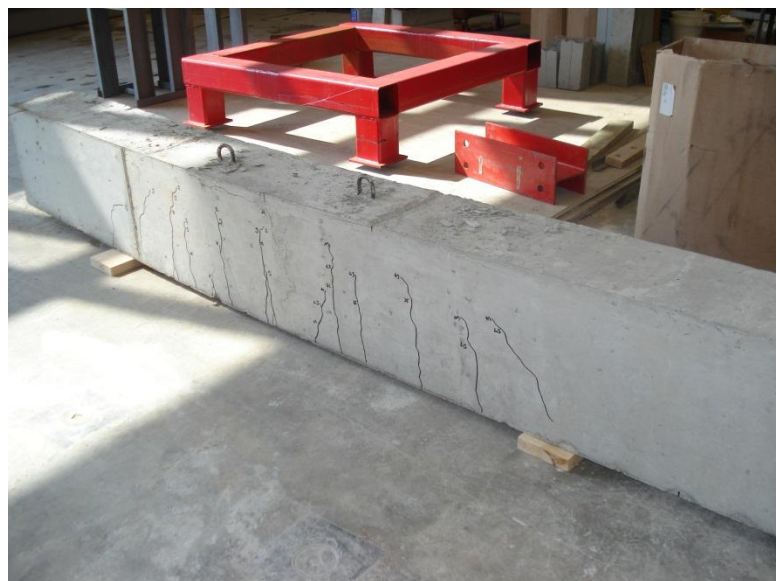
Figure 4.31. Failure of Beam 1

**4.9.1. Control Beams.** The failure of Beam 1 is seen in Figure 4.31. The yielding and deflection were similar to the other control beams tested. This beam began yielding at 58 k as shown in the load-deflection curve in Figure 4.32. The maximum load achieved was 77 k. Concrete crushing occurred at 1.5 in deflection causing a drop in the load. The load-strain graph of the steel rebar is seen in Figure 4.33.

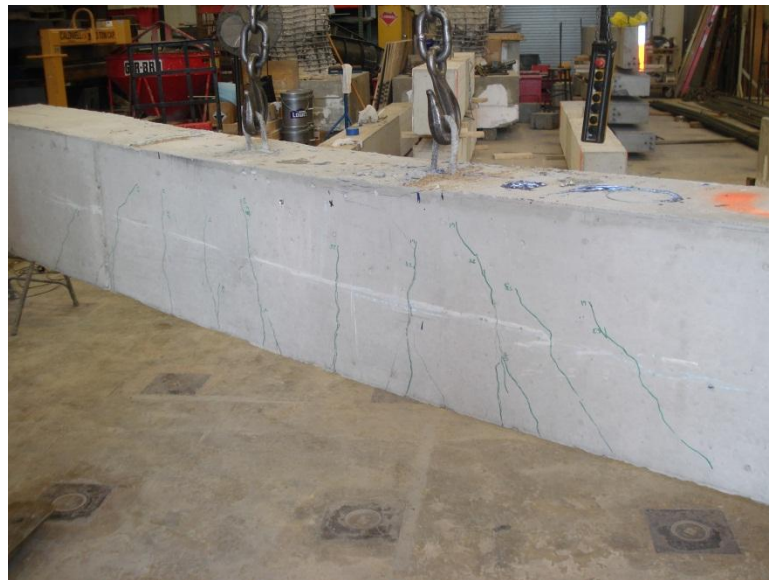
Figure 4.34. Failure of Beam 2

Beam 2 was the control beam from the second concrete pour. The failure of this beam can be seen in Figure 4.34. Shown in the load-deflection curve, Figure 4.35, the steel began yielding at 58 k. Beam 2 reached an ultimate load of 73 k. The load-strain curve for the steel rebar is shown in Figure 4.36.

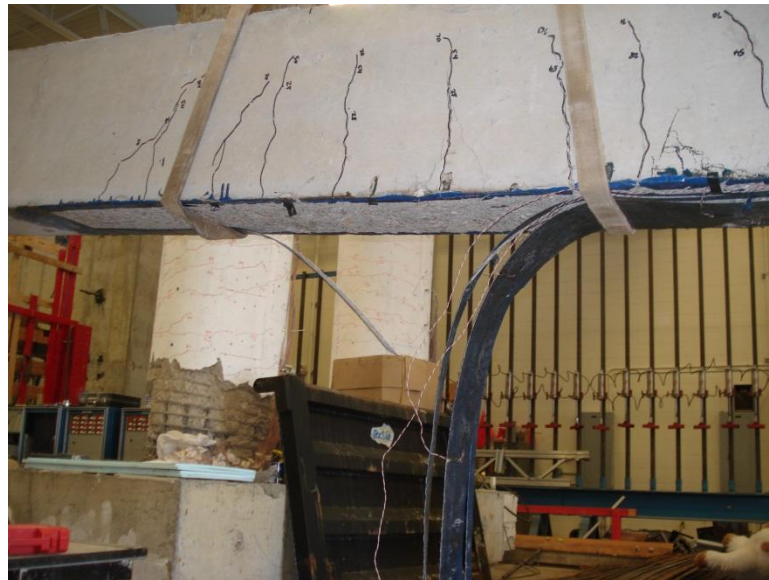
Figure 4.37. Failure of Beam 3

**4.9.2. 0 Staged FRP Beam.** Beam 3 had one single sheet of stage 0 FRP applied to the bottom face. The FRP failed due to debonding from the end of the sheet. This debonding can be seen in Figure 4.37. A small 1 in wide strip did fracture near the center but the majority of the sheet failed from debonding. The load-deflection graph is shown in Figure 4.38. This beam achieved a steel yielding load of 67 k and a maximum load of 88 k. The FRP failed at 88 k causing the load to drop to 65 k. There is no load recovery in this beam because there are no additional staged FRP levels to take the load. The second drop in load that occurs at 1.4 in of deflection is due to concrete crushing of the entire compression zone.

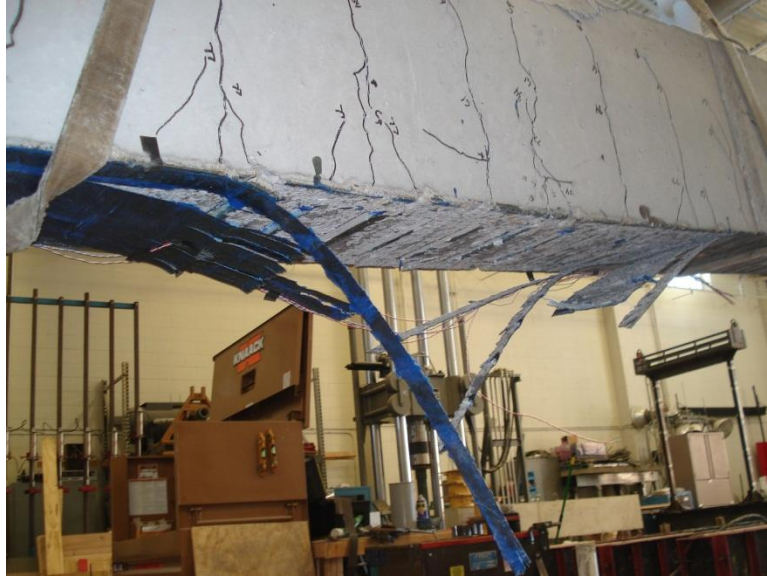
Figure 4.41. Failure of Beam 4

**4.9.3. 2 Staged FRP Layers.** Beam 4 had two levels of staging applied with the stage 1 middle sheet and the stage 0 outer strips. All the strips fractured near the middle of the beam, seen in Figure 4.41. The foam can still be seen in tact on the FRP strips. The load-deflection curve, Figure 4.42, shows that this beam began yielding at 65 k and reached an ultimate strength of 85 k.

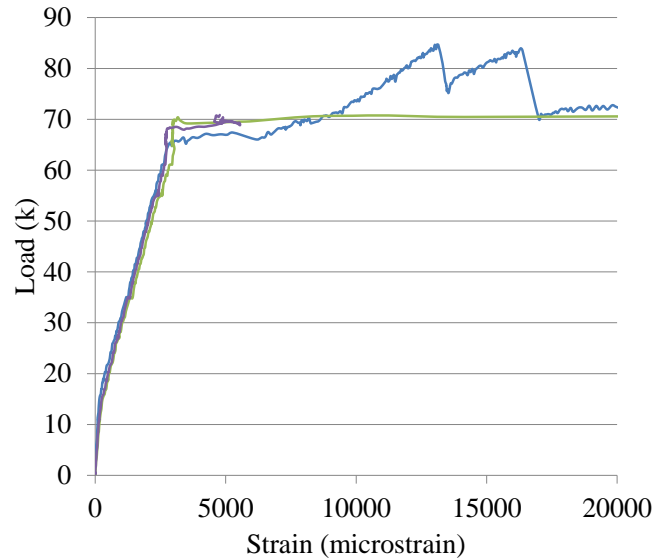
Figure 4.45. Load-Strain: Steel Rebar

The load-strain curves, seen in Figures 4.43-4.45, show that the stage 0 FRP strips broke at the first 85 k peak. The stage 1 strip recovered the load to 84 k again after the stage 0 failed. Stage 1 then failed at the 84 k peak. After this failure the load dropped back to 70 k. Concrete crushing occurred at 1.4 in of deflection causing an additional 5 k drop in load. Both the stage 0 and stage 1 layers appear to have delayed engagement of the FRP. The layers do not become engaged until 20 k.

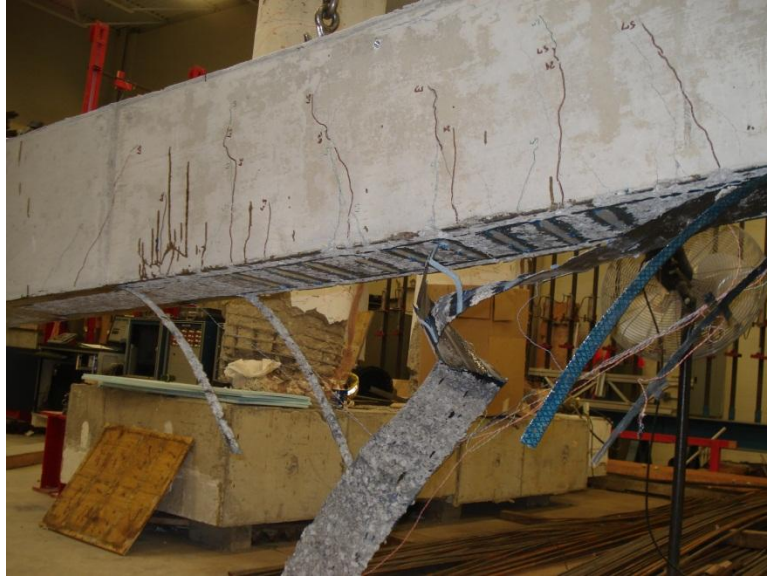
Figure 4.46. Failure of Beam 5

Beam 5 was from the second concrete pour and had the same test parameters as beam 4. The failure of this beam can be seen in Figure 4.46. Stage 1 failed due to debonding propagating from the end of the sheet. Stage 0 had a fracture of the fibers near the center of the beam. The load-deflection curve, Figure 4.47, shows that this beam was able to achieve 88 k before failing FRP. This beam had the stage 0 strips failing at separate times. Stage 1 then debonded a short time later. A greater separation in the failure of the different staged levels would be optimal.

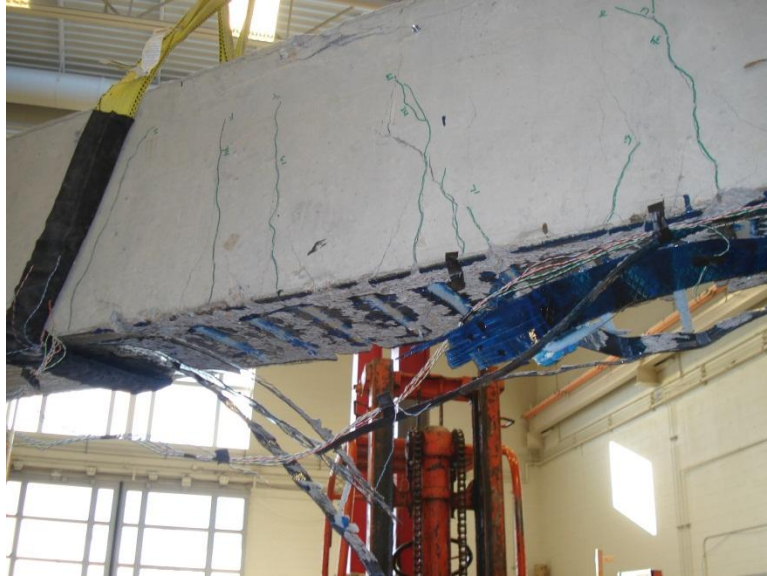
Figure 4.51. Failure of Beam 6

Beam 6 had two stages of FRP applied. Stage 1 was increased to 7.75 in wide while stage 2 was decreased to 2.25 in wide. This beam had all the FRP fracture near the center of the beam, as seen in Figure 4.51. From the load-deflection curve, Figure 4.52, it can be seen that the steel began yielding at 66 k and reached an ultimate strength of 88 k. Concrete crushing was the cause of the drop in load at 1.5 in of deflection.

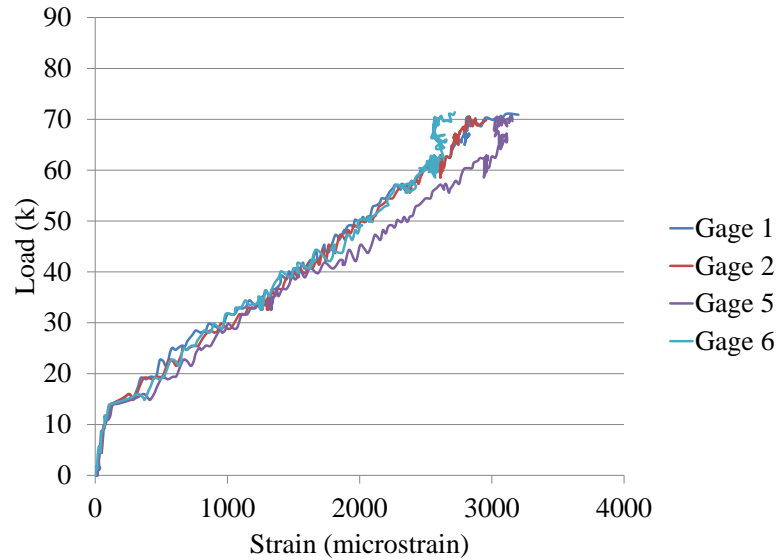
Figure 4.55. Load-Strain: Steel Rebar

The load-strain curves, Figures 4.53-4.55, were examined to confirm when each of the FRP strips failed. Visually it was seen that one side of the stage 0 strips failed at 81 k. The second stage 0 strip visually fractured at 88 k, which is backed up by Figure 4.54. Stage 1 held the load shortly after the second stage 0 strip failed. Stage 1 failed at 87 k. Both stages 0 and 1 did not engage until about 20 k. Only the stage 1 layer should be delayed.

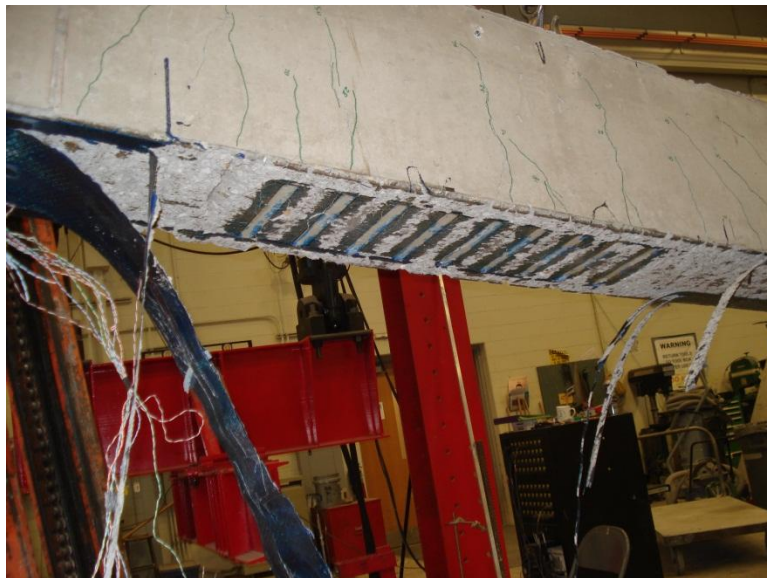
Figure 4.56. Failure of Beam 7

Beam 7 has the same FRP staging as Beam 6. The failure of the FRP is shown in Figure 4.56 with fracture of the stage 0 strips and debonding of the stage 1 strip. Figure 4.57 shows the load-deflection curve. This beam had steel yielding beginning around 65 k and an ultimate strength of 91 k. This graph appears to have a more ductile curve than Beam 6 because the FRP fails between 1.10 in and 1.30 in of deflection.

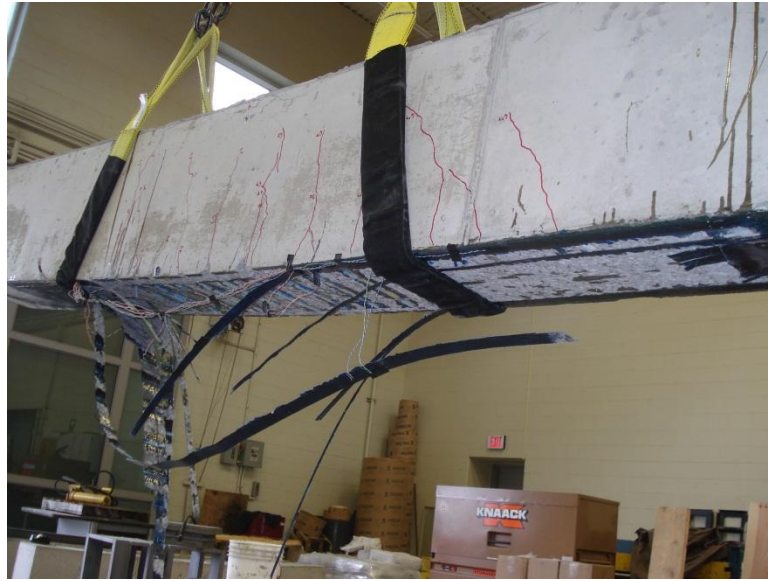
Figure 4.67. Failure of Beam 10

Beam 10 had a slight variation in the width of the foam compared to Beam 9. The failure of this beam is seen in Figure 4.67. All of the stages of FRP fractured. Stage 2 fractured near the end of the strip while stages 0 and 1 fractured closer to the center of the beam. The load-deflection curve, shown in Figure 4.68, shows that an ultimate load of 87 k was reached.

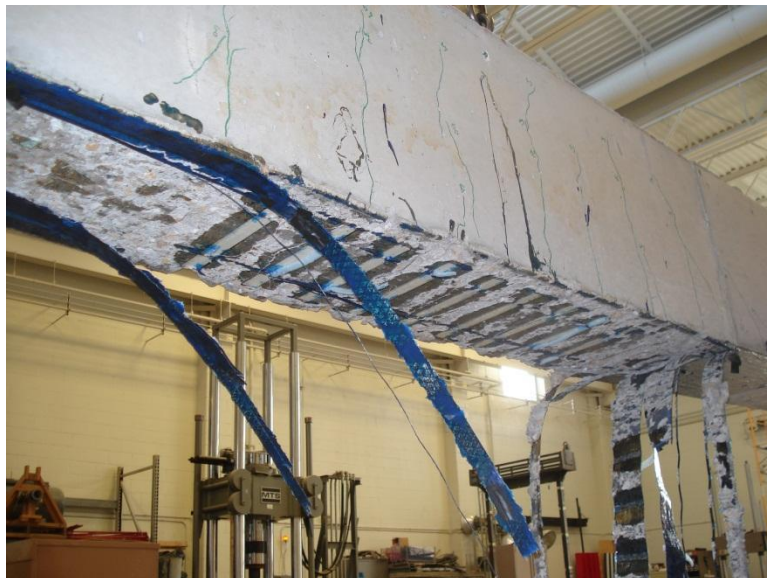
Figure 4.73. Failure of Beam 11

Beam 11 had three stages of FRP applied to the bottom face. As seen in Figure 4.73, this beam fractured at the stage 0 and stage 1 strip while the stage 2 strip debonded. The load-deflection curve, Figure 4.74, shows that yielding began around 59 k. Beam 11 reached an ultimate strength of 87 k.

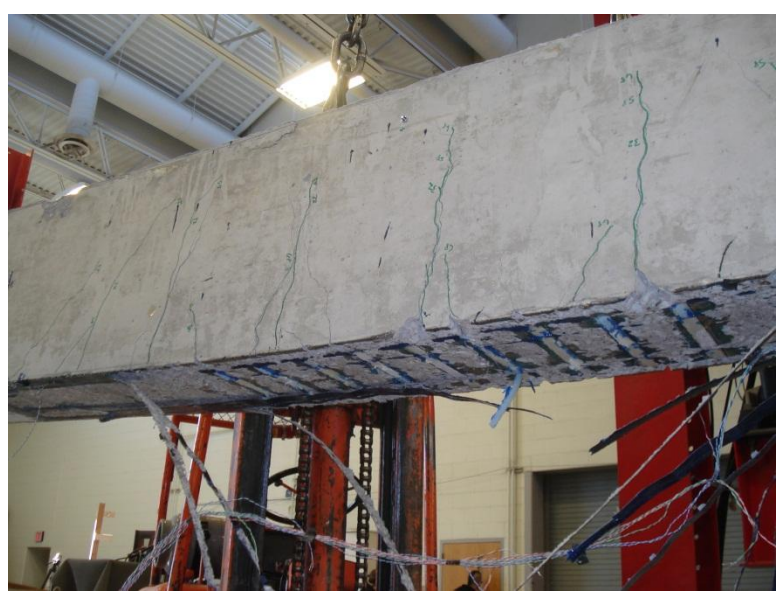
Figure 4.79. Failure of Beam 12

Beam 12 had the exact same FRP configuration as Beam 11. The failure of Beam 12 is shown in Figure 4.79. The stage 0 and stage 1 strips fractured and the stage 2 strip debonded from the end. The load-deflection curve in Figure 4.80 shows that Beam 12 reaches an ultimate strength of 84 k. The overall shape of the curve for Beams 11 and 12 are very similar to each other. This appears to be a fairly accurate repeat of results between two separate beams.
