Application of ground penetrating radar (GPR) for bridge deck condition assessment: using a 1.5 GHz ground-coupled antenna

**APPLICATION OF GROUND PENETRATING RADAR (GPR) FOR
BRIDGE DECK CONDITION ASSESSMENT: USING
A 1.5 GHZ GROUND-COUPLED ANTENNA**

MASTER OF SCIENCE IN GEOLOGICAL ENGINEERING

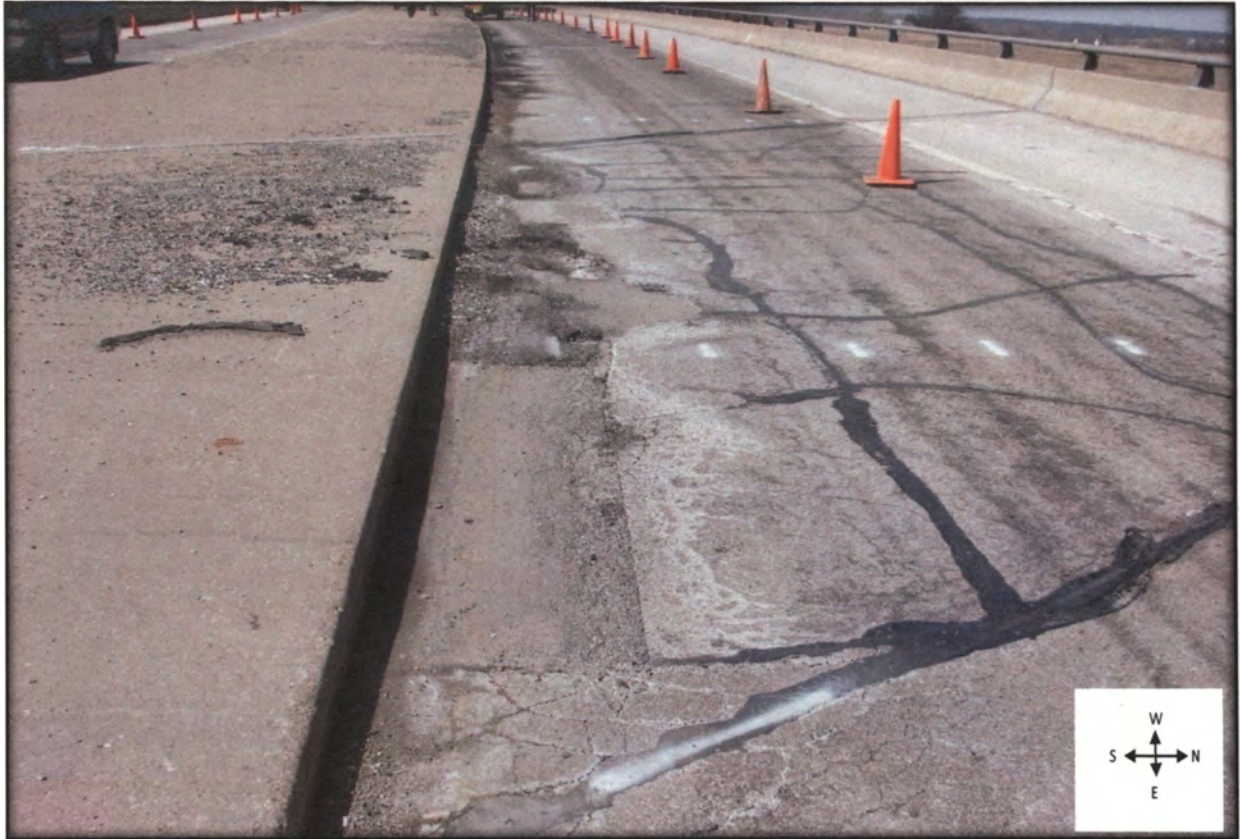
Figure 1.1. Severely deteriorated section of westbound lanes on Bridge A-090-0095.

1.1.1. Concrete Bridge A-090-0095. Constructed in 1971, this bridge is rated in the NBI as structurally deficient. It is approximately 286 feet long with single lane in both the westbound and eastbound directions. Both lanes are approximately 23 feet wide with a hot bituminous wearing surface and separated by an 18 ft wide concrete median. At the time of inspection the asphalt on the southern edge (close to the median) of the westbound lane (Figure 1.1) was severely deteriorated with numerous potholes, patches, seals, and substantial accumulated debris. The eastbound lane was in fair condition (visually) with few patches and seals, but it had accumulated mud on the southern shoulder (Figure 1.2).

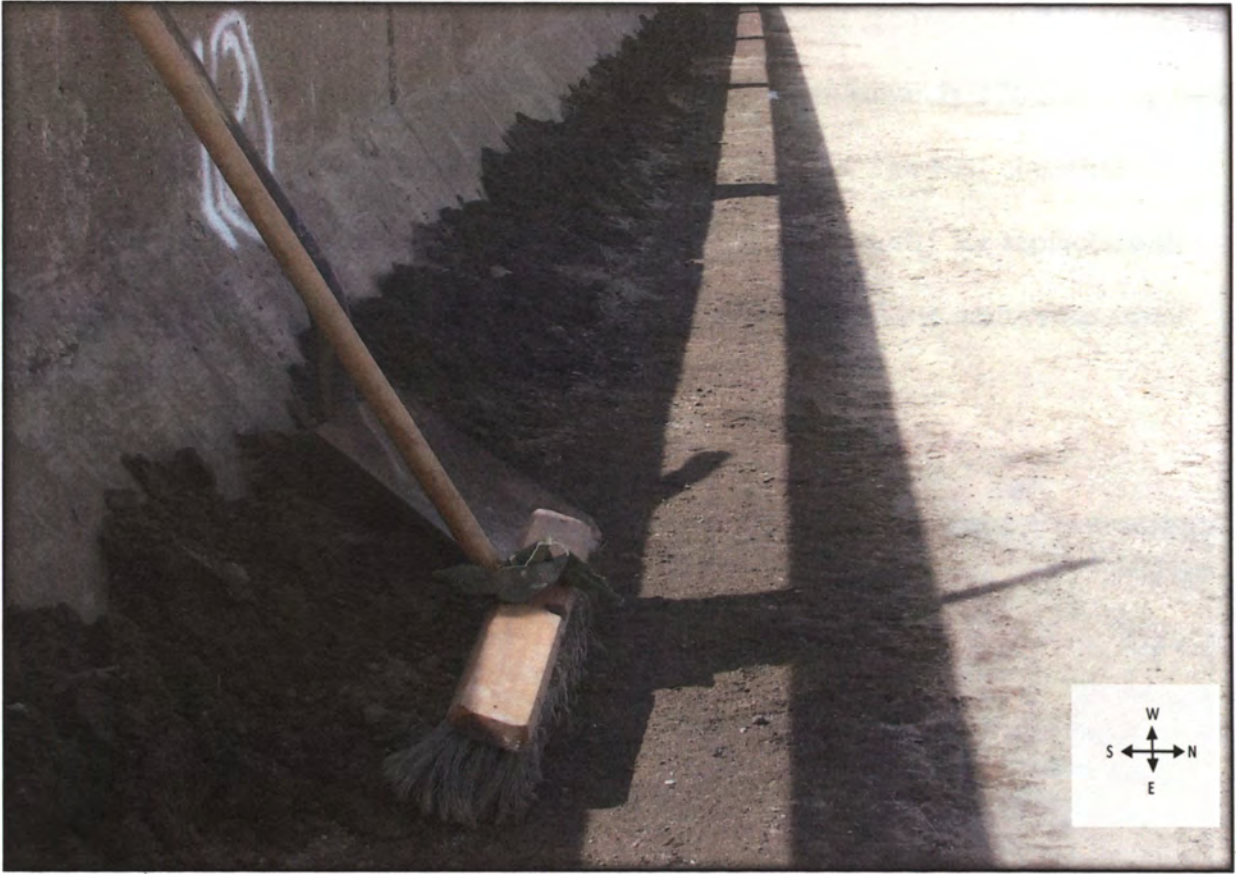
Figure 1.2. Accumulated mud at the southern shoulder of Bridge A-090-0095 eastbound.

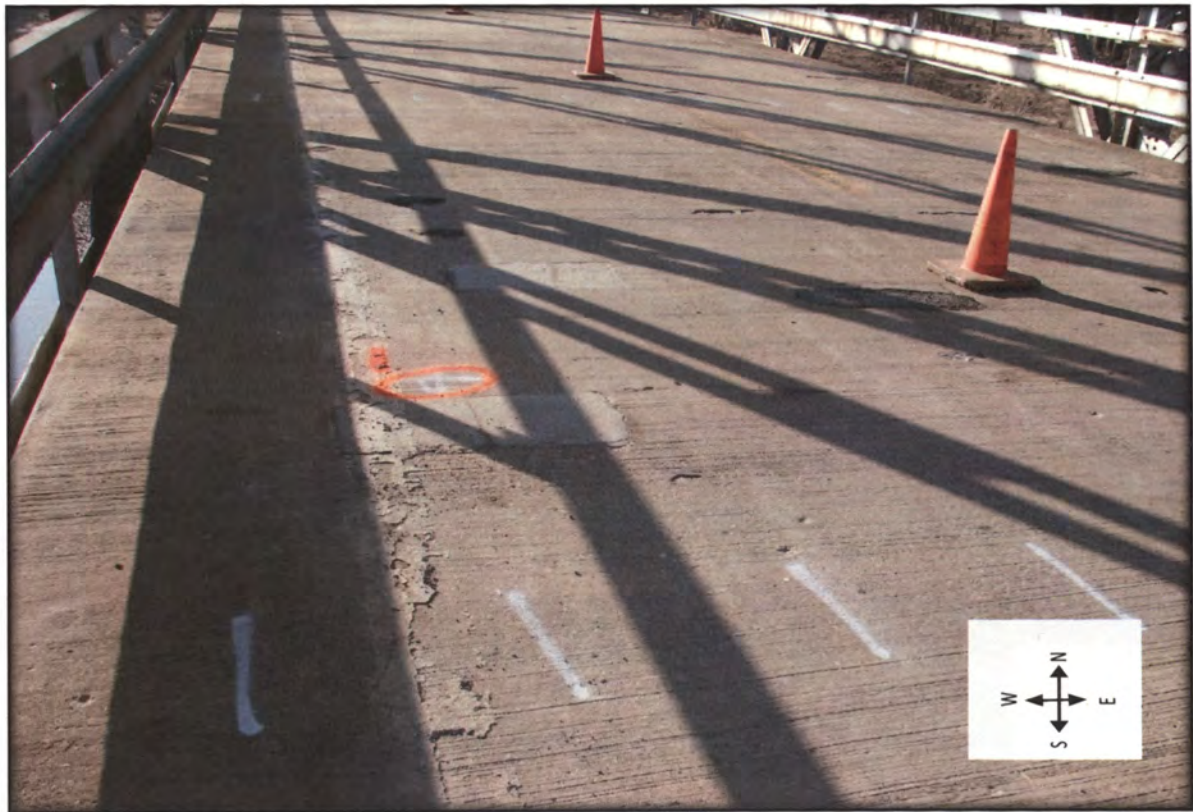
Figure 1.3. Concrete mortar removal and numerous small patches on concrete Bridge B-090-0087.

1.1.2. Concrete Bridge B-90-0087. Built in 1932 and reconstructed in 1979, the deck is a reinforced structural concrete slab measuring approximately 176 feet long by 24 feet wide and carrying both the north- and southbound traffic. The NBI classifies this bridge as structurally deficient and indicates that it is a high priority for replacement. The bridge visual inspection showed significant transverse cracking, numerous small patches, and some scaling (Figure 1.3).

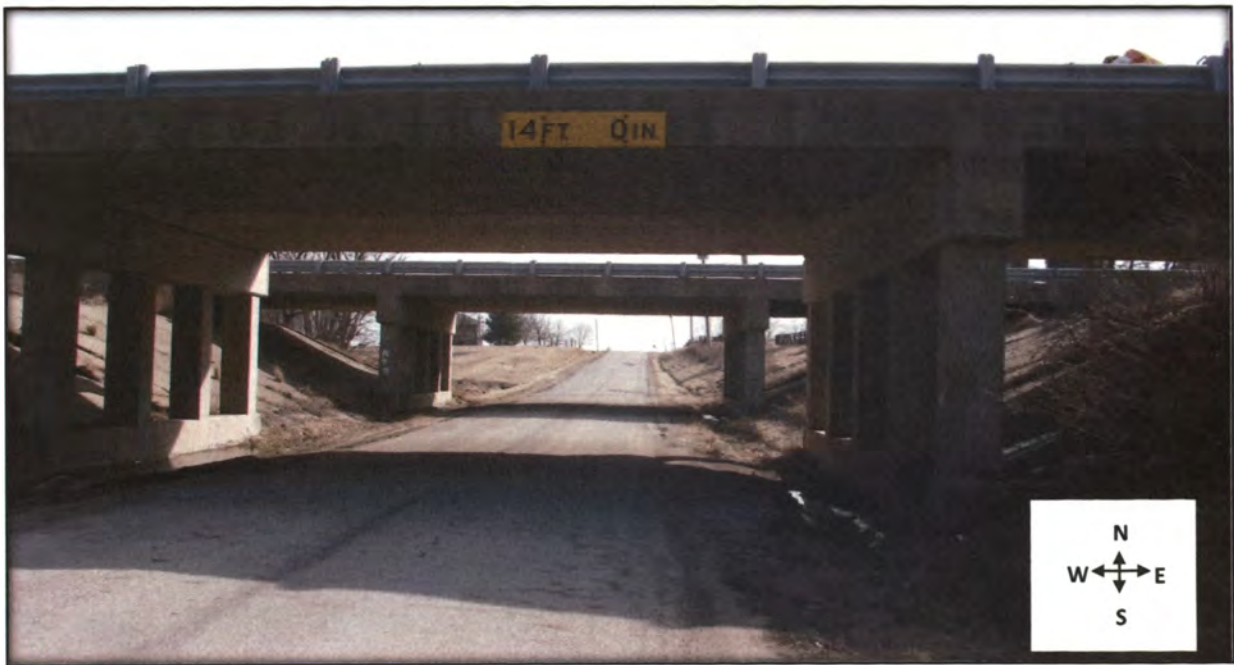
Figure 1.4. Bridge C-(048-0011 and 048-0012) with Bridge C-048-0012 in the foreground and C-048-0011 in the background.

1.1.3. Bridge C-(048-0011 and 048-0012). This is a concrete bridge structure with a hot bituminous wearing surface. The bridge was built in 1963, and according to NBI it is in good condition (Figure 1.4). Both the westbound (Bridge C-048-0011) and eastbound directions (Bridge C-048-0012) have double lanes approximately 109 feet long by 26 feet wide. The surface of all lanes was in good condition apart from a few small patches along the end expansion joints. However, the underside of the westbound lanes had severe corrosion that had led to debonding of the concrete and exposure of the bottom rebar mat (Figure 1.5).

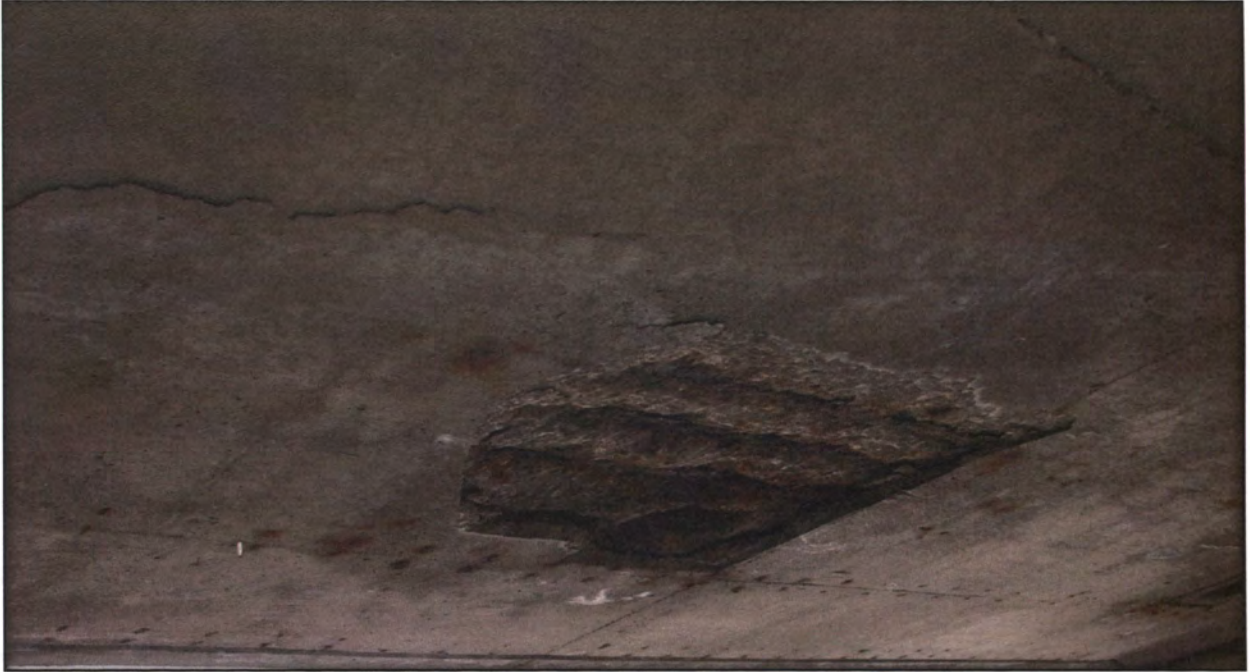
Figure 1.5. Underside of Bridge C- 048-0011 (westbound) showing corrosion deterioration and debonding of concrete at rebar level.

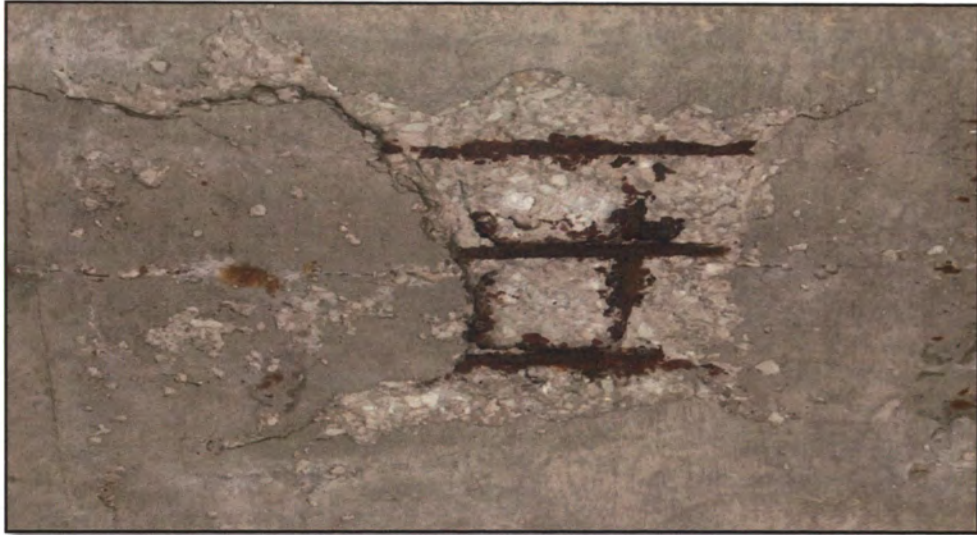
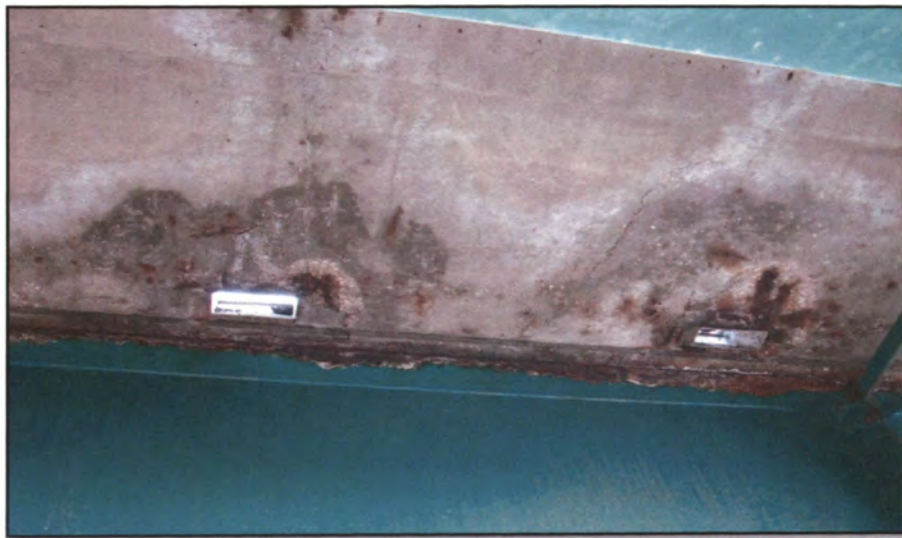
(a) Example of severely deteriorated bridge slab.

(b) Deterioration due to unguttered water drainage.

Figure 2.4. Underside view of deterioration on reinforced concrete bridge deck.

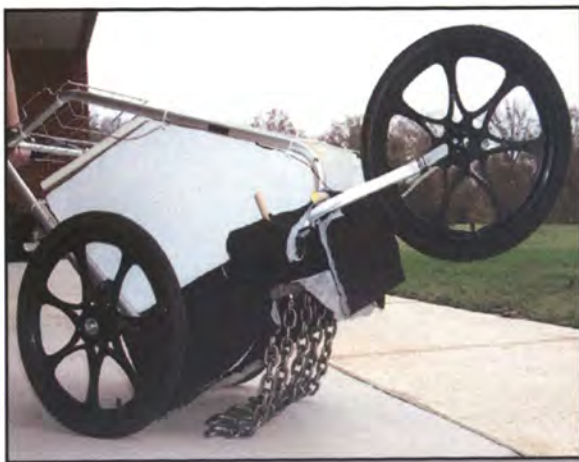
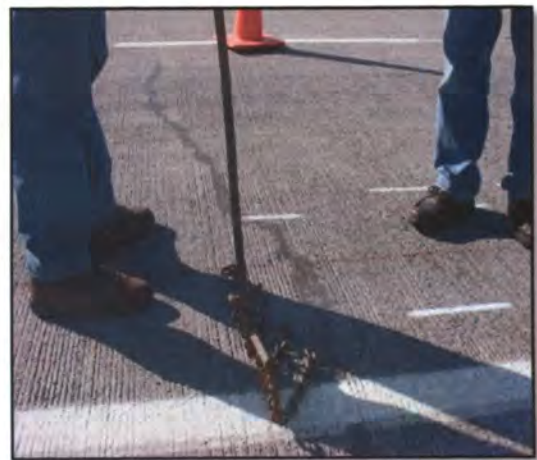
a) The automated chain drag system (ACDS). b) Manual chain dragging.

2.4.1. Sounding Methods. Intact concrete produces a sharp ringing sound, and deteriorated zones (i.e. those where there is de-bonding at concrete/asphalt or concrete/rebar level) emit a dull hollow sound when impacted with a hammer, or steel rod, or when a chain is dragged over it (Sohanghpurwala, 2006). This characteristic permits evaluation of concrete by sounding. The traditional chain dragging method is tiresome, time consuming, subjective and is prone to operator error. Furthermore, it is impractical in a noisy environment. However, chain dragging has come of age with the automated chain drag system (ACDS). Using a microphone, this tool records sound produced by dragging chains and uses a computer to analyze the sound, thus distinguishing intact sections of the bridge deck from delaminated sections (Costley, 2005). Figure 2.5 show both automated and manual chain dragging systems employed for both bridge and pavement inspection.

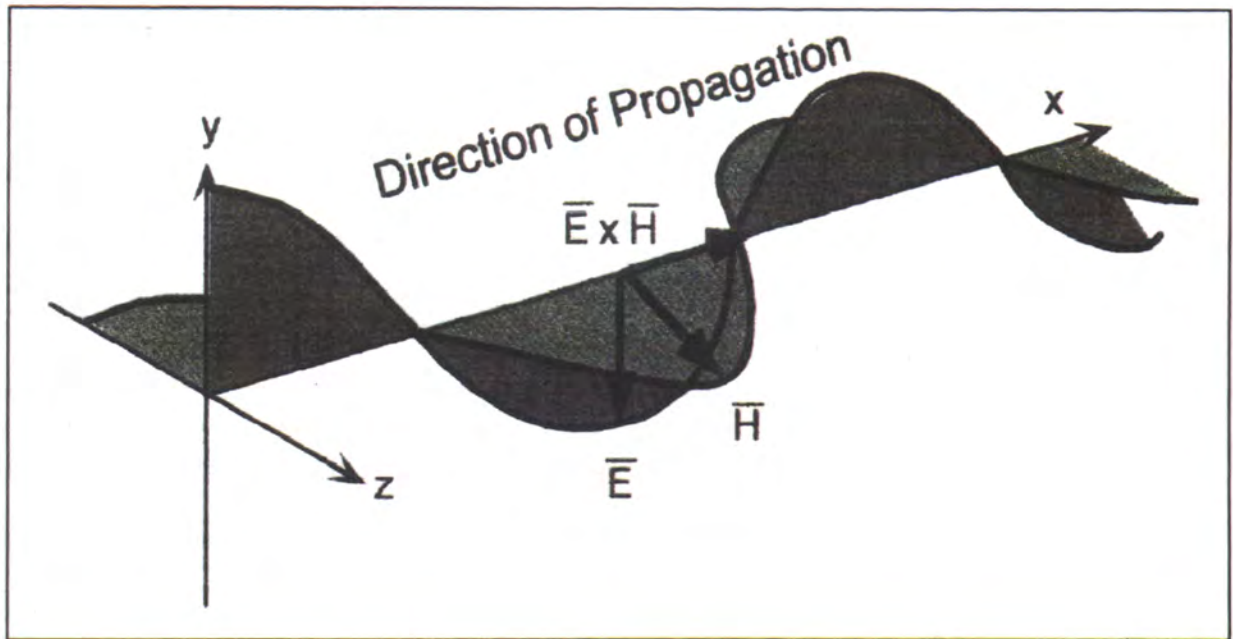
Figure 3.2. Basic elements of an electromagnetic wave, showing the two principle electric (E) and magnetic (H) components (Reynolds, 1997).

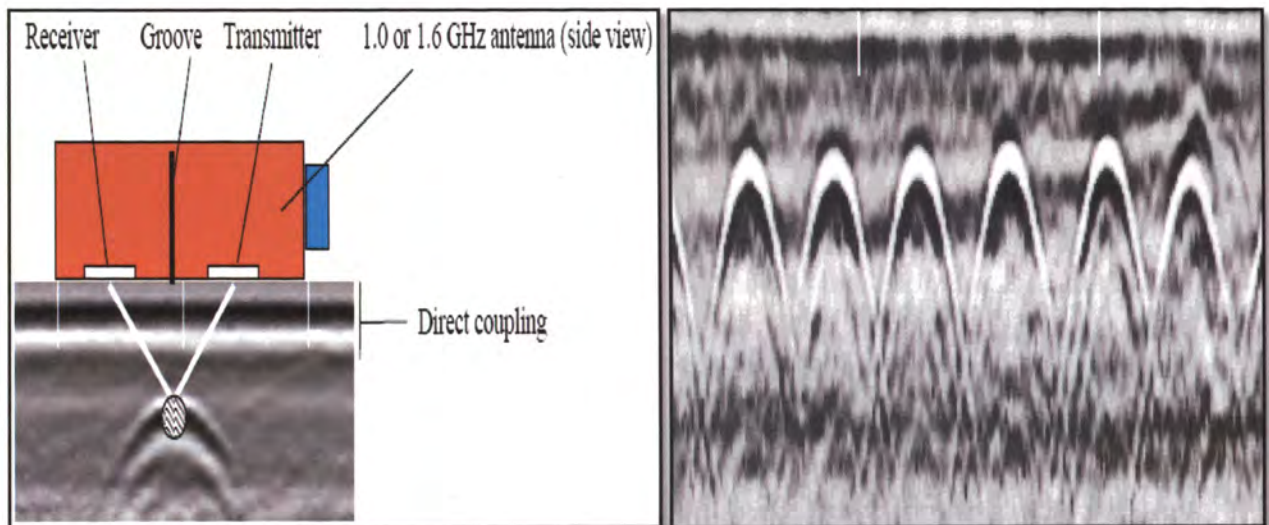
a) Target location.

Figure 3.3. a) Location of a target (GSSI Handbook, 2005) and b) *hyperbolic* (inverted U) shaped images associated with linear targets.

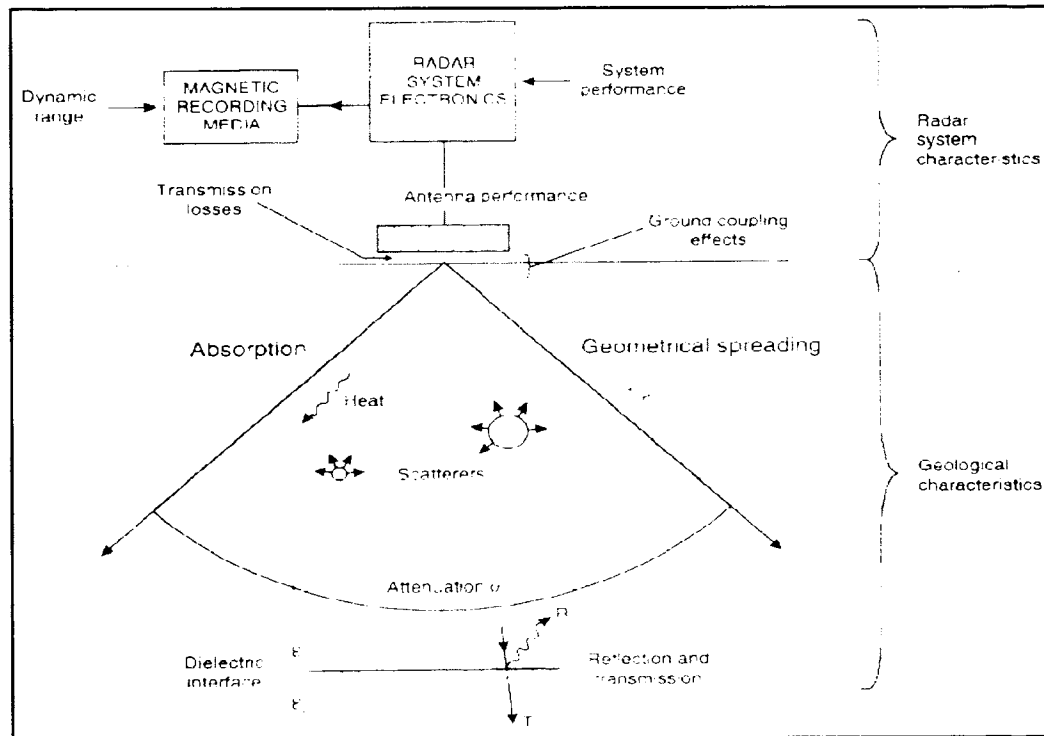
Figure 3.7. Processes that lead to signal attenuation (Reynolds, 1997).

Attenuation is the loss or dissipation of energy as radiowaves travel from the source through the subsurface. This is analogous to the loss of cell phone signal when driving through a tunnel and it is dependent on the nature and thickness of the overburden on the tunnel. The signal detected by the receiver undergoes numerous losses (Figure 3.7) during its transmission. This energy loss occurs due to factors such as, geometric spreading, ground coupling effects (transmission-coupling and retransmission-coupling loss), scattering, material loss, antenna loss, and transmission loss (due to moving charged particles).

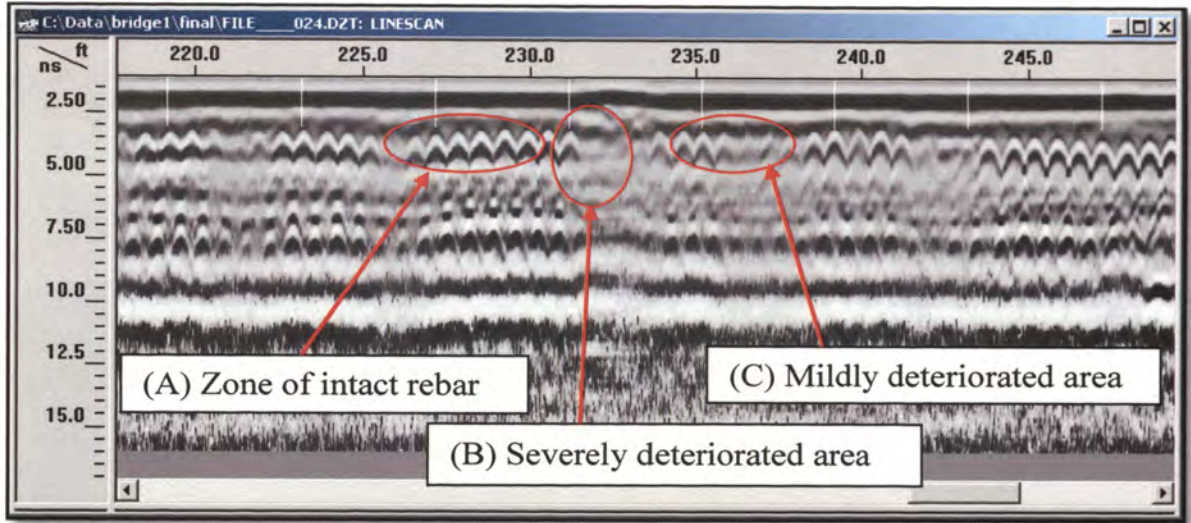
Figure 4.1. Characteristics of a deteriorated bridge deck.

When applied for bridge deck assessment different signatures in the GPR profile may be used for detecting corrosion of steel reinforcement within the concrete deck, which can indicate poor quality overlay bonding or delamination at the rebar level. Intact rebar has very high reflection amplitude and visually clear hyperbolic shape; however, corroded rebar leads to significant attenuation of the reflected GPR signal. Figure 4.1 shows various bridge conditions, including a) zones of intact rebar, b) severely deteriorated areas where rebar appear missing due to total signal attenuation, and c) mildly deteriorated regions where the rebar reflection is low. Another effect of corrosion and delamination on GPR signal is the late arrival times of reflections (i.e., increased travel time) due to reduction of signal velocity, which makes the affected rebar appear to be deeper than the intact rebar. Low signal strength (or reflection amplitude). Longer arrival time (i.e., increased vertical distance to the rebar) result from increased dielectric constant (i.e., decreased electromagnetic velocity) which is also indicative of deterioration.

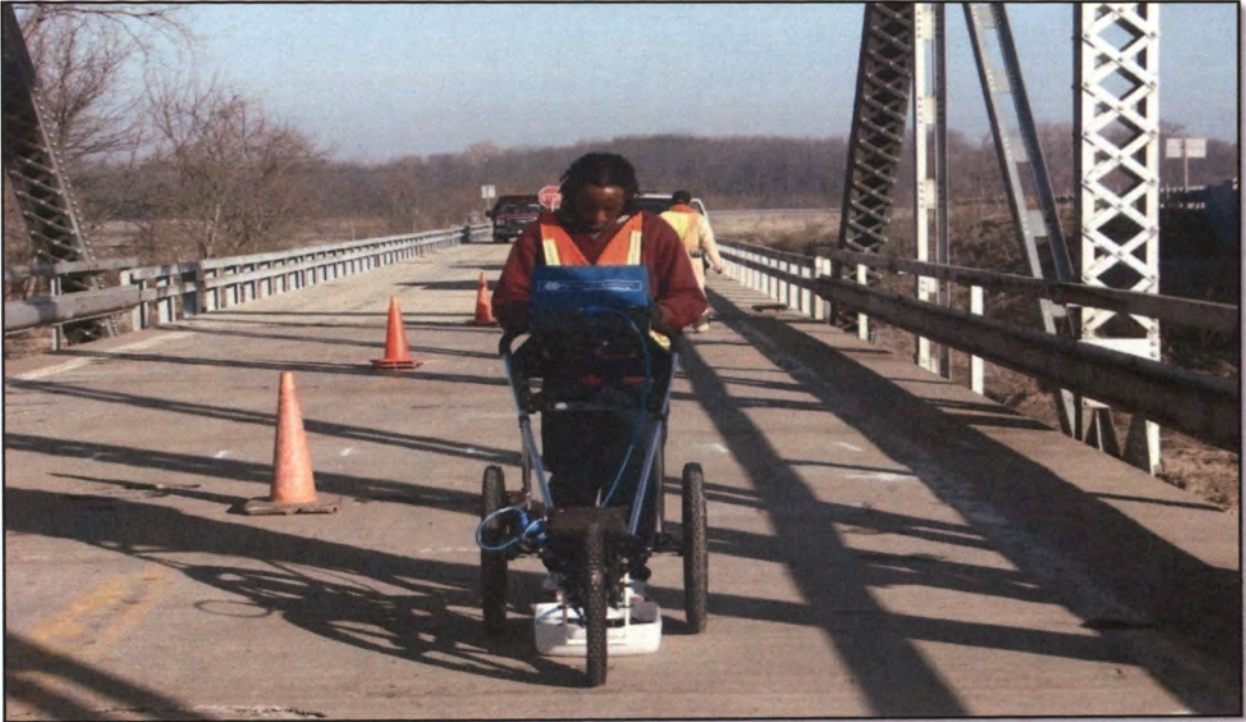
Figure 4.4. GSSI SIR-3000 GPR unit equipped with 1.5GHz antenna.

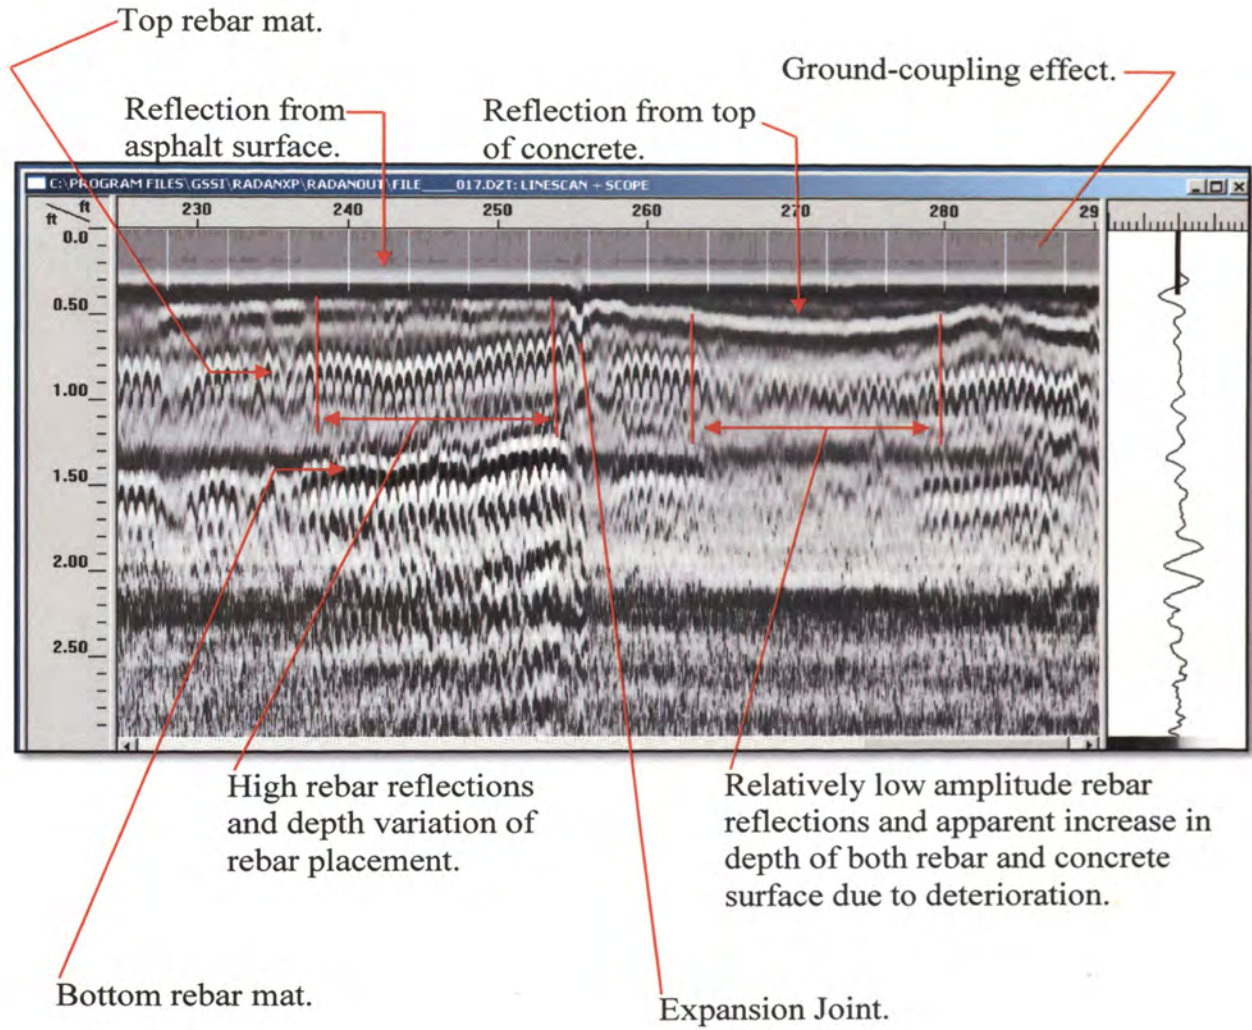
Figure 4.5. Visual examination of a GPR profile from Bridge A-090-0095.

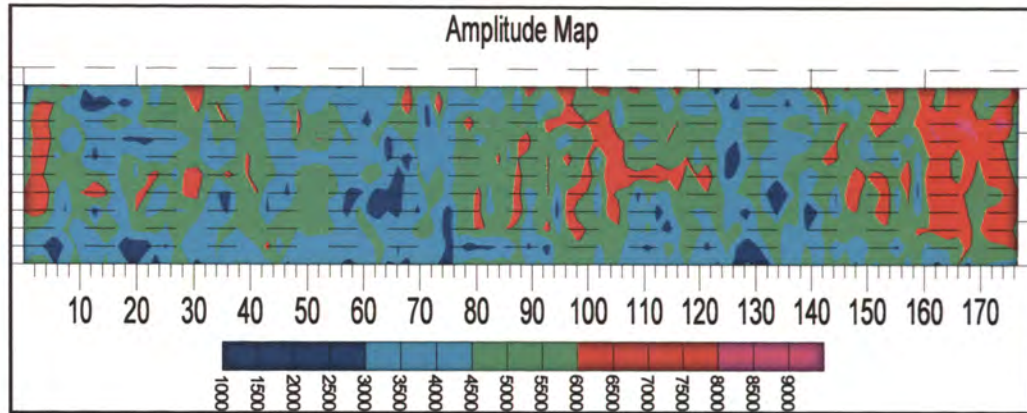
Figure 4.10. Contoured map showing variations in relative amplitudes of reflections from top of rebar of eleven GPR profiles acquired across the deck of structure No. 090-0087. Rebar amplitude increases from blue to purple.

Surfer mapping software was used to generate contour maps using the ASCII file. Amplitude maps were created with X and Y coordinates of rebar locations and reflection amplitudes. Depth maps were generated with X and Y coordinates of rebar location and depth. A total of five amplitude maps and five depth maps were generated, including two for Bridge A-090-0095 (west- and eastbound), one for Bridge B-90-0087 (north- and southbound), and two for Bridge C-((048-0011 westbound) and (048-0012-eastbound)). Figures 4.10 and 4.11 are examples of amplitude and depth maps respectively.

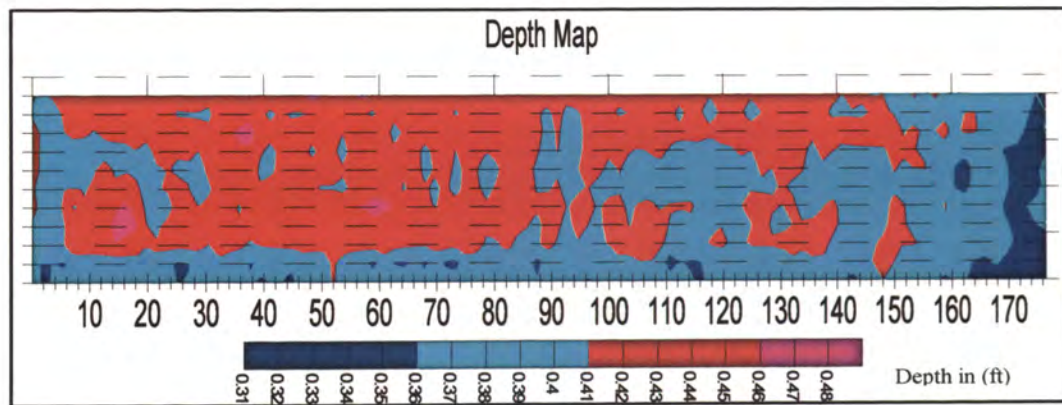
Figure 4.11. Contoured map showing variations in estimated depth (ft) of rebar on eleven GPR profiles acquired across deck of Structure No. 090-0087. Depth increases from blue to purple.

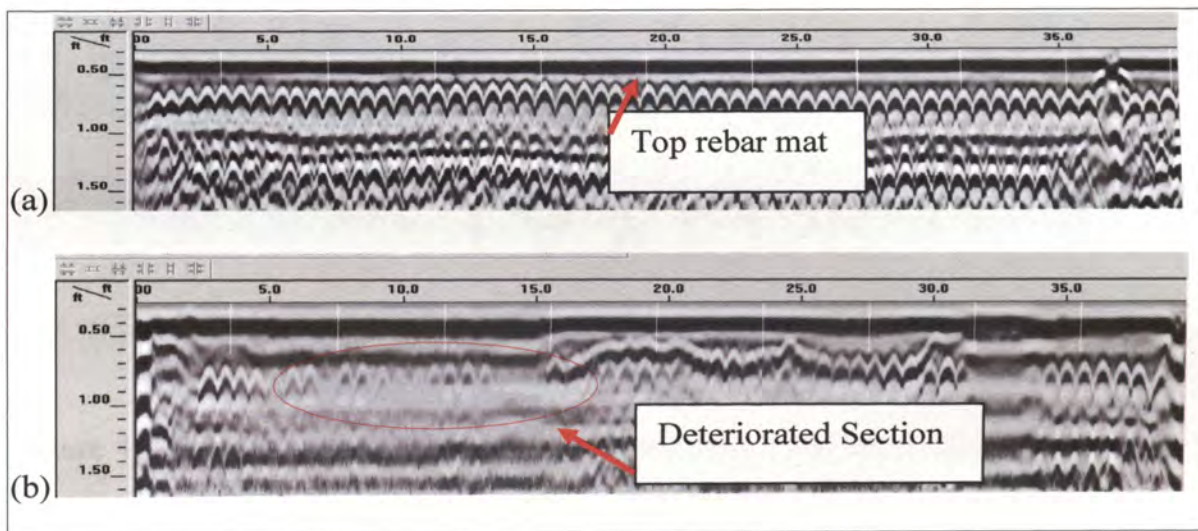
Figure 4.12. Examples from Bridge A-090-0095: (A) consistent signature for top rebar mat; (B) signature displaying amplitude and travel-time anomalies distinguishing areas of possible deterioration.

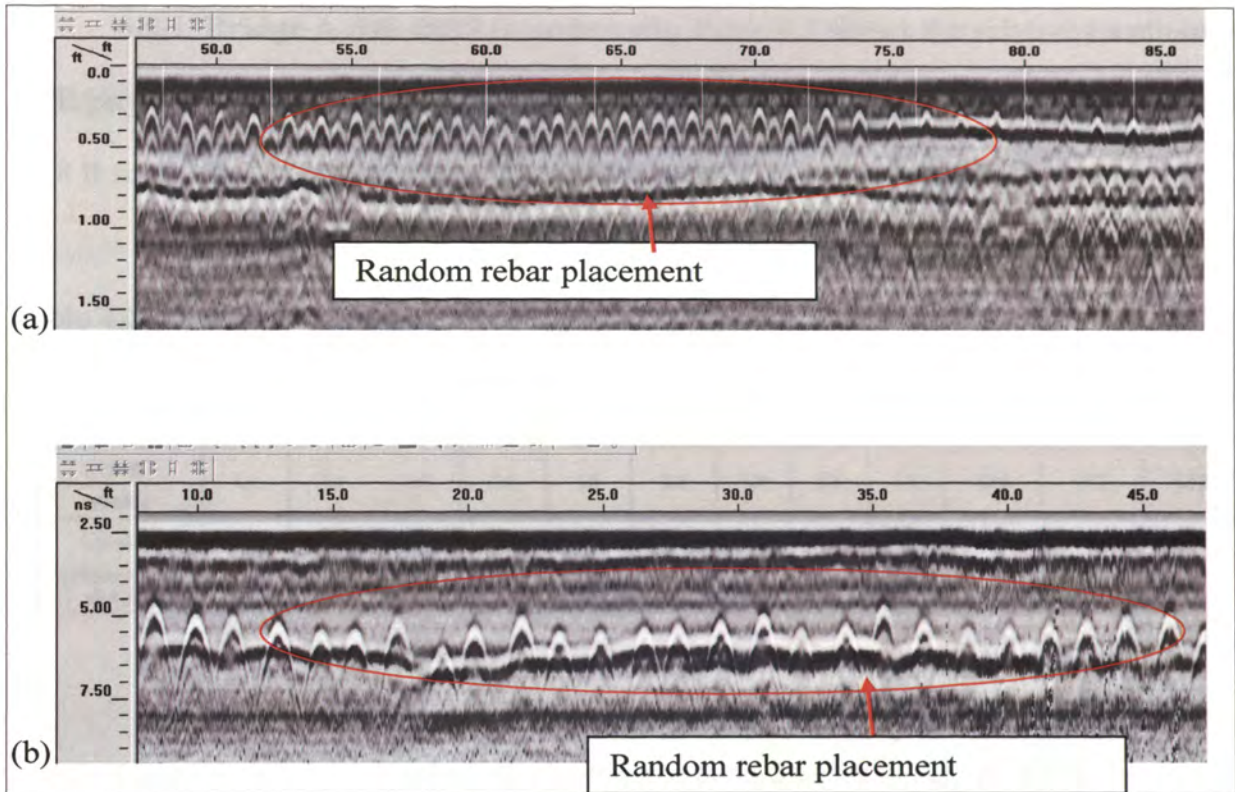
Figure 4.14. Variation due to random inconsistent rebar placement. (A) Example from Bridge B-90-0087, and (B) Example from Bridge C-048-0011.

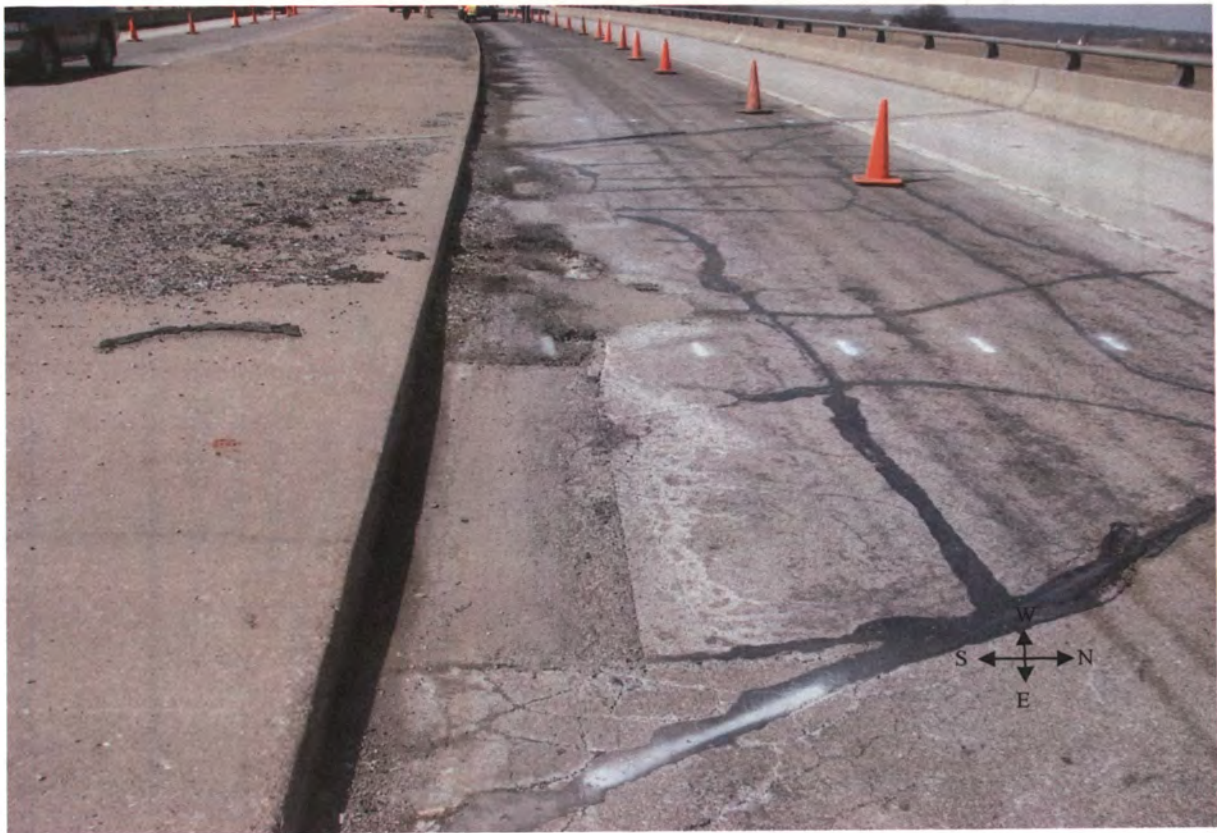
Figure 4.15. Part of the most (visually) deteriorated part of Bridge A-090-0095 (westbound).

(Table 4.4). The top part of each core (0.25"-1.00") had high chloride ions concentration than the deeper (2.75"-3.50") portion of the core, indicating that the deterioration concentrated on the top part of the bridge deck may be as a result of de-icing salt. The chloride ions concentration (Table 4.4) correlates well with the field observations (Figure 4.15; Table 4.3) and the amplitude map (Figure 4.16).

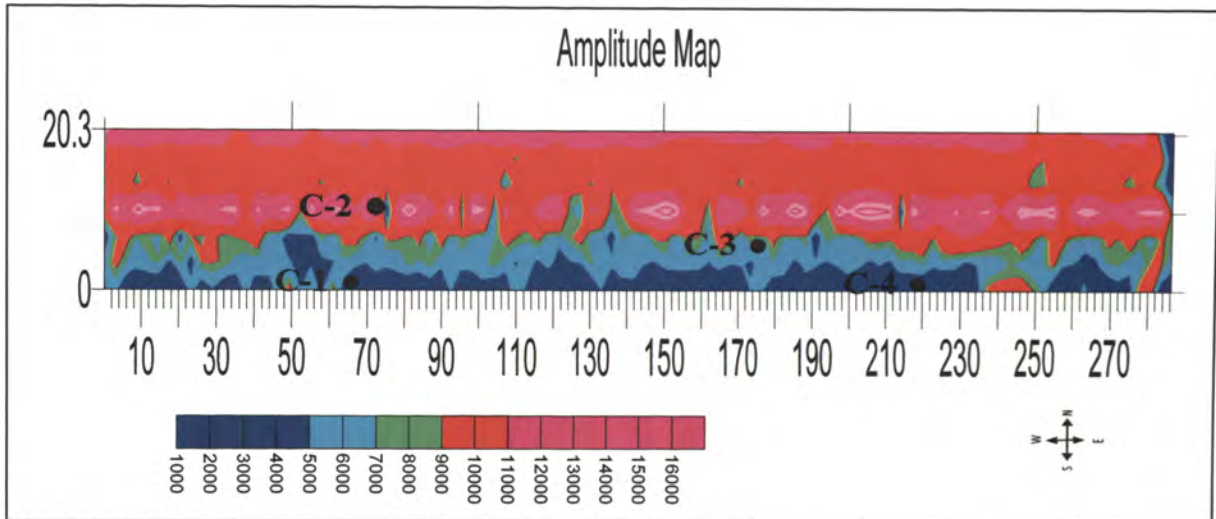
Figure 4.16. Contoured map showing variations in the relative amplitudes of reflections from top of rebar on GPR profiles and superimposed core locations acquired across westbound lanes of Bridge A-090-0095.

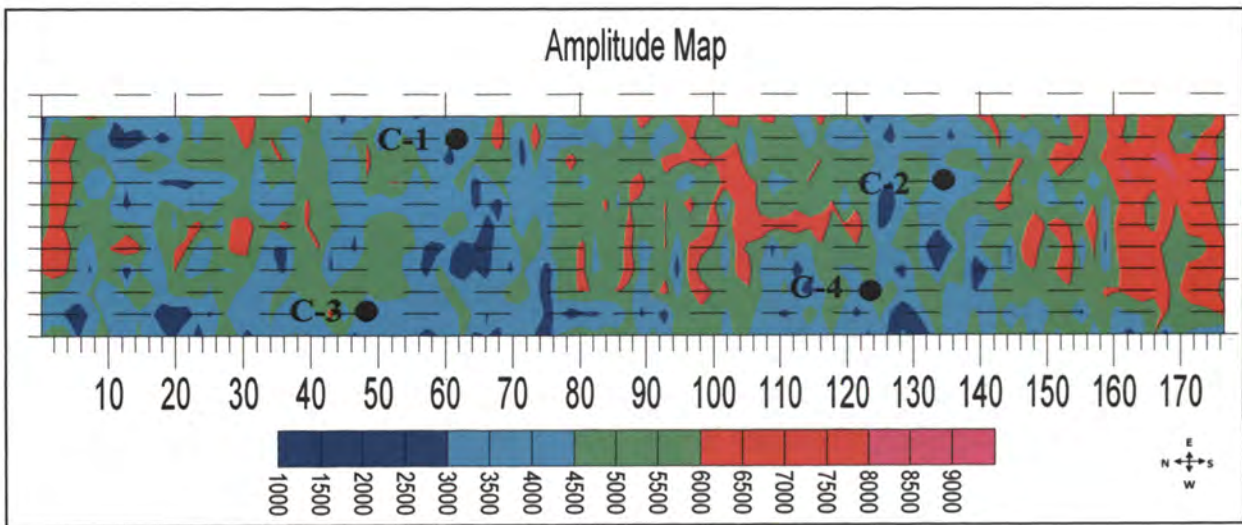
Figure 4.18. Contoured map showing variations in relative amplitudes of reflections from top of rebar acquired across deck of Bridge B-090-0087, with core locations superposed.

4.5.3. Bridge B-090-0087. This was the only bridge without asphalt overlay. A total of eleven GPR profiles were acquired along separate parallel traverses across the deck. The eastern-most GPR traverse (1) was 2 ft from the outer edge of the lane. The spacing between adjacent traverses was 2 ft (Figure 4.18). Table 4.8 is a summary of four cores samples with their locations superimposed on Figure 4.18. Deep blue areas on the amplitude map indicate significant deterioration and high chloride ion content (<3000 rebar amplitude and >400ppm); Light blue areas probably indicate deterioration and/or elevated chloride ion content (>3000 <4500 amplitudes).

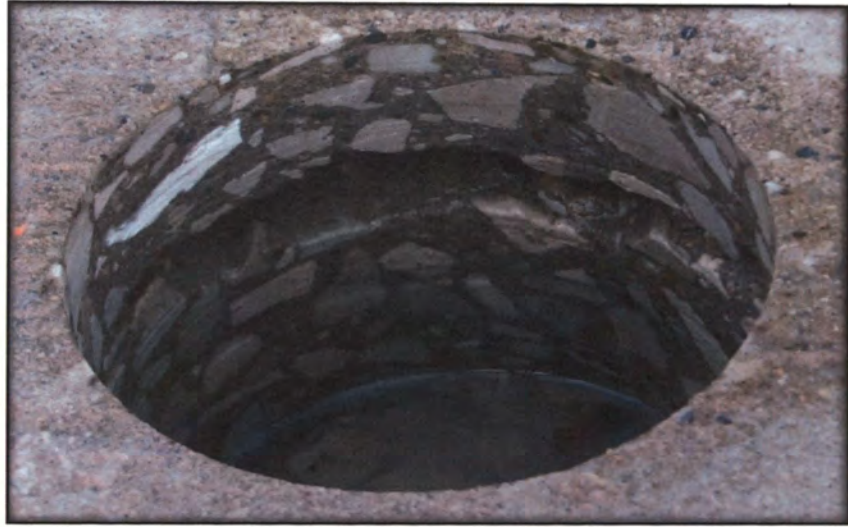
Figure 4.19. Core hole showing planer separation of concrete from Bridge A-090-0087 core C-1.

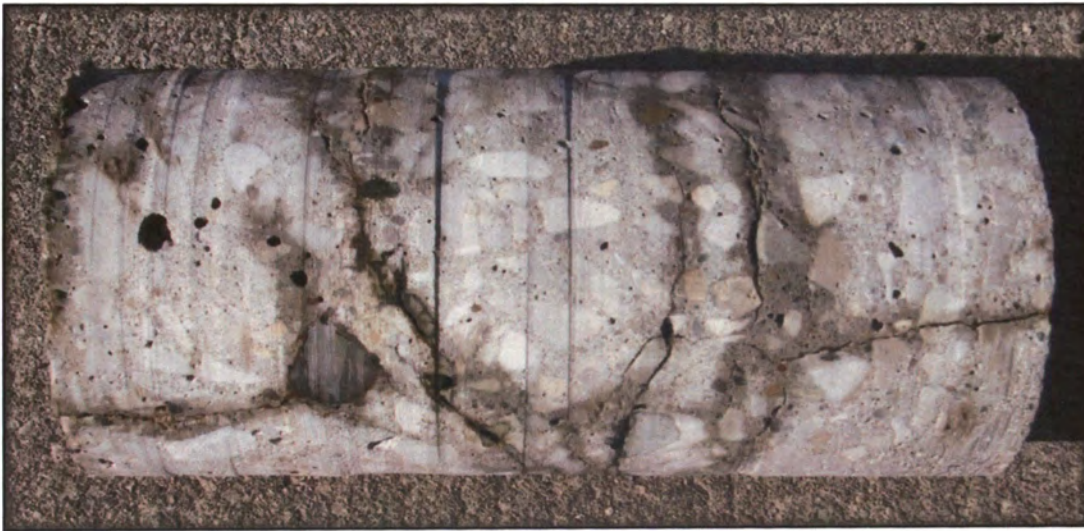
Figure 4.20. Deteriorated core sample from Bridge A-090-0087 core C-2 showing cracks and voids through length of core.

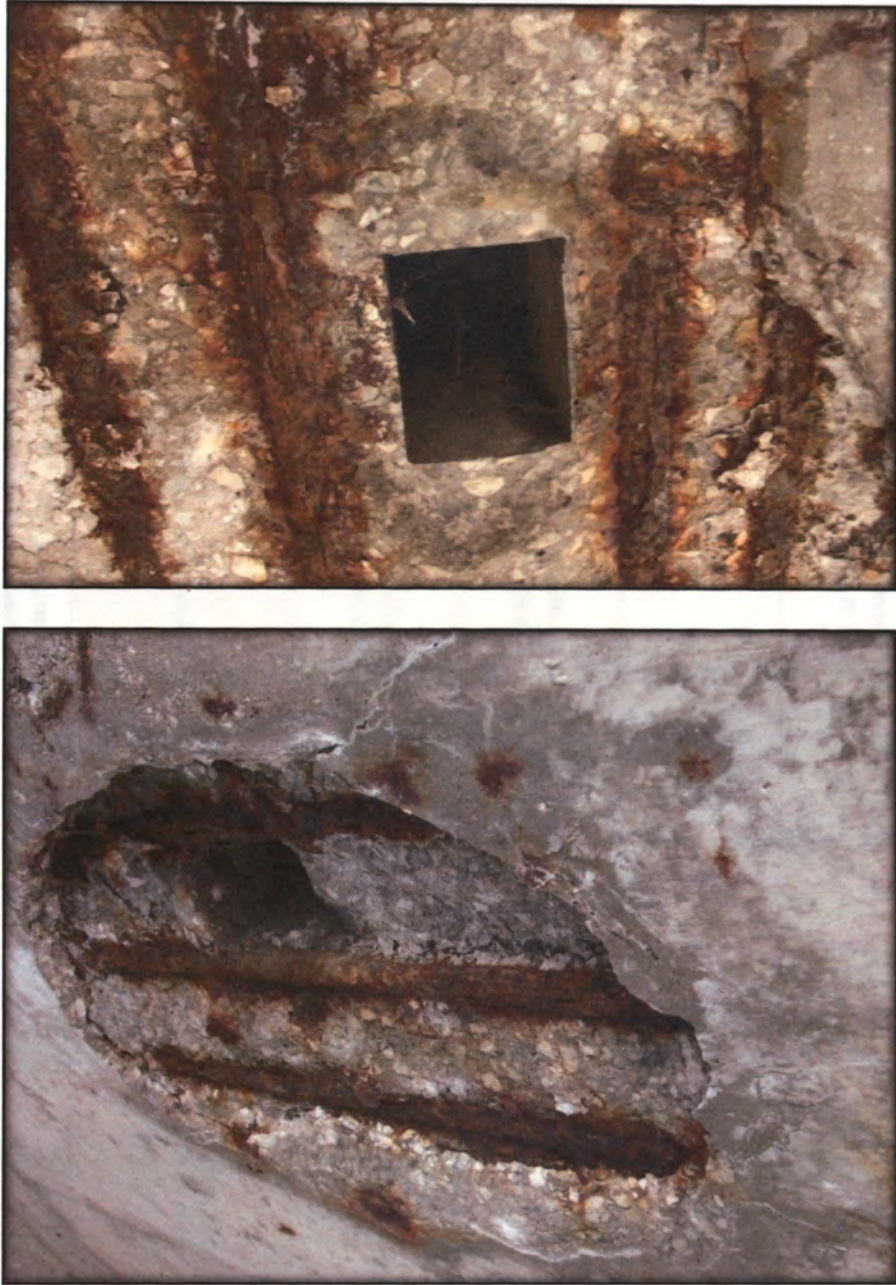
Figure 4.21. Significant deterioration on underside of Bridge C- 048-0011 around drainage outlets.

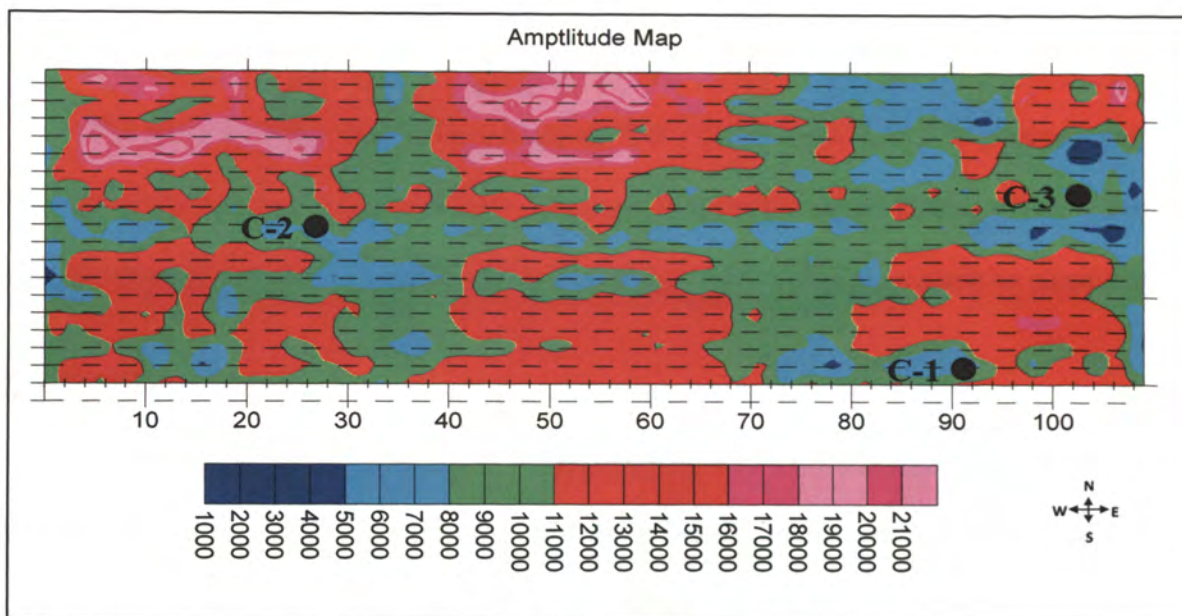
Figure 4.23. Contoured map showing variations in relative amplitudes of reflections from top of rebar on GPR profiles acquired across deck of Bridge C-048-0012 (eastbound), with core locations superposed.
