## Thermal fatigue testing of die casting die steels

THERMAL FATIGUE TESTING OF  
DIE CASTING DIE STEELS

THESIS

MASTER OF SCIENCE IN METALLURGICAL ENGINEERING

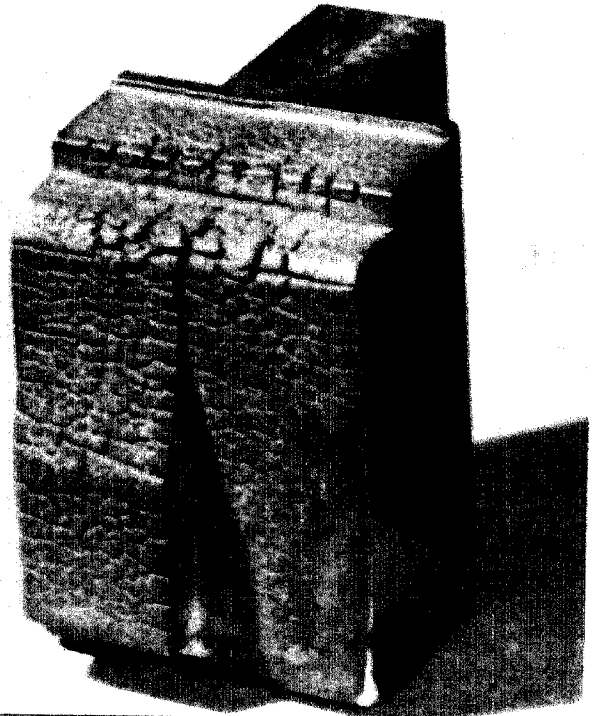
Fig. 4-(b) Severe heat checking in H-21 die after 3000 brass casting cycles

Roberts and Grobe<sup>(8)</sup> studied a number of dies to determine the mechanisms of die failure in die casting. The dies shown in Figs. 4a-b are good examples of heat checking. The checks filled with aluminum in Fig. 4a are in marked contrast to the oxidized steel background.

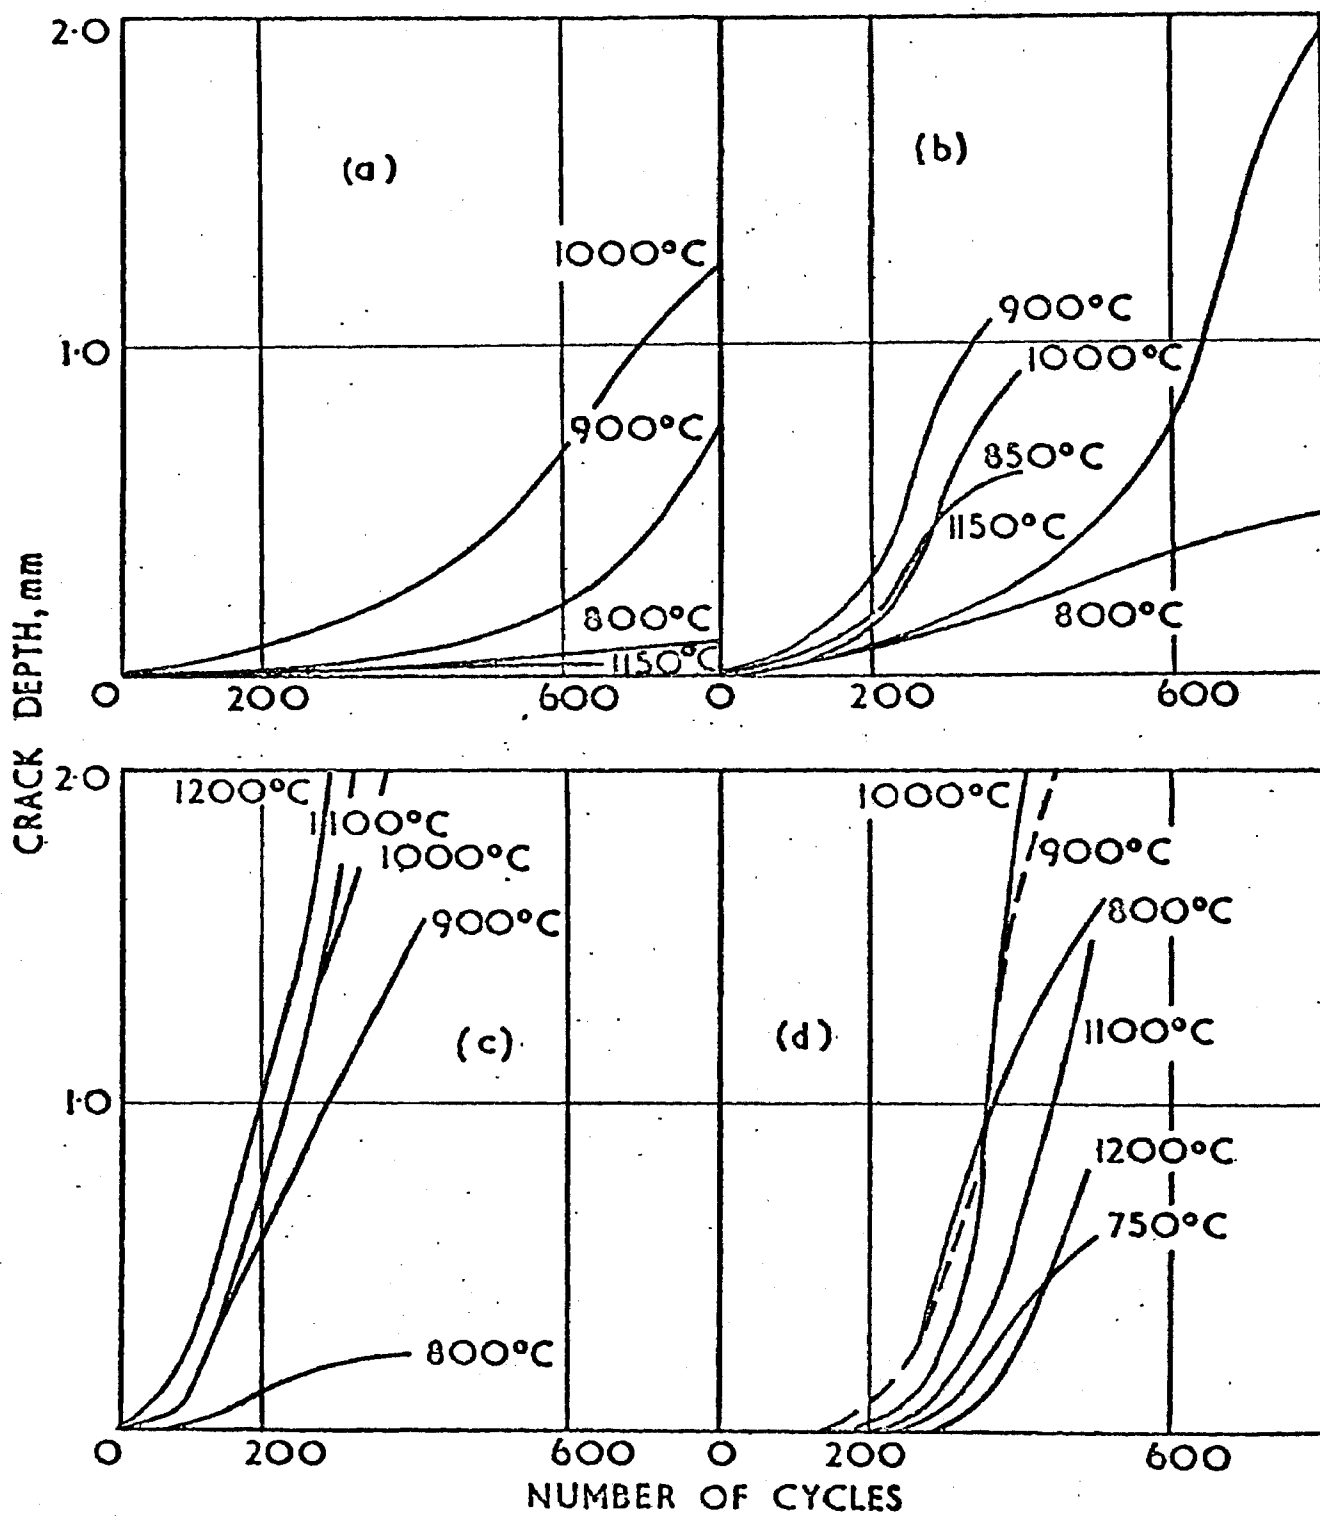
(a) 0.34% carbon steel  
(b) 0.89% carbon steel

(c) 1.24% carbon steel  
(d) Ni-Cr-Mo steel Ea. 25

Fig. 7—Influence of maximum temperature and no. of cycles on depth of cracks. Test-pieces cycled between temperatures shown and 40°C, in argon

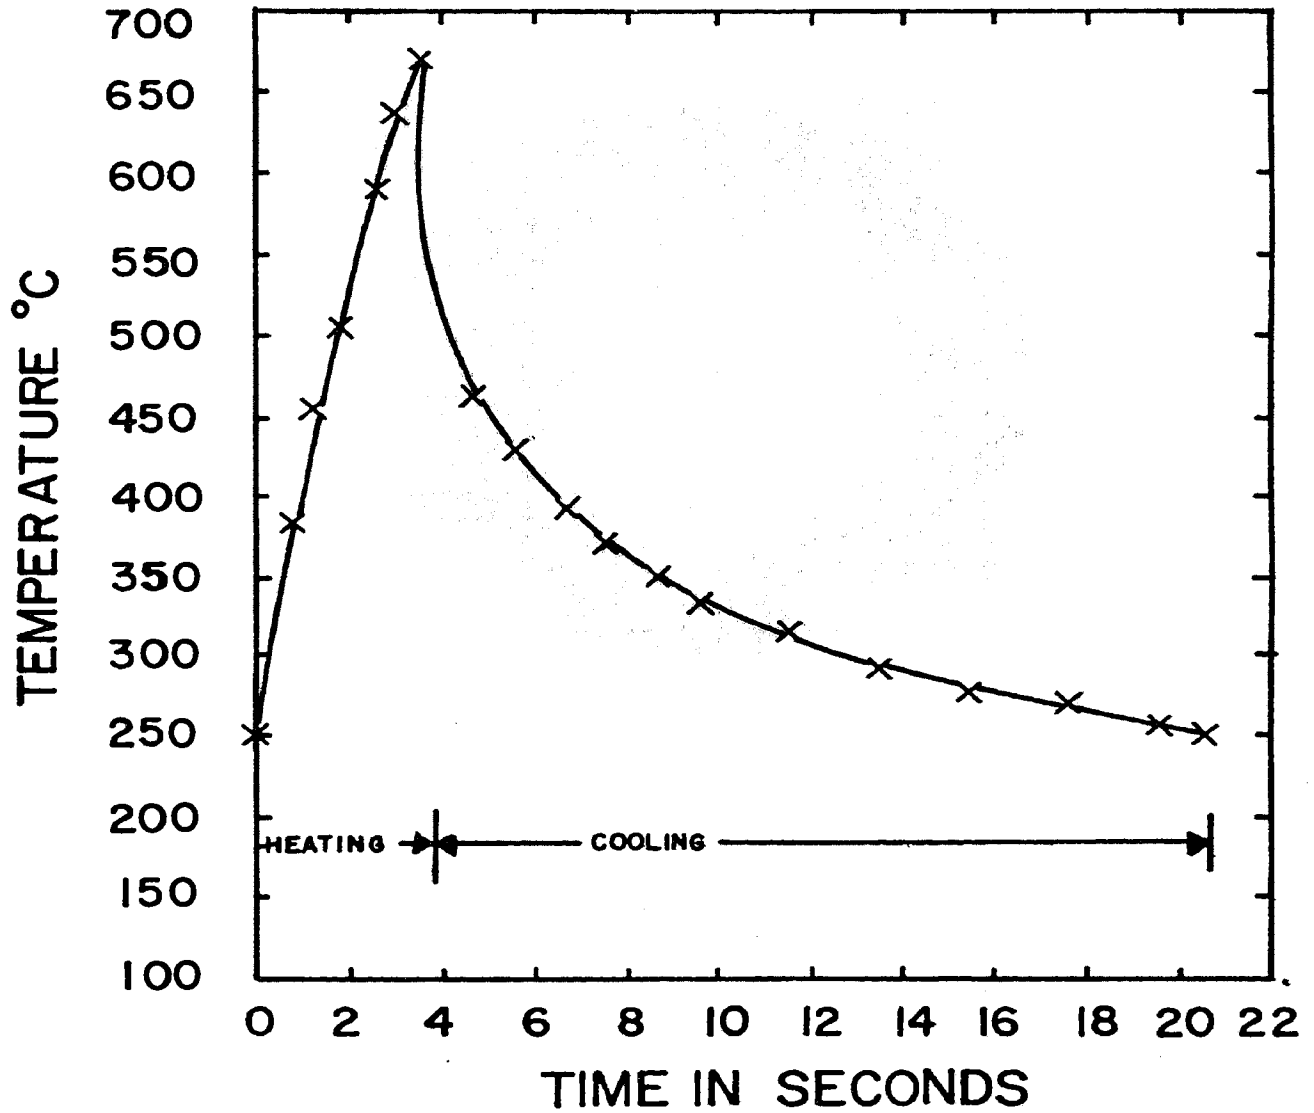
FIGURE 15

Fig. 15-Induction heating and air cooling cycle for thermal fatigue of die steels

## INDUCTION HEATING AND COOLING CYCLE

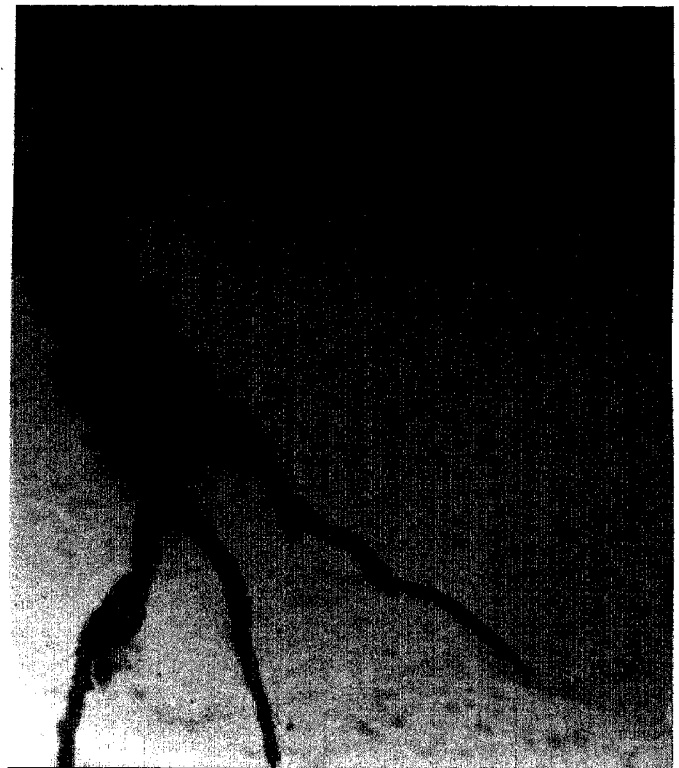
Fig. 19-Stress raising effect  
of a thermocouple hole  
only 0.04 inch below the  
top surface; 4340 steel,  
400 cycles 133X

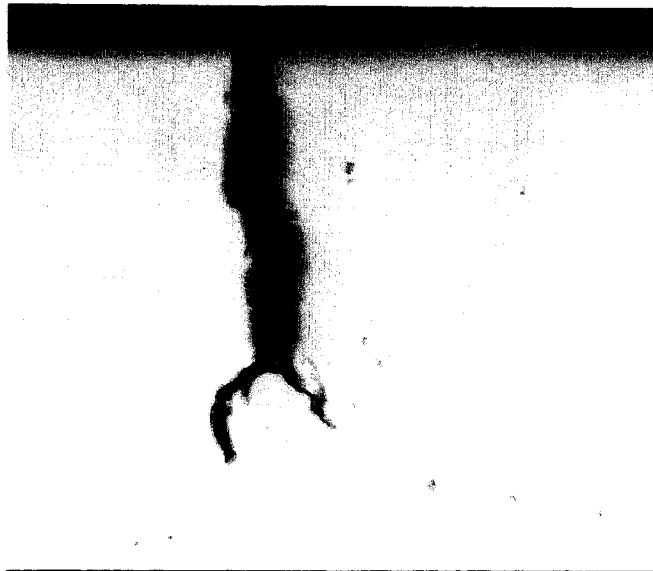
(c) 2700 cycles 133X

Fig. 32-(a) Initiation of a microcrack; (b) propagation of the microcrack; (c) a large macrocrack formation and its branching at an impurity or an inclusion in H-13

the edges (Fig. 32a), which propagate both radially and depth wise on further cycling (Fig. 32b). As the testing is being carried out in air, the walls of the crack are lined with oxide film (Fig. 32b). Further cycling causes the crack to propagate further and also opens up the width of the cracks (Fig. 32c). A branching of the crack at some inclusion or non-homogeneity in the steel can also be seen in Fig. 32c.

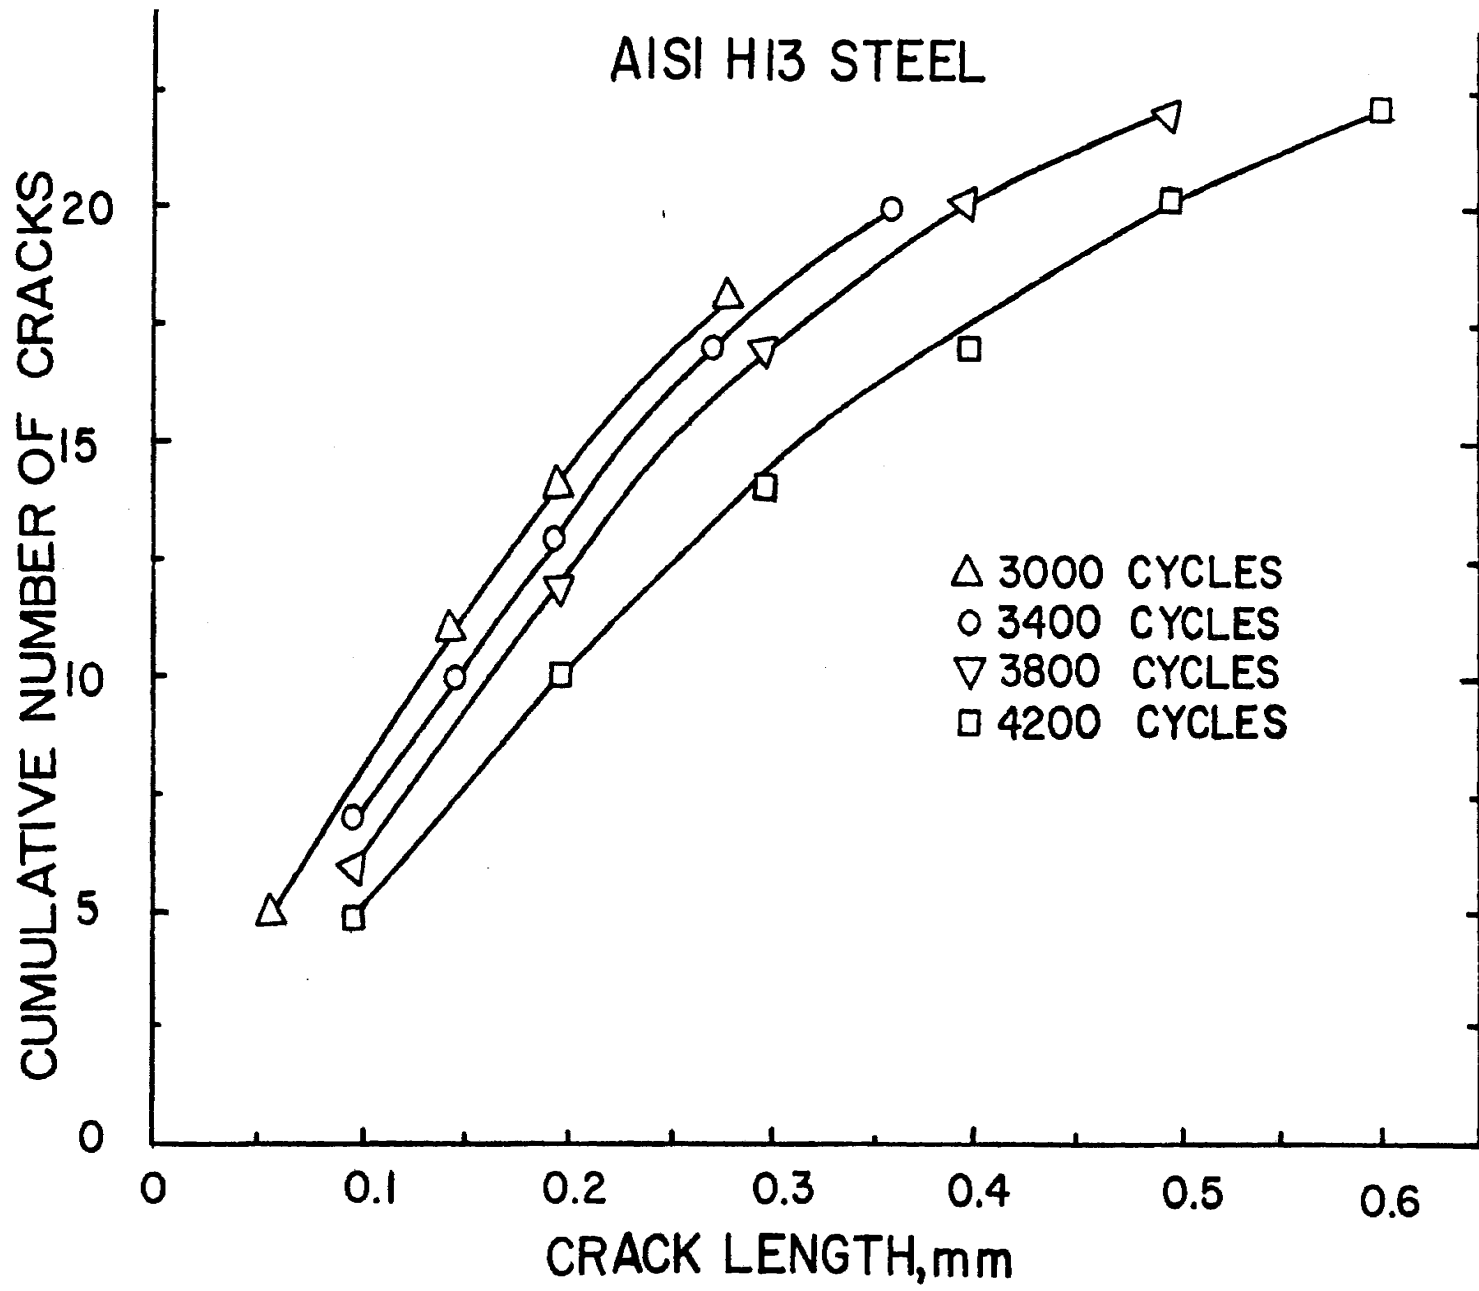
FIGURE 35

lg. 35-Cumulative number of cracks versus crack length  
at different stages of thermal cycling in AISI H-13  
steel

Fig. 35 shows the behavior of cumulative number of cracks at different cycles vs crack length for the region shown. These curves are very much similar to the one's shown for H-11 in Fig. 31.

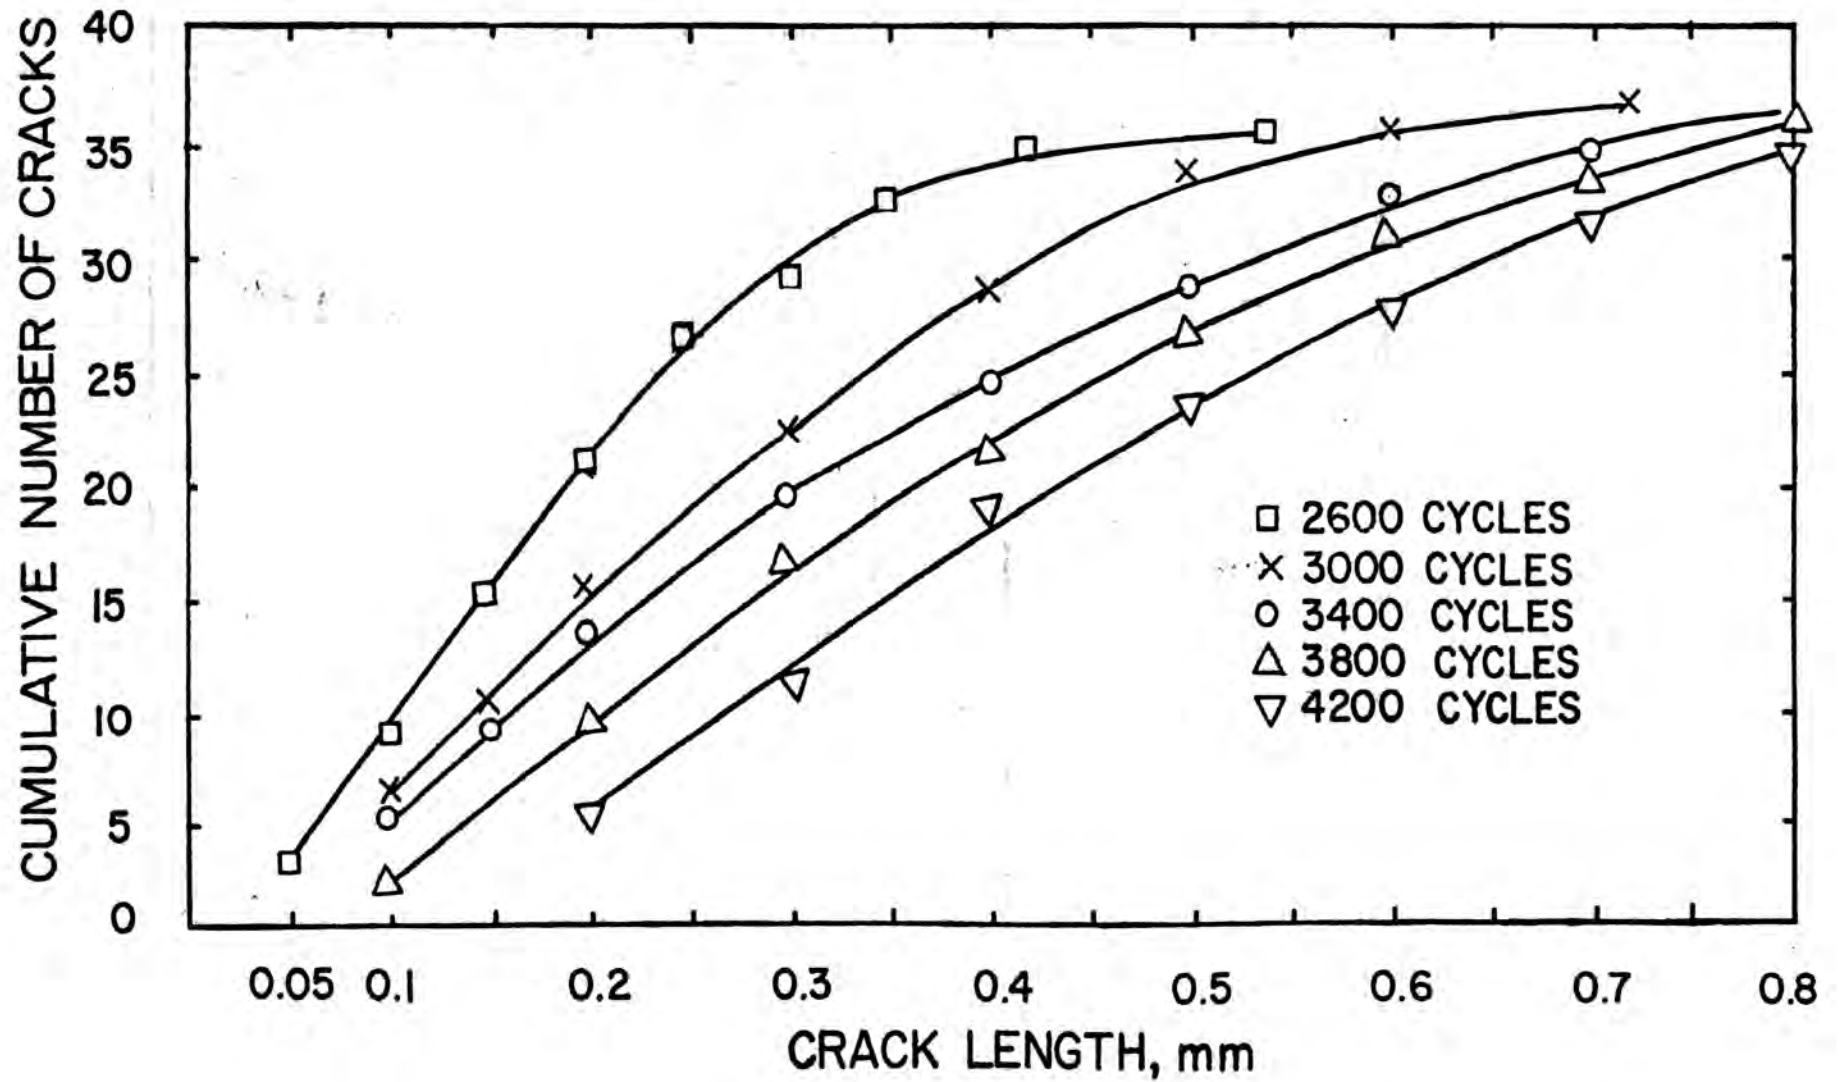
s. 39-Cumulative number of cracks versus crack length  
at different stages of thermal cycling in AISI H-21  
steel

AISI H-21 STEEL

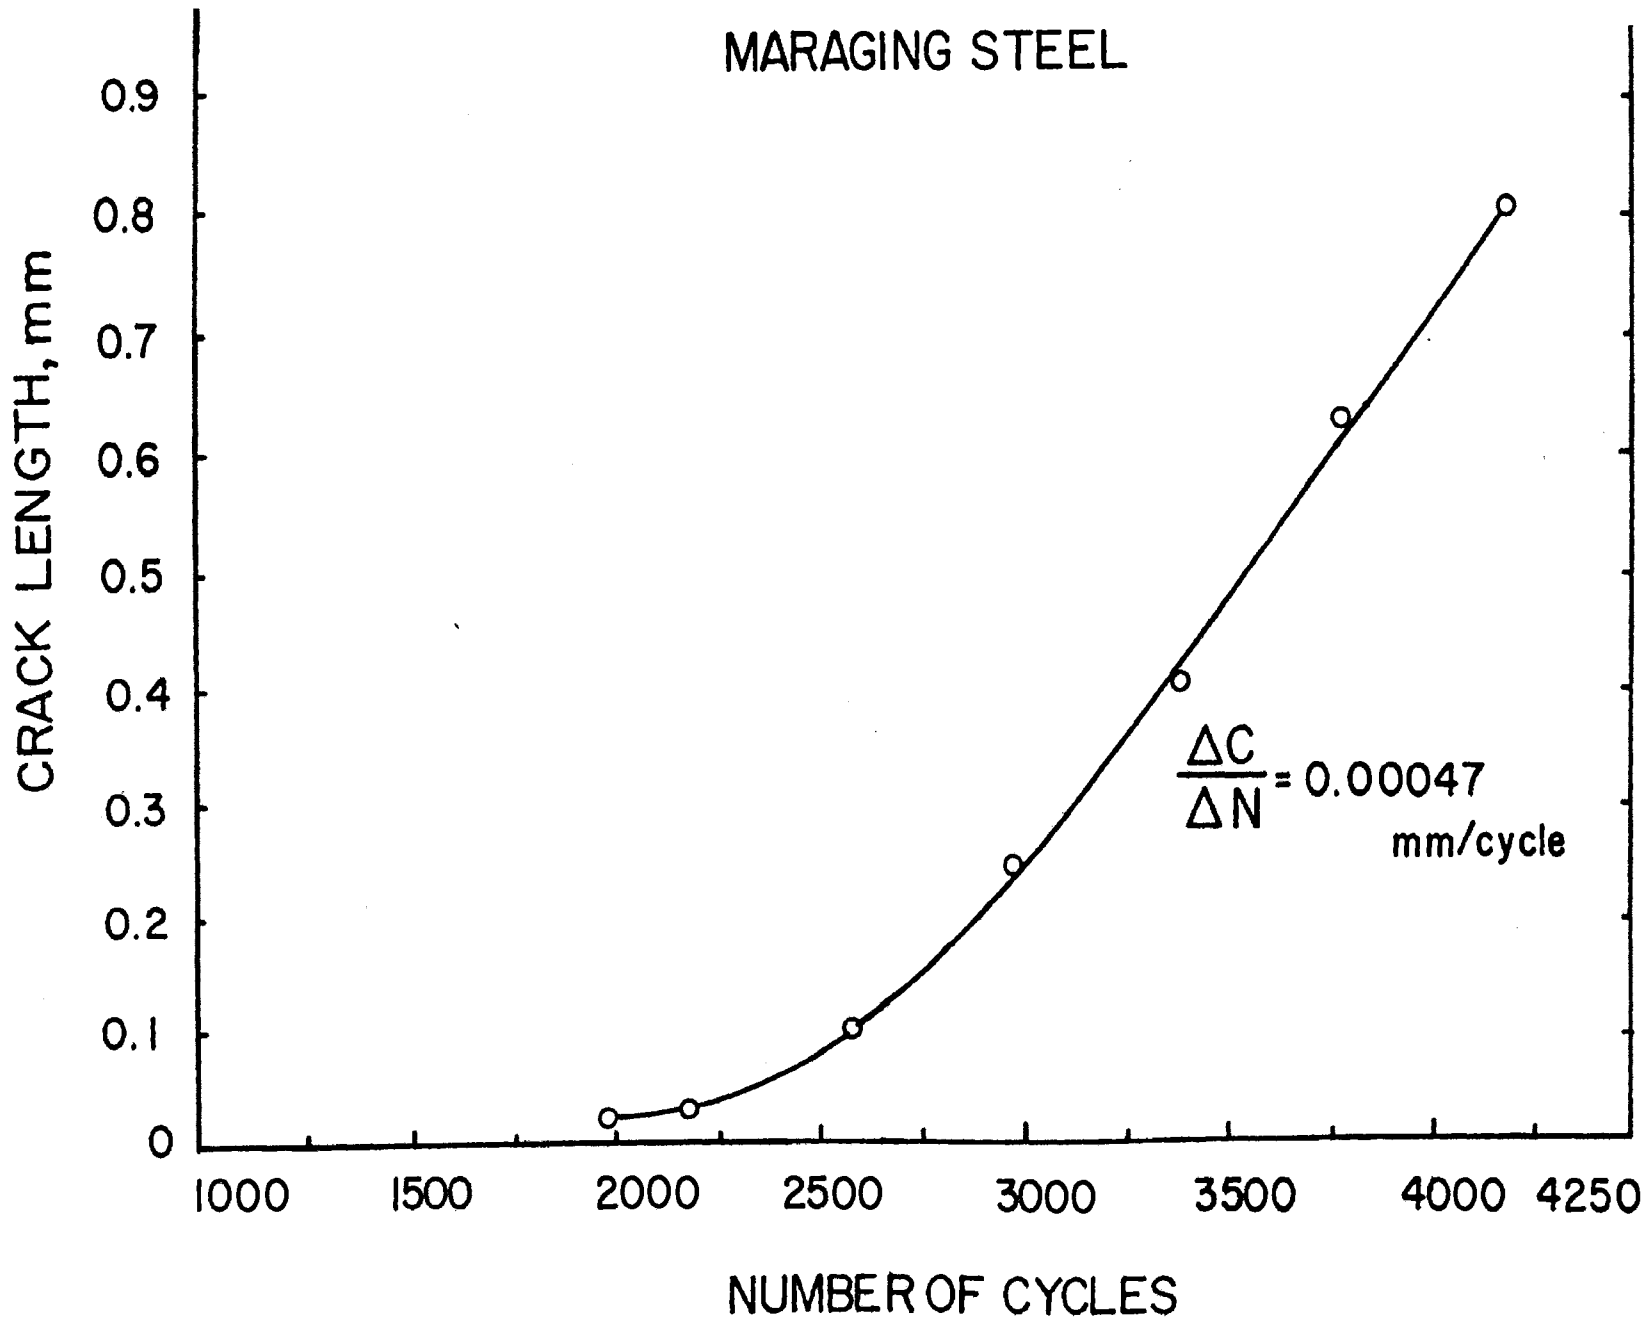
42-Propagation of the longest crack with thermal cycling in 18% nickel maraging steel

The propagation of the longest crack with higher number of cycles follows a trend very similar to that observed in the other steels tested earlier. The crack propagation rate in the linear region was observed to be 0.00047mm per cycle (Fig. 42). The maximum length of the longest crack after 4200 cycles was observed to be the lowest among all the

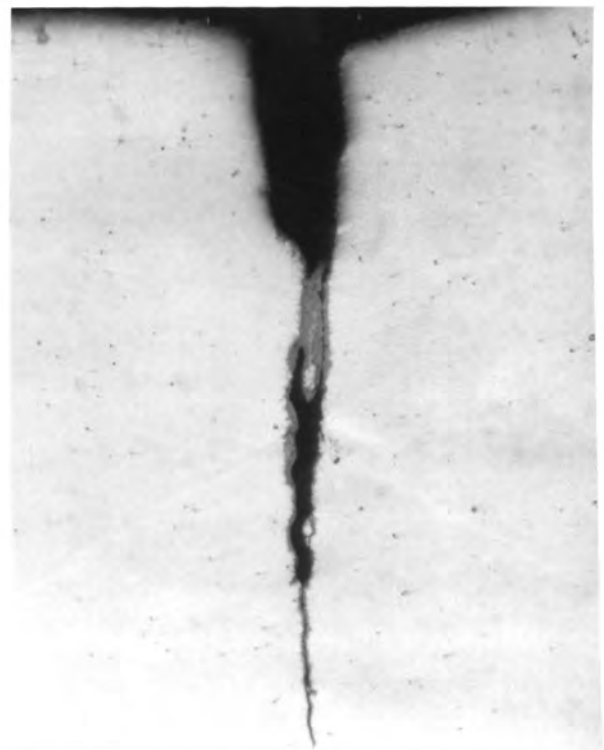
(c) 3800 cycles 133X

Fig. 44-Two adjacent cracks propagate simultaneously and finally join together on further cycling, causing the small chunk of metal to drop off and form a pit or heat check in maraging steel.

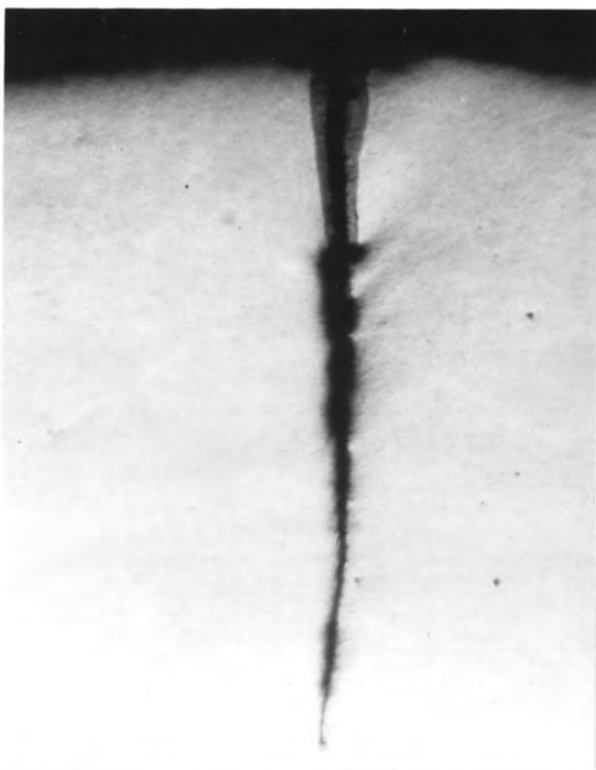
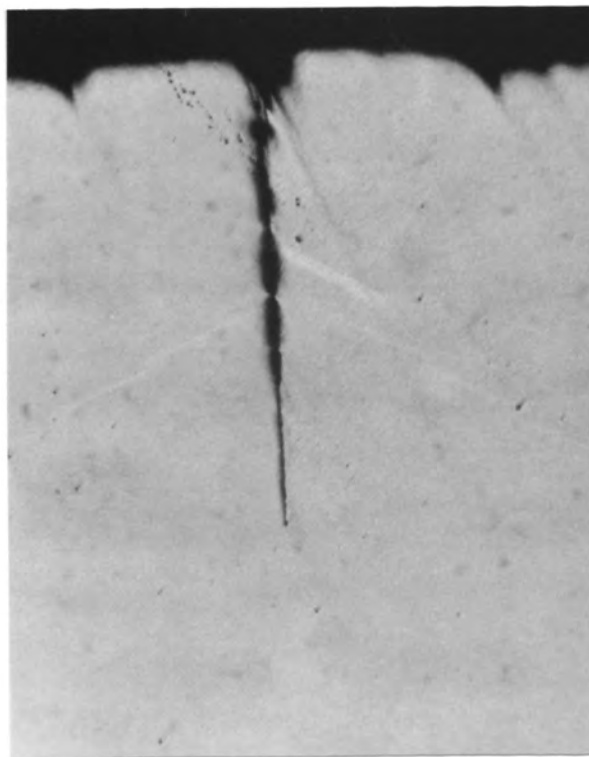
(a) 4200 cycles,  
top surface

(b) 4200 cycles, 0.014 inch  
below the surface

(c) 4200 cycles, 0.050 inch below the surface

Fig. 46-Appearance of a thermal fatigue crack at  
different depths from the top surface in H-21
