Use of high volume fly ash-wood fiber and polyurea layers for blast mitigation

A THESIS

In Partial Fulfillment of the Requirements for the Degree
MASTERS OF SCIENCE IN CIVIL ENGINEERING

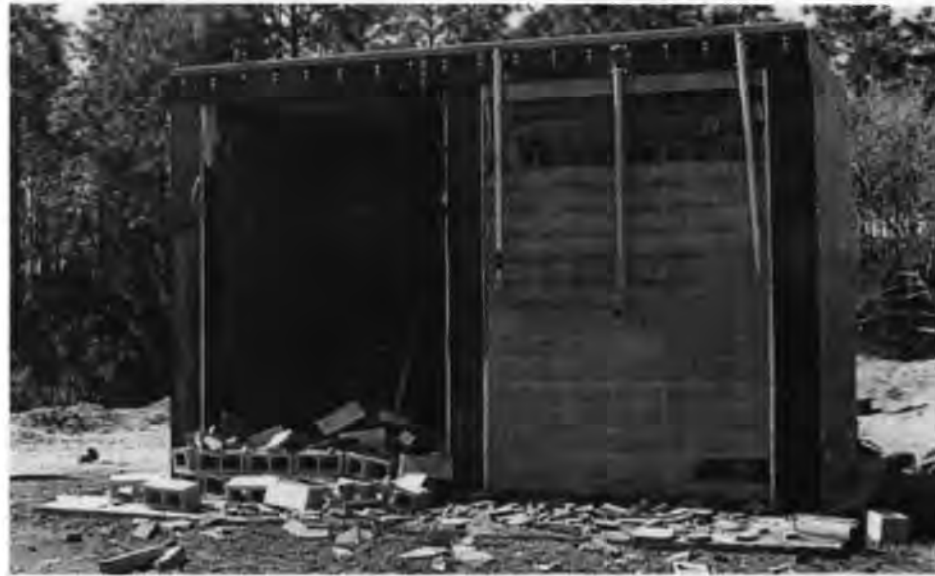
Figure 2.4 – External Test 1 Results. (Davidson, et al. 2004)

Research done by Davidson et al in 2004 investigated using polyurea on masonry walls. Davidson built dual wall sections at the AFRL at TAFB and then applied the polyurea to one wall. He then detonated a charge outside the structure and then analyzed the results. **Figure 2.4** illustrates post-event behavior after one of the events. The section of the wall on the right side in **Figure 2.4** was coated with polyurea, while the wall section on the left that was reduced to rubble was not coated with polyurea. Davidson found that the polyurea was very effective at strengthening a masonry wall against blast (Davidson, et al. 2004).

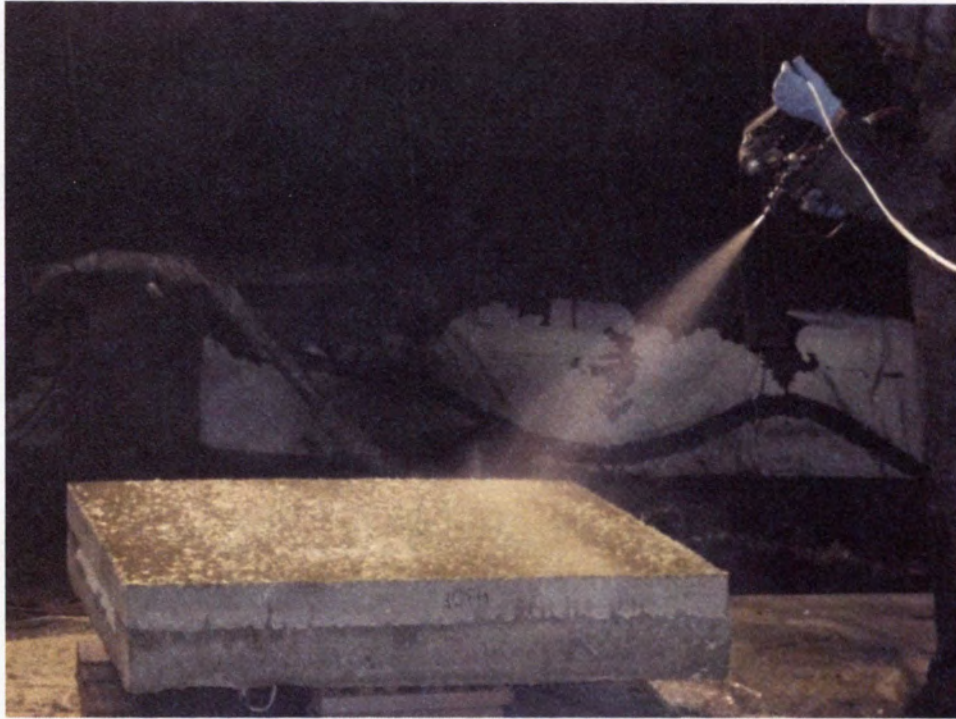
Figure 3.8 – E-Glass DFRP B Application

The panels were given at least two weeks to cure under laboratory conditions. After this amount of time the panels were transported to LINE-X in Columbia, MO to coat the panels with the polyurea systems. Four different configurations of polyurea were used: Plain polyurea A (A), polyurea A with glass fibers (A/F), plain polyurea B (B), and polyurea B with glass fibers (B/F). Prior to spraying the panels, the surface was ground using a hand grinder or sand blaster. The grinding created a rough surface for the polyurea to adhere to. The next step was to apply a primer to the panels, which required at least 8 hours but no more than 12 hours to set. The primer was applied to enhance the bond performance of the applied coating systems. After allowing the primer to set the polyurea was applied to the panels until a depth of 6.4 mm (0.25 in) was achieved. A trained professional handled coating the panels; **Figure 3.8** illustrates the polyurea application. The glass fiber was added to the polyurea by attaching a Glasscraft chopper to the polyurea spray gun. The chopping mechanism operated on compressed air and blew the chopped pieces of fiber into the stream of polyurea.

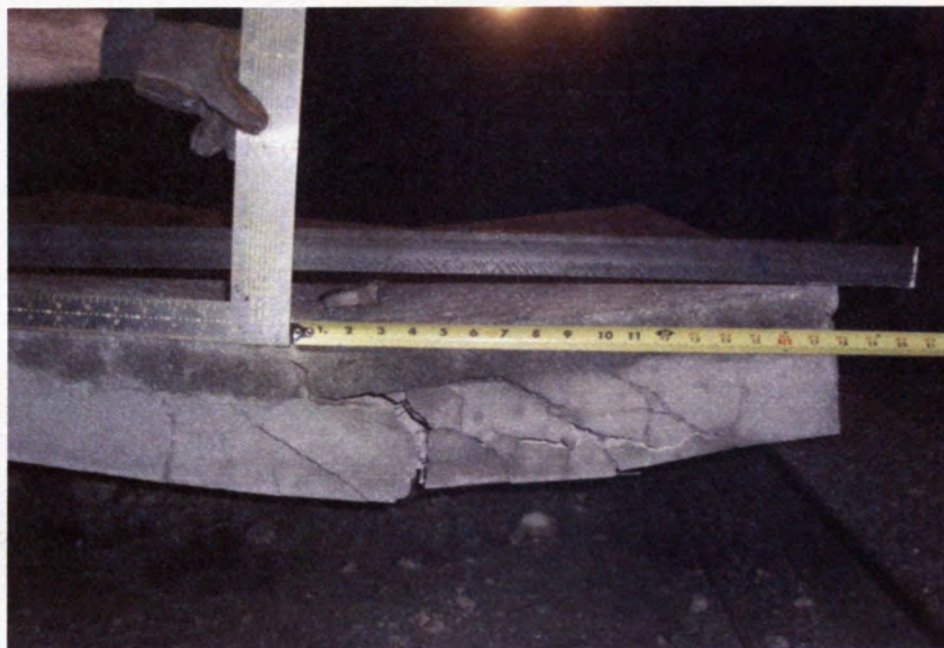
straight edge laid across the panel to represent the original surface of the panel so the gap between the straight edge and panel formed represented the residual deflection. A ruler was then used to measure the residual deflections or gap. This process is illustrated in **Figure 3.12**. The residual deflections were taken at the center of the panel and front and back edges of the panel. The residual deflections were taken prior to and after blasting. This proved somewhat difficult with the sacrificial FA-WF layer since it would occasionally break off during the blast event.

Figure 3.12 – Measuring Residual Deflections

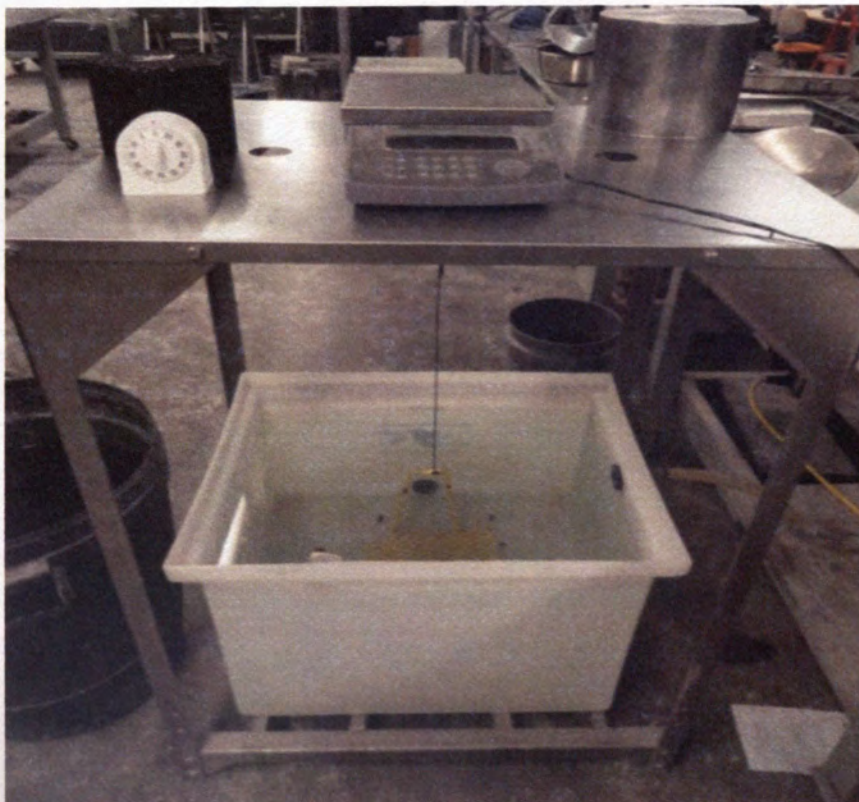
Figure 3.16 – Water Bath Setup for Density

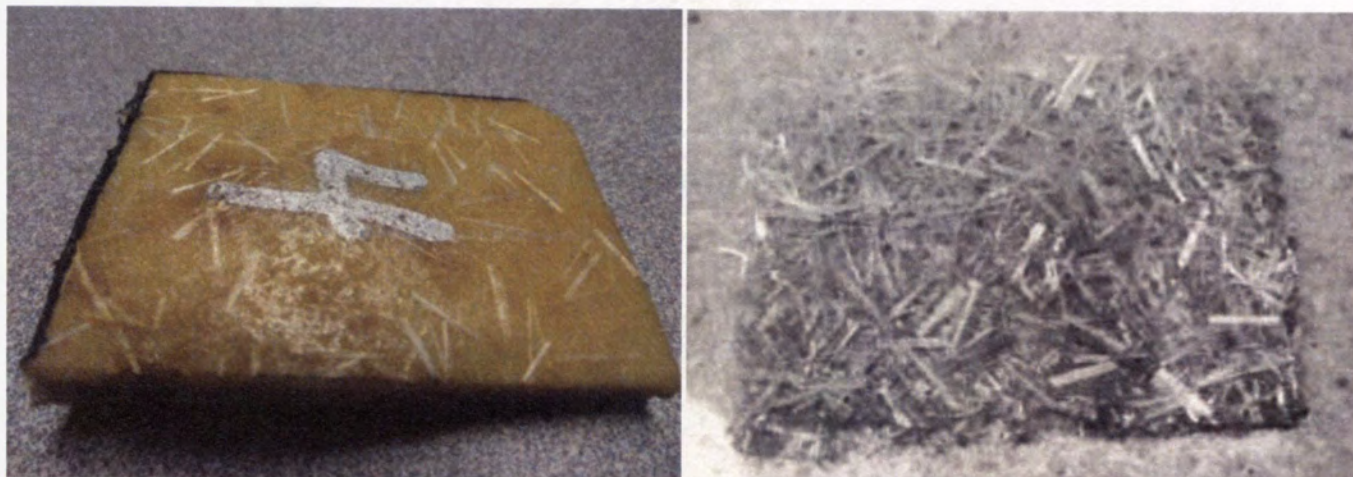
(a) Specimen Before

(b) Specimen After

specimen plus glass slide was recorded then the samples were placed in a muffle furnace which was set to 600°C (1112°F) for 2 hours to melt down the polyurea and leave behind the glass fibers. After allowing the specimens to cool the mass of the glass slide plus remnants (glass fibers), and the glass slide by itself were recorded. The muffle furnace, a sample before the ignition loss and that sample after the ignition loss are displayed in **Figure 3.17**. The fiber ratio was then found as a simple mass ratio of the mass of the glass fibers to the initial mass of the specimen. These values are reported in **Table 3.11**.

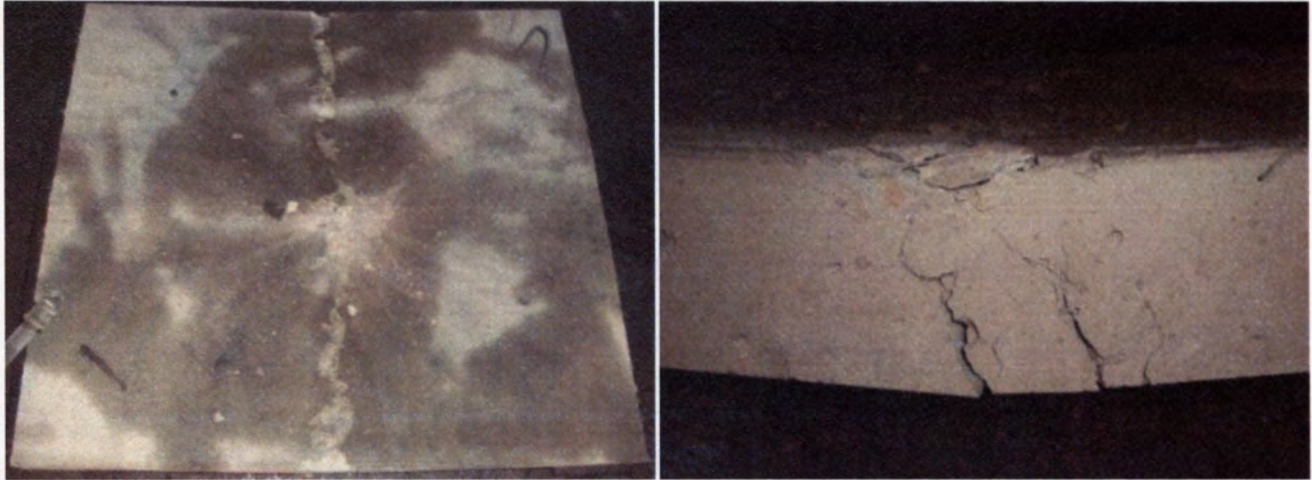
The blast event resulted in significant damage to the panel. A large 10. mm (0.39 in) wide flexural crack illustrated in **Figures 4.3b and 4.3c**, extended along the bottom of the panel and resulted in spalling in the center of the panel (**Figure 4.3c**). Evidence of concrete crushing was observed on the compression and is illustrated in **Figure 4.3a**. This damage indicates that the panel failed structurally and at containing the blast.

(a) Concrete Crushing on Compression Face (b) Flexural Cracks on Front Face

(c) Flexural Crack and Spalling on Tension Face

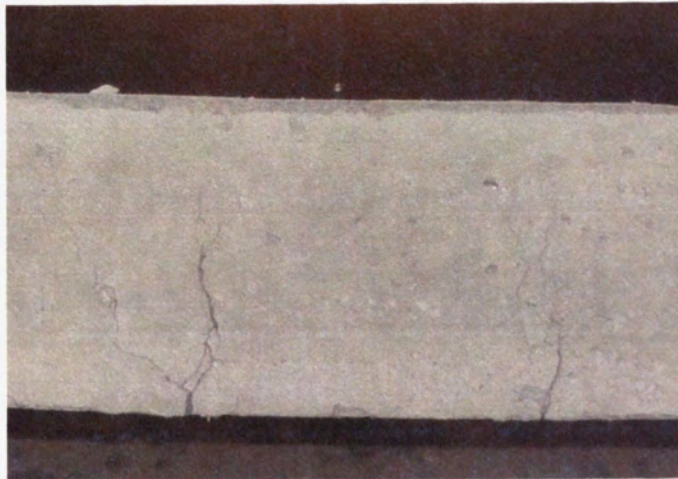
(c) Flexural Cracks on Back Face

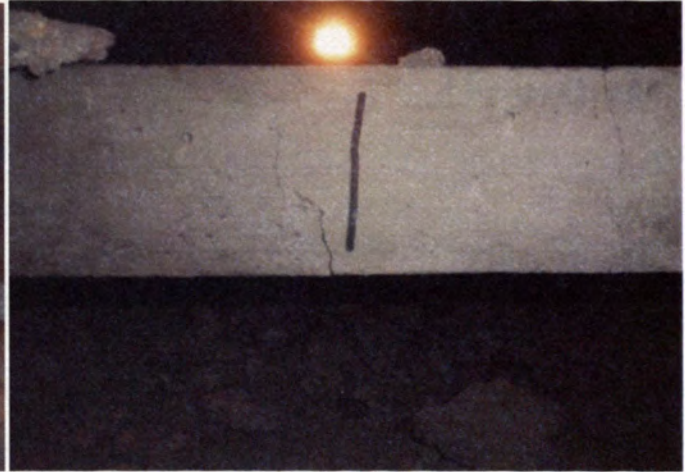
(d) Flexural Cracks in the Back Face

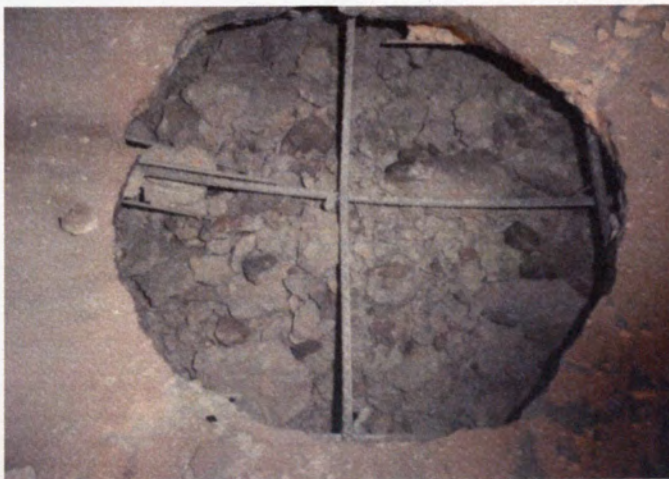
(e) Hole From Above the Panel

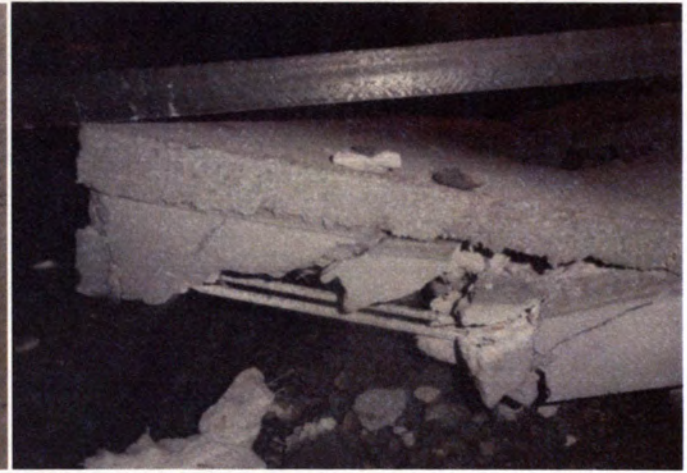
(d) Flexural-Shear Crack in the Back Face

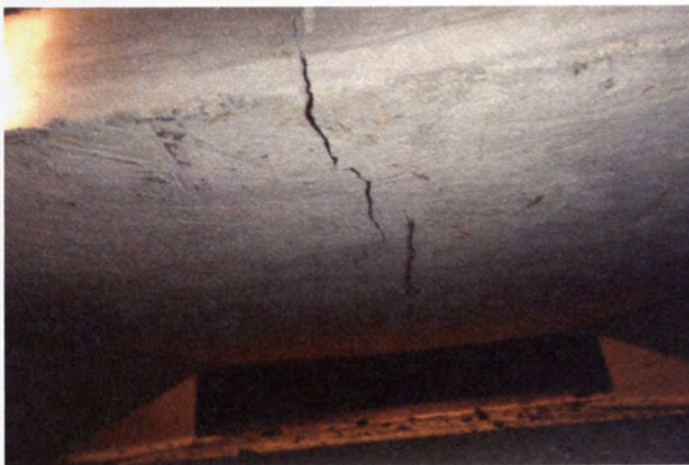
major flexural crack run along one of the chair legs. The compression face of the panel experienced some scarring and cratering (**Figure 4.15b**) and minimal cracking. Overall the panel performed very well against the first blast event.

(c) Flexural Crack in the Tension Face

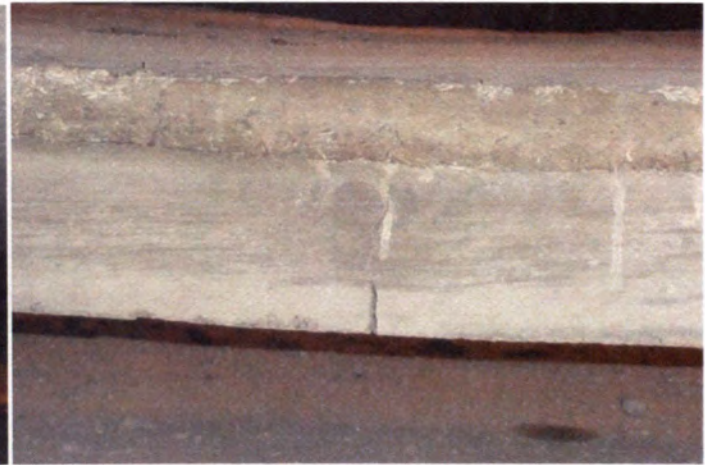
(d) Flexural Crack in the Back Face

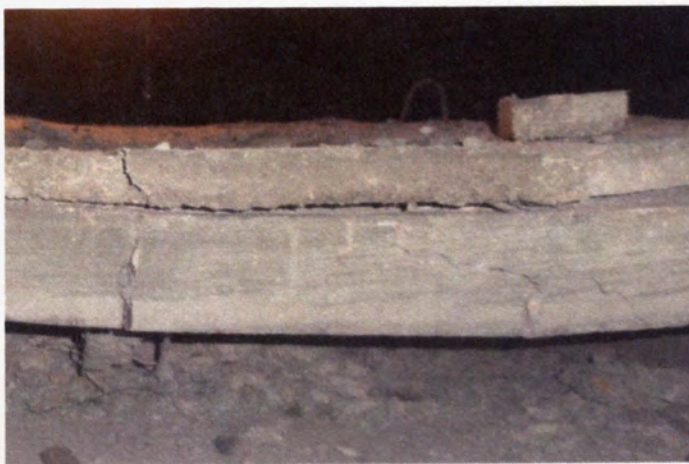
(e) Flexural Cracks in the Back Face

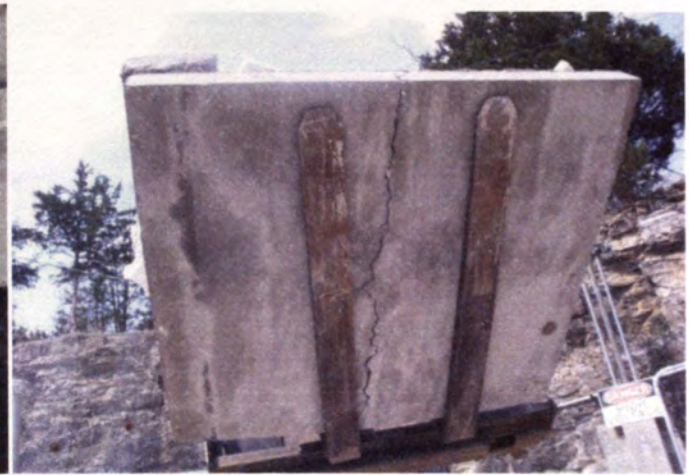
(d) Flexural Crack Tension Face

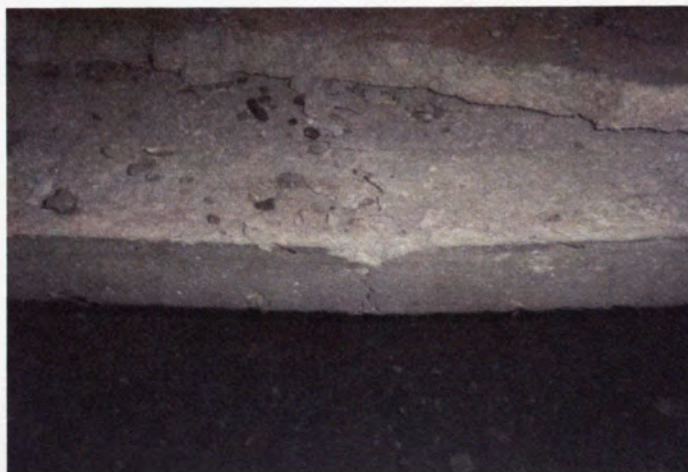
The second blast event—a 1.4 kg (3.0 lb) charge at a 150 mm (6.0 in) standoff—significantly increased the damage, but the panel system still contained the blast. The residual deflections increased dramatically and the cracking in the SFRC and FA-WF also increased. Several large pieces of the sacrificial FA-WF layer detached from the panel, which is illustrated in **Figures 4.21b, 4.21d, and 4.21e**. This suggests that the bond between the SFRC and FA-WF layers is rather weak. A large bulge, which is illustrated in **Figure 4.21c**, developed in the polyurea under the panel indicating that the SFRC fragmented and attempted to punch through the polyurea layer. However, there was no tearing in the polyurea layer, so the panel adequately sustained the blast without allowing any material to penetrate through the other side of the panel. If this had been a non-structural wall or floor panel it would have been considered successful in containing the specific blast pressure tested. The FA-WF layer above the bulge in the center of the panel did not show any signs of punching, as illustrated in **Figure 4.21b**, suggesting that the two layers delaminated. **Figure 4.21f** illustrates a location where there was significant delamination between the SFRC and sacrificial FA-WF layers. A 1.7 mm (0.067 in) wide flexural crack is illustrated in **Figure 4.21e**. The large residual deflection, cracks, and large bulge indicate the panel failed in the traditional sense of strength design. The cracks and residual deflection indicate a flexural failure, where the steel likely exceeded its yielding stress and while the panel still has some capacity it would probably have a dramatic failure upon further loading. The bulge suggests a complete shear failure at that section of the panel, meaning the panel has little to no capacity for further loading in the center of the panel.

(e) Large Crack Back Face of Panel

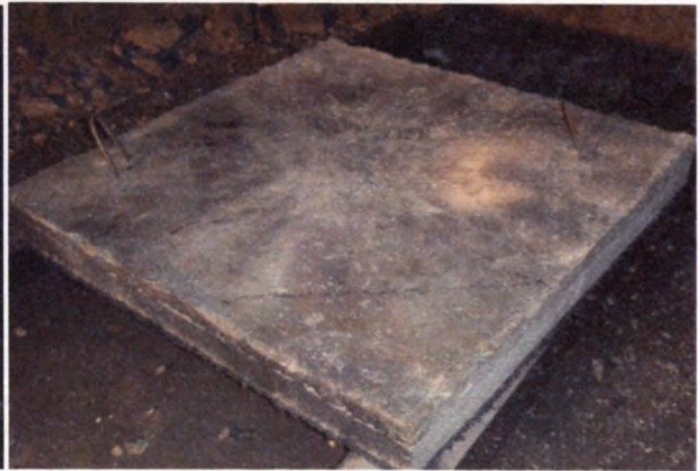
(d) Isometric View Cracks Outlined

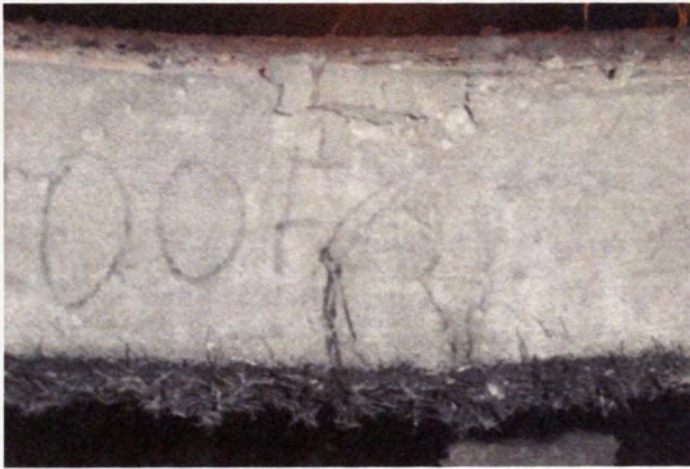
in **Figure 4.27c** and indicates the panel may have failed in flexural strength meaning the reinforcement has yielded. However, the flexural cracks in **Figure 4.27c** do not appear to propagate through the member. This and rough surface of the SFRC in **Figure 4.27d** make it difficult to determine if there is any surface cracking on the SFRC but the large residual deflection suggests there was significant cracking. **Figure 4.27e** shows the tension face of the panel and as it is apparent there was no bulging. **Figure 4.27f** illustrates that there was no cratering or sign of shear punching near the center of the panel. As mentioned before much of the reason for limited damage in these panels is due to the increased stand-off distance from the air-gap. The decreased damage may be additionally attributable to shock impedance mismatch between the layers. Overall, this panel system performed very well and the best of the hybrid systems.

(c) Flexural Crack Back Face

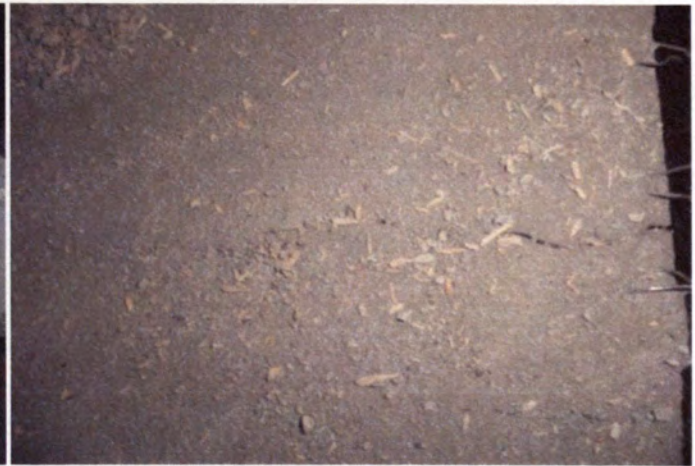
(d) Crack in the Compression Face

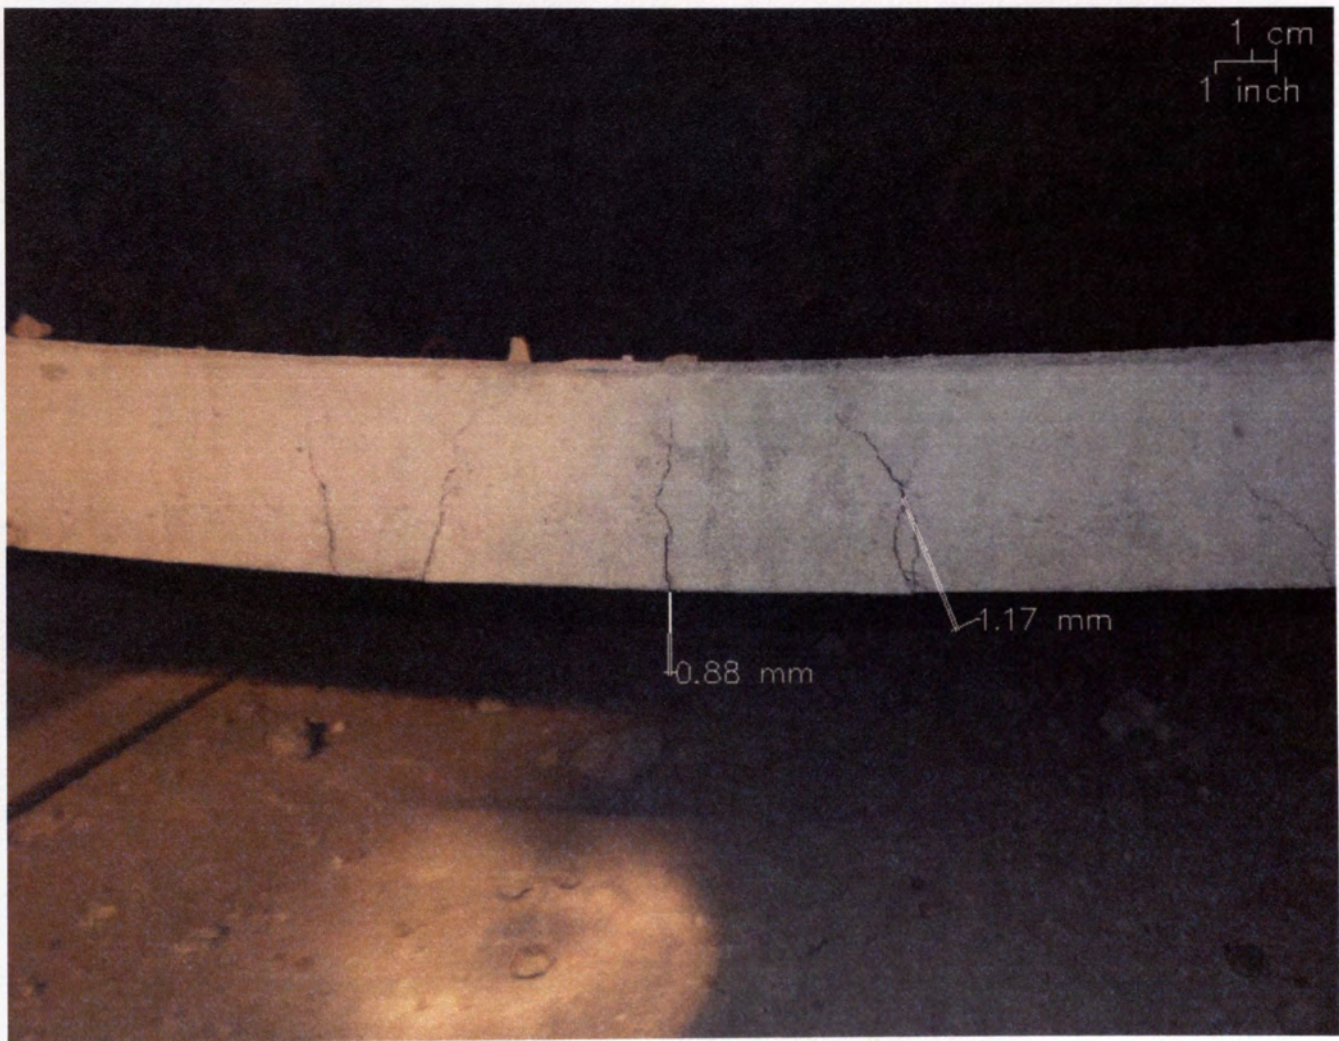
Figure E.5 – Flexural Cracks in the Front Face of 2-RC

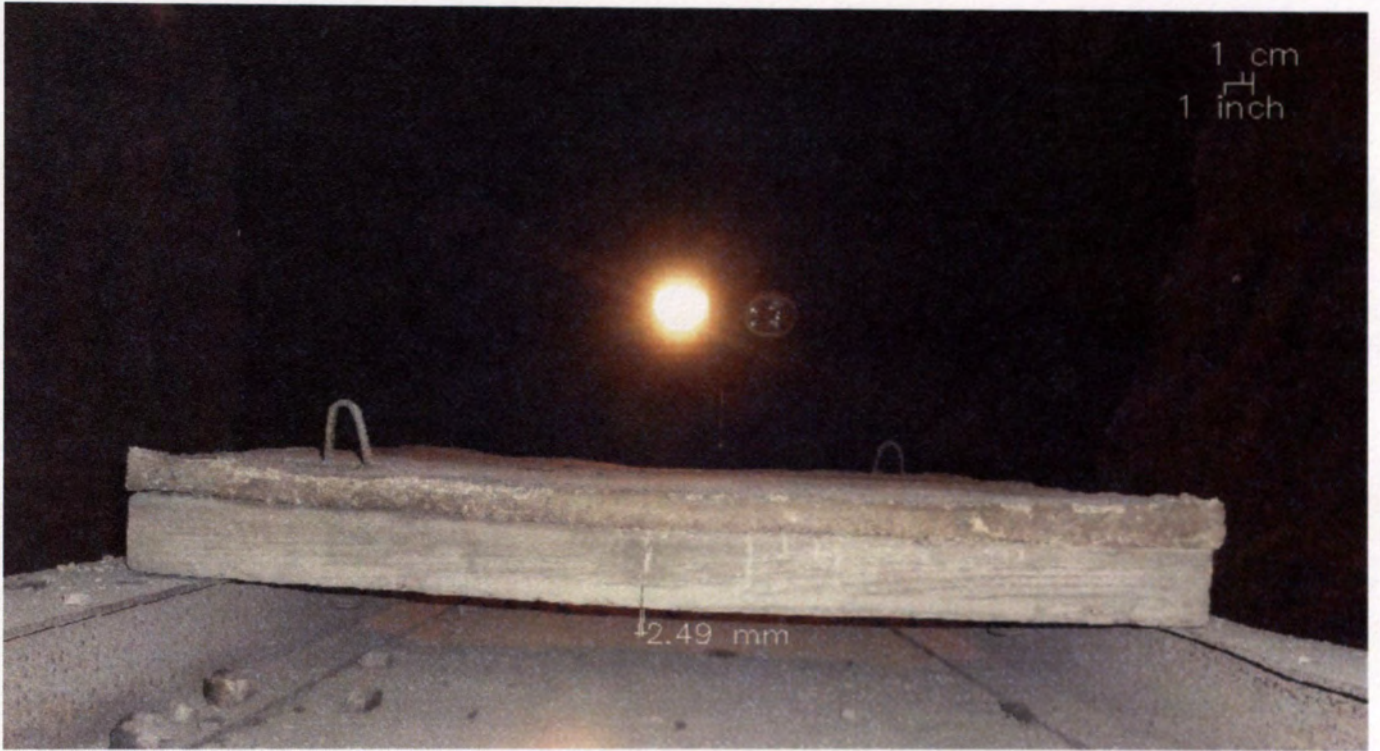
Figure E.8 – Flexural Cracks in the Back Face of 2-H, 1st Event

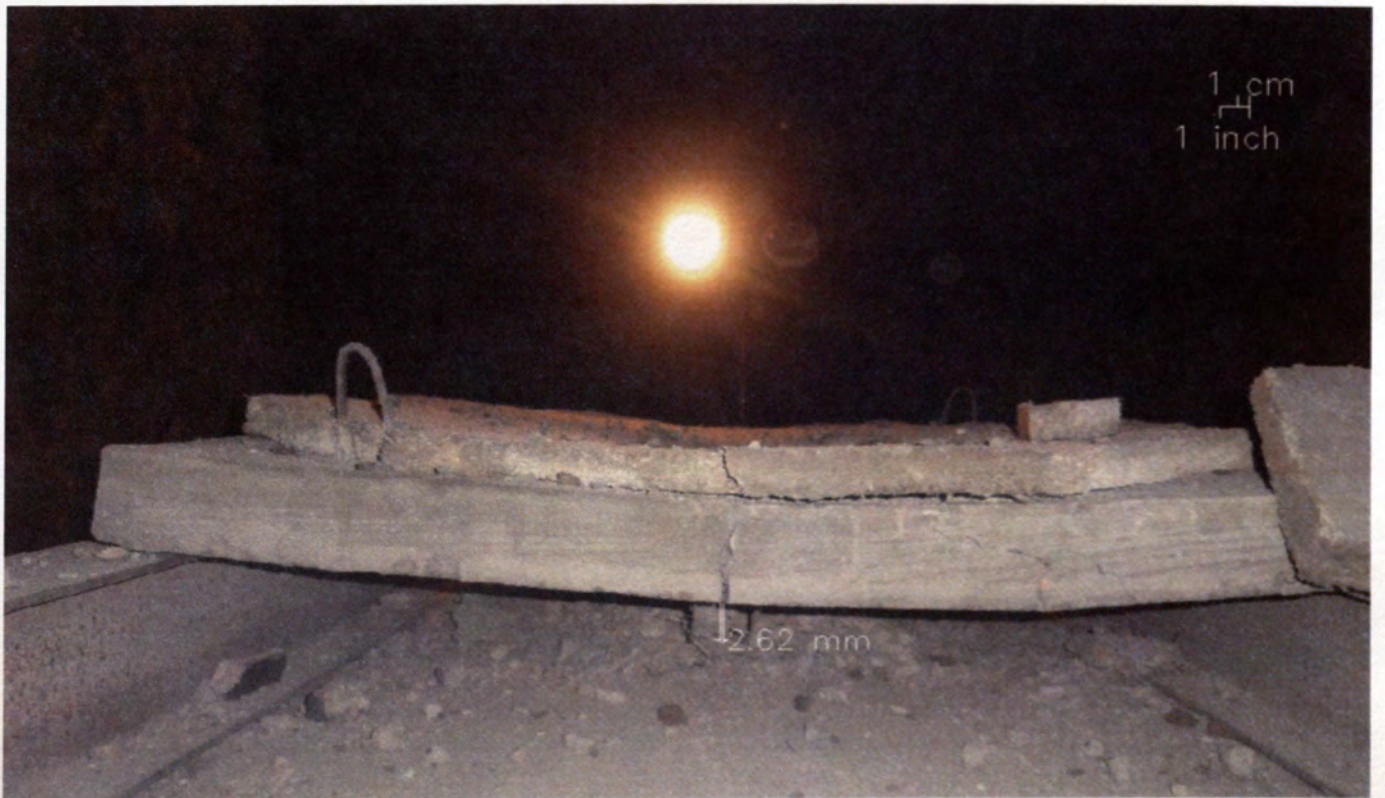
Figure E.9 – Flexural Cracks in the Back Face of 2-H, 2nd Event

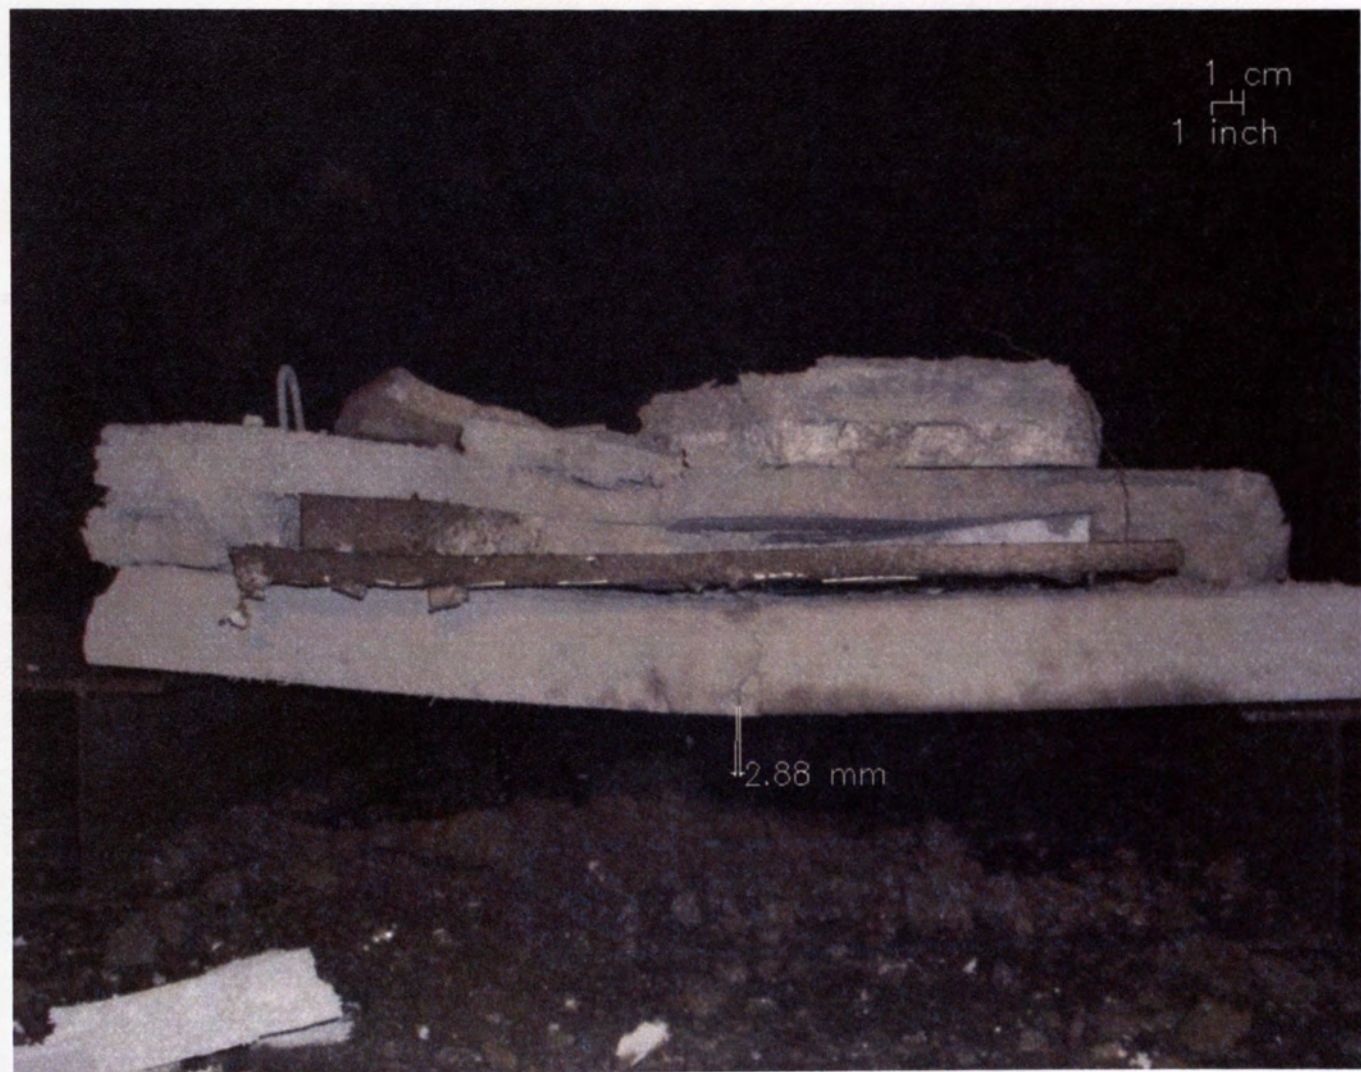
Figure E.10 – Flexural Cracks in the Front Face of H-FG, 2nd Event

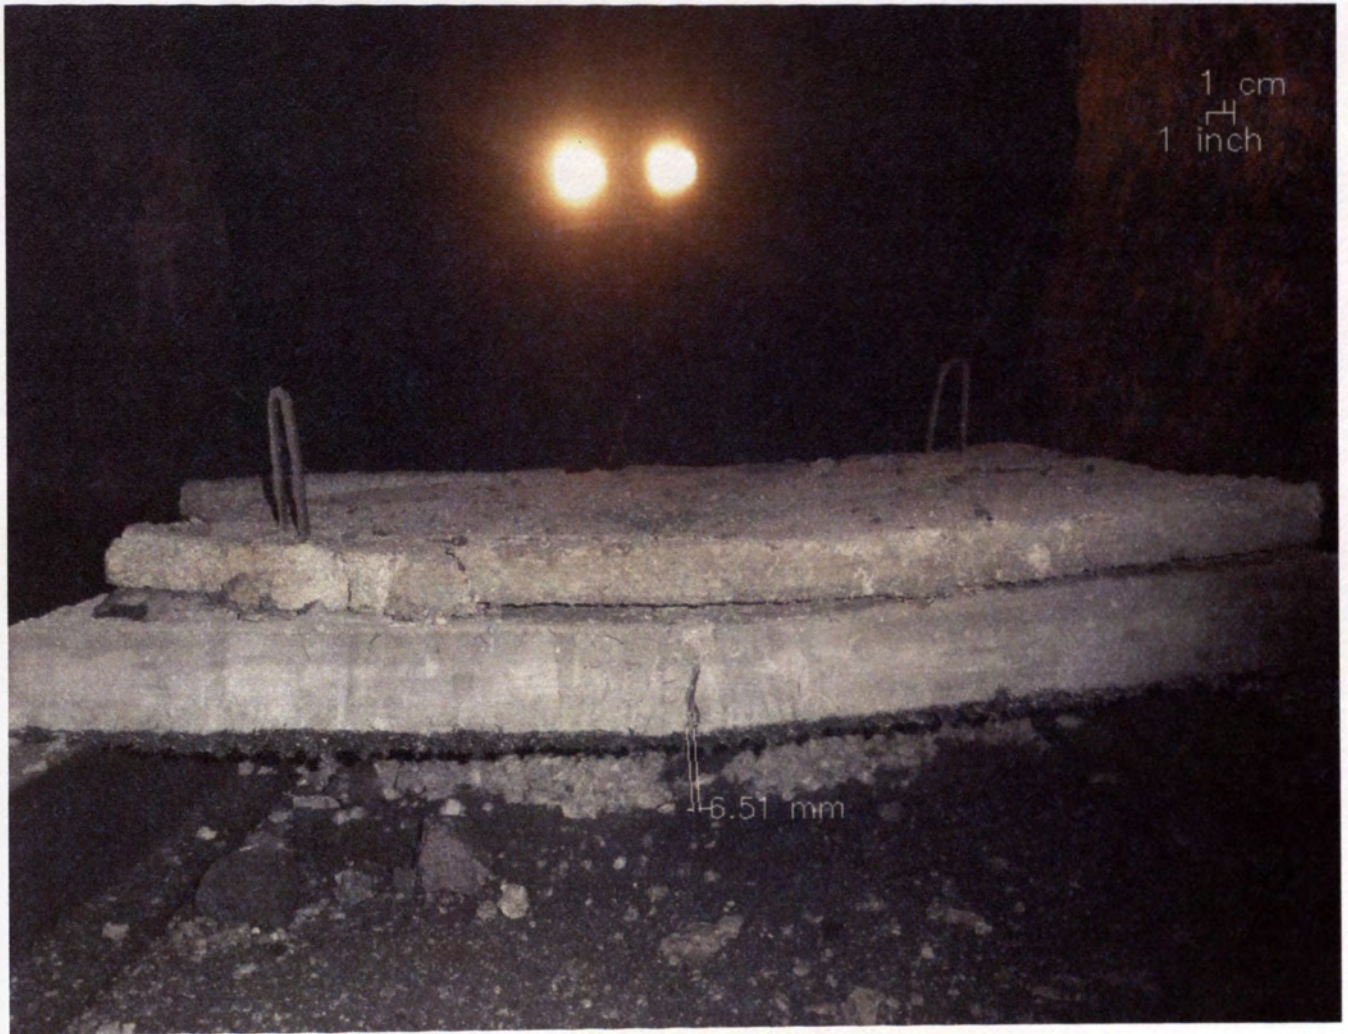
Figure E.12 – Flexural Cracks in the Back Face of H-A/F, 2nd Event

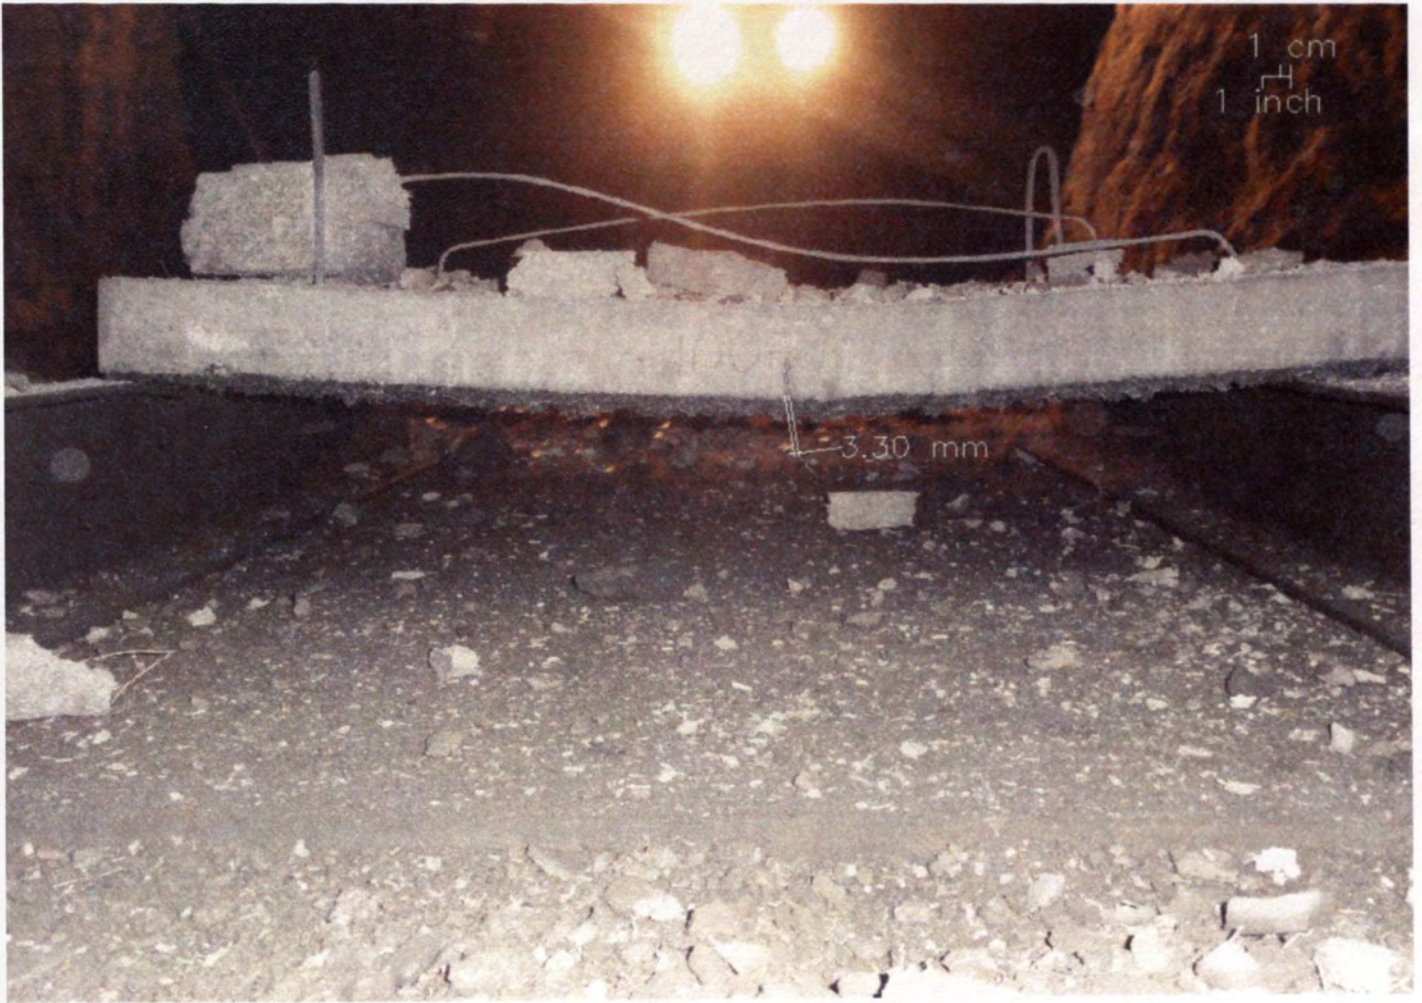
Figure E.13 – Flexural Cracks in the Back Face of H-FG-A/F, 2nd Event

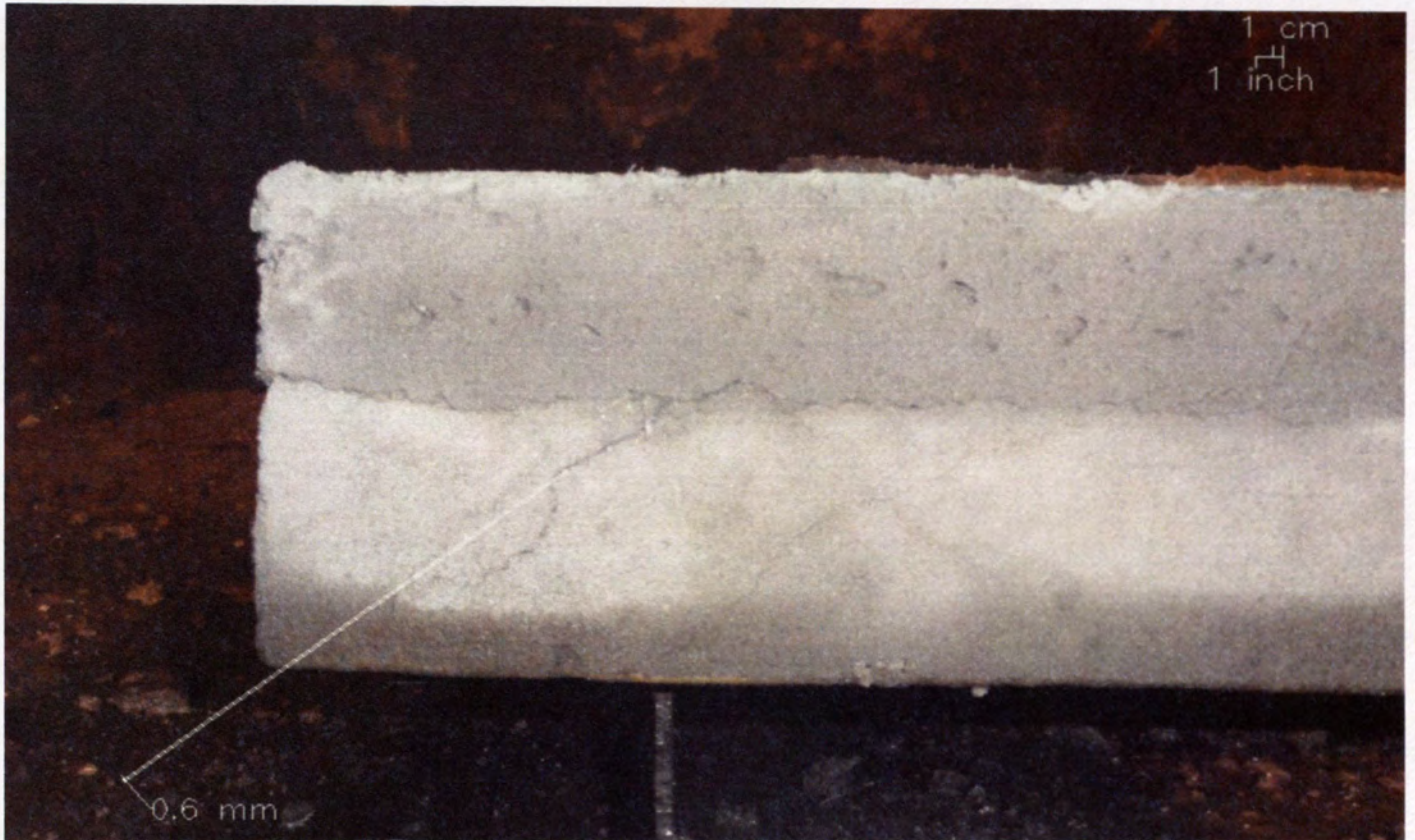
Figure E.14 – Shear Cracks in the Front Face of H-B, 1st Event

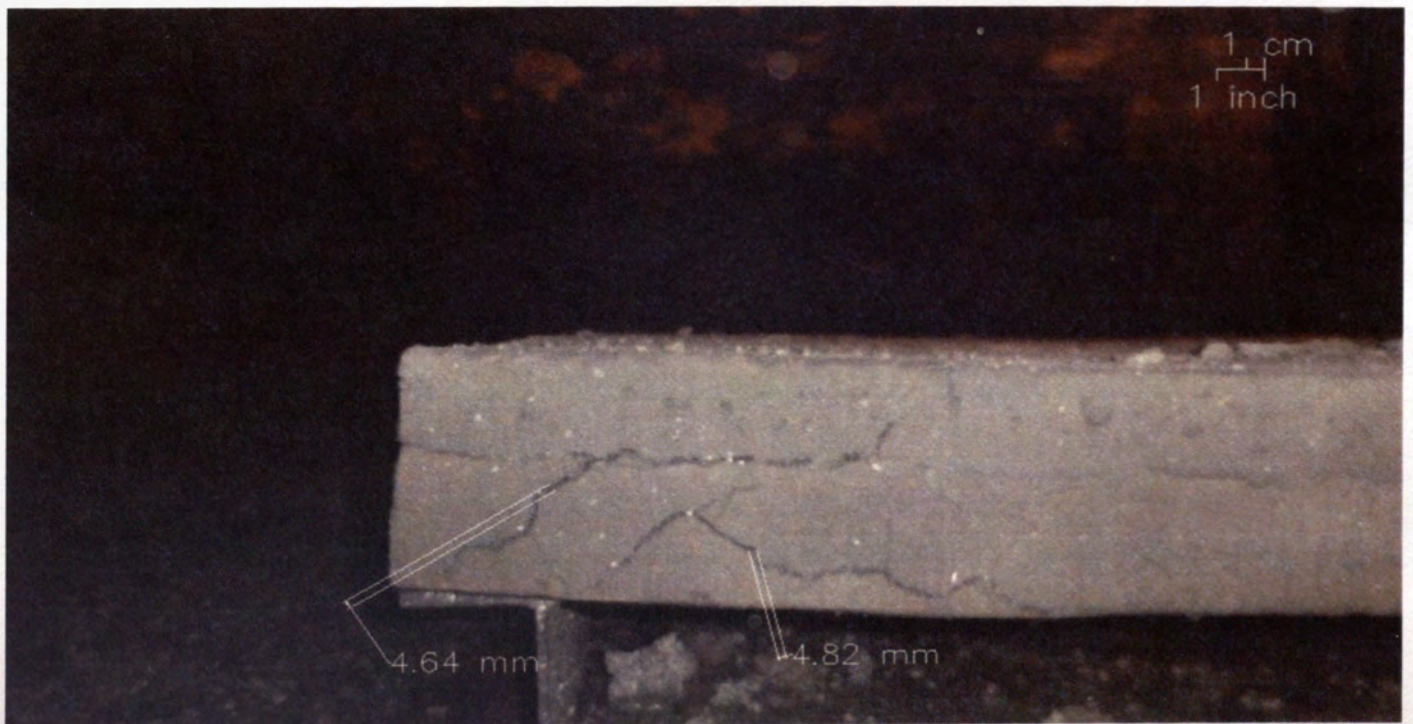
Figure E.15 – Shear Cracks in the Front Face of H-B, 2nd Event
