Damage detection through acoustic emission of fracture processes in concrete masonry units

DAMAGE DETECTION THROUGH ACOUSTIC EMISSION OF FRACTURE
PROCESSES IN CONCRETE MASONRY UNITS

MASTER OF SCIENCE IN CIVIL ENGINEERING

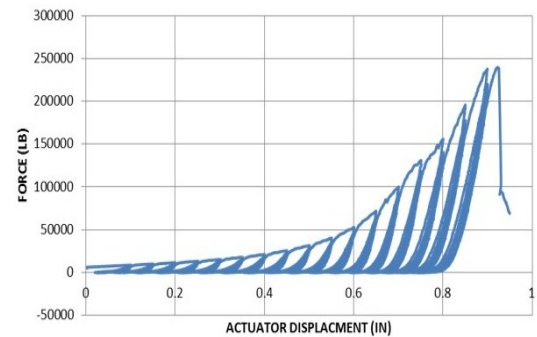
(a) Force-Time Plot 37% Rubber CMU Grouted

(b) Force-Displacement plot 37% rubber CMU grouted

Two major benefits were identified in the rubber which can be seen in the force displacement relationship. The 37% rubber brick was able to endure more cycles of loading thus higher strain. In contrast, the normal grouted specimen (see Figure 3.4) suffered from a lack of stiffness and strength during the last complete cycle. The softening behavior can be seen in the plots of force and displacement in Figures 3.4b and 3.5b as the change in the slope of the force displacement curve. Interestingly, the slope of the last group of curves in Figure 3.4b is more shallow indicating the material softened. The

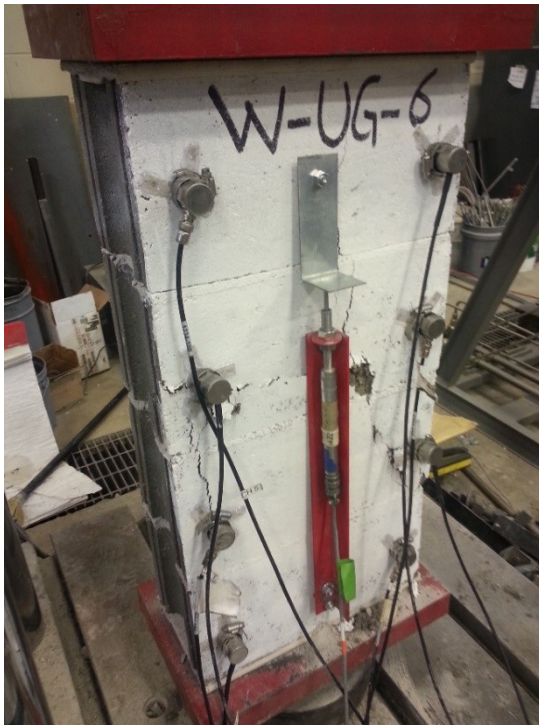
Figure 3.6. Damaged specimens with and without grout from the completion of cyclic test with and without Rubber

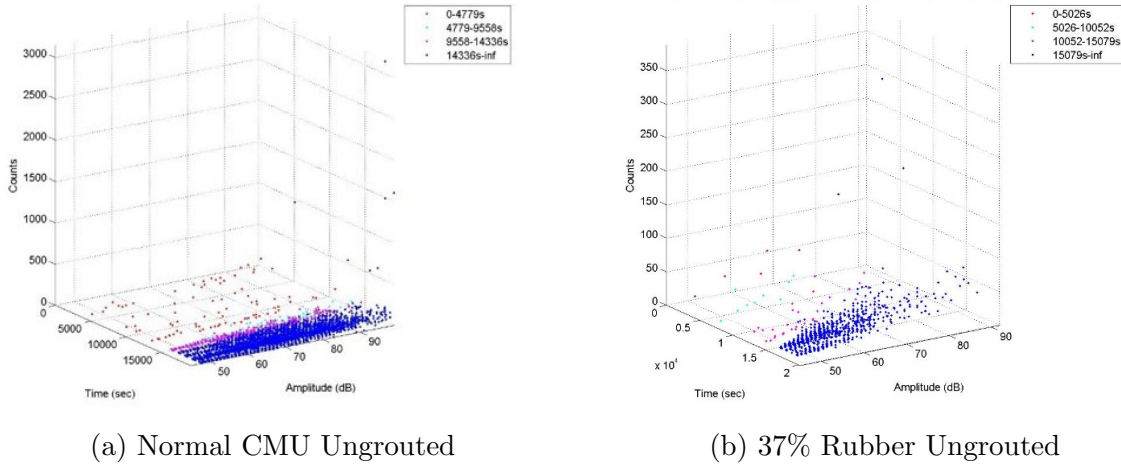
Figure 3.8. R sensors ungrouted specimens amplitude-counts-time

number of times the waveform passed a threshold (counts), there were some interesting trends. Plots of amplitude and counts over time, Figures 3.8 and 3.9 and Appendices A13, A14, A17 and A18 reveal that significant structural damage produces signals with a high amplitude and counts.

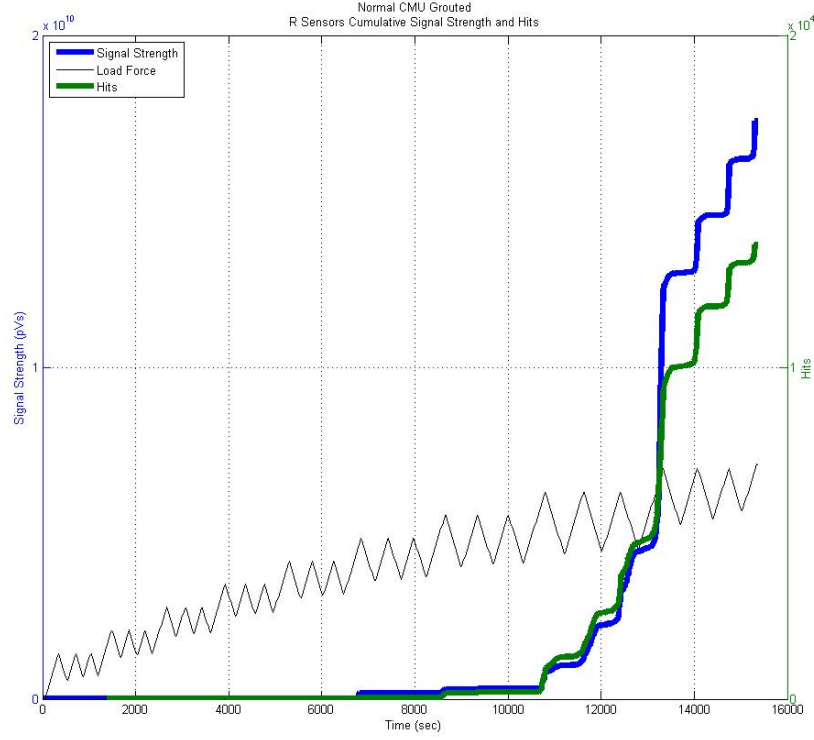
Figure 3.15. Normal grouted cumulative signal strength and hits R sensor group

cumulated hits and signal strength for the R sensors. This agrees with the notion that elastic wave energy released by cracking is proportional to recorded hits. From studying all of the plots it appears that fewer cumulated hits corresponded to a smaller cumulated signal strength. The specimens that had a larger rubber content showed the highest attenuation of frequencies in the upper spectrum. This finding can be seen in plots that compare both the two sensors hits in Figure 3.14 and in Appendix A23. The ungrouted normal CMU had the least attenuation. Both types of sensors collected sounds at the same given moments in time, which is represented by the shape of these curves (see Figure 3.15). The signal strength is a relative term because specimens without grout seemed to produce higher signal strength. Comparing specimens in Appendix A23 this came as a surprise, since it would be expected that a grouted specimen would have cracked more surface area thus accumulated more recorded damage. One possible reason for this behavior was the higher amount of sound reflections from the small element thickness.

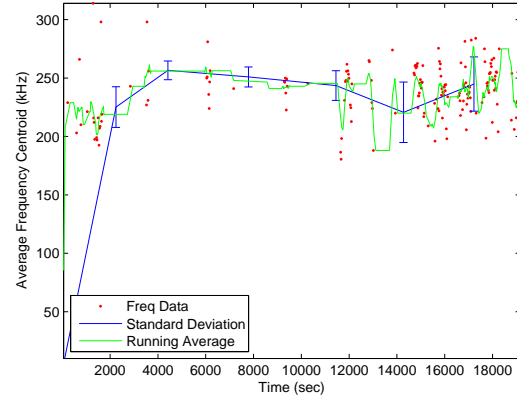
Figure 3.18. Average frequency centroid of individual channels normal CMU ungrouted prism

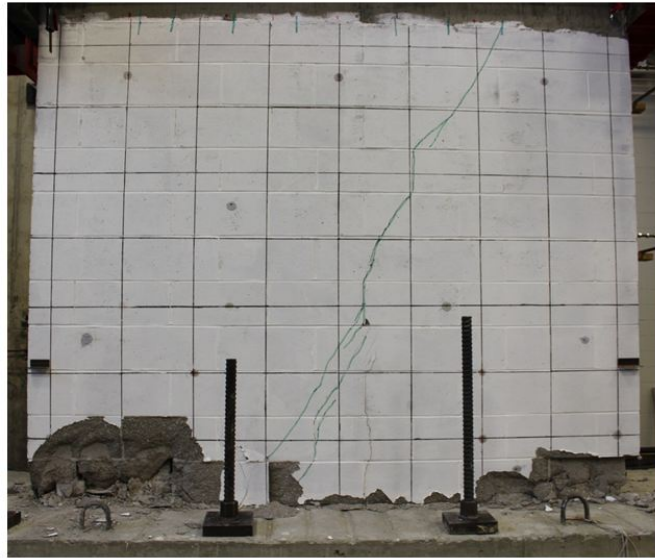
Figure 4.6. Shear Wall One damaged (the shear crack is indicated in green)

A large diagonal shear crack propagated spontaneously as the wall reached a peak displacement of 2.8. This crack can be seen in Figure 4.6. Extensive damage can be seen in both of the walls' toe areas as those areas were subjected to large amounts of compressive force. It should be noted that the wall's damage was primarily related to the wall's compressive force as it was rocked back and forth. From visual inspection, the wall behaved as a rigid body instead of as a flexural member because of the lack of fixity at the base. As the wall was rocked in the north/south direction, compression built up at the toe in that particular direction as the other toe separated at the bed joint. The tensile forces that occurred due to the cantilever action was resisted by post-tensioning. The effect of the additional post-tensioning was additional frictional force between the wall-foundation and higher stiffness seen in the scope of the load hysteresis.

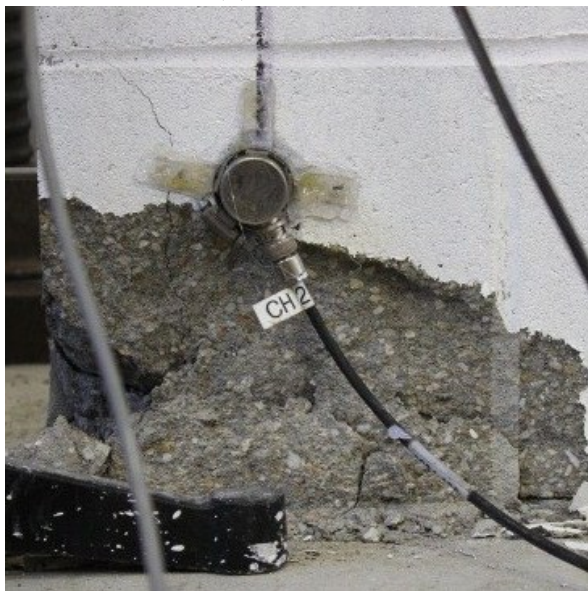
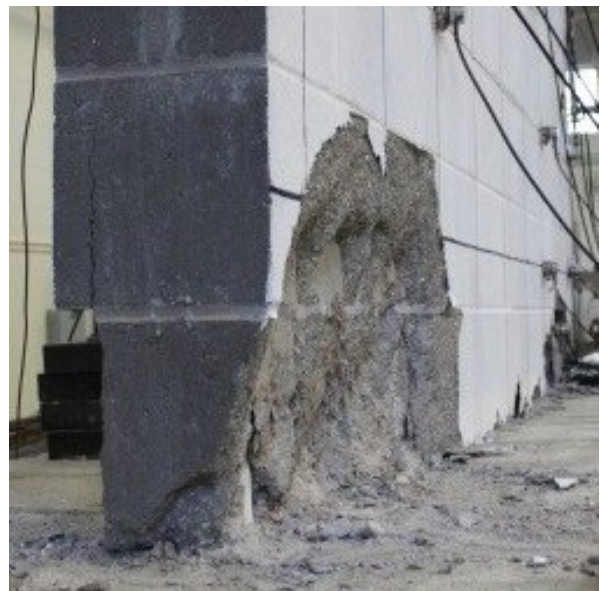
(a) Stage one

(b) Stage two

(c) Stage three

(d) Stage four

The first sign of cracking occurred at the end of the wall and progressed as the strain became more significant (see Figure 4.7a). The material properties were different for each wall because each was a composite of concrete masonry, mortar and grout. The
