Bridge deck assessment using visual inspection, ground penetrating radar, portable seismic property analyzer-ultrasonic surface wave, hammer sounding and chain drag

BRIDGE DECK ASSESSMENT USING VISUAL INSPECTION, GROUND
PENETRATING RADAR, PORTABLE SEISMIC PROPERTY ANALYZER-
ULTRASONIC SURFACE WAVE, HAMMER SOUNDING AND CHAIN DRAG

A THESIS

GEOLOGICAL ENGINEERING

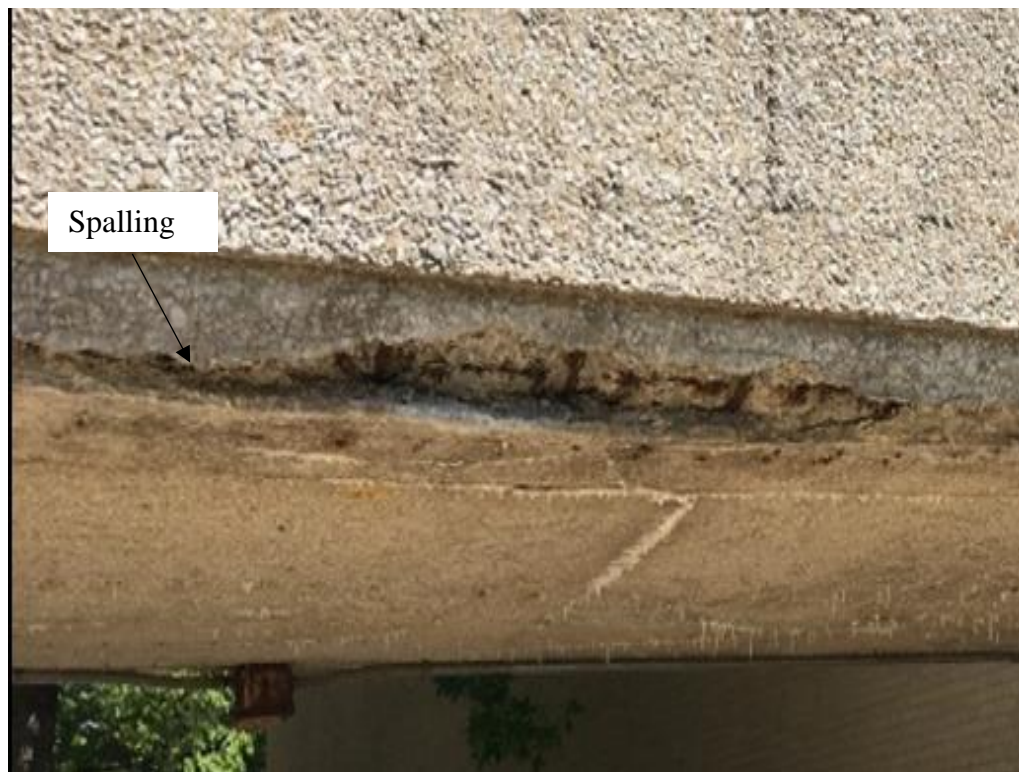
1.2.1. Spalling. Spalling is fragmenting or delaminating of the concrete surface as shown in (Figure 1.2). Spalling is caused by internal pressure and cracking due to presence of reinforcement corrosion, and/or freeze thaw cycling, and/or alkali silica reaction, and/or poor construction practices. This problem can be managed by appropriate covering the steel rebar, lowering water to cement ratio or reducing de-icing salt [4, and 6].

Figure 1.2. Bridge deck deterioration shows spalling.

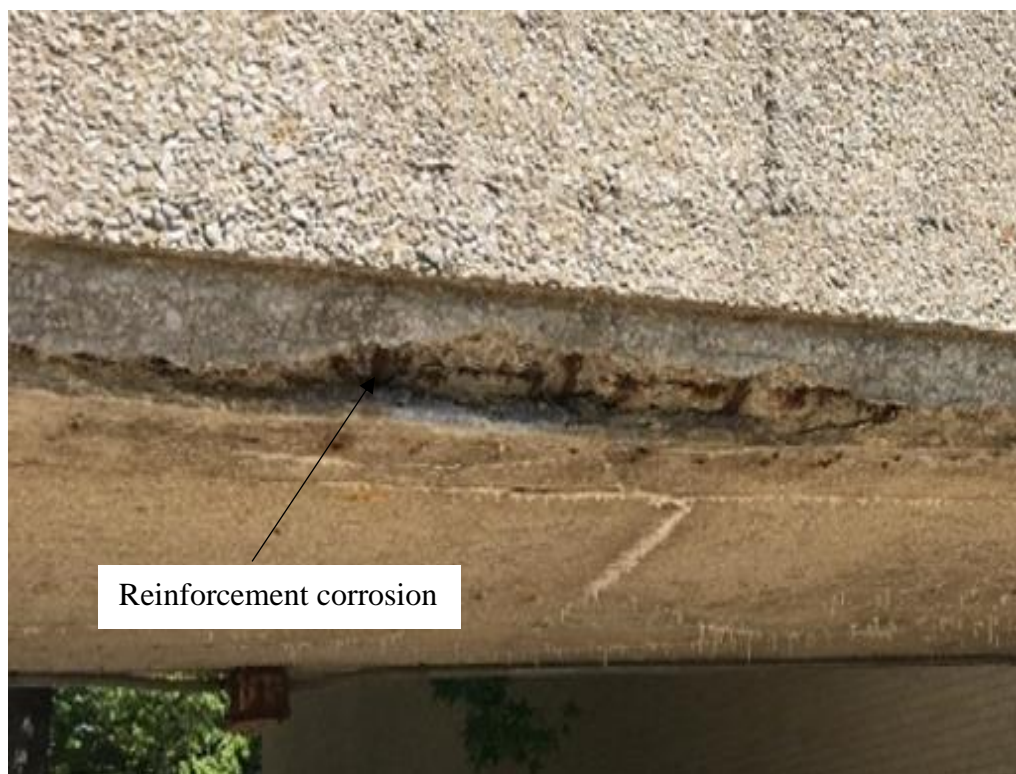
1.2.2. Reinforcement Corrosion. Reinforcement corrosion is the rusting of embedded steel rebars, which creates an expansion of steel and concrete interface until the concrete breaks away from the steel rebar creating cracking and spalling as shown in (Figure 1.3). Reinforcement corrosion is caused by the chloride ions and carbon dioxide (carbonation) reach the rebar through pores and fractures in concrete, lower the pH and

Figure 1.3. Bridge deck deterioration shows reinforcement corrosion.

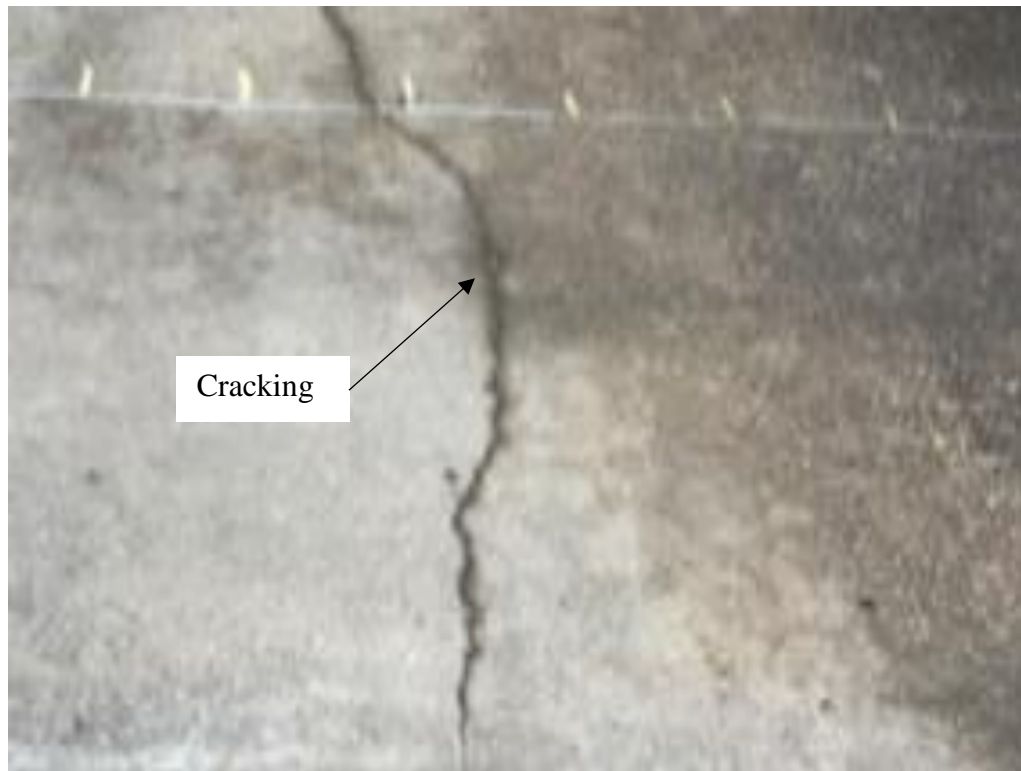
1.2.5. Cracking. Cracking is breaking or fracturing of concrete bridge deck into small or large parts as shown in (Figure 1.6). It occurs due to tensile forces caused by shrinkage, freeze and thaw cycling, overloading, reinforcement corrosion, and chemical reactions in the concrete bridge deck [1, and 6]. Cracking cause a loss of bond between the concrete and the embedded reinforcements. It also enhance more reinforcement corrosion by allowing chemicals and water to infiltrate into the internal structure of concrete [7]. The progressive reinforcement corrosion can promote further cracking along the concrete structure [4].

Figure 1.6. Bridge deck deterioration shows cracking.

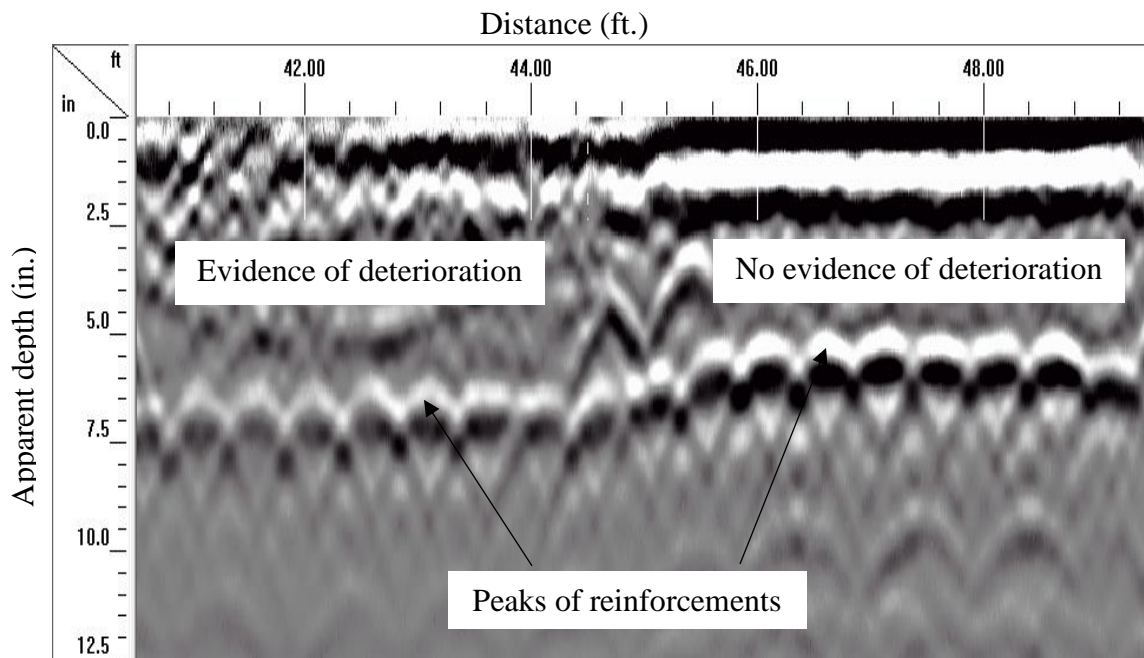
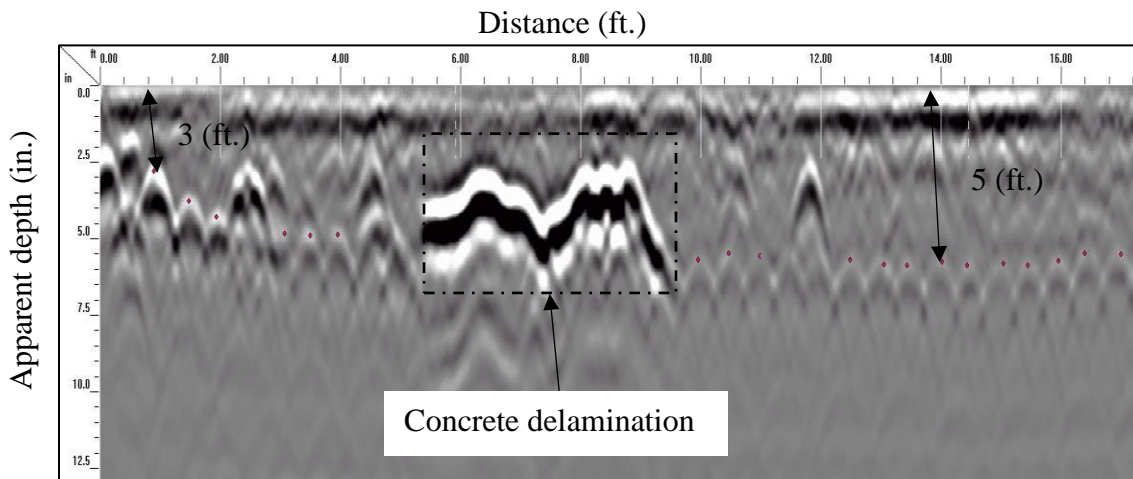
A given example of GPR scans are shown in (Figures 2.2 and 2.3) which illustrate a vertical scale of apparent depth (in.) and a horizontal scale of distance (ft.). The GPR scans show areas of concrete delamination and varying apparent depth to the top of embedded concrete reinforcements. Therefore, due to varying apparent depth of reinforcements, GPR data is not useful to assess bridge deck condition in this study. Typically, bridge deck assessment using GPR is determined by the relative concrete condition with consistent embedded depth of reinforcements. Where area of good concrete condition or no evidence of deterioration is associated with shallow apparent depth of reinforcements and/or stronger hyperbolic reflections (bright reflections), while area of evidence of deterioration is associated with deep apparent depth of reinforcements and/or weaker hyperbolic reflections (blurred reflections).

Figure 2.2. Example of GPR data shows reflections from top of embedded reinforcements.

Figure 2.3. Example of GPR data shows delamination and varying depth to top of embedded reinforcements.

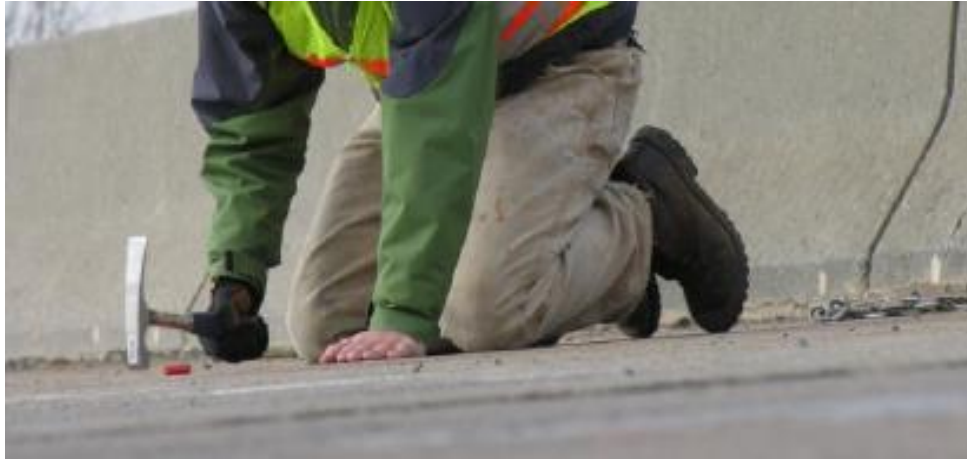
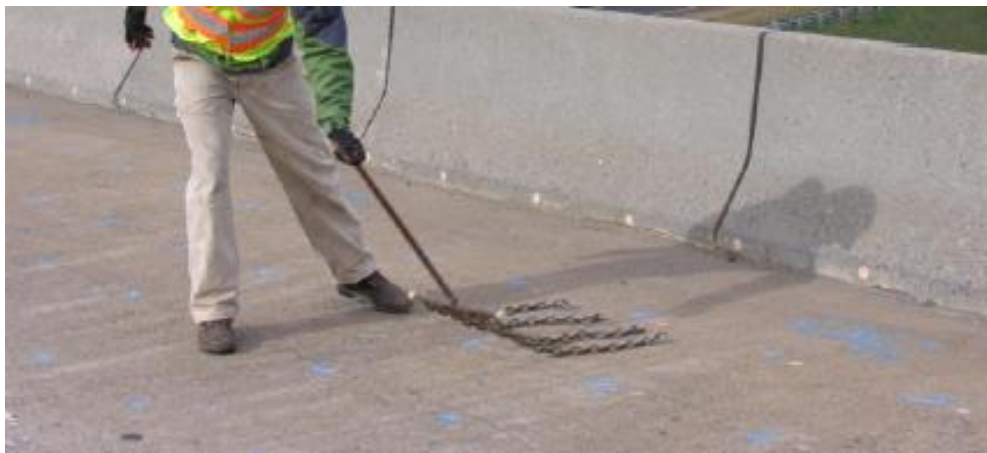
Using hammer sounding and chain drag for bridge deck assessment should follow standard practice [3 and 29]. The standard, ASTM D4580-12, includes setup of the geometry along particular areas or the whole area of the bridge deck, and then tapping the hammer or dragging the chain over the concrete bridge deck. Hollow or solid sound can be heard during implementing these methods, where hollow sound is indicative of delamination and solid sound is indicative of non-delamination [22 and 24]. Eventually, the delaminated areas are mapped along the bridge deck. Hammer sounding and chain drag can provide inexpensive and rapid data that can be used for bridge deck assessment. However, the data interpretation is subjective or qualitative [20, 31, and 19].

Figure 2.8. Hammer sounding [1].

Figure 2.9. Chain drag [1].

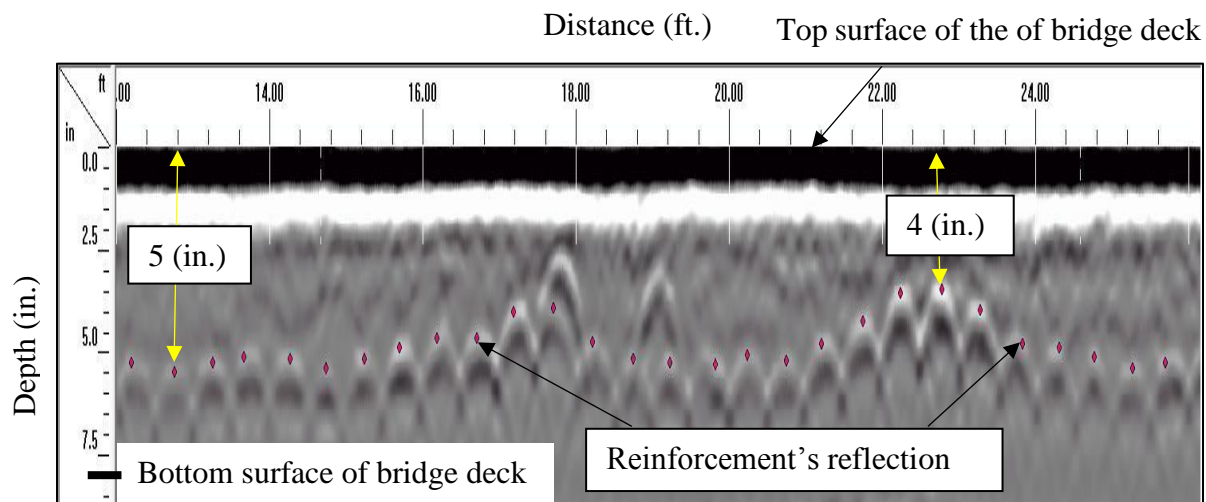
After GPR data acquisition, the acquired GPR profiles were patched together and processed by using GSSI RADAN 7 processing software. An example of processed GPR profile is showing in (Figure 5.5). The basic processing steps included time-zero correction, and background removal. The hyperbolic EM reflections were manually picked to calculate the arrival travel time and amplitude of the reflected signals from each reinforcement. Excel spreadsheet was created which includes two-way travel times (in units of nanoseconds, ns) and amplitudes (in units of normalized decibels, NdB). Two-way travel time was converted into apparent depth (in unit of inches, in). Each GPR profile was assigned coordinates (x, y) in the same excel spreadsheet. Finally, two contour maps were generated using Surfer version 10 (by Golden Software) depicting the apparent depth and amplitude variations along the reinforced concrete bridge deck. The amplitude and apparent depth view maps were used to determine the relative concrete conditions according to particular amplitude and apparent depth ranges in which concrete condition is classified into either "good", "fair", "poor", or "severe".

Figure 5.5. GPR profile # 7 shows reflections from varying depth of reinforcements along the bridge deck.

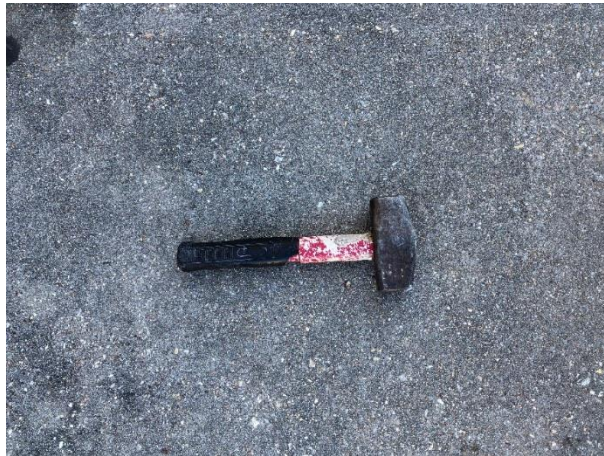
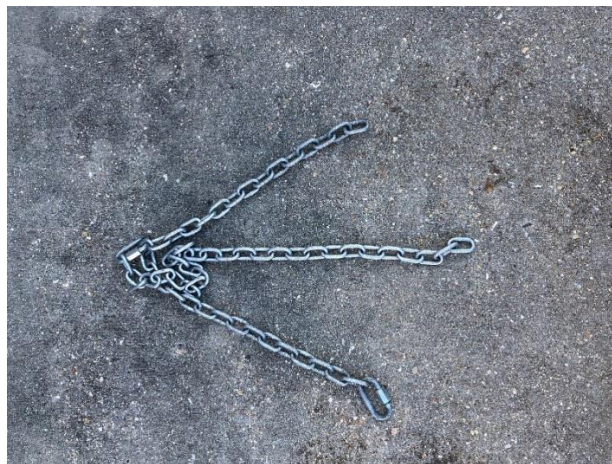
Hammer sounding and chain drag data were acquired along the reinforced concrete bridge deck as shown in (Figures 5.9 and 5.10) respectively. Data were acquired by identifying areas of no delamination (solid sound) and severe delamination (hollow sound). The identified areas were marked with a chalk on the bridge deck as shown in (Figure 5.11). There was no data processing required for this technique. The data were interpreted qualitatively and it could vary from inspector to another depending on the experience and level of deterioration [30 and 38].

Figure 5.9. Hammer sounding.

Figure 5.10. Chain drag.

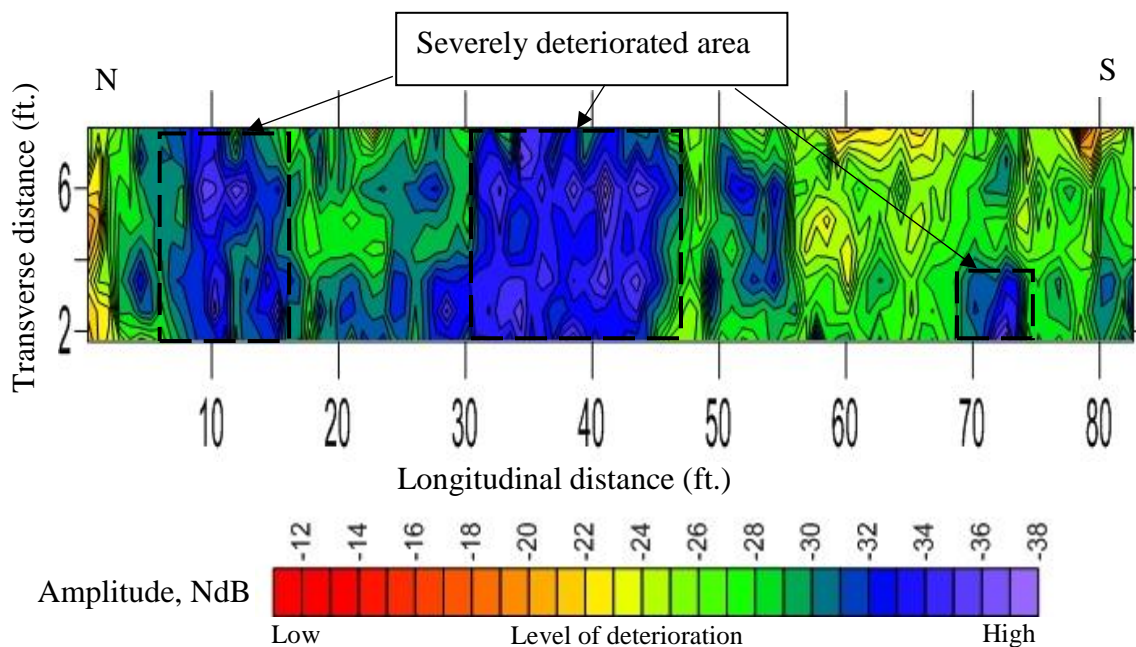
The amplitude variations map determined the relative concrete condition of the reinforced concrete bridge deck as shown in (Figure 6.2). The relative concrete condition was divided into four categories: “Good concrete condition” indicated area of no evidence of deterioration, which included amplitude range of 12-18 (NdB); “Fair concrete condition” indicated area of fair evidence of deterioration, which included amplitude range of 18-24 (NdB); “Poor concrete condition” indicated area of evidence of deterioration, which included amplitude range of 24-31 (NdB); “Severe concrete condition” indicated area of severe evidence of deterioration, which includes amplitude range of 31-38 (NdB).

Figure 6.2. GPR amplitude variations map.

The amplitude and apparent depth maps show a good correlation where the area of severe deterioration is mainly located on the center of the bridge deck, while the remaining area of the bridge deck is of approximately moderate to less deterioration.

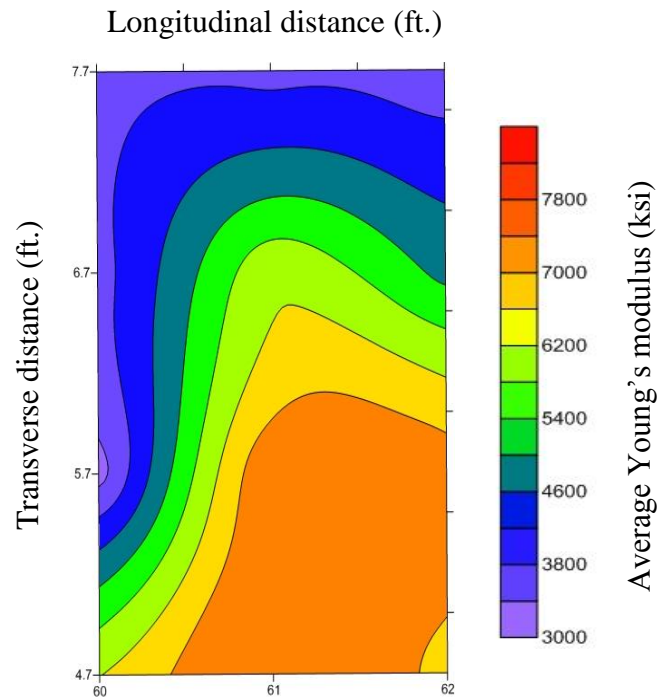
Figure 6.5. Contoured map shows average Young's modulus variations for section (A).

Figure 6.6. Contoured map shows average Young's modulus variations for section (E).

Figure 6.7. Contoured map shows average Young's modulus variations for section (C).

Figure 6.8. Contoured map shows average Young's modulus variations for section (D).

Figure 6.9. Contoured map shows average Young's modulus variations for section (B).

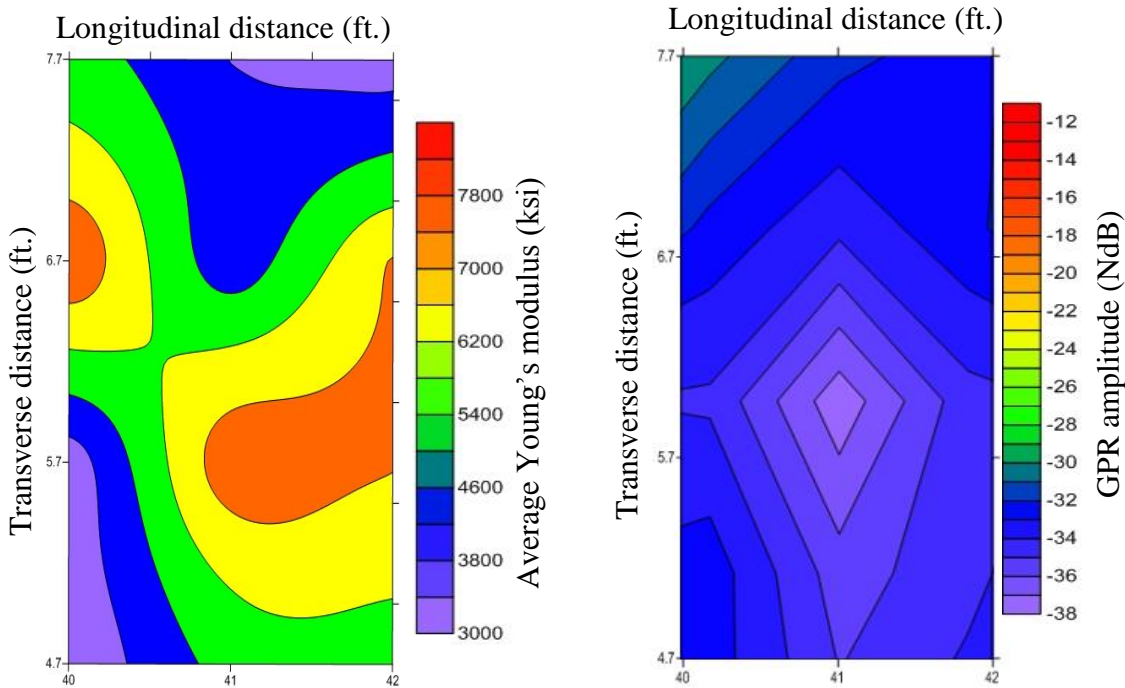
Figure 6.12. PSPA-USW average Young's modulus and GPR amplitude variations for section (A)

Figure 6.13. PSPA-USW average Young's modulus and GPR amplitude variations for section (B)

Figure 6.14. PSPA-USW average Young's modulus and GPR amplitude variations for section (C)

Figure 6.15. PSPA-USW average Young's modulus and GPR amplitude variations for section (D)

Figure 6.16. PSPA-USW average Young's modulus and GPR amplitude variations for section (E).
