Imaging the subsurface in eastern part of Lake Chesterfield using a combination of geophysical tools

A THESIS

GEOLOGICAL ENGINEERING

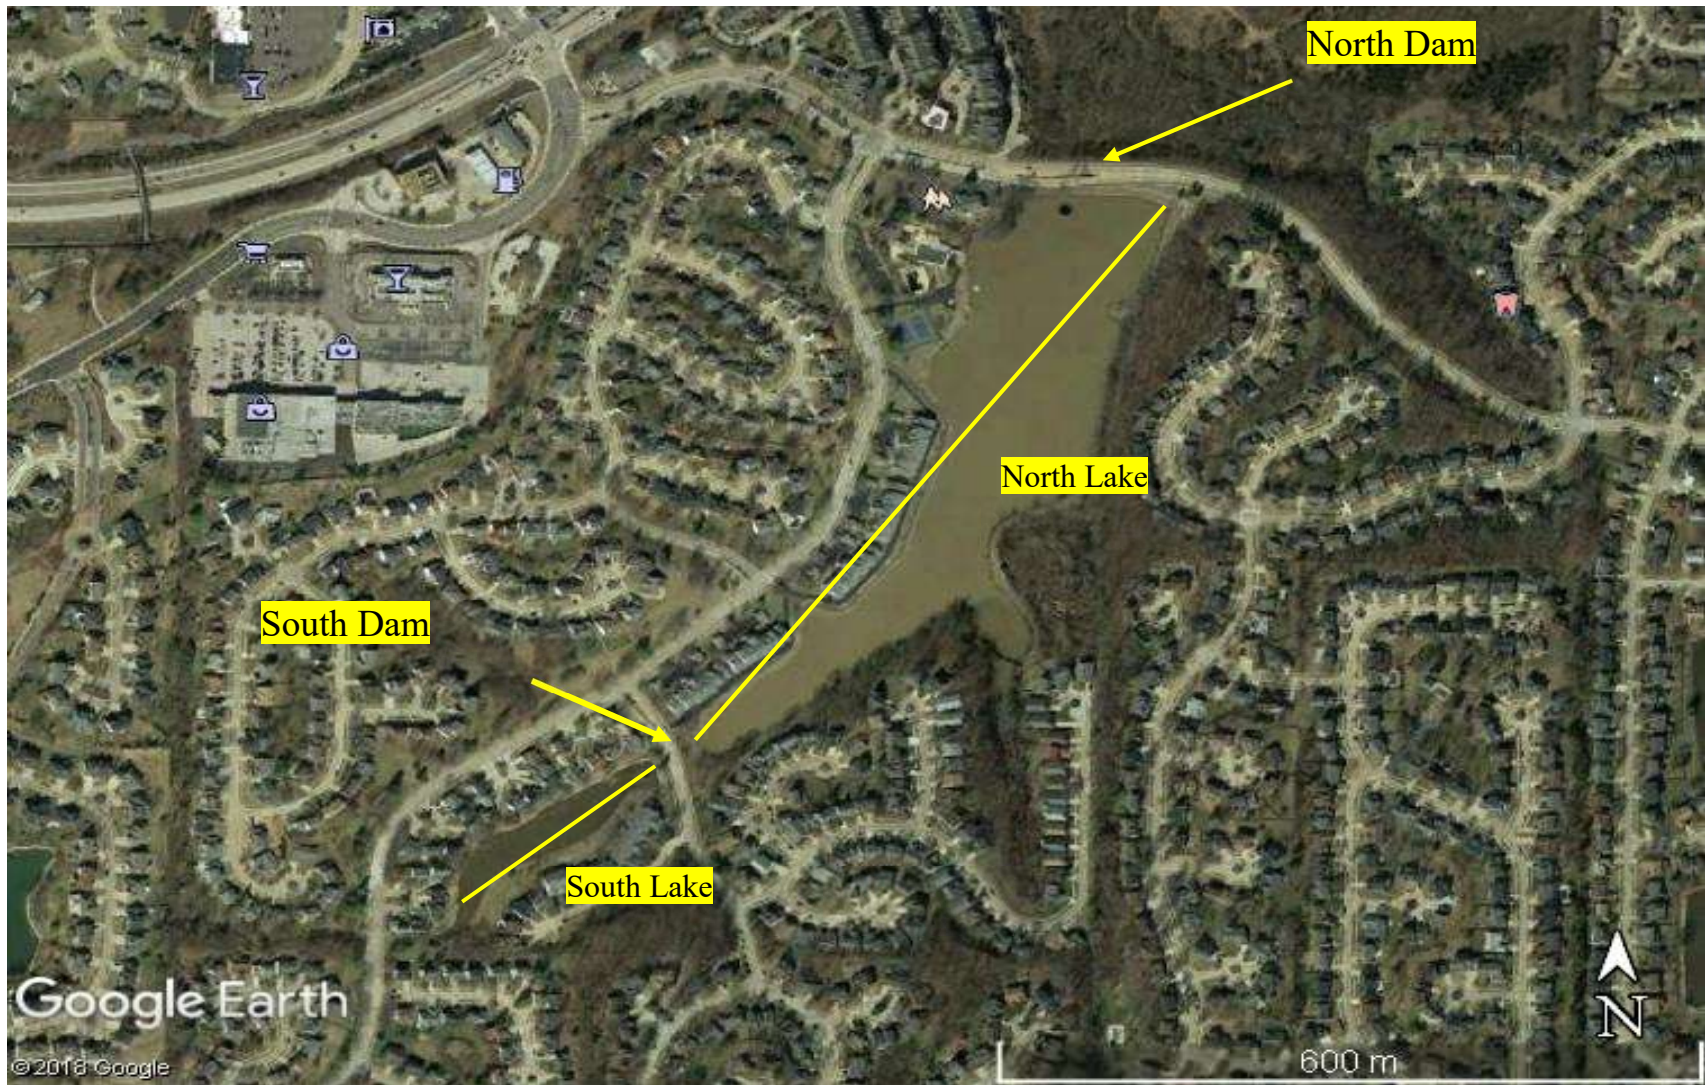
Figure 1.3. Map of Lake Chesterfield with two dams marked. Measuring based on Google Earth.

Geotechnology, Inc. Construction started in 1986 and finished in 1987. The purpose was to provide stormwater detention and recreational zone for residents in the Lake Chesterfield Community. The North Dam is 700 ft. long, 90 ft. wide, and 32 ft. high; the South Dam is 200 ft. long, 65 ft. wide, and 15 ft. high. Both dams have driveway constructed on the top (Figure 1.2). Lake Chesterfield was divided into two parts by the South Dam. The northern section of Lake Chesterfield is approximately 2100 ft. long and 590 ft. wide (maximum). The size of the northern section of the lake is 22 acres when fully loaded (Figure 1.3). The southern section is much smaller at approximately 700 ft. long and 130 ft. wide (maximum).

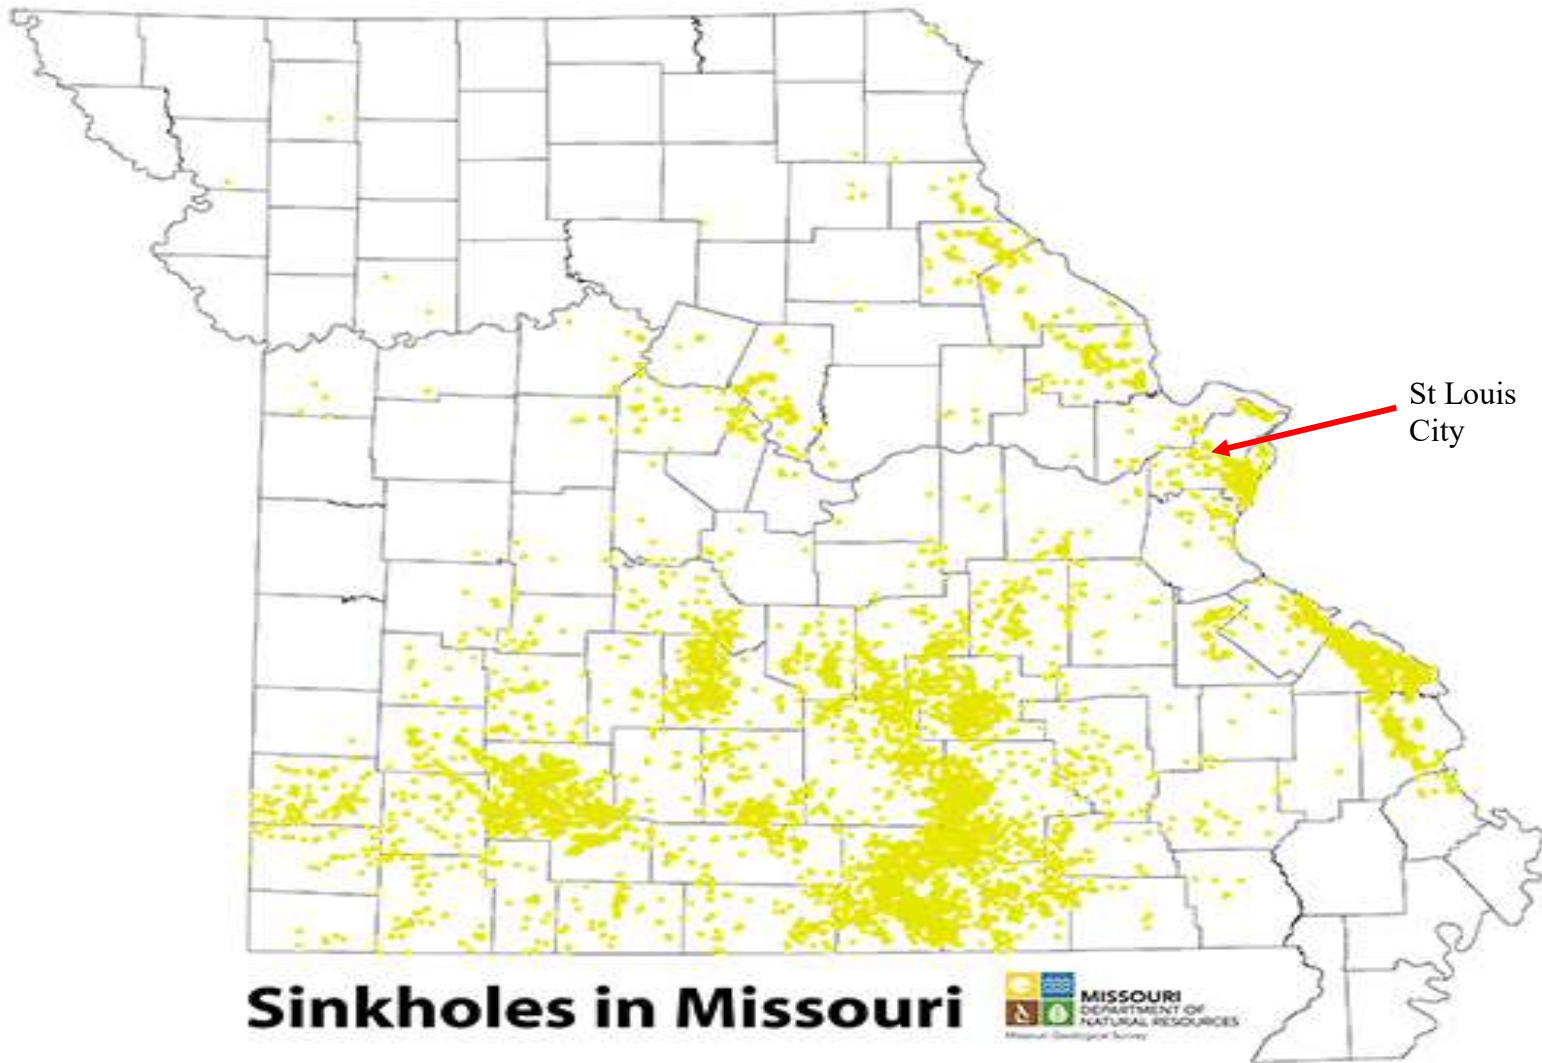
Figure 3.6. Verified sinkholes in Missouri (MODNR, 2018).

Carbon dioxide in the atmosphere dissolves in surface water to form carbonic acid. The carbonic acid reacts with carbonate rock to form soluble ions that lead to the formation of sinkholes. Karst features are always associated with frequent caves and sinkholes in the subsurface. From the database provided by Missouri Department of Natural Resources (MODNR), the Geological Survey Program has verified 15,981 sinkholes in Missouri (Figure 3.6) and are frequently presented in St Louis city.

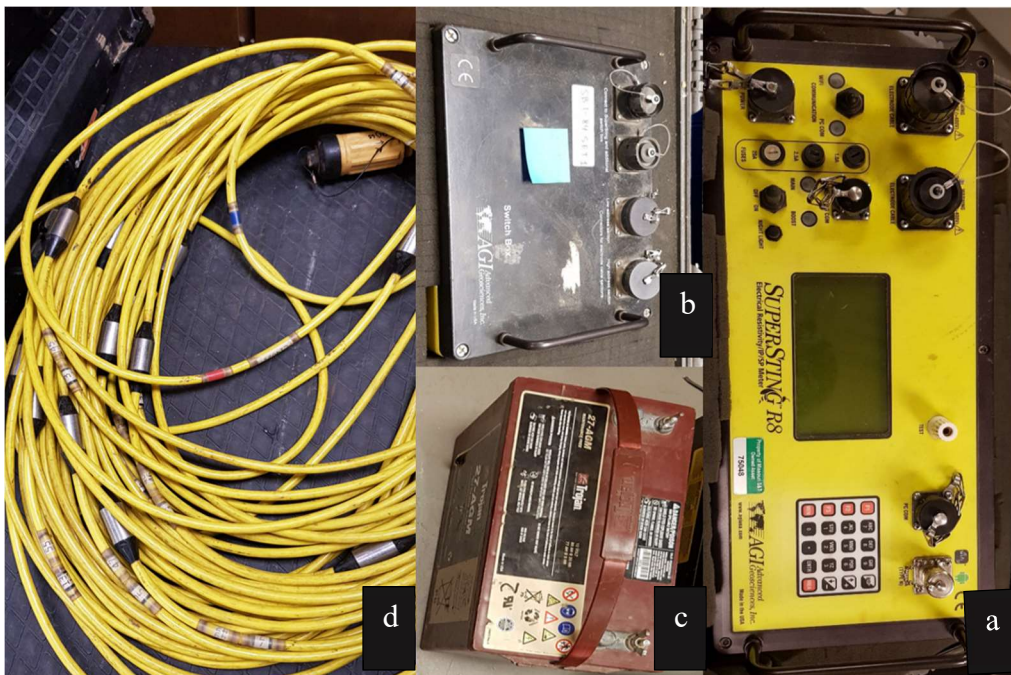
Figure 4.2. Equipments of ERT survey: a. supersting control unit; b. switch box; c. battery; d. survey cable.

4.1.1. Philosophy. Electrical resistivity tomography survey is relatively straightforward. The equipment of ERT survey including SuperSting R8 (Figure 4.2-a), switch box (Figure 4.2-b), batteries (Figure 19-c), cable with electrode contact (Figure 4.2-d), and steel pins (Figure 4.3). The basic theory of ERT is using known AC current input into the ground using battery or generator and measuring the potential differences (ΔV). The resistance (R) of the subsurface can then be calculated using Ohm's law:

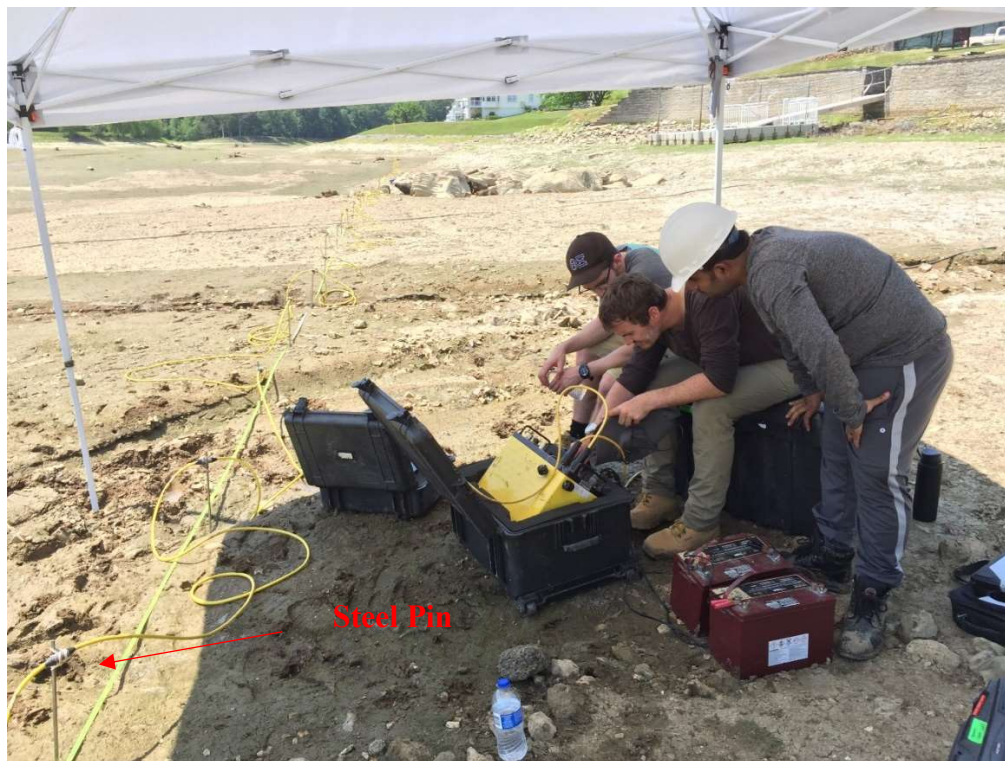
Figure 4.3. The setup of an ERT system.

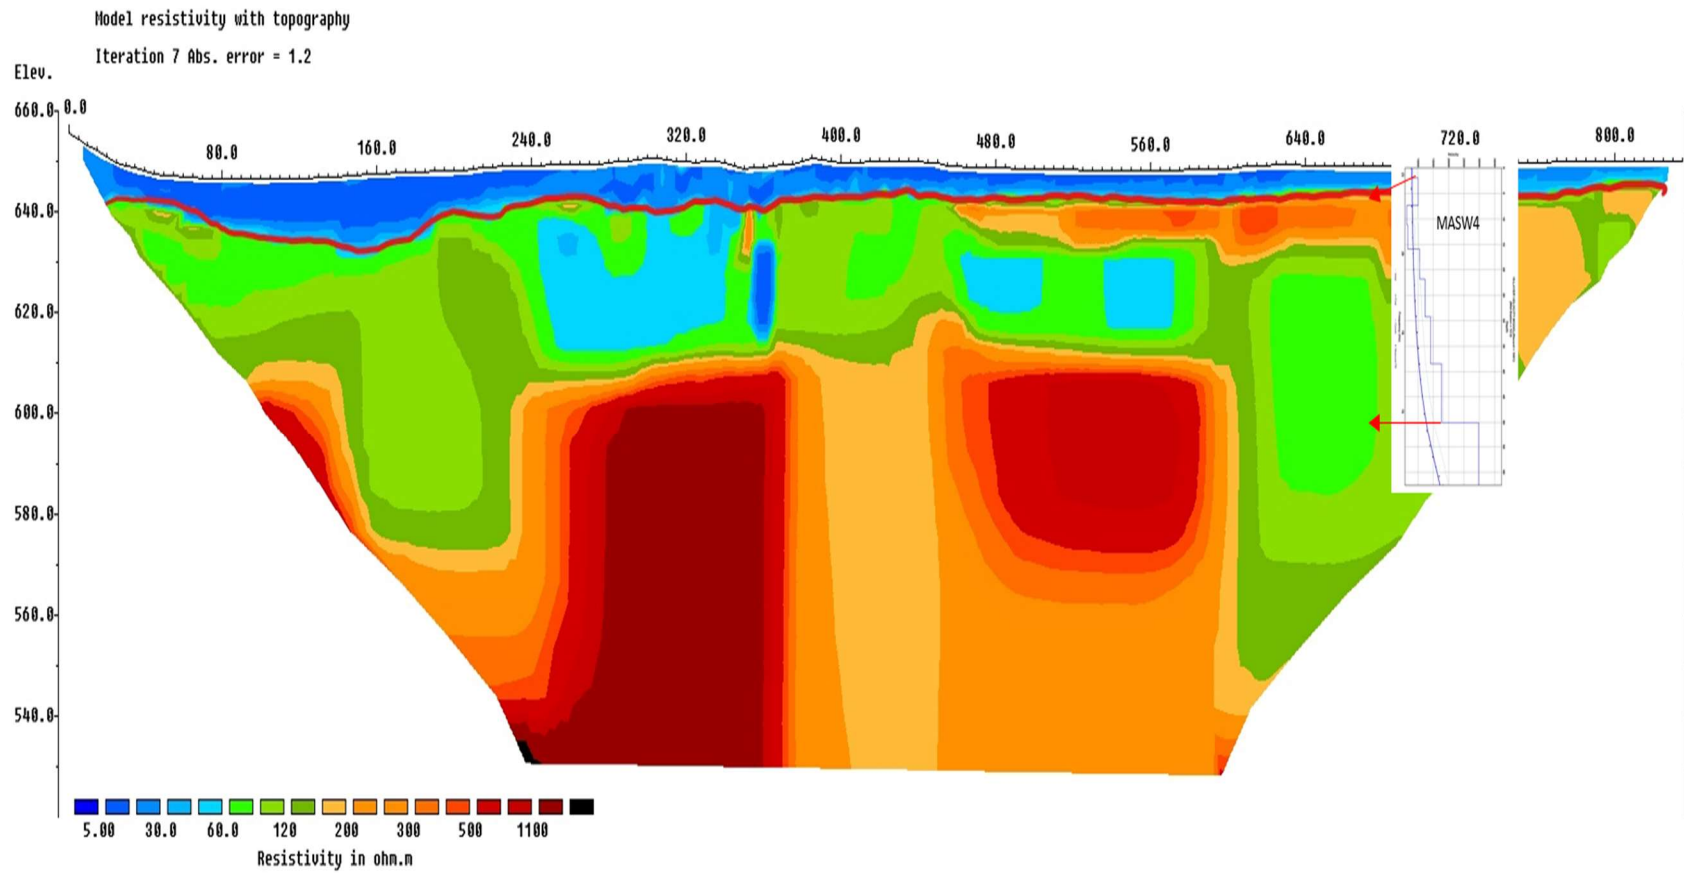
Figure 4.19. MASW 1-D shear-wave velocity profile 4 correlate well with ERT profile 5 at station 670.

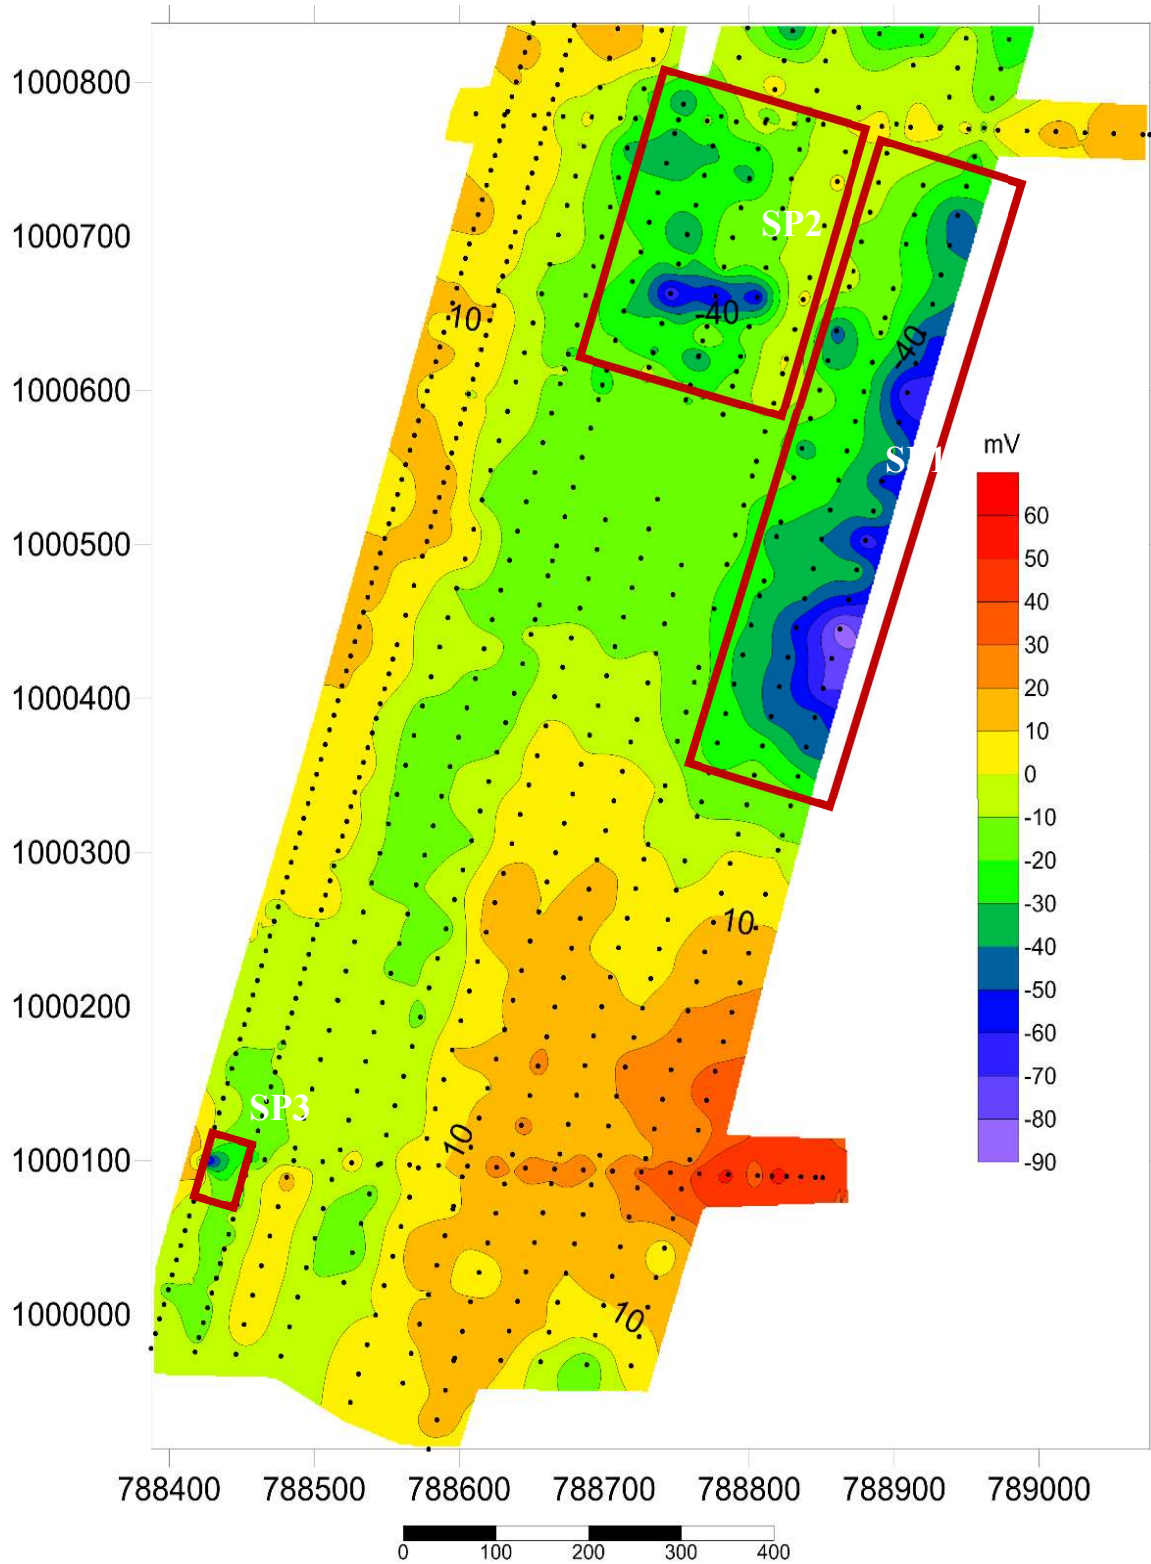
Figure 4.21. Contoured plot of the SP data acquired in the field, SP1 and SP2 were interpreted as seeping vertically into the subsurface. The anomalous areas were marked using red rectangles.

4.3.2. SP Data Interpretation. A total of 690 SP points was tested in the field; the result is plotted as contour map (Figure 4.21). Three anomalous area were identified and are labeled as SP1, SP2, and SP3. SP1 was situated near the eastern shoreline. SP2 was situated in the north part of ERT 1, 2 and 3. Only one data point in SP3 was shown negative, and no neighboring points had similar data. This abnormal area might create by mistake during the survey. The interpretation of SP data is consistent with the interpretation of the ERT profiles. SP anomalies are observed in areas where ERT anomalies are present.

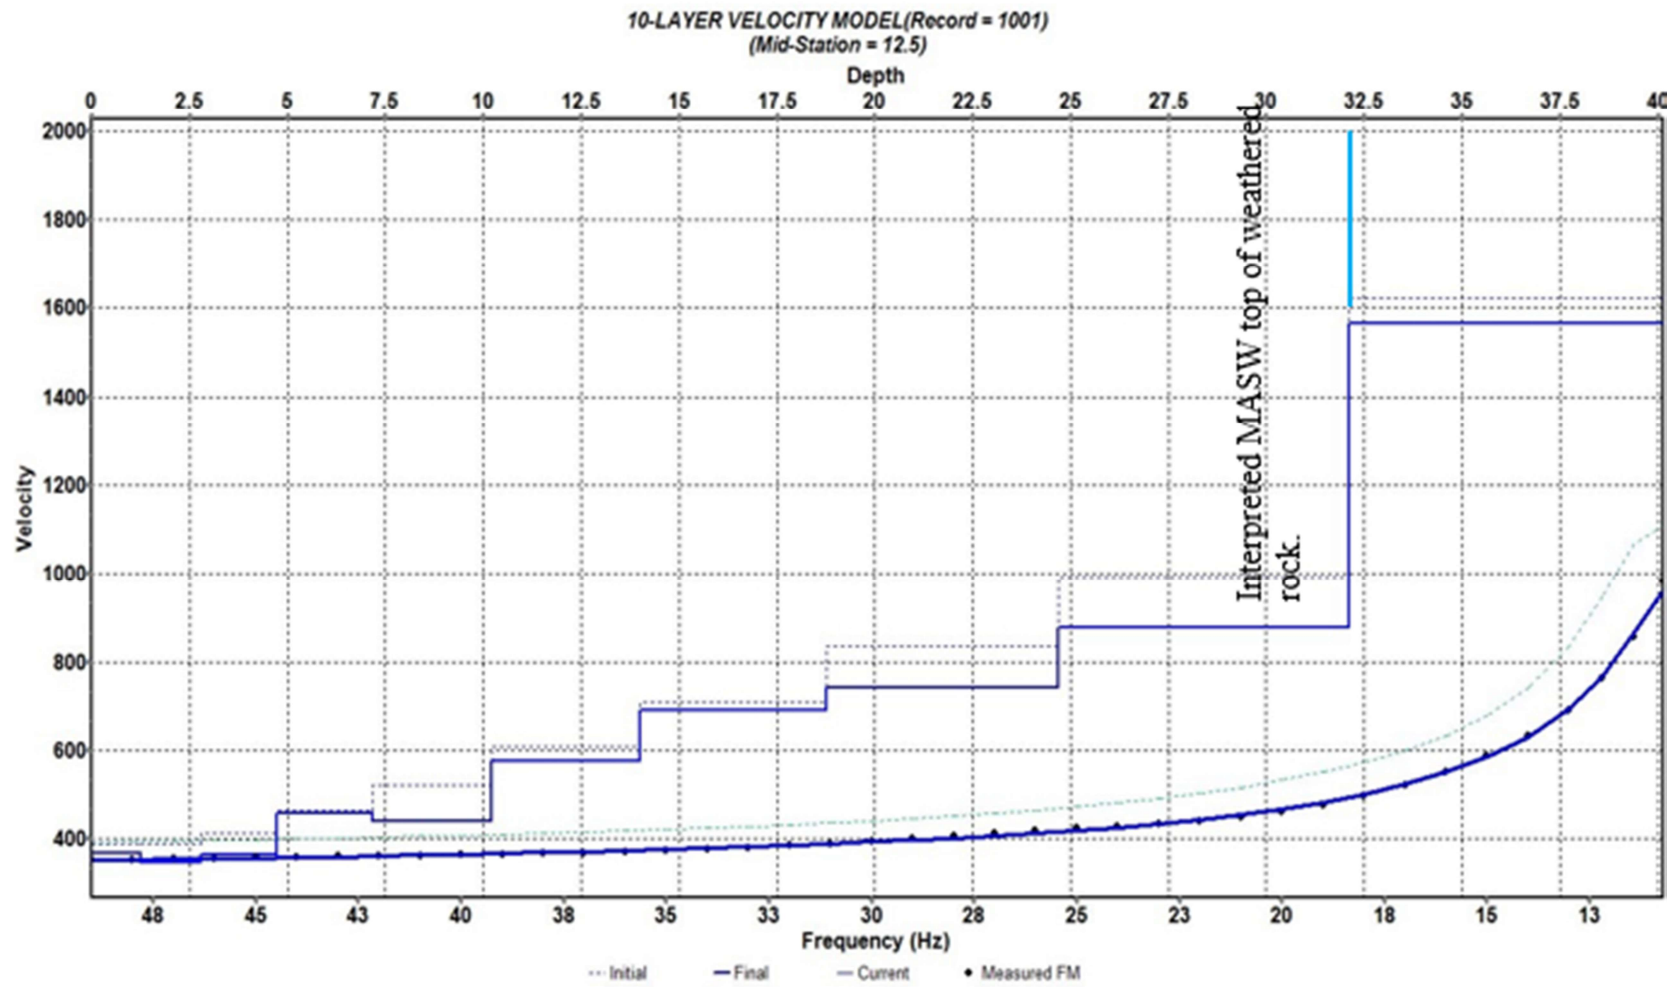
Figure B 2. 1-D shear-wave velocity profile generated for the MASW 2.

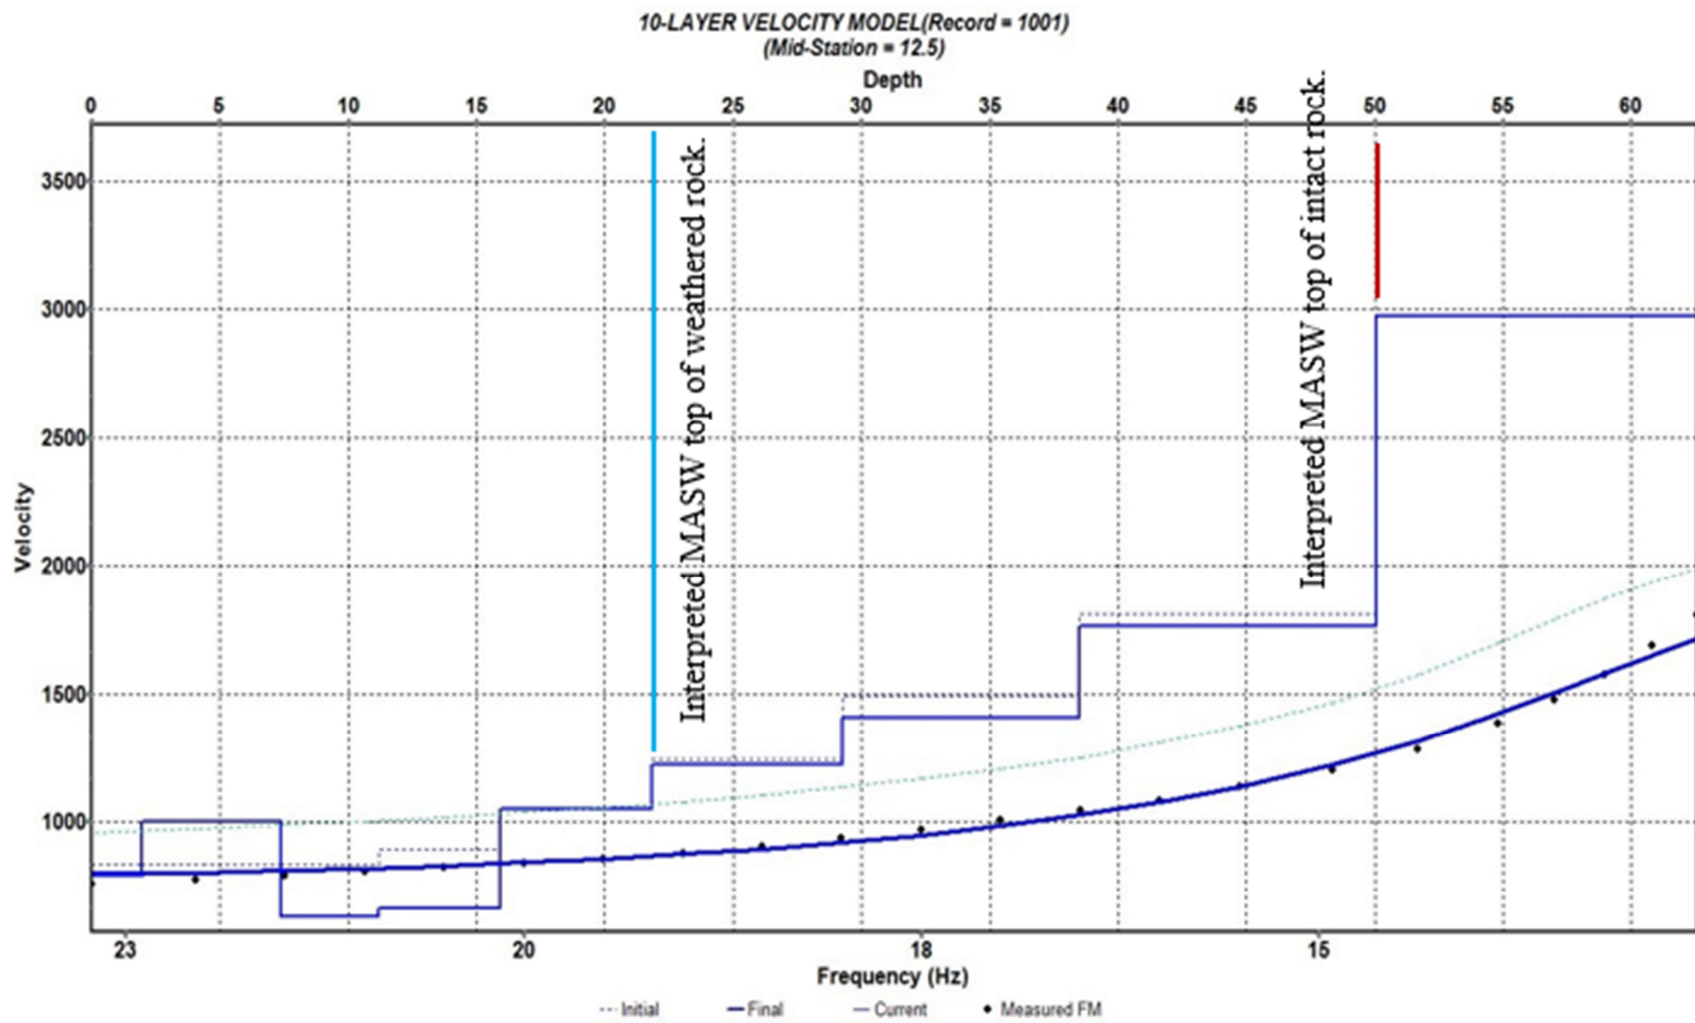
Figure B 3. 1-D shear-wave velocity profile generated for the MASW 3.
