Geophysical imaging beneath Lake Chesterfield, Missouri

GEOPHYSICAL IMAGING BENEATH LAKE CHESTERFIELD, MISSOURI

A THESIS

In Partial Fulfillment of the Requirements for the Degree
MASTER OF SCIENCE IN GEOLOGICAL ENGINEERING

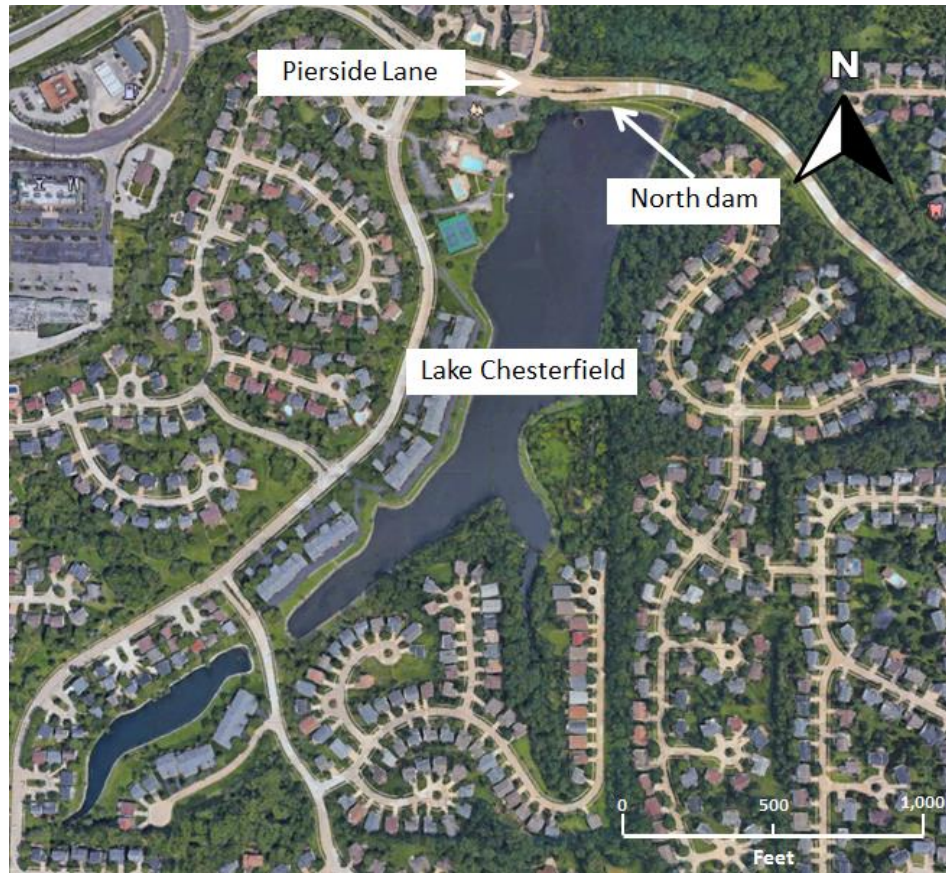
Figure 1.1. Google Earth image of Lake Chesterfield and North Dam.

The North Dam is 32 ft. in height and 700 ft. long. A road, Pierside Lane, runs atop the crest of the dam (Figure 1.1). The base of the dam is at an elevation of approximately 640 ft. The dam was constructed with a clay core with the remaining earth fill consisting of silt, sand, gravel and clay (Eckelkamp, 1986).

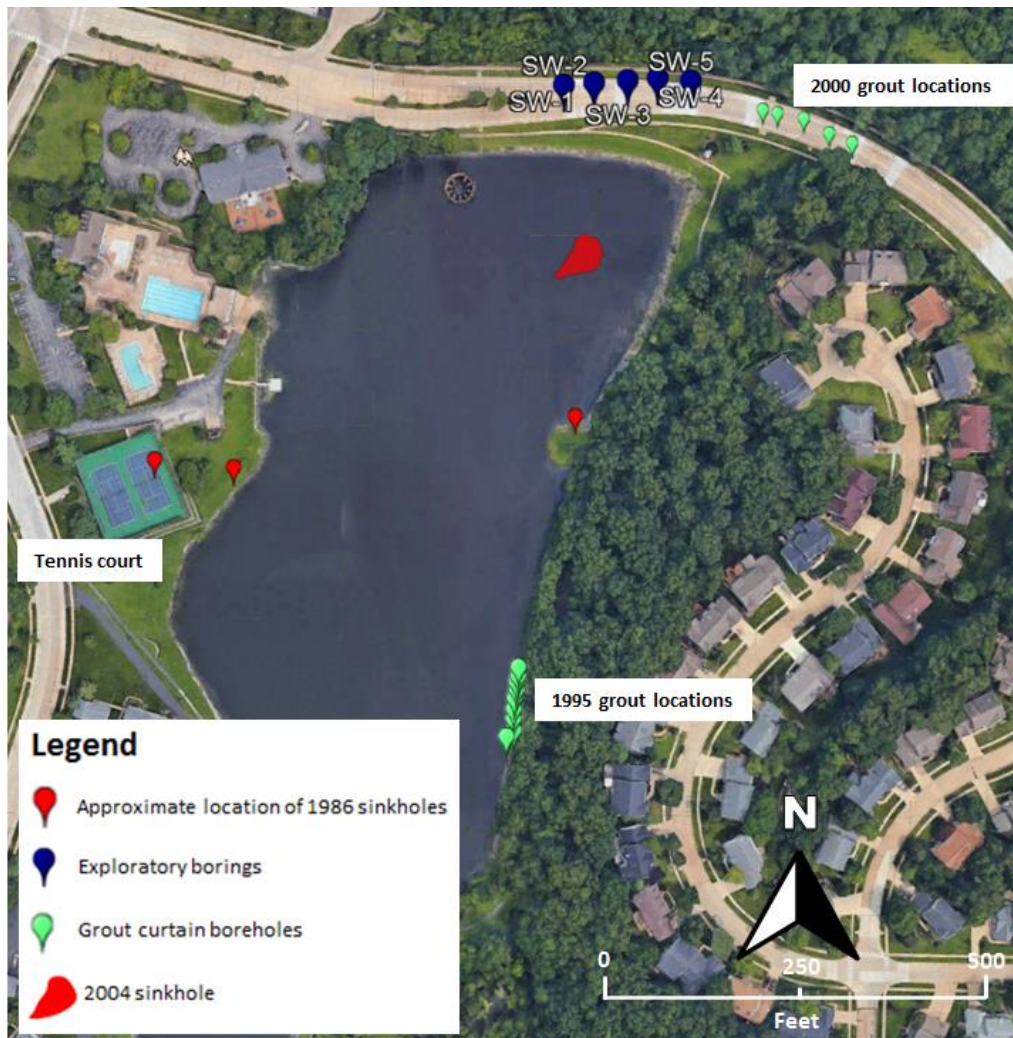
Figure 1.3. Locations of previous sinkholes, exploratory borings and grout injection points.

Three sinkholes were discovered in 1986 on the northern section of the lake when the area was initially graded (Figure 1.3). Two of the sinkholes were on the western side of the lake near the tennis courts. One of the two sinkholes on the western edge was excavated down to a depth of 20 ft. where a karst trench trending NNE/SSW was discovered. This sinkhole was treated by placing several feet of 2-3in rock in the passageway, capping with concrete and backfilling. The second sinkhole on the western edge was excavated down to a depth of 35 ft. As no cavity was present the excavated sinkhole was backfilled. The third sinkhole was discovered approximately 1000 ft. south of the North Dam on the eastern side of the lake near a knoll that extends from the eastern shore. This sinkhole was sealed using graded rock filler, whereby large rocks are placed in the throat of the sinkhole and progressively smaller rocks are placed on top before backfilling with native soil.

A zone of leakage was identified on the lake in 1995 (Figure 1.3). This zone of leakage was believed to be parallel to the eastern shore. The geophysical company Strata Services, Inc. was hired to grout the seepage pathway. Nine grout holes were drilled and 4144 cubic feet of neat cement/pozzolan slurry and 1620 cubic feet of sand-cement/pozzolan slurry were injected.

In 2000, a subsidence feature with associated leakage developed in the NE section of the dam (Figure 1.3). A total of five grout holes were drilled. Grout was injected at an angle of 12 degrees oriented towards the lake to penetrate underneath the subsidence feature. 796 cubic feet of neat cement/pozzolan slurry and 486 cubic feet of sand-cement/pozzolan slurry were injected. Strata Services, Inc. concluded that this grout curtain should seal any leakage associated with the subsidence. Leakage was temporarily reduced.

Shannon and Wilson, Inc. drilled 5 core holes, SW1 - SW5 (Figure 1.3) on the earth filled dam to ensure the structural integrity on the dam hadn't been compromised. The core holes indicated that the subsurface (to a depth of 48 feet in one corehole) was comprised of reddish-brown fat clay and silt with chert fragments. The underlying limestone was moderately to highly weathered limestone inbedded with shale and chert. Shannon and Wilson, Inc. concluded that the structural integrity of the North Dam had not been compromised.

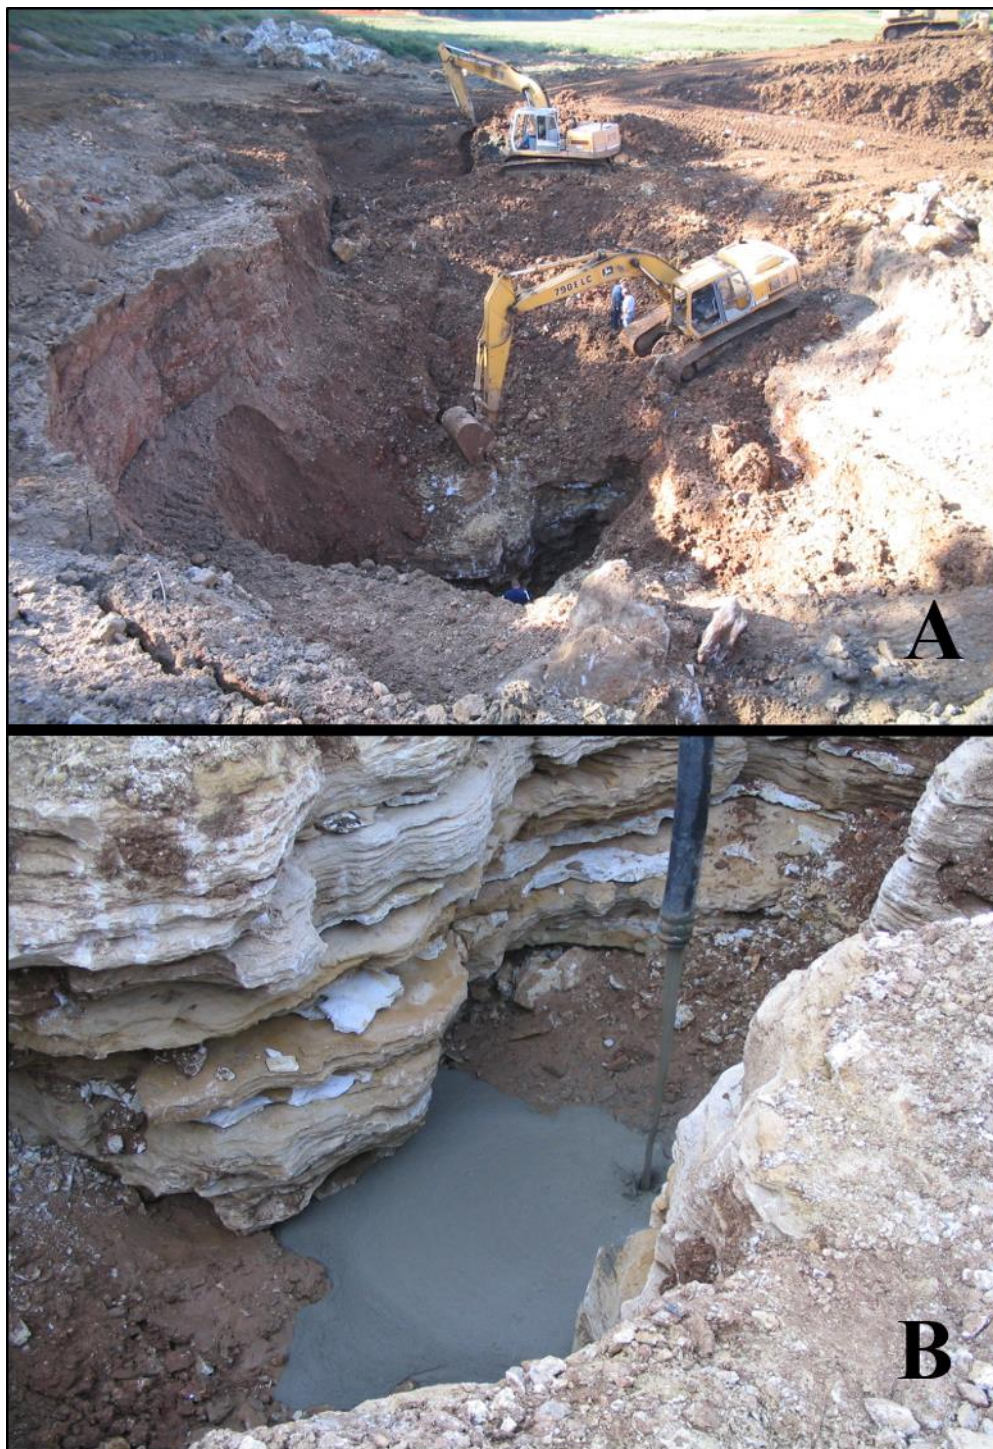
Figure 1.4. Photo A and B of 2004 sinkhole and remediation. A: Looking south along Lake Chesterfield, showing scale of the sinkhole and remediation. B: Sinkhole being filled with grout, in this photo you can clearly see the highly weathered limestone (Wieners, 2005).

In June 2004, a sinkhole formed at the north end of the lake (Figure 1.4). Leakage through this feature rapidly and fully drained the lake. A dye test found that the water that drained into the sinkhole emerged 3.5 miles north of the lake at Lewis Spring. This suggests to the author that the waters that drained into the sinkhole flowed to the north beneath the dam along the original Caulks Creek pathway. This should not be surprising as bedrock beneath Caulks Creek would have been extensively weathered, in places, and would be an ideal conduit for mostly horizontally flowing water.

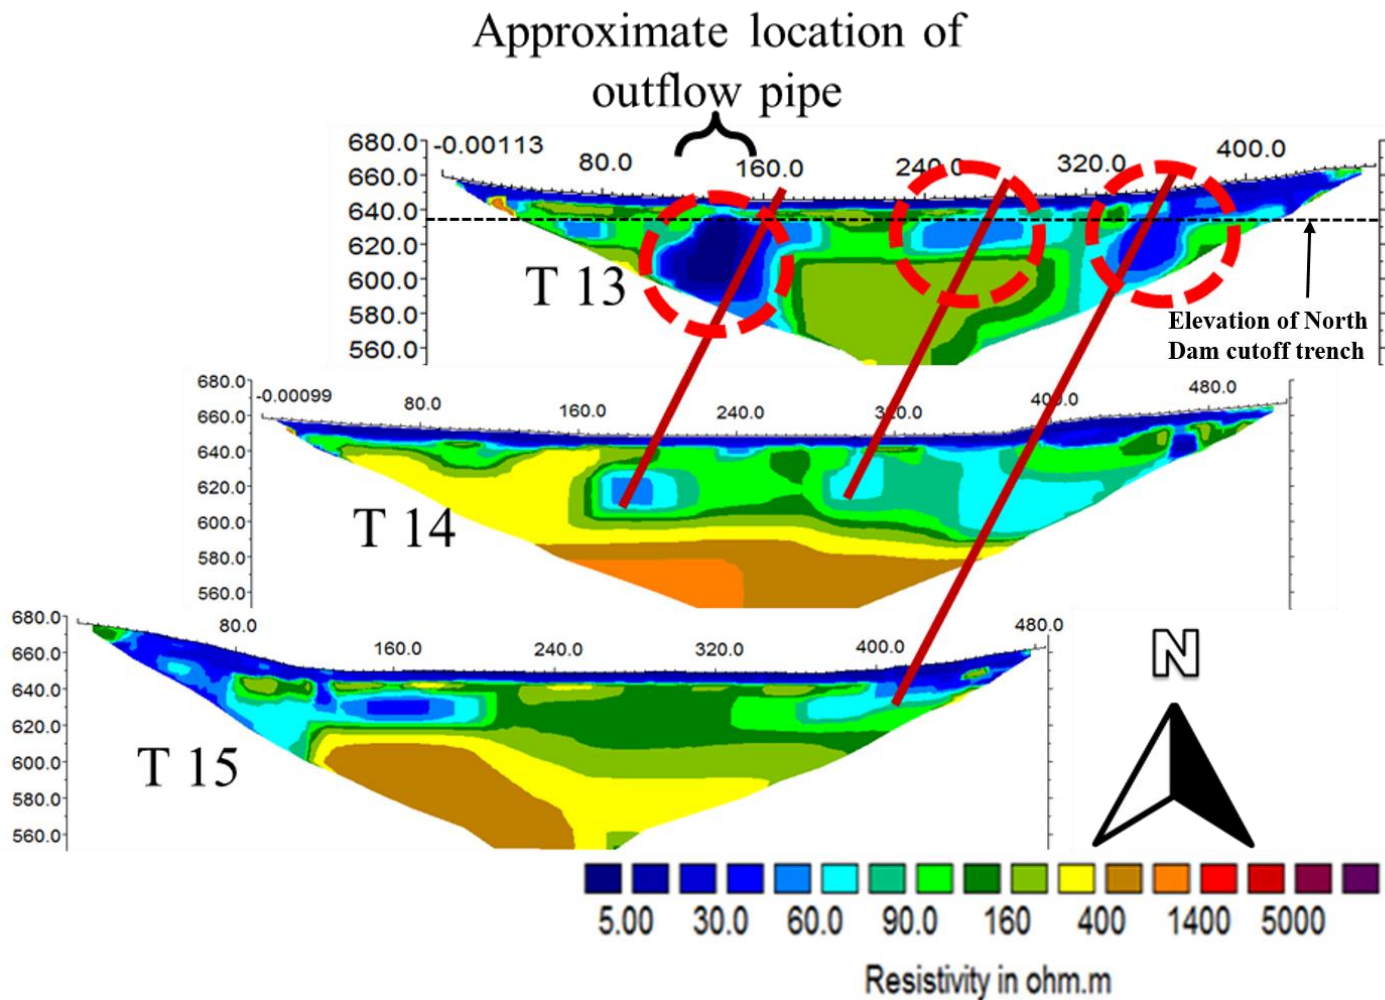
Figure 3.8. Northern W-E orientated ERT traverses 13-15. Solid red lines between traverses 13-15 are interpreted flow paths linking the traverses. Dashed red circles are possible seepage pathways beneath the dam. Dashed black line shows the base elevation of the cutoff trench (Anderson, 2018). Elevations and distances are in feet.

The horizontal low resistivity zones in ERT traverses 13-15 (Figure 3.8), are more or less perpendicular to Caulks Creek, and interpreted as horizontal flow paths. These interpreted flow paths are believed to contain significant piped clay and are hence characterized by low resistivity values. It is believed that these interpreted flow paths continue beneath the dam. If this premise is correct, then the interpreted flow paths could serve as horizontal conduits for waters flowing to the north beneath the dam along the old Caulks Creek pathway. The low resistivity values near the location of the outflow pipe could be the result of the electrical current flowing through the outflow pipe instead of the ground, this could be confirmed or not by drilling at this location.

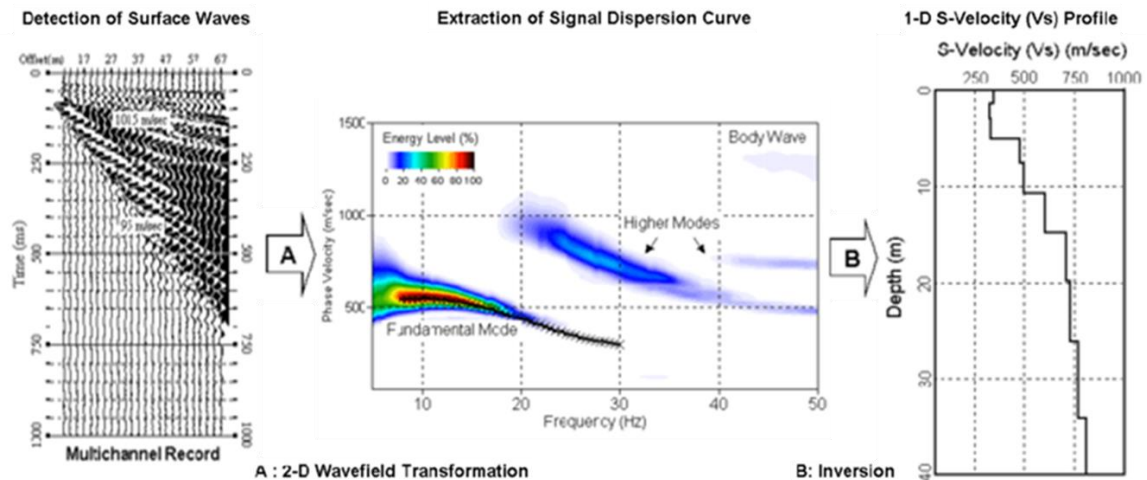
Figure 3.9. Overview of MASW data processing.

Images from left to right: (1) Extraction of a trace from the raw data; (2) Creation of a phase velocity vs frequency profile (dispersion curve); (3) Generation of a 1-D vertical shear wave velocity profile (depth vs. shear wave velocity).

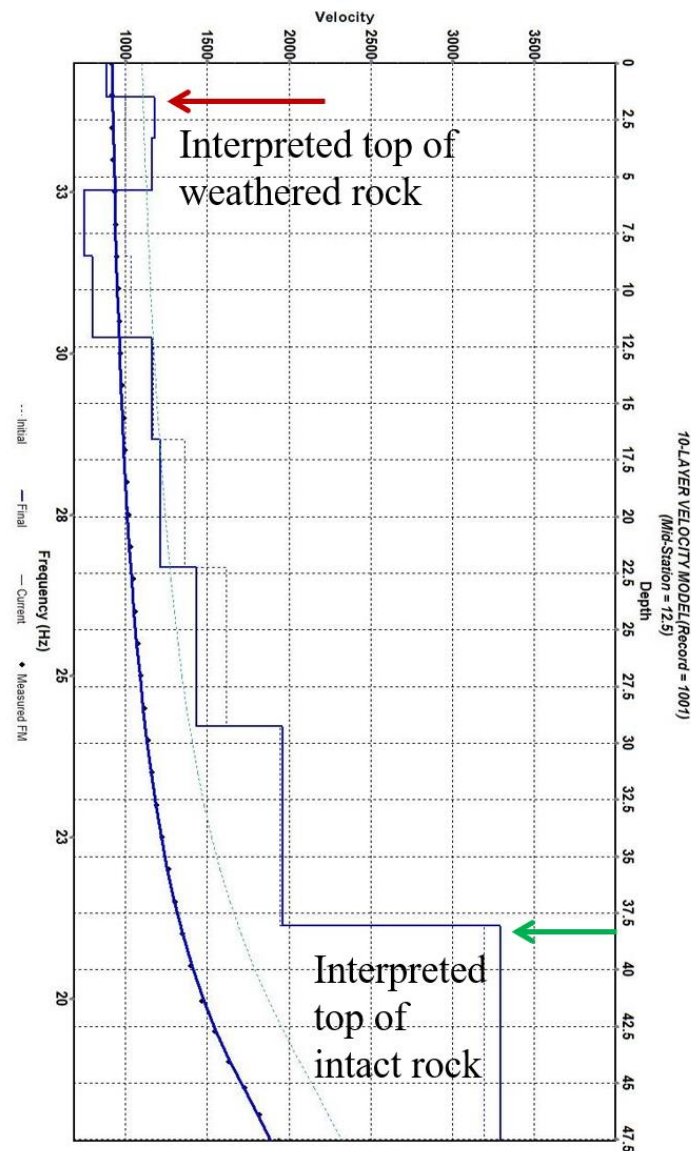
Figure 3.12. 1-D 10-layer model of shear-wave velocity profile of MASW profile 3.

The interpreted top of rock at station 349 ft. on the ERT profile shown in Figure 3.5 is at a depth of approximately 5 ft. The zone interpreted as highly weathered rock extends from a depth of approximately 10 ft. to a depth of approximately 20 ft. The top of soft rock (at best) on the corresponding MASW 1-D shear-wave velocity profile Figure 3.12 is at a depth of approximately 1.5 ft. Based on shear-wave velocity only, the material at depths between 6 and 16.5 ft. would be classified as soil (according to NEHRP classification system (Table 3.1)). According to the NEHRP classification system, the earth material at depths greater than 38 feet would be classified as rock.

When comparing the MASW and ERT data sets, the depths to weathered and intact rock are reasonably consistent with each other. This gives us confidence in our data and interpretation. It is not unreasonable to expect discrepancies (as shown in this example, Figure 3.5 and 3.12) between the MASW and ERT estimates of depth to top-of-rock. Discrepancies between the MASW and ERT estimates can be attributed to a couple

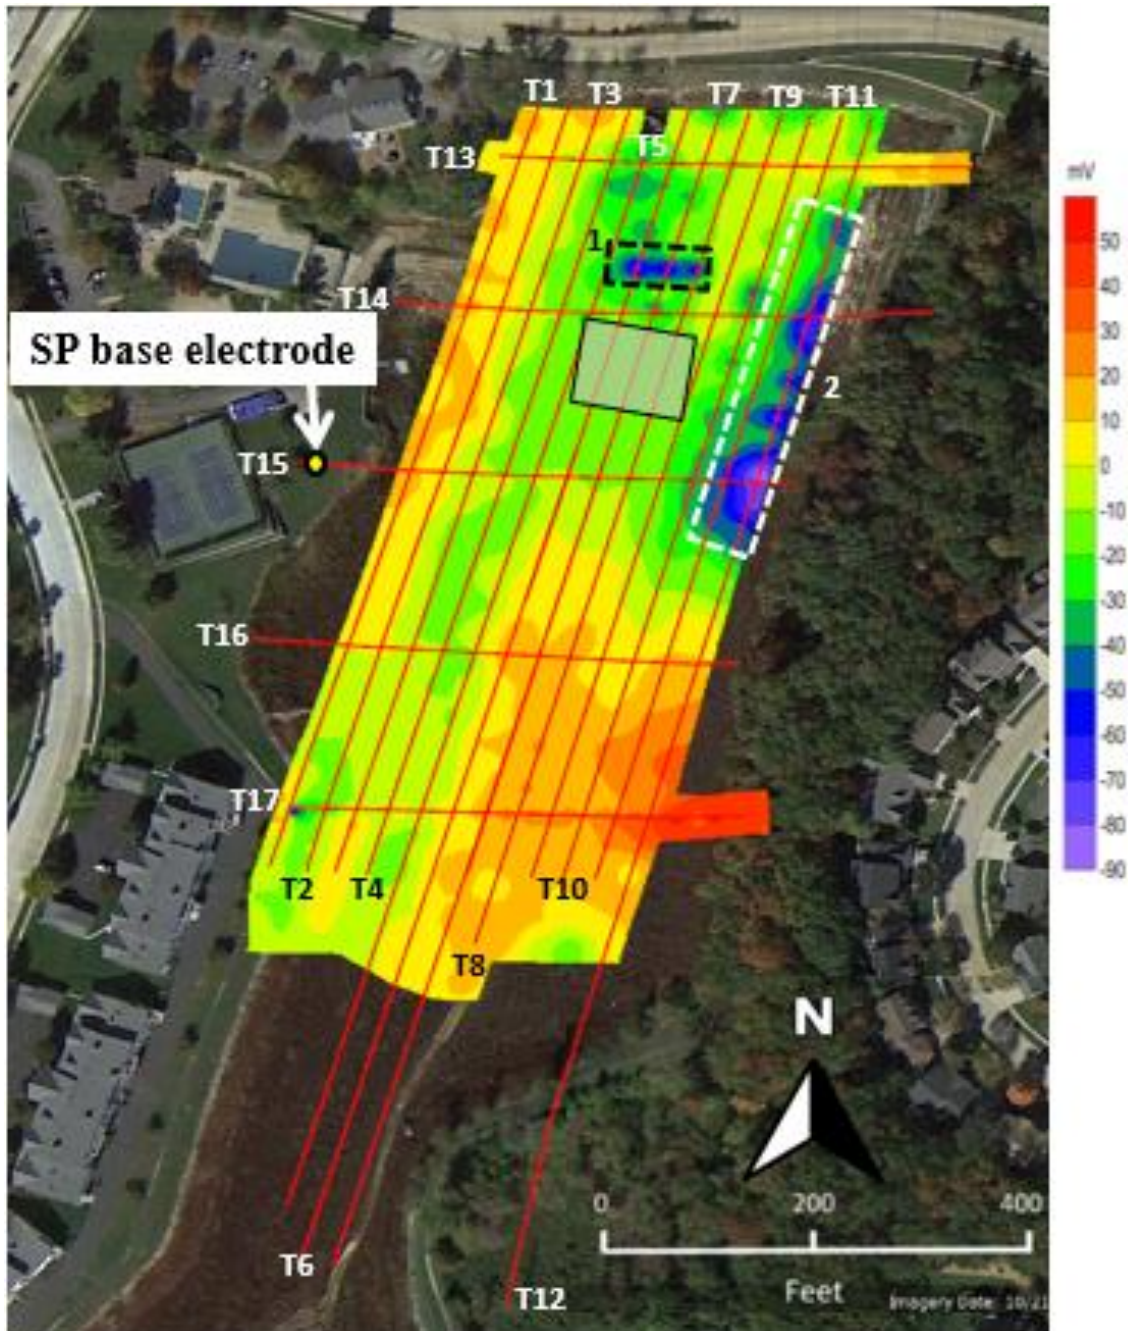
Figure 3.15. Contoured SP data overlaid on Lake Chesterfield. Red lines indicate the location of the ERT traverses (T1-17) along which the SP data were acquired. Two prominent negative SP anomalies are highlighted (1 and 2). These anomalies are shown in blue/purple. Data couldn't be acquired in grey shaded area due to the presence ponded water (Anderson, 2018).

3.3.3. SP Data Interpretation. The SP results, as seen in Figure 3.15, show two main areas of interest. The first is Location 1, which was located 180 ft. from the start on traverses 6-8. The second is Location 2, which was located along the northeast edge of the lake.

These two areas are characterized (mostly) by negative (blue) SP values. The areas of negative SP values correlate well with areas of low resistivity on the ERT profiles, suggesting that water is infiltrating the subsurface at these locations. As these negative zones are not located above the interpreted solution-widened joints on the ERT data. Expectations then, are that the seeping waters flow to the north through the zone of weathered rock and beneath the dam through the interpreted seepage pathways (Figure 3.8), and not down through the solution-widened joints (Figure 3.7).
