Unmanned aerial and traversing vehicle – A mobile platform for bridge inspections

UNMANNED AERIAL AND TRAVERSING VEHICLE
-A MOBILE PLATFORM FOR BRIDGE INSPECTIONS

A THESIS

MASTER OF SCIENCE IN CIVIL ENGINEERING

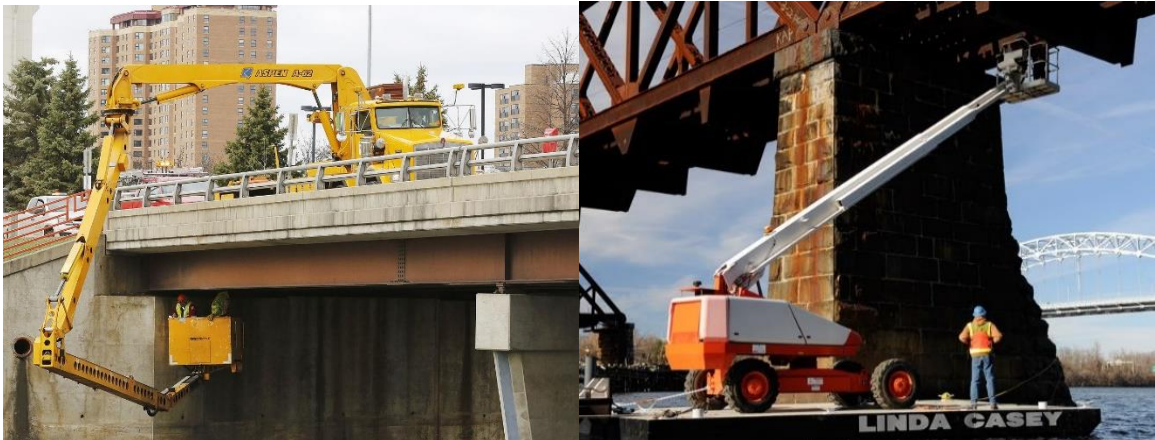
Figure 1.1. Common Aerial Work Platforms:
Snooper Truck (left) [5], Boom Lift Secured to Barge (right) [6]

The most common bridge inspection method involves the use of aerial work platforms (AWP). This includes snooper trucks and boom lifts shown in Figure 1.1, along with other under bridge inspection vehicles that allow the inspector to examine each element of the bridge’s structural system. Each of these AWP provide specific benefits which allow them to be more economical in different situations. Snooper trucks provide access to the underside of the structure over the side of the bridge. This is particularly useful on narrow bridges in which the articulated arm can provide the reach necessary to extend to the center of the bridge. Situations where the area beneath the superstructure of the bridge is inaccessible also encourages the use of snooper trucks. When spans are wide and the bridge underclearance allows for it, boom lifts, or boom trucks, may be used to perform the inspection. The lifts on these vehicles can provide access from the ground surface, while also having the option to be secured to barges for bridge inspections over waterways.

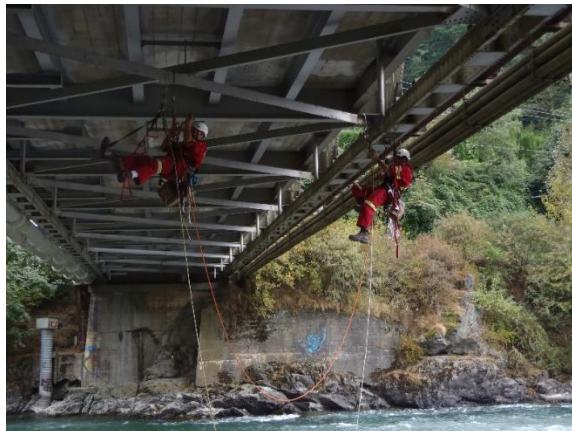
Figure 1.2. Rope Access Bridge Inspection [7]

Rope access is another method of bridge inspection (Figure 1.2). This method involves certified rope access professionals using climbing equipment to repel below the bridge. It is typically used when snooper trucks and boom lifts are not able to approach the bridge superstructure. Using rope is also a common technique for large, above deck supported bridge types including over truss, tied arch, suspension, and cable stayed bridges.

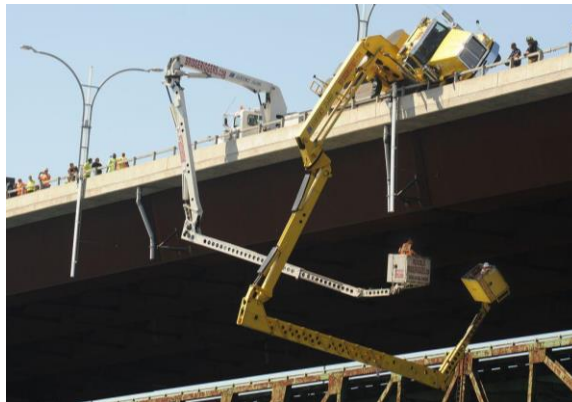
Figure 1.5. Snooper Truck Tipped Over onto Siderail [9]

involving vehicles, machinery, and improper safety measures. Climbing equipment may break while beneath the bridge and boom and snooper trucks can tilt or break while inspectors are in the bucket due to the large moment created during full extension (Figure 1.5). Health concerns also arise while inspecting below the deck due to the potential buildup of mold and fungus as well as animal droppings which typically must be disturbed and removed in order to clearly see the bridge elements. Removing bridge inspectors from these hazardous areas is the most efficient way to mitigate these risks. Using drones would allow inspectors to remain safe at a control station without placing themselves in a potentially harmful situation.

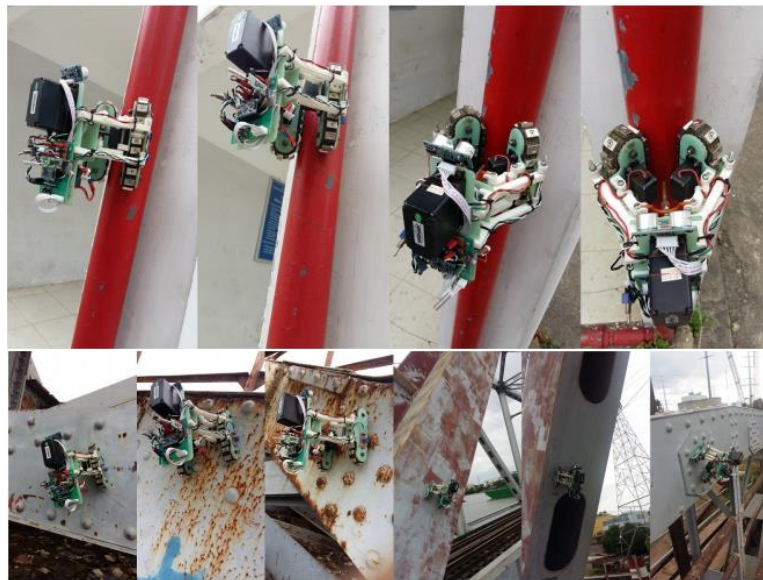
Figure 2.7. Crawling Drone V2 Field Test Structures [18]

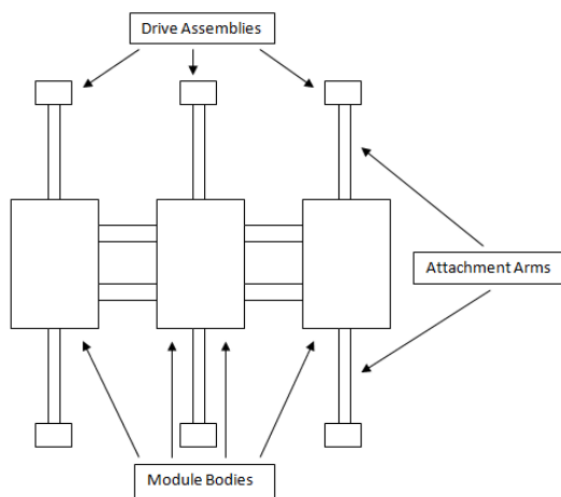
Figure 2.8. University of Virginia Drone Outline [19]

Magnetism has its advantages, but it also comes with its own set of problems. The first is clear; the structure must be magnetic. Concrete, wood, and other structures do not apply to these designs. Magnetism relies heavily on distance, condition of the metal surface, and frictional values. That means if the force created is overcome or reduced for any reason: overturning moments from large payloads, environmental factors like wind, ice, debris, or heavily corroded surfaces, the drone could detach from the surface. This would cause almost instant and potentially catastrophic failure. Because of this, a design was conceptualized by the Center for Transportation Studies at the University of Virginia [19]. This robotic platform had three major design elements as shown in Figure 2.8. The module bodies were the main components of the drone which contained the power supply, control mechanisms, and radio equipment. The drive assemblies allowed for the attachment to the beam flanges and would give the drone the ability to traverse along the girder system. The front and back wheels attached above the flange while the middle wheel provided a vertical force to the underside of the flange adding stability and security. Each of these wheels could be independent, able to detach and reconnect as the drone encountered obstacles like shear stiffeners. This conceptual design was rather large compared to the other drones in this literature review. With an approximate length of 1.83 m (6.0 feet) and a width of 1.52 m (5.0 feet), the design spanned between two girder flanges. The module system would be placed in three separate parts due to the potential weight of the drone. In this location, the drone also needed to avoid lateral bracing located on typical steel girder construction which runs from girder to girder. Connecting the arms and wheels towards the top of the module bodies helped to avoid this. The main concerns that arose with this conceptualization were size, weight, and initial placement of the system.

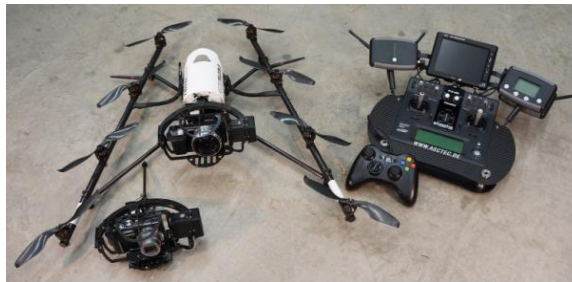
Figure 2.9. BUW Falcon Photo UAV [20]

2.3.2. Unmanned Aerial Vehicles. A conference paper written by Norman Hallermann and Guido Morgenthal examined the use of a BUW Falcon Photo UAV (Figure 2.9) produced by Ascending Technologies as a bridge inspection drone [20]. Due to being released prior to FAA regulation Part 107, the drone was limited to 5 kg (11.02 lbs). Eight rotors in a V-shaped configuration gave flight capability to the drone creating a maximum takeoff weight of 2.2 kg (4.85 lbs). With built-in redundancies, failure of up to two of the motors was possible without affecting the stability of the craft. The stability, accuracy of position, and orientation of the flight system was created using eleven different sensors including accelerometers, a gyroscope, a compass, and a barometric altitude sensor. Global Positioning System (GPS) monitoring with an inertial measurement unit also allowed for stable flight in winds up to 12 m/s (26.8 mph). With a standard payload of 650 g (1.43 lbs), this drone was limited to small, compact camera attachments. With the complete system being fueled by an 8000 mAh battery pack, the UAV was designed for an estimated flight time of 18 minutes with the standard payload. Through the GPS software installed on the

BUW Falcon Photo, pre-planning of semi-autonomous flight missions were possible. The ability to create a pre-determined path using existing data allowed for automatic data acquisition which could be highly efficient by reducing the potential for locations where the cameras failed to photograph, also known as “dead zones”.

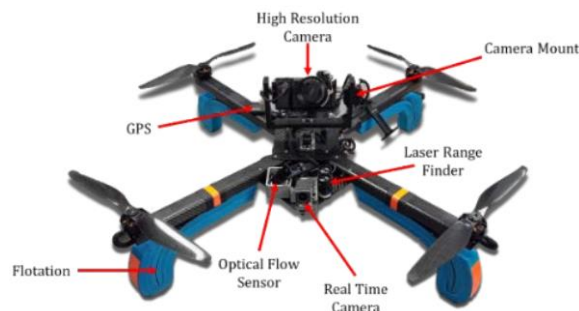
Figure 2.10. Dr. Bridge et al. Inspection Drone Design [22]

maneuverability than a hexacopter according to the study. A camera was mounted above the drone for maximum visibility along with a laser range finder for position control and crash avoidance. The camera could be independently controlled using a servo motor but, due to the brush motors chosen for the rotor system, the video tended to be shaky. Brushless motors would have increased stability, but also increased weight, therefore decreasing flight time and payload. Even without stabilization, the camera provided enough clarity for inspectors to spot deficiencies. An optical flow sensor, similar to those found in wireless computer mice, was used to track positioning. The sensor was faced upward at the bridge deck rather than down below where water passing beneath the bridge could affect position. This sensor allowed the drone to automatically hold its position while the camera could be rotated to examine the bridge structure. Unlike the other drones discussed in this literature review, Dr. Bridge and Ifju also examined the concern of “what if it crashes”. Since the bridges examined in the study were over water, the landing gears were retrofitted with polyethylene foam to increase the buoyancy of the vehicle. This also provided a dampening effect if the drone were to crash on a hard surface.

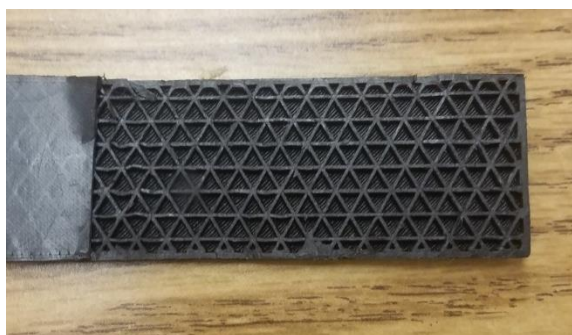
Figure 3.1. 3D Printed Triangular Infill

All drone parts and lab test specimens were printed using a Markforged Mark Two. Specified printer settings are located in Table 3.3. Each of these values were chosen as a starting point for testing purposes. If the material application needed more strength, settings could be changed, and material properties found in Section 4.1 could be reevaluated. The triangular infill pattern shown in Figure 3.1 was specifically chosen due to a triangle's inherent structural stability while reducing the amount of material used on the drone.

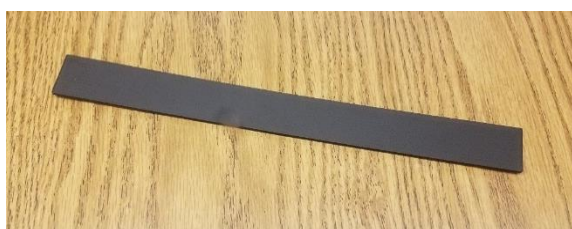
Figure 3.5. Tensile Specimen

Onyx was considered a random-discontinuous fiber orientation and therefore specimens were printed with the recommended geometry. Tabs, ends which are thicker than the central gage area, were not directly required for the fiber orientation. They may be implemented if specimen failure occurred near the grips (<1 specimen width), but this issue did not occur as shown in the results. To determine the area of each printed specimen, width and thickness measurements were taken at three locations and averaged. In order to be determined as valid, width tolerance was required within 1% (± 0.25 mm (± 0.01 in)) of the intended value and thickness was required by ASTM D3039 to be within a 4% tolerance (± 0.1 mm (± 0.004 in)). The tensile specimen used is shown in Figure 3.5.

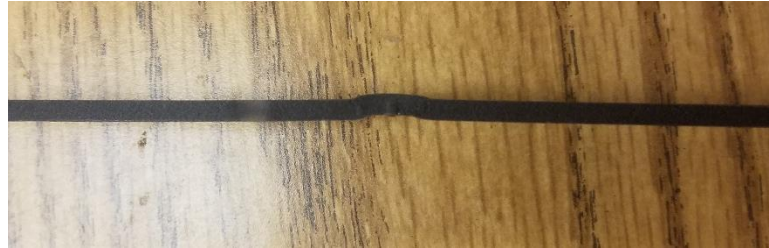
Figure 3.9. Recommended Geometry Visual Buckling

specimen was increased until the final dimensions shown in Table 3.6. These dimensions gave adequate percent bending results as discussed in Section 4.1.2.

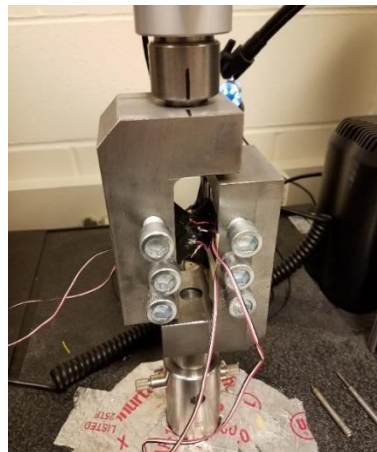
Figure 3.13. Complete Shear Test Setup

Strain gages were then zeroed using the data acquisition system before inserting the specimen into the second half of the fixture to capture any strain bending resulting from the complete test set up. The shear fixture was then placed in the Instron machine (Figure 3.13) and the constant head-speed was performed. Data was recorded at a rate of two readings per second as suggested by ASTM D7078. Failure should occur within the gage section and not at the point of an obvious specimen flaw.

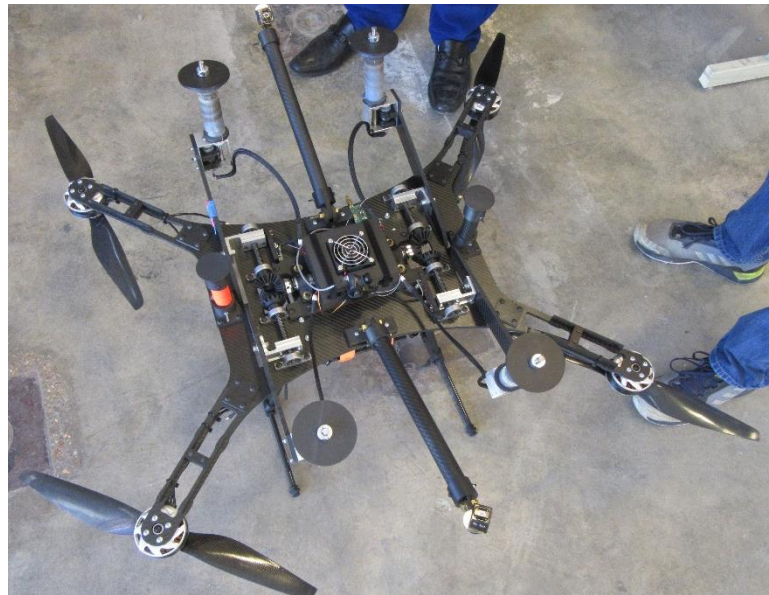
Figure 4.3. BridgeBot Mobile Platform Prototype

The proposed design took flight using four brushless DC outrunner motors, each providing approximately 67 N (15 lbs) of thrust. By simply switching the 47.0 cm (18.5-in) propellers for 54.6 cm (21.5 in), the system could be increased to nearly 98 N (22 lbs) of thrust. The objective was to maintain a minimum 2:1 ratio of thrust to drone weight for flight stability. Rotors were attached by four carbon fiber plate arms which were secured directly to the drone’s carbon fiber frame. Support walls were also added to these arms to increase rigidity during takeoff when forces were the greatest on the rotor arms.

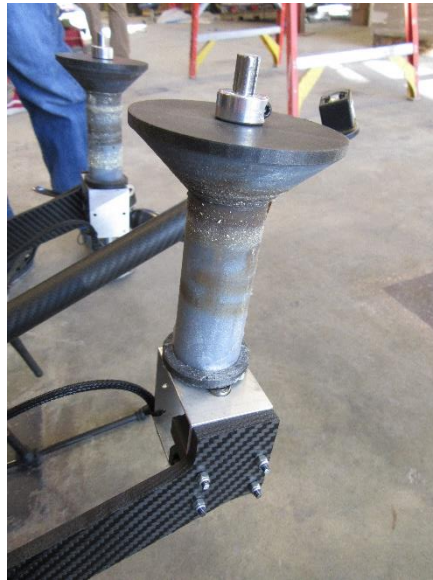
Figure 4.5. 3D Printed Onyx Wheels

At the end of each clamping arm were the grips which also acted as the BridgeBot traversing mechanisms. These 3D printed Onyx wheels (Figure 4.5) were each powered by their own DC motor. The wheels were overlaid with a with a flexible urethane coating to increase the coefficient of friction against the beam to help with stability during inspection. In order to pass flange splice plate connections, the wheels required the ability to roll over a connection plate. The introduction of an inverted conical portion to the top of each wheel allowed the drone to ride up onto the connection plate while traversing along the bridge girder and keep the flange towards the center portion of the wheel.

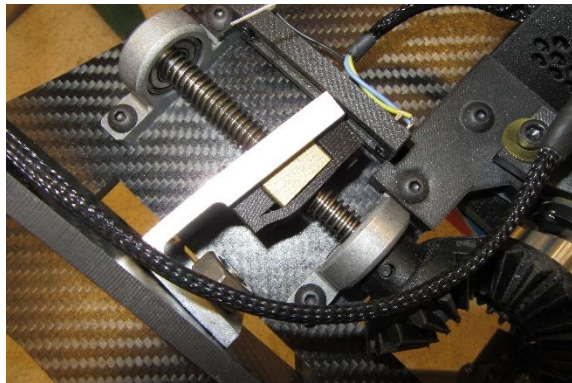
Figure 4.11. Delamination of Onyx Material at Lead Screw Bracket

For the first dataset, damage began to occur rather early in testing. Due to the force created by the lead screw on the traversing bracket, the Onyx portion began to delaminate (Figure 4.11). To confirm the results, the drone was rotated, and the test was performed on the second clamping mechanism. Crack initiation began at approximately 67-89 N (15-20 lbs), but it was chosen to continue the test due to the location of the damage. It was assumed that though delamination was occurring, the screws which attach the small Onyx bracket to the L-shaped aluminum bracket would limit the crack width as was seen at test completion. Testing was terminated at approximately 200 N (45 lbs) due to the large deflection of the wheel gearbox (Figure 4.12). It was decided that flipping the brackets would drive the Onyx material into compression and would be a simple solution for a second round of testing.

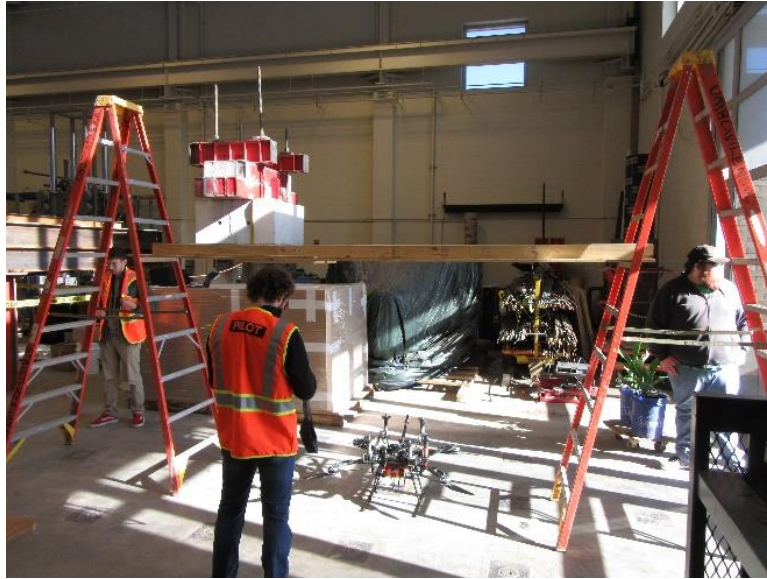
Figure 4.14. Complete System Test Laboratory Setup

Several conclusions were made from the results of the complete system test. Concerns mentioned in Section 4.2.2.1 regarding the rotor arms were apparent during the initial takeoff, while rotors were throttled against the base of the test fixture, and during landing. Undesired flexing occurred at the cantilevered connection of the rotor arm to the main frame and at the ends of the slits in the frame which was cut for the clamping mechanisms. This did not hinder the flight capabilities, but it did cause a slight bouncing motion to occur during takeoff and cause the wires to disconnect as mentioned above. Though clamping force was not analyzed while traversing the setup, large deflection of the wheels was not seen compared to the clamping test at high loads. Therefore, it could be assumed that the clamping mechanism can provide more than the minimum force necessary to clamp onto a girder and perform an inspection. Using a position-controlled clamping mechanism without yet establishing a relation between flange sizes and a position on the remote controller did not cause an issue during the test but being within a close distance to the lab setup made this a possibility. On full size structures, this would not be an option. If the size of the girder is unknown, a position-controlled sensor would also not be as efficient.

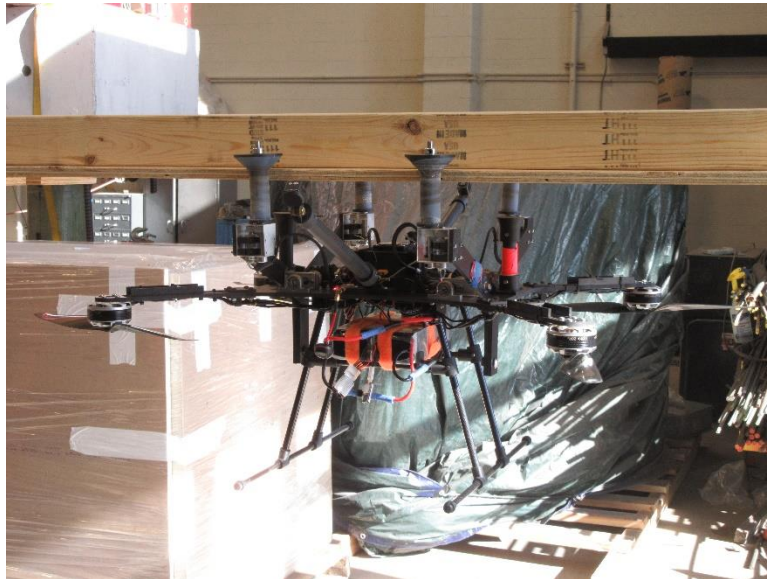
Figure 4.15. Fully Engaged Clamping System
