Foundations Performance of Large Diameter Tanks

Proceedings: Fourth International Conference on Case Histories in Geotechnical Engineering, St. Louis, Missouri, March 9–12, 1998.

FOUNDATION PERFORMANCE OF LARGE DIAMETER TANKS

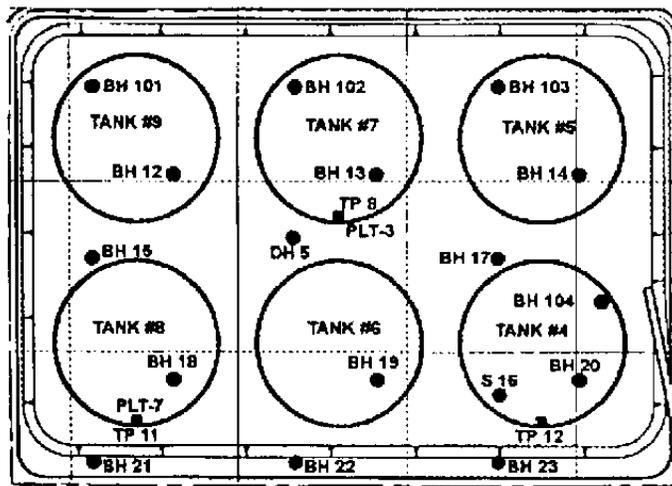
Fig. 1 Process water and fuel oil tank farms

The six floating roof fuel oil tanks are 60 m in diameter and 15 m high and are located immediately south of the existing power plant. The six fixed roof process water tanks are 96.8 m in diameter and 20 m high and are located east of the new power plant, several hundred meters north of the fuel oil tanks and immediately north of the existing power plant. The layouts of these two tank farms are shown on Fig. 1, which also includes information to be referenced in subsequent sections. (It should be noted that Fig. 1 shows the layout of the two tank farms together to save space in this paper. The tank farms are actually several hundred meters apart, as indicated above.)

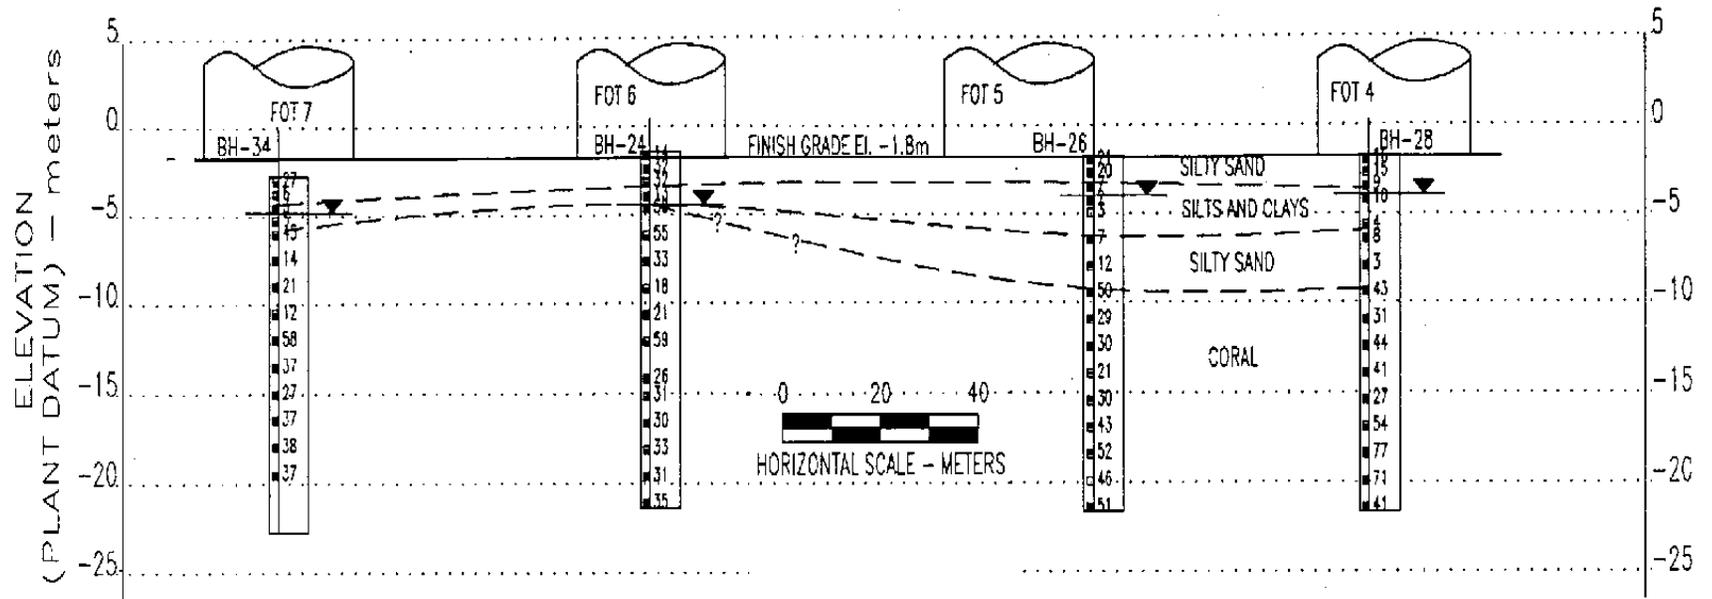
Fig. 2 FOT area subsurface profile

Subsurface conditions disclosed by SPT borings drilled at the fuel oil tank farm area are illustrated by the typical subsurface profile shown on Fig. 2. Also included on Fig. 2 are typical fuel oil tanks and final grade information. The stratigraphy includes a 2-m thick upper layer of generally loose to medium dense, fine, silty sand underlain by about 2 m of generally soft to medium stiff silts/clays. Another 4 m of silty sands are encountered beneath the clay layer on the western portion of the fuel oil tank farm. Intermittent ledges of coralline limestone are encountered in a generally dense sand matrix beneath the silty sand (8 m depth) and silts/clays (4 m depth.) This sand layer with coralline limestone is identified as the coral layer on Fig. 2. SPT refusal was often encountered in the coralline limestone, which was then cored. Ground water was encountered at a depth of about 2 m below existing grade at the time of drilling. Laboratory consolidation tests on representative, undisturbed samples of the silt/clay layer disclosed the following typical values: OCR = 2.3, CR = 0.21, RR = 0.03 and $c_v = 4.2$ m²/yr.

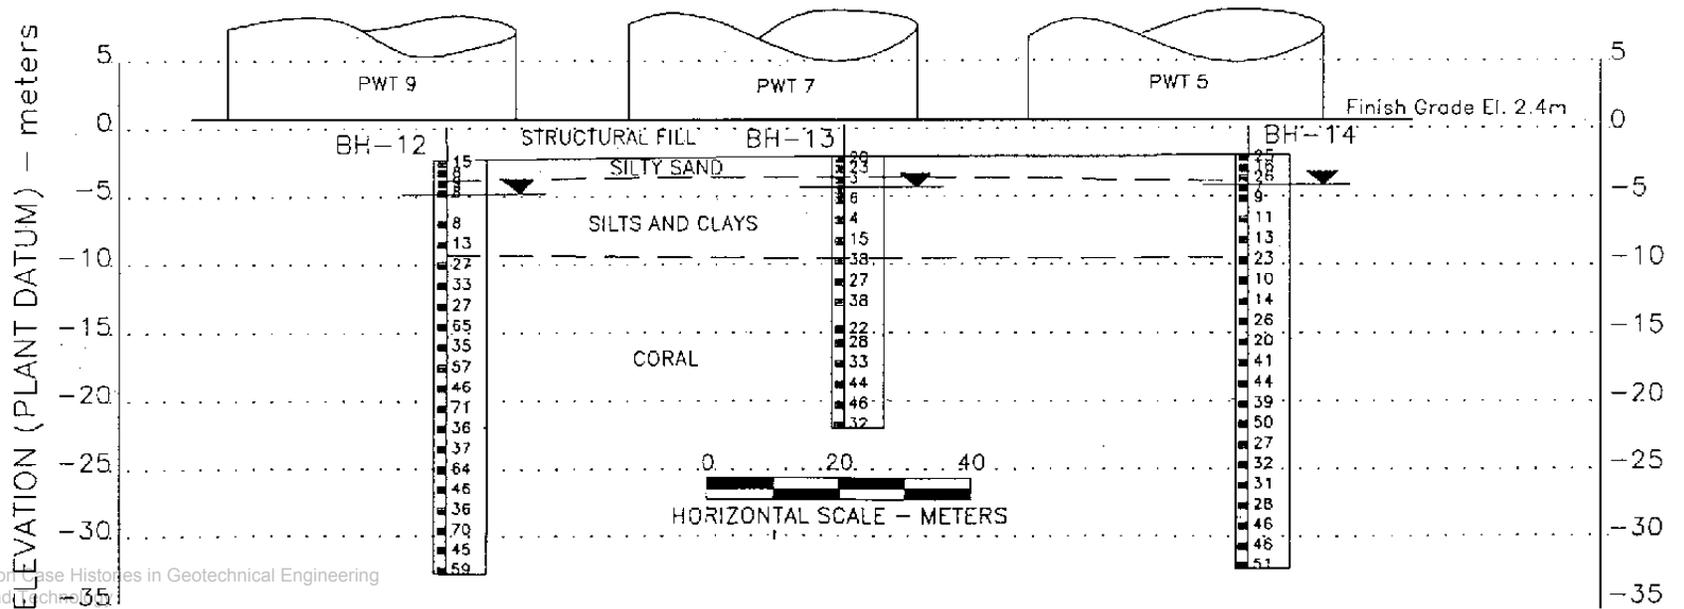
Fig. 3 PWT area subsurface profile

Subsurface conditions disclosed by SPT borings drilled at the process water tank farm area are illustrated by the typical subsurface profile shown on Fig. 3. Also included on Fig. 3 are typical process water tanks and final grade information. The stratigraphy is similar to that encountered by the SPT borings drilled at the fuel oil tank farm area, except that the coral layer is consistently encountered at a depth of about 8 m below grade. Ground water was encountered at a depth of about 2 m below existing grade at the time of drilling. Laboratory consolidation tests on representative, undisturbed samples of the silt/clay layer disclosed results similar to those at the fuel oil tank farm area.

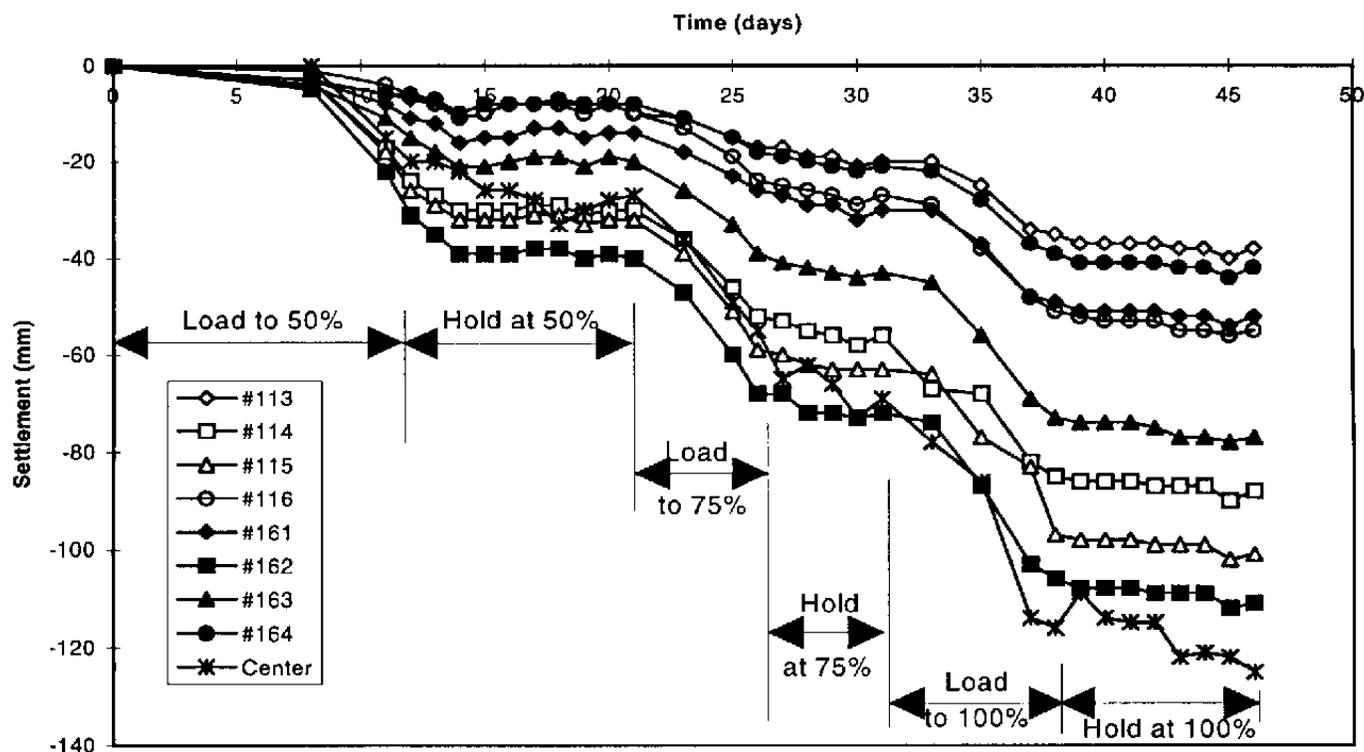
Fig. 5 Time vs. settlement curve for fuel oil tank No. 4

The time vs. settlement curves for the eight settlement markers located along the sides and at the center of FOT #4 are shown in Fig. 5.

The data in Fig. 5 indicate that the maximum settlement at the edge of FOT #4 was 111 mm and the minimum settlement was 38 mm. The average settlement along the edge of the tank was about 71 mm, which is larger than the predicted 55 mm but well within tolerable limits. The data in Fig. 5 also show how quickly the settlements stabilized after loading stages were reached. Based on these results, the hydrotesting procedure was changed to allow holding the 100 percent load for a period of no more than 2 weeks for the remaining fuel oil tanks.

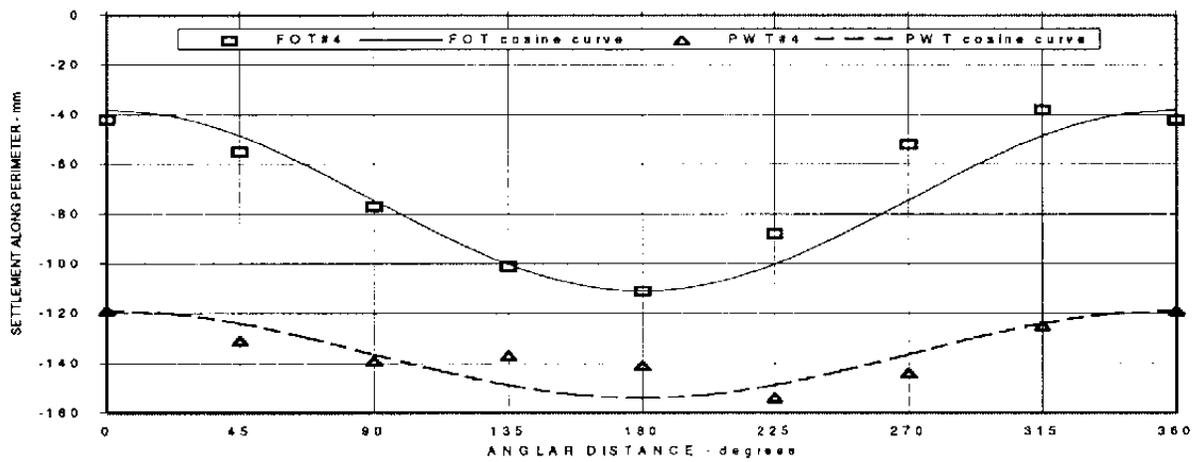
Fig. 6 Out-of-plane distortion

Figure 6 shows a plot of settlements for equally spaced markers located along the perimeter of FOT #4 and PWT #4 at the end of hydrotesting under 100 percent load. The figure includes a continuous cosine-shaped curve that would represent a perfect tilt of the tank and actual settlement measurements that are represented by hollow squares. The vertical distances between the hollow squares and the continuous curve represent out-of-plane differential settlements at the settlement marker locations.

The data in Fig. 6 indicate that the maximum out-of-plane differential settlement for FOT #4 was about 23 mm. The maximum out-of-plane distortion was about 1/2,100, or 0.047 percent. This value is about five times smaller than the 0.22 percent allowable.

The data in Fig. 6 indicate that the maximum out-of-plane differential settlement for PWT #4 was 13 mm at the southern side of the concrete ringwall footing. The maximum out-of-plane distortion was about 1/400, or 0.025 percent. This value is more than 8 times smaller than the allowable.

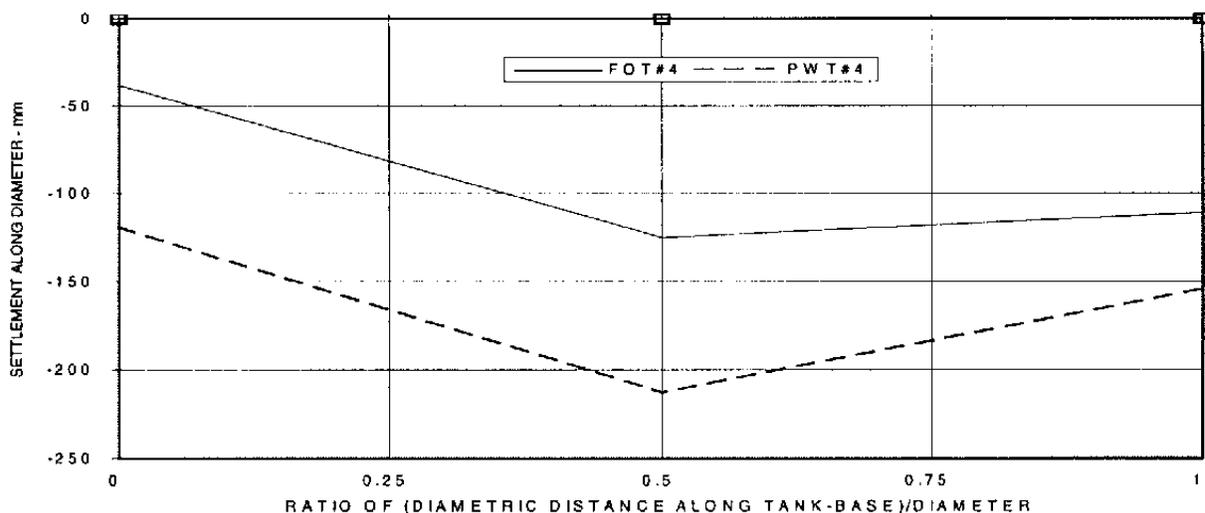
Fig. 7 Center-to-edge distortion

Figure 7 shows a plot of settlements of two points on the perimeter where maximum and minimum edge settlements were measured, as well as the center of tank settlement for FOT #4 and PWT #4. The data in Fig. 7 indicate that the maximum edge-to-center differential settlement for FOT #4 was 87 mm. The maximum edge-to-center distortion was about 1/870, or 0.29 percent. This value is more than 6 times smaller than the allowable.

The center-of-bottom-plate settlement shown in Fig. 7 was calculated based on the settlement analysis results and edge settlements shown in Fig. 8 (the settlement marker at the center of the bottom plate was damaged, as shown by readings on Fig. 8). The data in Fig. 7 indicate that the maximum edge-to-center differential settlement for PWT #4 was 94 mm. The maximum edge-to-center distortion was about 1/515, or 0.19 percent. This value is more than 10 times smaller than the allowable.

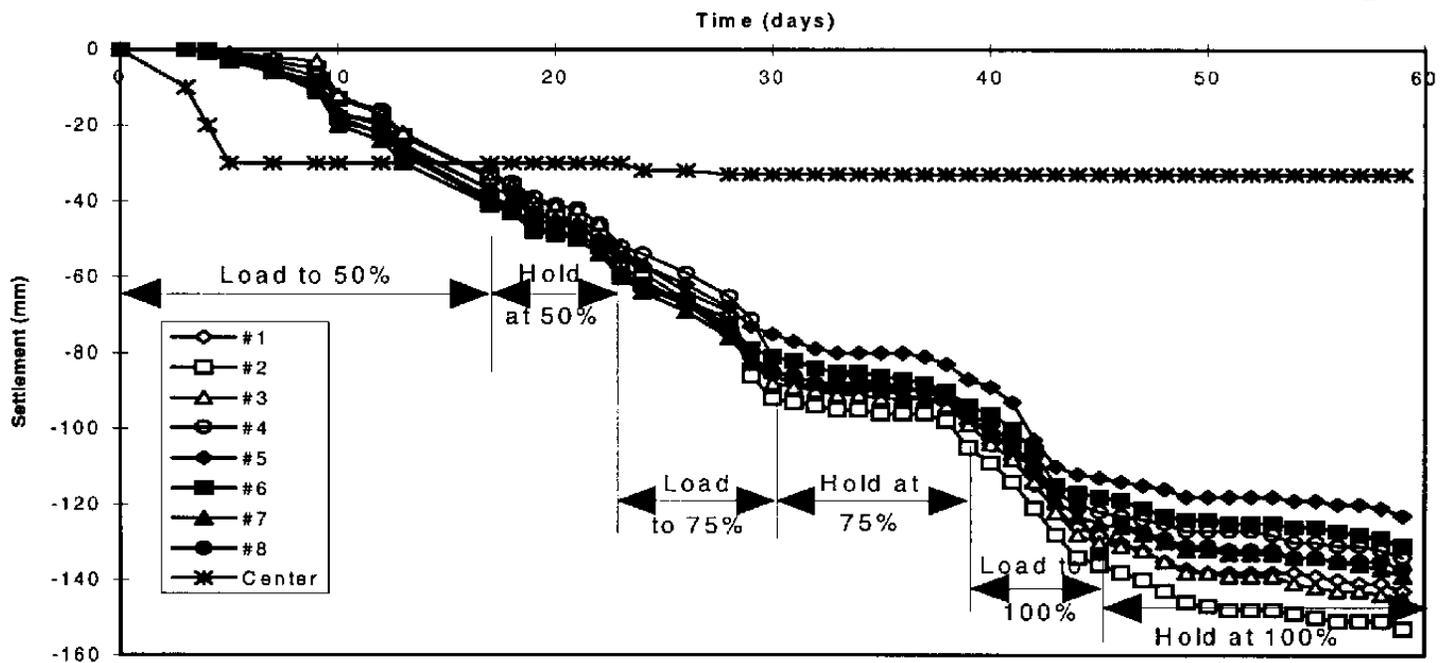
Fig. 8 Time vs. settlement curve for process water tank No. 4

The time vs. settlement curves for the eight settlement markers located along the sides and at the center of PWT #4 are shown in Fig. 8. It can be observed that the settlement marker placed at the center of the tank was damaged while filling the tank to 50 percent capacity. Also, the holding period at 50 percent loading did not fully stabilize before the tank was filled to 75 percent capacity.

The data in Fig. 8 indicate that the maximum settlement at the edge of PWT #4 was 154 mm and the minimum settlement was 119 mm. The average settlement along the edge of the tank was about 136 mm, which is almost identical to the predicted 140 mm and well within tolerable limits. The data in Fig. 8 also show how quickly the settlements stabilized after the 75 percent and 100 percent loading stages were reached. Based on these results, the hydrotesting procedure was changed to allow holding the 100 percent load for a period of no more than 2 weeks for the remaining process water tanks.
