Analysis of the Behavior of the Piled Foundations of a Group of Earthquake Damaged Buildings

Francesco Castelli
University of Catania, Italy

ANALYSIS OF THE BEHAVIOR OF THE PILED FOUNDATIONS
OF A GROUP OF EARTHQUAKE DAMAGED BUILDINGS

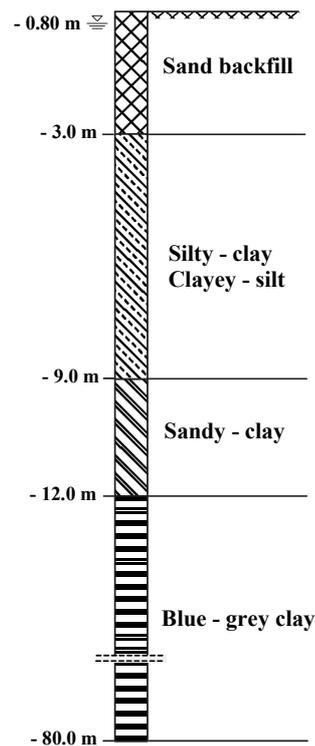
The investigated area has plane dimensions of 4100 m² and a maximum depth of 80 m. The upper deposits mainly consist of alternating layers of grey-silty-clay and sandy-clay. Layers of sand were found at depths of between 9 and 12 m. The lower deposits mainly consist of a medium stiff, over-consolidated (*OCR* = 2.0 to 6.0), marine clay with low to medium plasticity index. Figure 3 shows the soil profile versus depth of the area where the buildings are located. The water table is located at around - 0.80 meters from the ground surface.

Fig. 3. Soil profile of the examined area.

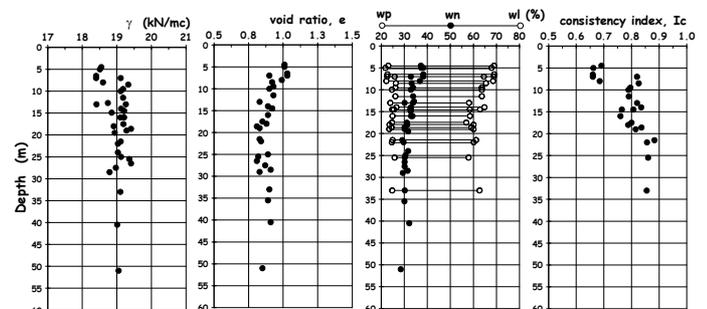
The clay fraction is prevalently in the range of between 60 ÷ 70 %. This percentage decreases to 30 ÷ 40 % at certain depths where a sand fraction of 15 ÷ 30 % and a gravel fraction of 2 ÷ 10 % are present. The silt fraction is in the range of about 25 ÷ 40 %. The values of the natural moisture content w_n prevalently range between 30 and 35 %.

Characteristics values for the Atterberg limits are: $w_l = 60 ÷ 65$ % and $w_p = 22 ÷ 26$ %, with a plasticity index $PI = 30 ÷ 40$ %. Data shown in Figure 4 indicate a very high degree of homogeneity of the soil deposit. This indication is also confirmed by comparing the blow counts N_{spt} obtained by the standard penetration tests (*SPT*) and reported in Figure 5, with the penetration resistance q_c derived by the cone penetration tests (*CPT*) reported in Figure 6. In this last case, the variation of q_c versus depth shows the existence of soil layers with different mechanical properties.

*Fig. 4. Soil properties derived by laboratory tests.*

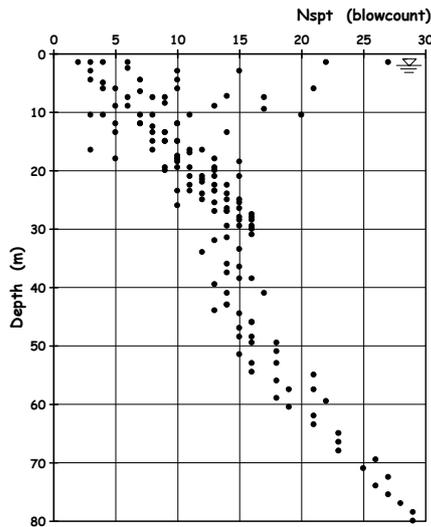
Fig. 5. Standard penetration test results.

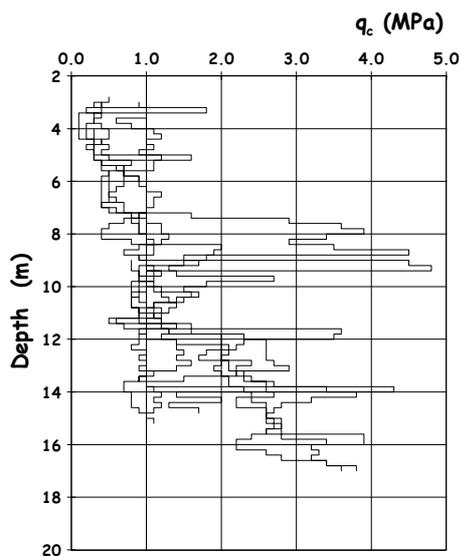
*Fig. 6. Cone penetration test results.*

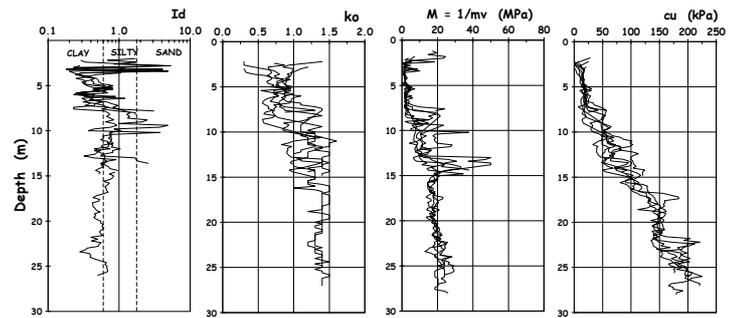
The Marchetti's flat dilatometer tests (*DMT*) were used to assess *OCR* and the coefficient of earth pressure at rest k_o (Figure 7) following the procedure suggested by Marchetti (1980). For a depth up to - 10 m from the ground surface, *DMT* results show an *OCR* ranging between 1 to 3 (k_o = 0.5 ÷ 1), showing that the upper clay deposit can be considered normally consolidated or lightly over-consolidated. For the lower clay deposit, the *OCR* values obtained by *DMT* range from 5 to 7 (k_o = 1.0 ÷ 1.5) with an average value equal to 6 up to a depth of about - 30 m.

Fig. 7. Marchetti's flat dilatometer test results.

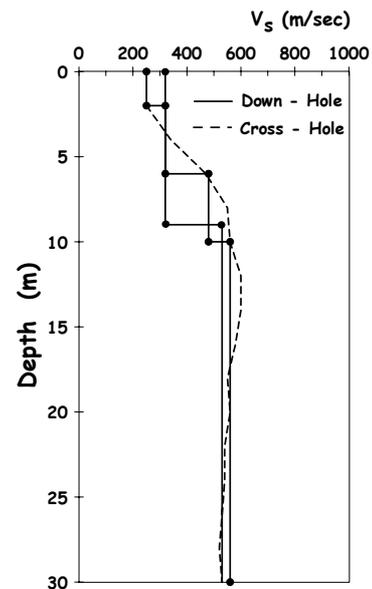
Particularly up to -10 meters from the ground surface, an average value of the shear waves velocity $V_s = 320$ m/s can be assumed.

*Fig. 8. Shear waves velocities versus depth.*

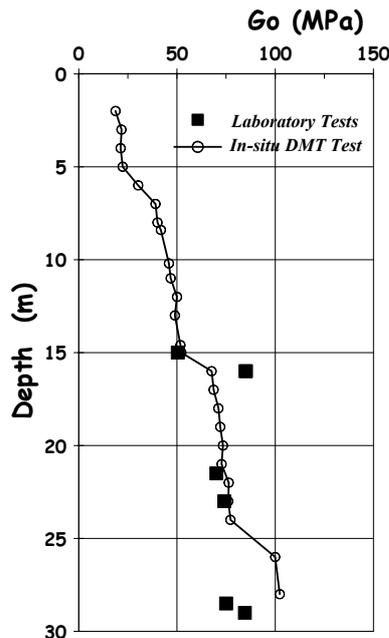
A very good agreement was observed (Figure 9) between the value of G_o determined by the laboratory tests and those derived by the following empirical correlation proposed by Hryciw (1990):

Fig. 9. G_o values versus depth.

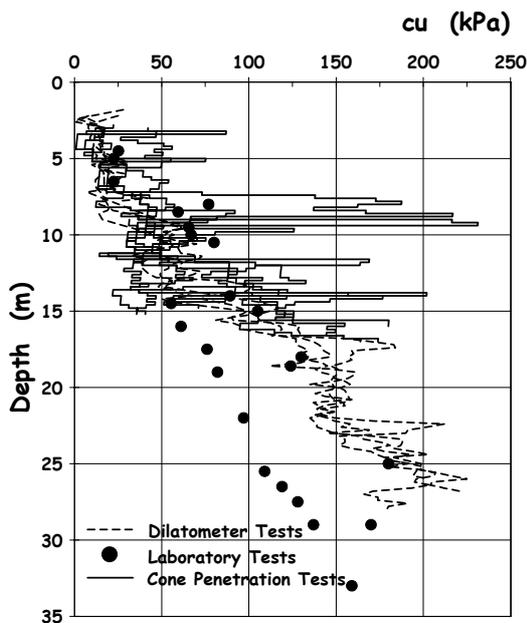
Fig. 10. Assessment of the undrained shear strength values.

and laboratory tests has been carried out (Figure 10).
To express the variation of the undrained shear strength versus depth, the following relationship was derived: c_u (kPa) = 7.5 z, where z is the depth from the ground surface.

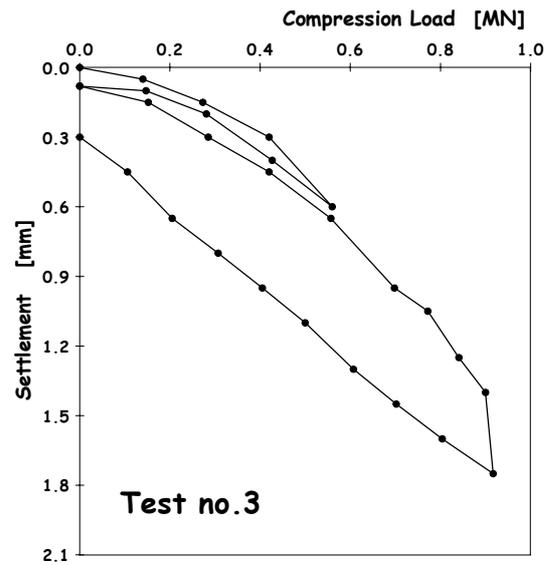
The experimental results show that the measured settlements were less 7.2 mm for the maximum load applied and less than 2.0 mm for the design load.

The residual settlement was ranging between 1.0 and 0.34 mm and the trend of the load-settlement curves derived by the load tests, named *Test no.1* (Figure 12), *Test no.2* (Figure 13) and *Test no.3* (Figure 14), shows a marked non-linear behavior of the soil-pile interaction. In particular, load-settlement curves seem to follow a hyperbolic law, then the loading curve may be analyzed by transforming the data and plotting to yield a straight-line relationship in a plane (*settlement*, *settlement/load*), the slope of which allows to estimate the ultimate failure load, as suggested by Chin (1970). The ultimate pile capacity is assumed generally equal to 90 % of the value so determined.

Fig. 12. Test no.1: Measured load-settlement curve.

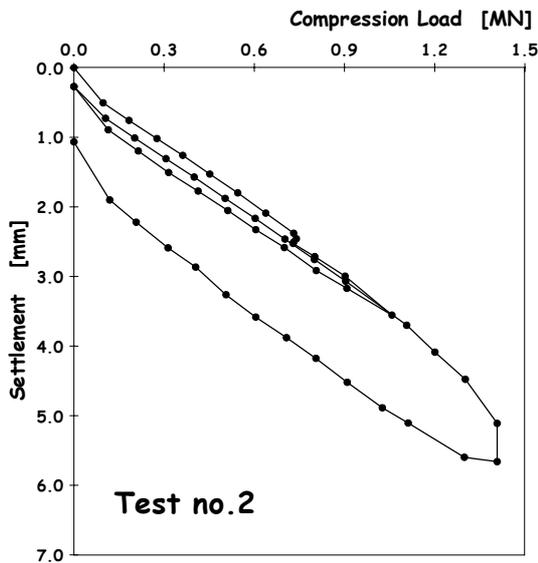
Fig. 13. Test no.2: Measured load-settlement curve.

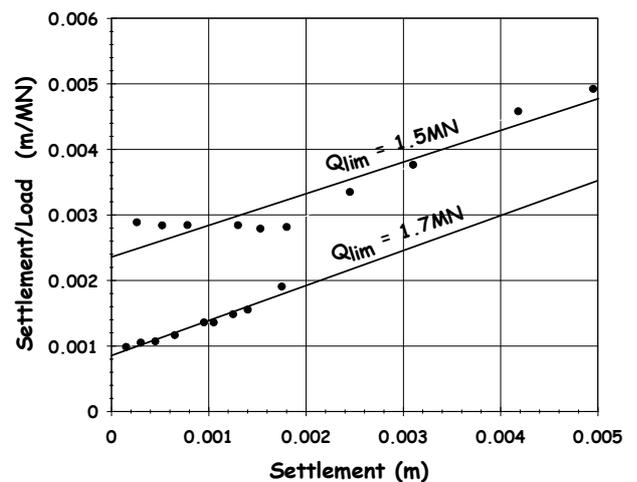
According to this procedure the ultimate failure load derived by the load tests is ranging between around 1.5 MN and 1.7 MN (Figure 15), in a very good agreement with the value of 1.53 MN computed in undrained conditions by the well-known Vesic's pile capacity relationships.

The safety factor of the soil-pile system derived by the back-analysis of the load tests is greater than 3, thus the effectiveness of the piled foundation was considered able to support axial loads, instead of the damages occurred on the structures due to the earthquake.

Fig. 15. Evaluation of the ultimate vertical failure load.

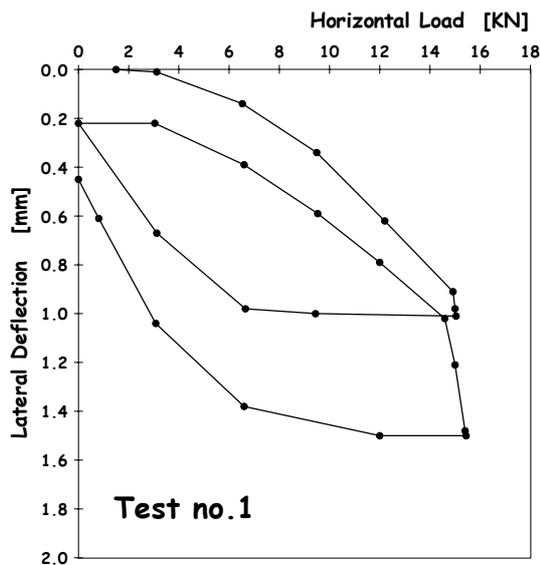
Predicted lateral responses based on dilatometer-evaluated model parameters agreed well with measured field behavior from the two lateral pile load tests. It is found that, also in the case of lateral loading, the hyperbolic representation of load-deflection curves provides an objective means to determine the ultimate lateral load capacity (Castelli *et al.*, 1995), which is comparable with the computed values based on Brom's theory. The experimental results show that the measured lateral deflection for the maximum load applied was ranging between 1.5 and 4.0 mm, while the residual lateral deflection was ranging between 0.45 and 1.3 mm. The ultimate failure lateral load derived by the hyperbolic representation of the load-deflection curve is equal to around 1.9 kN.

The ultimate failure lateral load was not able to support horizontal seismic forces for the scenario earthquake, thus a few number of piles were added to the existing piled foundations.

*Fig. 16. Test no.1: Measured load-lateral deflection curve.*

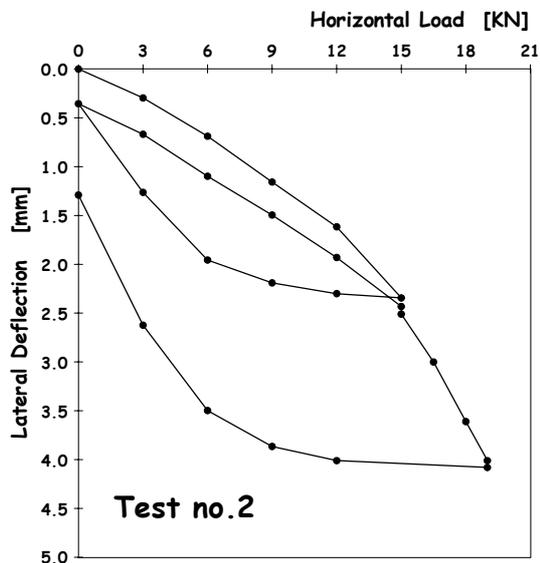
Fig. 17. Test no.2: Measured load-lateral deflection curve.
