(2004) - Fifth International Conference on Case Histories in Geotechnical Engineering

Case Studies of Pile Foundations Undergoing Lateral Spreading in Liquefied Deposits

K. Ishihara
Chuo University Kiso, Tokyo, Japan

M. Cubrinovski
Kiso-Jiban Consultants, Tokyo, Japan

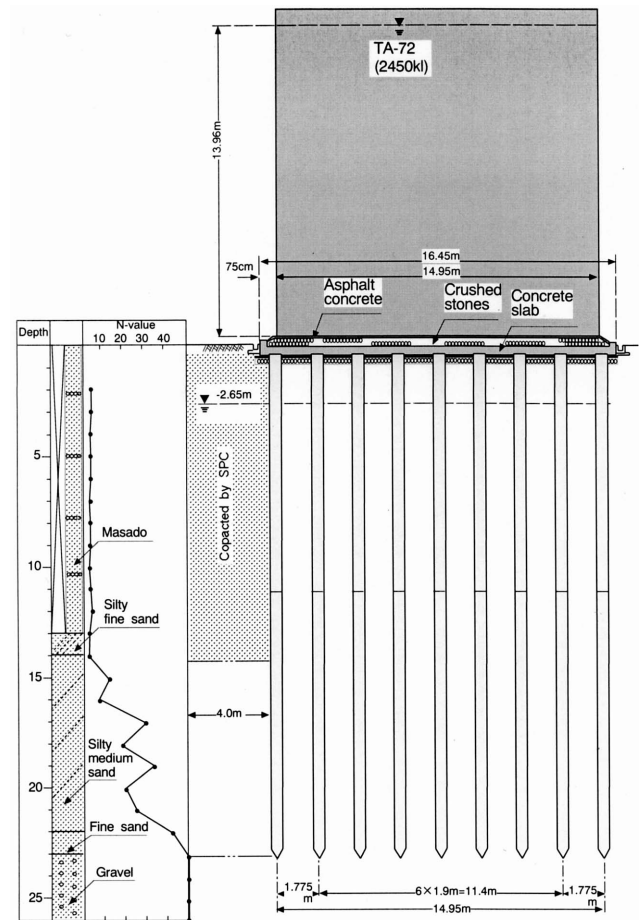
Fig. 4. Plan view of foundation

To inspect the damage to the piles, a detailed field investigation was conducted on two piles of Tank TA72. The investigated piles No. 2 and No. 9 are indicated in Fig. 4. Trenches 70 cm wide and 1 m deep were excavated at 4 sections shown in Fig. 10, and the upper portion of the pile was exposed. The wall of the cylindrical piles was cut to open a window about 30 cm long and 15 cm wide. From this window, a bore-hole camera was lowered through the interior hole of the hollow cylindrical piles to examine the damage to the piles throughout the depth. The outcome of the bore-hole camera recordings is shown in Figs. 11 and 12 for the pile No. 2 and No. 9 respectively together with the inclination of piles measured by means of the inclinometer lowered into the central hole of the pile. It may be seen in these figures that the piles developed multiple cracks and suffered largest damage at a depth of approximately 8 to 14 m, which corresponds to the

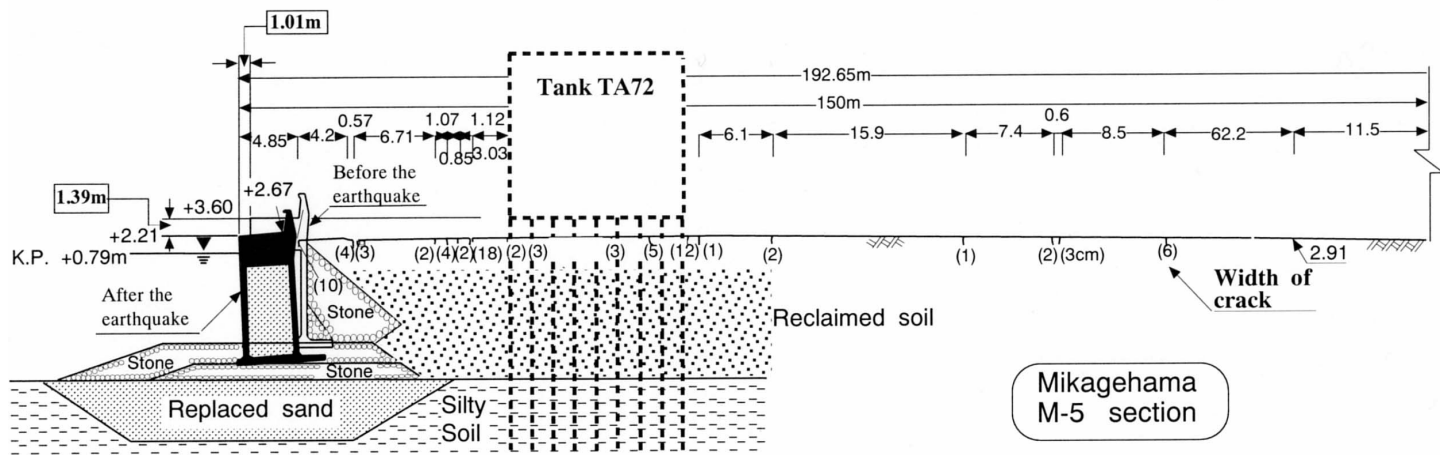
*Fig. 8. Detailed profile of the quay wall movement and ground distortion in the backfills at Section M-5*

vicinity of Tank TA72, as shown in Fig. 2. The results of the ground survey are displayed in Fig. 8 where it may be seen that the quay wall moved approximately 1 m towards the sea. The seaward movement of the quay wall was accompanied by lateral spreading of the backfill soils resulting in a number of cracks on the ground inland from the waterfront. By summing up the width of the crack openings measured along the M-5 section, the lateral ground displacement was obtained and it was plotted as a function of the distance from the waterfront, as shown in Fig. 9. As indicated in this figure, the permanent lateral ground displacement corresponding to the location of Tank TA72 is seen somewhere between 35 and 55 cm.

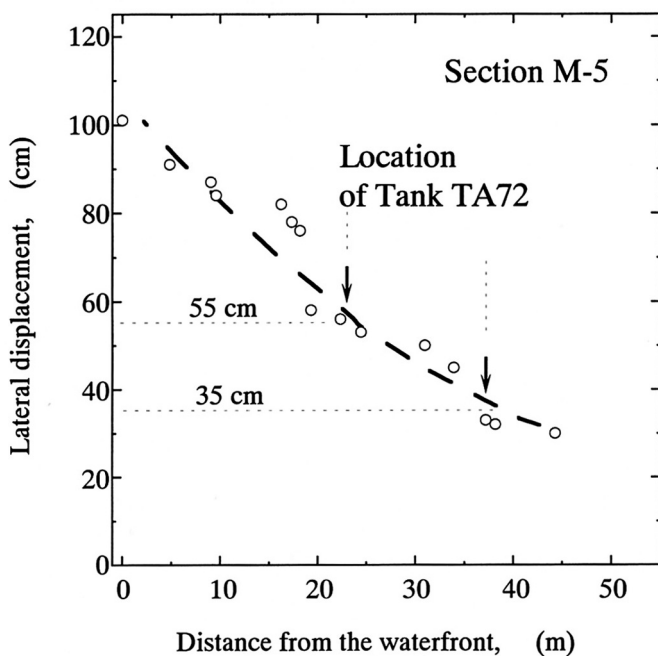
Fig. 9. Lateral ground displacement versus distance from the waterfront along Section M-5

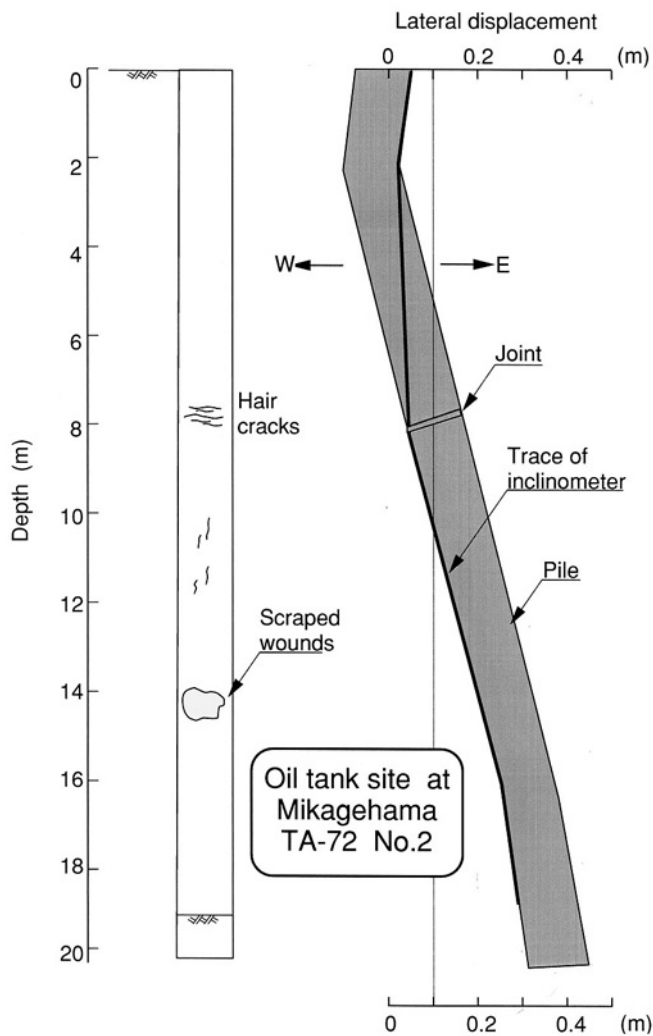
Fig. 11. Lateral displacement and observed cracks on the inside wall of Pile No. 2

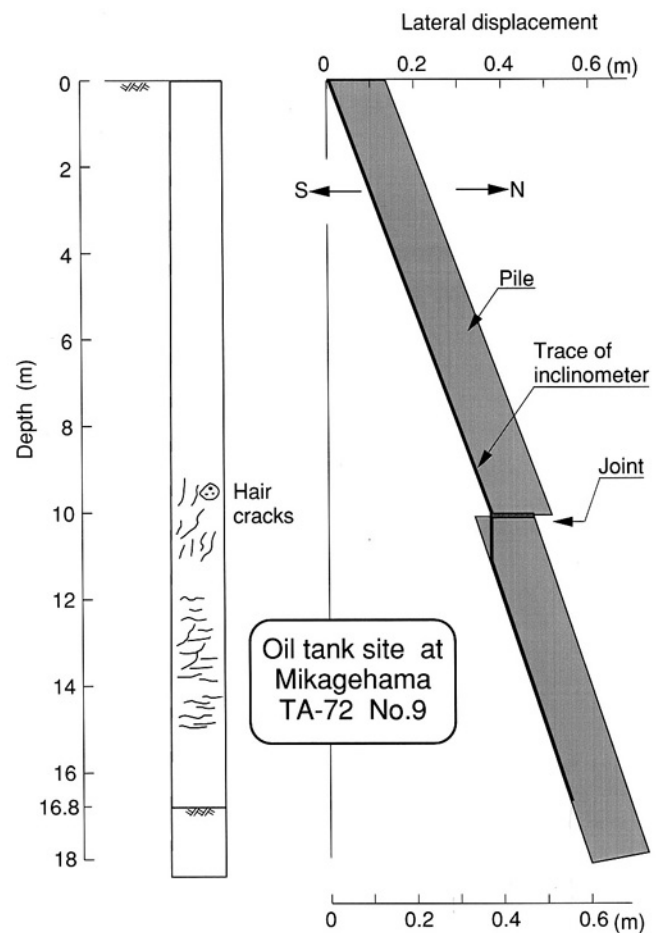
Fig. 12. Lateral displacement and observed cracks on the inside wall of Pile No. 9

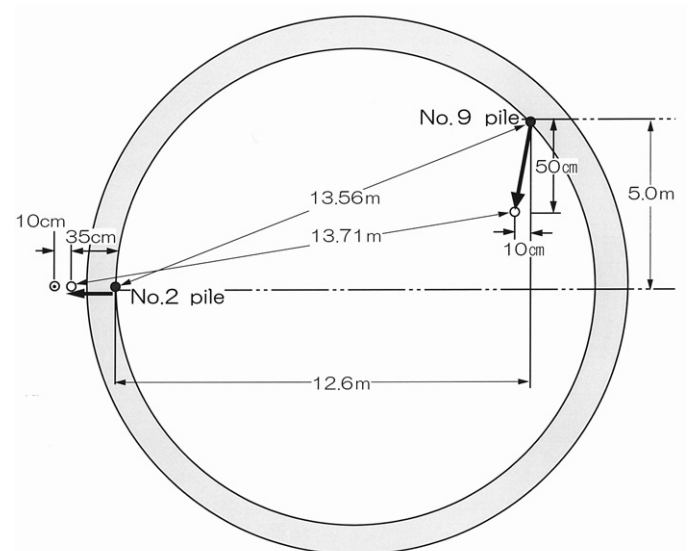
Fig. 13. Permanent lateral displacements of Pile No. 2 and Pile No. 9 at the head of the pile

depth of the interface zone between the liquefied fill deposit and underlying silty soil layer. The observed permanent horizontal displacements at the head of the piles are shown in plan-view of Fig. 13.

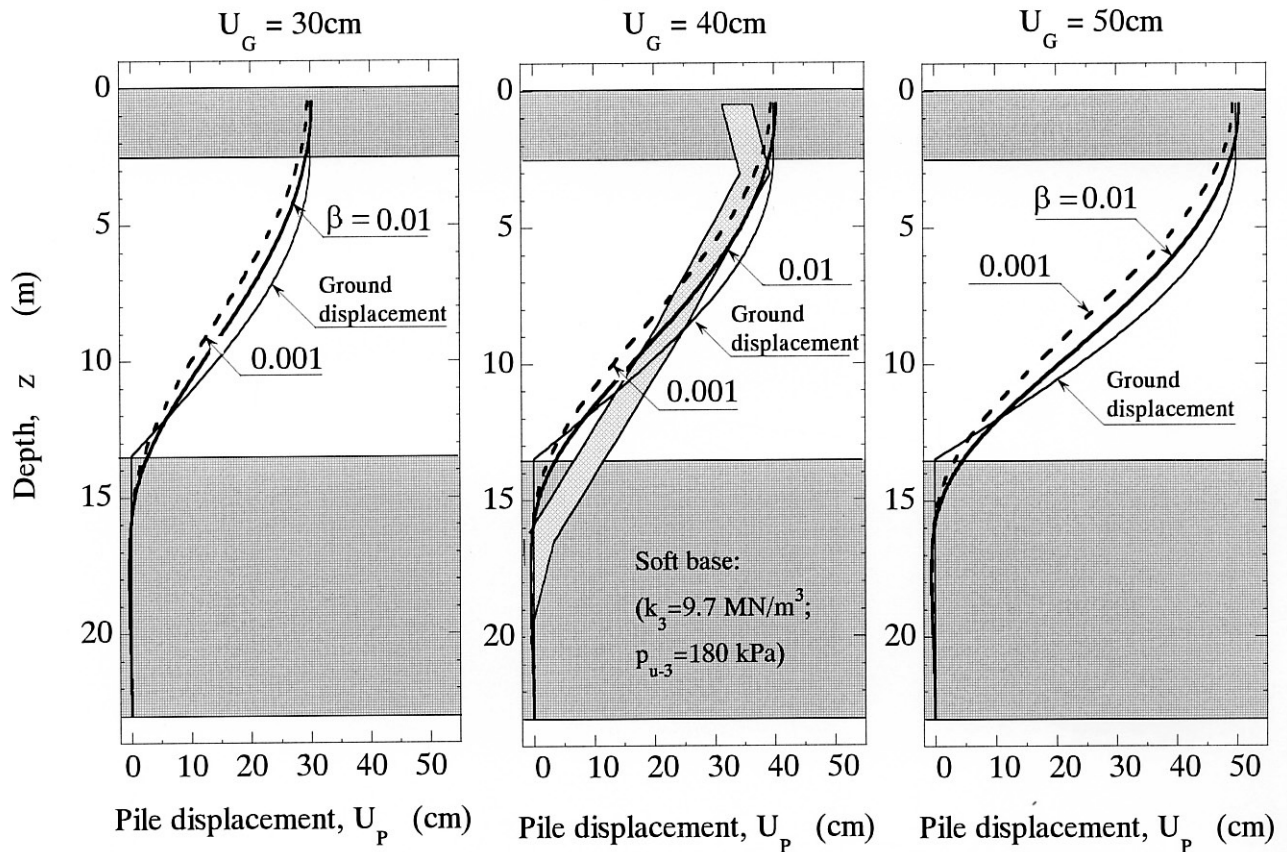
Fig. 18. Computed pile displacements in analyses with applied ground displacements of 30, 40 and 50 cm

18a through 18c for the three cases where the ground displacement was assumed as 30, 40 and 50 cm respectively. For purpose of comparison, the measured displacements of Pile No. 2 are quoted from Fig. 11 and superimposed in Fig. 18b. A reasonably good agreement between the computed and observed displacements of the pile is seen in this figure. The displacement of Pile 9 was directed almost perpendicular to the direction of the lateral flow as seen in Fig. 13. This appears to have resulted from complex interaction between the pile and the foundation slab atop.

Looking over the results of the back-calculation in Fig. 18, one can recognize that the computed displacement at the pile head is nearly equal to the applied displacement at the ground surface. The same scheme of analysis was implemented also for the case of β_2 = 1/1000. The result of this analysis is shown in Fig. 18 together with the case of β_2 = 1/100. It may be seen from the results of the analyses with β_2 = 1/100 and β_2 = 1/1000 that the pile response is not very sensitive on the value of β_2. It is important to recognize however that while the eventual pile displacements are similar for the cases of β_2 = 1/100 and 1/1000, the causative loads for the pile response are different between these two cases. Namely, in the case of β_2 = 1/100, even though the stiffness of the liquefied soil is reduced significantly, the major driving force on the pile comes from the soil in the liquefied layer. Therefore, the lateral load from

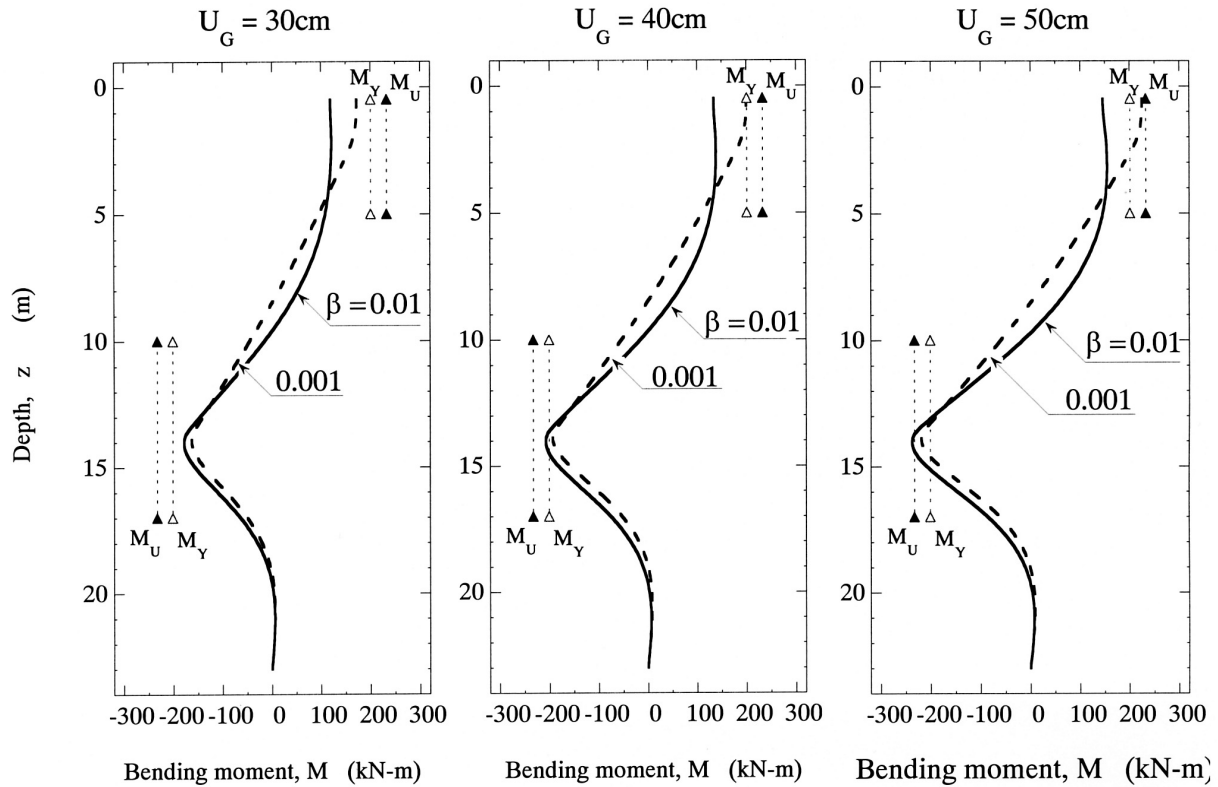
Fig. 19. Computed bending moments in analyses with applied ground displacements of 30, 40 and 50 cm

In accordance with the pile displacements as above, the computed bending moments are seen to increase with the increasing magnitude of the ground displacement as shown in Figs. 19a-19c. The maximum bending moment develops near the interface between the liquefied layer and underlying non-liquefied base layer, at depths of about 12 m to 15 m. The magnitude of the computed bending moments and their distribution throughout the depth are found to be in good correspondence with the damage to the piles observed in the field inspection as presented in Figs. 11 and 12.
