Foundation Failure Case Histories Reexamined Using Modern Geomechanics

Rodrigo Salgado
Purdue University, West Lafayette, IN

Andrei Lyamin
University of Newcastle, Australia

Jeehee Lim
Purdue University, West Lafayette, IN

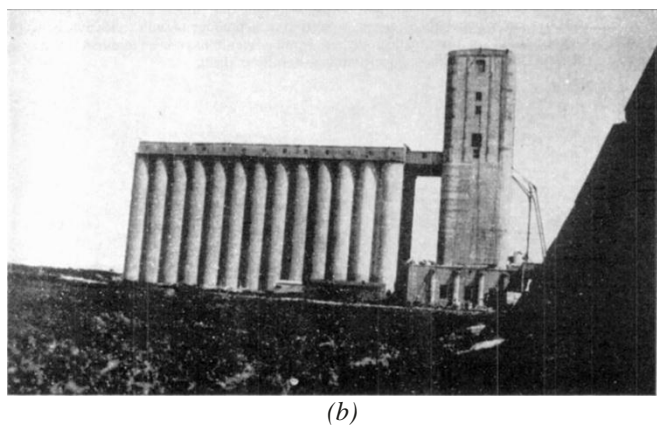
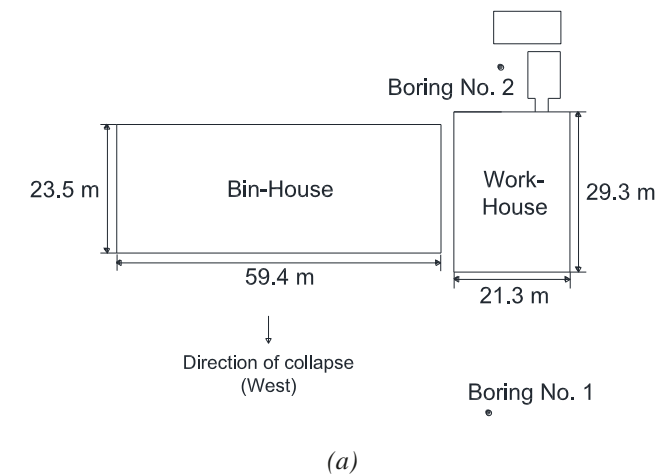
Fig. 1 The Transcona grain elevator: (a) the elevator foundation plan and (b) the structure before collapse (after White, 1953). Used with permission from ICE Publishing.

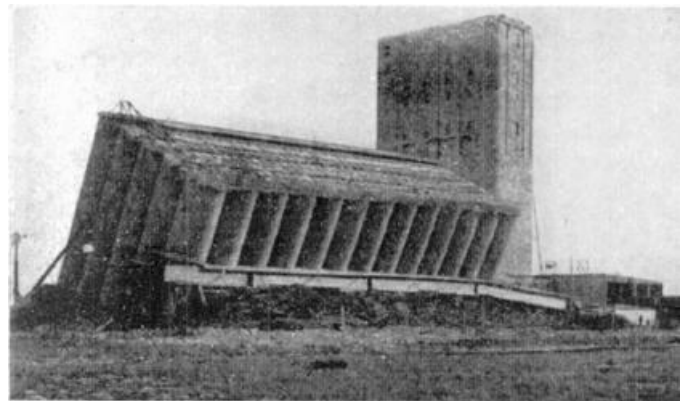
As soon as settlement started, it increased steadily, but slowly, to about 0.30 m within an hour. After that, the structure tilted toward the west during the next 24 hours until its lean was 26 degrees, 53 minutes from the vertical. A 7.5-9.0 m wide strip of ground on the east side of the bin-house bulged up about 1.2-1.5 m (except on the south side, where the work house was located), while the west side settled as much as 9 m below its original level (Fig. 2). As the photos in Fig. 1 and Fig. 2 attest, all of this happened slowly enough that White (1953) could take photographs during the event and have an accurate recollection of what happened.

Fig. 2 The collapse of the Transcona Grain Elevator (White, 1953). Used with permission from ICE Publishing.

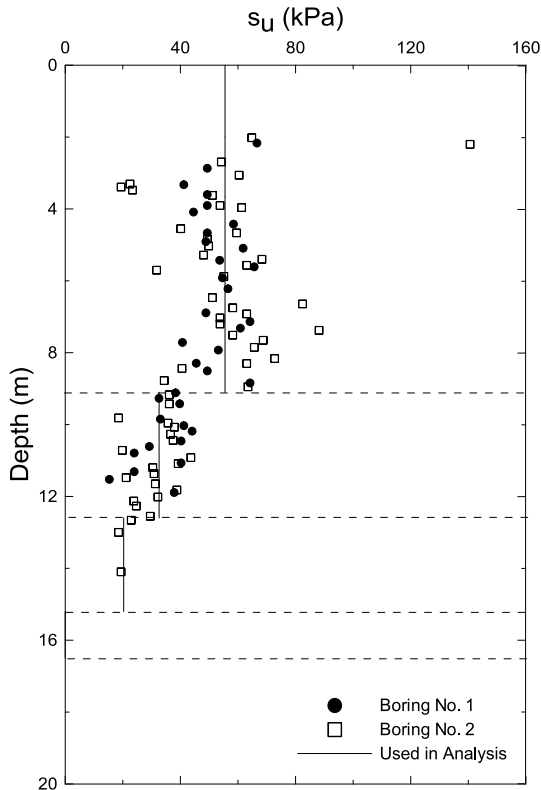
The undrained shear strength s$_u$ was assumed constant with depth within each of the layers identified in Fig. 3; the vertical lines in this figure represent the values of s$_u$ assumed in the analysis for each layer, which are given numerically in Table 2. The layer of fractured limestone was treated as a frictional material. A high friction angle, of as much as 50 degrees, would likely be appropriate for the fractured limestone. Analyses show, however, that even a layer with friction angle as low as fifteen degrees would deflect the slip mechanism up into the overlying clay, so characterization of the fractured limestone turns out not to be critical to the results of the analysis (and the friction angle is noted as greater than 15 degrees in Table 2).

Fig. 3 Undrained shear strength with depth (based on borings No. 1 and No. 2).

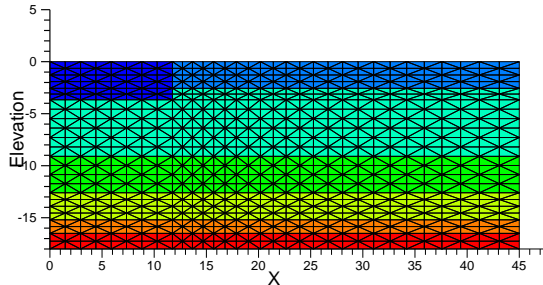
Fig. 4 Two-dimensional (plane-strain) mesh for the Transcona elevator.

We will start by analyzing the Transcona elevator collapse using 2D limit analysis. 2D analysis would be suitable for a plane-strain problem (one in which the shear strain components in one plane and the strain component normal to that plane are all zero). Assumption of plane strain is a frequent assumption in soil mechanics, even when it does not strictly apply. Every problem is in fact three-dimensional; the cross section of the problem in this case refers to the cross section corresponding to the smaller plan dimension (the width B of the foundation). Fig. 4 shows the finite element mesh used for the 2D limit analyses. Fig. 5 shows the same mesh distorted after collapse (in truth, an image based on the velocities at failure and thus on the last displacement increments), and Fig. 6 shows the plastic energy dissipation as a result of the collapse. Both the distorted mesh and the plot of energy dissipation show where shearing localized at collapse. The distorted mesh does not represent accumulated displacement but rather results from scaling up the incremental displacements at collapse, giving a qualitative view of slip pattern at collapse. The lower bound on the unit limit load was 284 and the upper bound was 296 kPa. Since

the estimated unit load at the time of collapse is 293 kPa, there appears to be a good match; however, neither our estimates of shear strength nor the estimate of load at the time of collapse is free of error. Additionally, the foundation is not long enough with respect to its width for the problem to approximate a plane-strain problem. Accordingly, we also performed 3D limit analysis of the same problem.

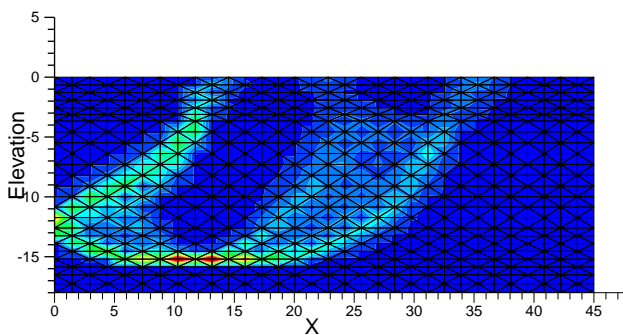
Fig. 6 Contours of plastic power dissipation from the two-dimensional (plane-strain) analysis of the Transcona elevator failure.

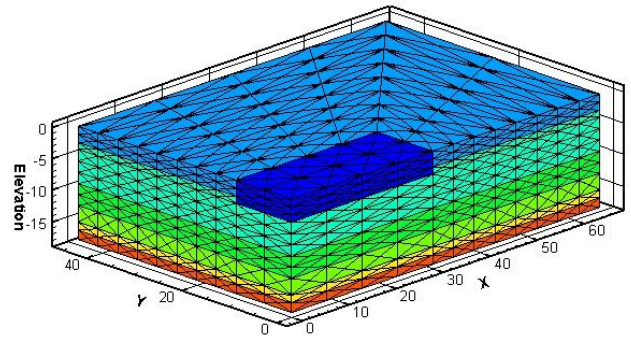
Fig. 7 Three-dimensional mesh for the Transcona elevator.

The mesh for the 3D analysis is shown in Fig. 7, the distorted mesh in Fig. 8, and the power dissipation plot in Fig. 9. The resulting lower and upper bounds on limit unit bearing capacity are 310 and 376 kPa. The larger difference between

the bounds compared with that for the 2D analysis reflects the greater challenges of a 3D analysis. Comparisons of 3D finite element limit analysis with the solutions of problems that can be solved exactly (such as by Salgado et al. 2004 and Lyamin et al. 2007) show that the lower bound is significantly closer to the collapse load, so that we can expect the collapse load, as calculated using 3D FELA to be of the order of 320-330 kPa, less than 10% greater than the estimated load at collapse.

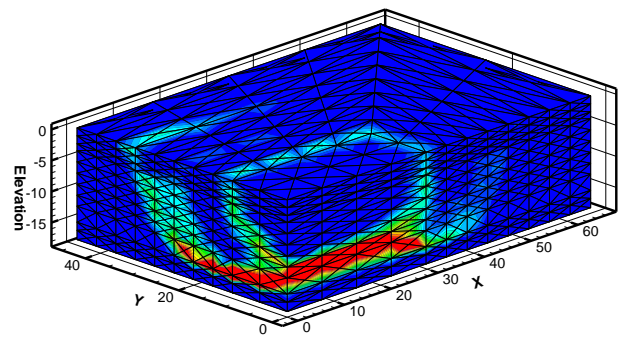
Fig. 9 Contours of plastic power dissipation from the three-dimensional (plane-strain) analysis of the Transcona elevator failure.

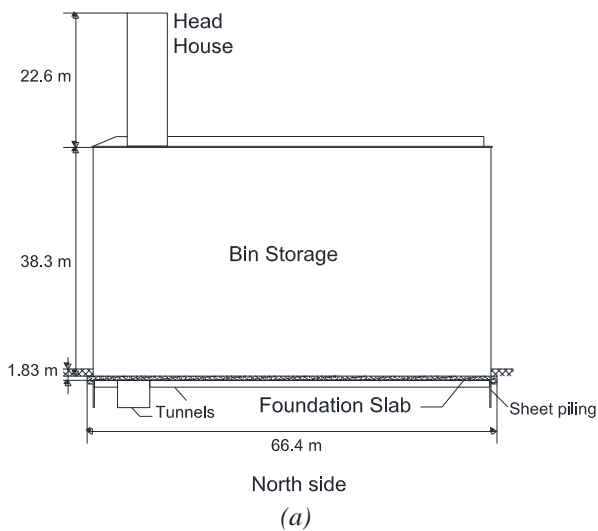
The Fargo grain elevator was a reinforced concrete grain elevator built during the summer and fall of 1954 about two miles west of Fargo, North Dakota (located in roughly the same geologic setting and 230 miles south of Transcona). It consisted of 20 circular bins that were arranged in two rows of 10 bins each and attached structures (Fig. 10(a) and (b)). The height and inside diameter of the bins were 37.2 m and 5.8 m. This structure rested on a reinforced concrete raft foundation that was 15.8 m wide, 66.4 m long and 0.71m thick. The outer 0.91 m edge around the structure was thickened to 1.32m. Except for this thickened edge, the base of the foundation was located 1.83 m below the ground surface. The raft foundation was interrupted locally by tunnels. There were also sheet piles that had been installed around the foundation; they should have had negligible effect on the performance of the raft.

Fig. 10 Fargo Grain Elevator: (a) Section view (b) Plan view.

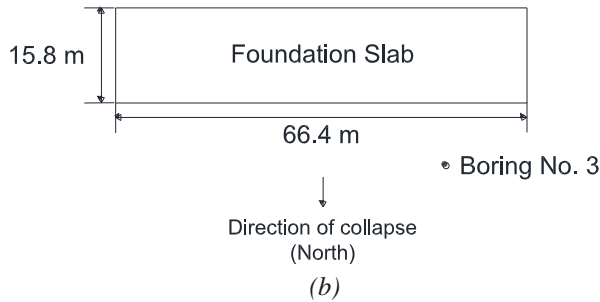
Until fall of 1954, only a small amount of grain had been stored in the elevator. The first time the elevator was filled with a large quantity of grain was April, 1955. Filling started then, and, in the early morning of June 12, 1955, the elevator collapsed and disintegrated. On May 10, 1955, after major filling had started, seven elevation benchmarks were installed, and the settlements of the foundation were recorded together with applied loads once a week after that. Fig. 11 shows the resulting load-settlement curve. The collapse happened when the unit load at failure was estimated at 260 kPa, with an estimated eccentricity of 0.96 m west and 0.03 m south from the centroid of the raft. Subtracting the weight of the 1.8m of soil excavated from the site, the net unit load at the time of failure was approximately 228 kPa. Failure produced a mass of concrete debris and grain on the north side of the original location of the structure. The ground bulged up as much as 1.83 m on the south side of the structure.

Fig. 11 Unit load versus settlement.

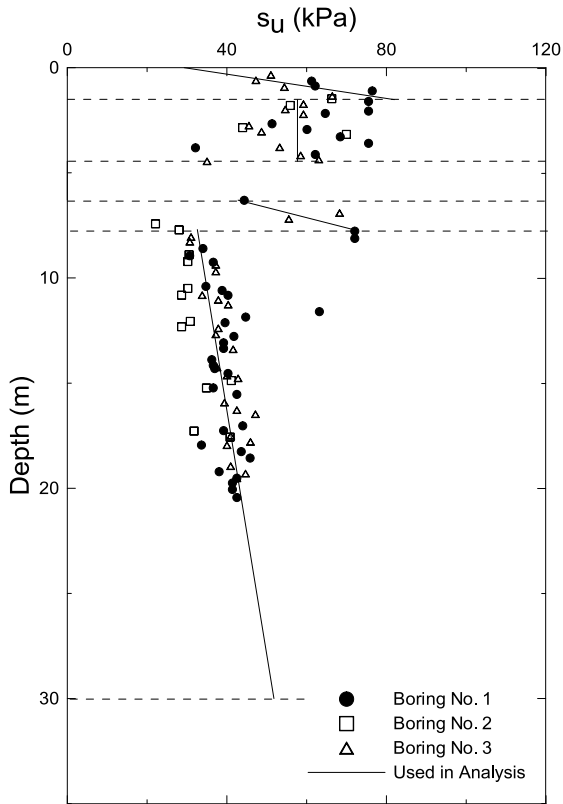
Fig. 13 Shear Strength with depth (Boring No. 1, 2 and 3).

For the bottom clay layer, a credible range for $ds_u/d\sigma'_v$ was established based on the available CU test results, and this value optimized (resulting equal to 0.17) to best fit the vane test results. The natural water content, the density and the liquid and plastic limits were also obtained for various depths within each of the layers. The highest plasticity index observed for each clay layer was used to estimate the correction factor from Fig. 12, resulting in values of 0.75 for layer 1, 0.7 for layer 2 and 0.62 for layer 4. For the sand layer, only SPT results are available (Fig. 13 and Table 3). The ground water level was located at the depth of 1.90m. Although the borings extended down to a depth of approximately 20 meters, we know that, in this area of the country, glacial till is found at depths of approximately 30 meters and sound rock at depths exceeding 60 meters. On that basis, in Fig. 13, we have extended the shear strength observed down to a depth of 30 meters, where glacial till then begins. The shear strength profile used in our analysis of this failure is indicated in Fig. 13 through straight line segments; it is given numerically in Table 4.

Layer No.	Depth (m)	s_u or ϕ
1	0-1.52	29.3-82.0 kPa (linear increase)
2	1.52-4.45	57.7 kPa
3	4.45-6.30	$\phi = 30\text{-}34^o$
4	6.30-7.70	42.8-71.7 kPa (linearly increase)
	7.70-30	32.6-51.8 kPa (linearly increase)

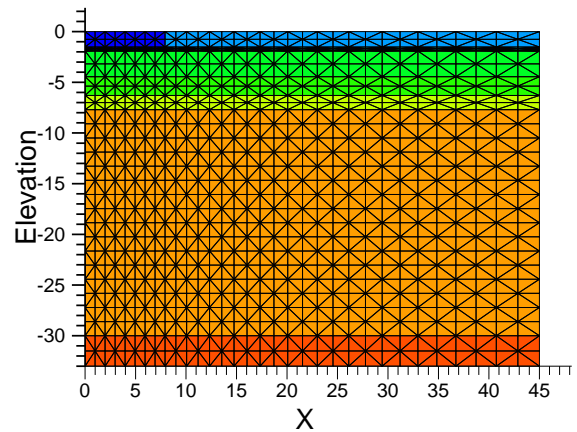
Fig. 14 Two-dimensional (plane-strain) mesh for the Fargo elevator.

We have again used limit analysis to bound the collapse load from below and above. Starting with plane-strain analysis, Fig. 14 shows the mesh used in the analyses. Fig. 15 shows the soil mass distortion at collapse, and Fig. 16 shows the power dissipation throughout the soil mass. Both of these figures give an indication of the nature of the deformation associated with collapse. The lower bound limit unit bearing capacity ranged from 290 to 295 kPa as we varied the friction angle of the sand layer between 30 and 34 degrees, a credible range for loose sand.

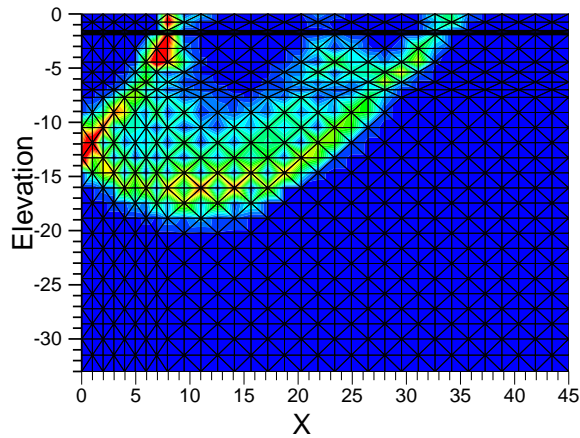
Fig. 16 Contours of plastic power dissipation from the two-dimensional (plane-strain) analysis of the Fargo elevator failure.

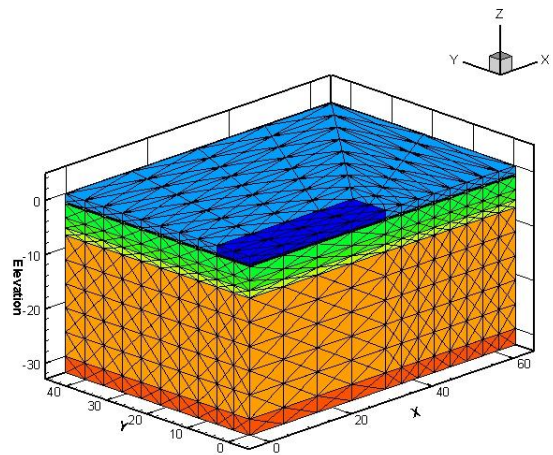
Fig. 17 Three-dimensional mesh for the Fargo elevator.

Fig. 17 shows the 3D mesh. Fig. 18 and Fig. 19 provide indications of the deformation field within the soil at collapse. The lower bound was calculated as 310 kPa, and the upper

bound as 378 kPa. As indicated earlier, the collapse load is expected to be much closer to the lower bound. This leaves our lower bound estimate about 15% higher than the estimated load at the time of collapse.

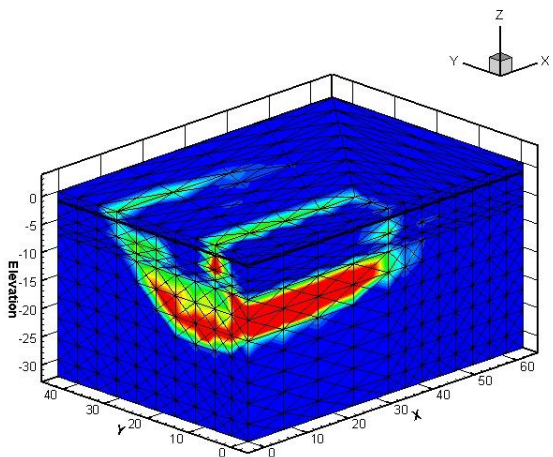
Fig. 19 Contours of plastic power dissipation from the three-dimensional (plane-strain) analysis of the Fargo elevator failure.

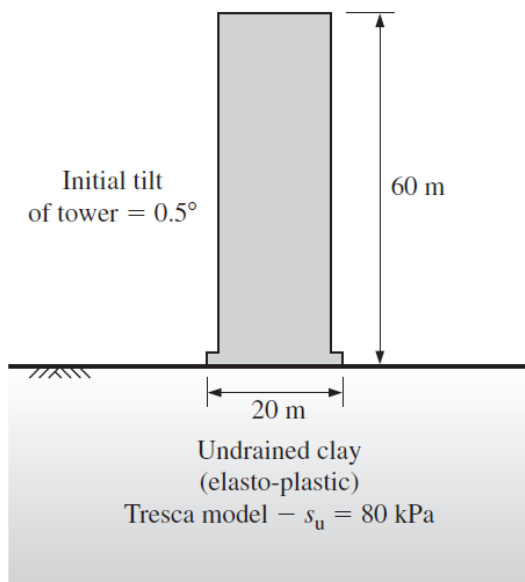
Fig. 20 Tower with an initial lean of 0.5 degrees on top of a Tresca soil (clay) with undrained shear strength of 80 kPa (redrafted after Potts 2003). Used with permission from ICE Publishing.

The beginnings of an answer lie in the Mitchell et al. (1977) observation that the maximum shear stress at points or within zones in the clay layer matched or exceed the estimated soil shear strength, even if the factor of safety was equal to 2. This indicated that a plastic zone had likely formed below the south end of the Tower. Potts (2003) provides a simple example that illustrates the type of collapse that the Tower of Pisa could have experienced. This type of collapse, known as leaning instability, is closely associated not only with the shear strength of the soil, which we use in our bearing capacity calculations, but also with the soil stiffness, as represented by its shear modulus. Fig. 20 shows a tower (with geometry quite similar to that of the Tower of Pisa) on top of a clay with s_u = 80kPa. The tower is built with an initial inclination of 0.5˚. A finite element analysis then simulates the

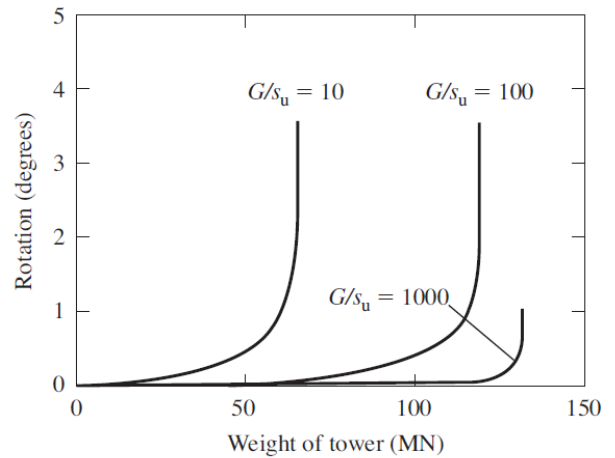
soil-tower response as the weight of the tower is gradually increased for three different values of soil stiffness: G = 10s_u, G = 100s_u, and G = 1000s_u. Note that, since the value of s_u is the same in all three cases, the weight at which collapse would occur would be the same if bearing capacity were the mechanism of collapse. Instead, as shown in 9, collapse takes place for a much lower tower weight in the case of low stiffness (G/s_u = 10). It also happens quite suddenly. Why the difference?

Fig. 21 Weight leading to collapse of the tower versus relative stiffness G/s_u of the foundation soil (redrafted after Potts 2003). Used with permission from ICE Publishing.

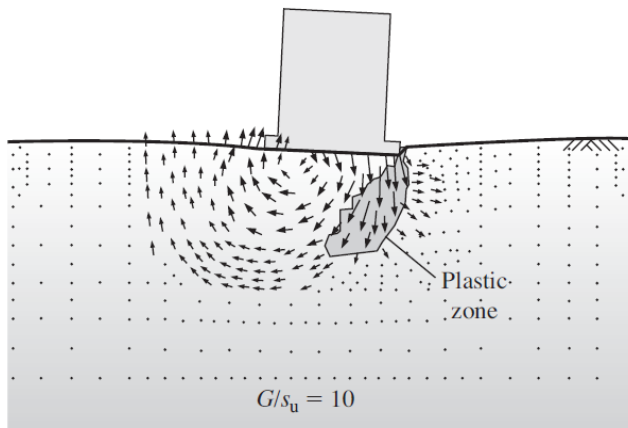
Fig. 22 shows a plot of incremental displacements at the last loading increment (just before collapse) for the case of low stiffness. It also shows that the shear stress in the soil becomes equal to the shear strength (forming a plastic zone, represented as a shaded zone) in only a portion of the soil deposit, and a plastic mechanism does not form. So how does collapse occur? In essence, it occurs through an overturning failure. The low stiffness of the soil as it enters the plastic range does not provide enough support beneath the right edge of the tower after a plastic zone forms there to balance the moment of the weight of the tower with respect to the center of the foundation. Contrast that with the full plastic mechanism that forms below the tower in the high-stiffness-ratio case, shown in Fig. 23. Here, clearly, we have a bearing capacity failure, which is a very different mechanism from leaning instability, hence the difference in tower weights for which these two failures are observed.

Fig. 22 Displacement field and plastic zone for soft (low-shear modulus) soil (redrafted after Potts 2003). Used with permission from ICE Publishing.

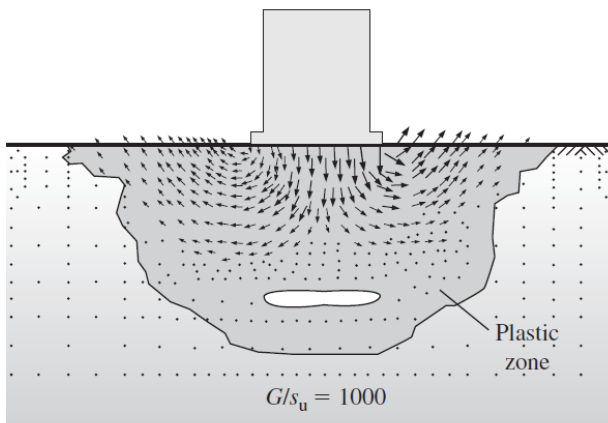
Fig. 23 Displacement field and plastic zone for stiff (high-shear modulus) soil (redrafted after Potts 2003). Used with permission from ICE Publishing.
