1991 - Second International Conference on Recent Advances in Geotechnical Earthquake Engineering & Soil Dynamics

Considerations to Damage Patterns in the Marina District During the Loma Prieta Earthquake Based on Rayleigh Wave Investigation

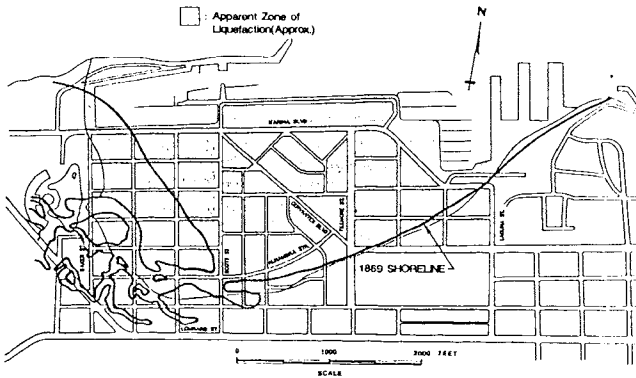
Fig. 3 shows the map of the Marina District after Seed et al. (1990) in which apparent zone of liquefaction is also shown. Solid line in the map shows the shore line in 1869. The central part of the Marina District was hydraulically filled with sand after 1896. Their study indicates that the apparent zone of liquefaction encompasses the entire hydraulic fill zone, as well as portions of the earlier fill around the perimeter of the District and overlying the coastal marshes at the western end of the District. Considerable damage to buried

Fig. 3 Map of Marina District and old coastline (after Seed et al., 1990)

utilities occurred throughout much of the apparent zone of liquefaction. Thus it appears that the major cause of the damage to buried utilities was due to soil liquefaction.

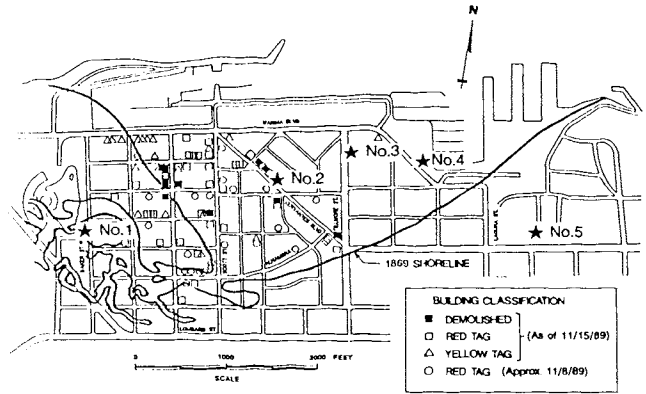
Fig. 4 Map showing damage to structure in the Marina District (after Seed et al., 1990) and test sites

Most of the collapsed and damaged houses, on the contrary, concentrate on the west part of the liquefied zone, and very few structural damage is observed on the east part of the liquefied zone, as shown in Fig. 4. They concluded therefore that a majority of the damage to structures in the District on October 17, 1989 was not due primarily to soil liquefaction but caused by strong shaking.

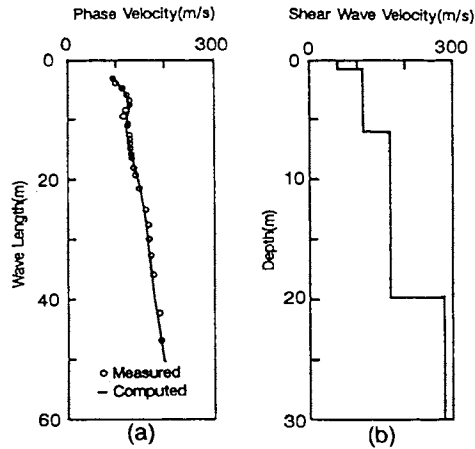
Fig. 5 Measured and computed dispersion curve
and resulting shear wave velocity at Site #4

The open circle in Fig. 5(a) shows the correlation between phase velocity and wavelength observed at Site No. 4. The inverse analysis was then conducted for the observed correlation assuming a three or four-layer model with appropriate initial soil properties.

Also shown in Fig. 5(a) is the computed dispersion curve from the inverted soil model shown in Fig. 5(b). The computed dispersion curve appears to show a good agreement with the observed correlation, indicating that the inversion was successfully conducted. Particularly noted is a good agreement in trend at short wavelengths which cannot be obtained without considering the effects of higher modes of Rayleigh waves in the

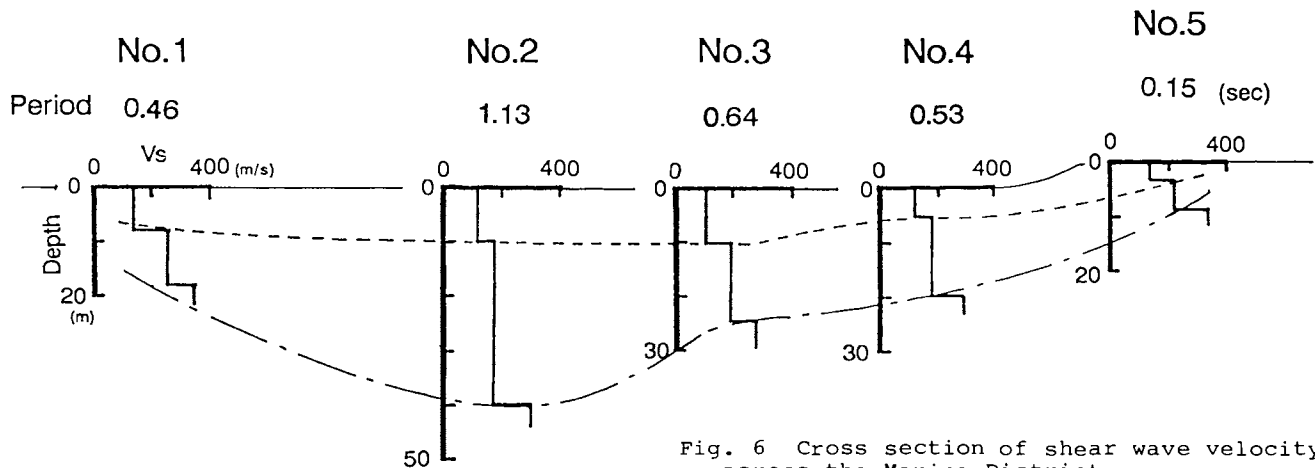
The inverse analyses were also conducted for
other four sites, and the resulting cross sec-
tion of shear wave velocity profile across the
District is shown in Fig. 6. The shear wave
velocity of the top layer is approximately 110
to 135 m/s in the liquefied zone and more than
140 m/s outside the liquefied zone. The shear
wave velocity of the second layer is between 165
and 185 m/s in the hydraulic fill zone and about
235 m/s outside the fill zone, i. e., Sites No.
1 and 5. The second layer is underlain by a
stiffer layer with a shear wave velocity greater
than about 300 m/s. Broken lines in the figure
indicate the boundaries between these layers.

The thickness of the top layer takes its maximum
of about 10 meters in the center of the hydrau-
lic fill zone, i. e., Sites No. 2 and 3, and
decreases with distance toward the perimeter of
the liquefied zone. Such a layer with a low
shear wave velocity appears to diminish at Site
No. 5 which is outside the fill zone.

The second layer also takes its maximum thick-
ness at the center of the liquefied zone, and
decreases its thickness with distance toward the
edge of the liquefied zone.

1) The hydraulic sandy fills in the liquefied
   zone have shear wave velocities less than 135
   m/s with thicknesses varying up to 10 meters.
   Such sandy soils are likely to liquefy during
   moderate to strong earthquakes (e. g., Toki-

Fig. 6 Cross section of shear wave velocity
across the Marina District

2) The hydraulic fills in the zone of structural damage are thick and loose, i. e., the thickness is about 10 meters and $V_s = 120$ m/s which combination appears worse than that of any other site with little or no structural damage.

3) The second layer is thicker and softer in the fill zone than outside the fill zone, and even thicker within the zone of structural problems, i. e., the thickness is about 30 meters at Site No. 2 and equal to or less than 15 meters in other sites within the fill zone.

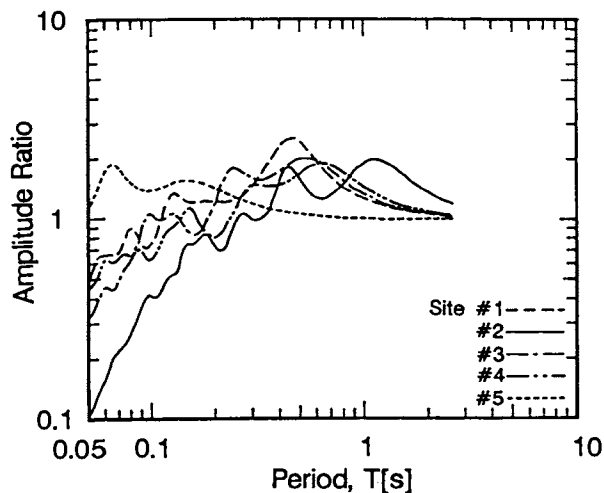
Fig. 8 summarizes the amplification characteristic curve for all sites. The maximum amplification ratios between the assumed bedrock and the ground surface during the earthquake are on the order of 2 and does not seem to vary significantly from site to site. However, the predominant

Fig. 8 Amplification characteristic curves at five sites in Marina District

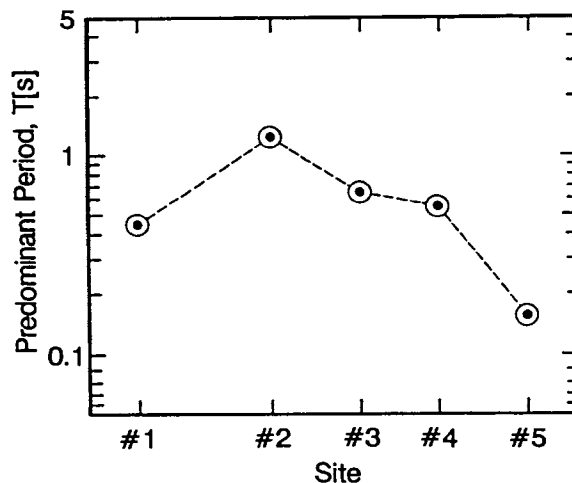
Fig. 9 Variation in predominant period with site in the Marina District

period which provides the maximum amplification ratio significantly depends on site condition. Fig. 9 shows the variation of the predominant period of ground motion with site. There is a definite trend in which the deeper the bedrock and/or larger the thickness of the young Bay Mud deposit, the longer becomes the predominant period.

1) The predominant period in the zone of structural damage is about 1 sec which is considerably longer than that in any other site.

2) The damage patters of structures appear to be significantly affected by the predominant period of the ground motions in such a way that the damage increases as the predominant period of the ground motions increases at least up to about 1 sec.
