Quest and Probe Related to Erosion in the Wrap-Around of an Embankment

R.J.R. Cardia

Civil Engineer, Civil Engineering Central Laboratory, CESP, Ilha Solteira, SP, Brazil

SYNOPSIS: CESP's divers team found several basalt blocks scattered on the stilling basin of a power plant. Water flowing through bottom outlets was initially supposed to cause erosion in the upstream rip-rap of the wrap-around. Events chronologically reported are: Underwater inspection; removal of materials; monitoring devices behavior; hydraulic tests. Hinder analyses led to recognition of misunderstanding on anomalous mechanism and misconception on the actual sources for the hauled rubbish.

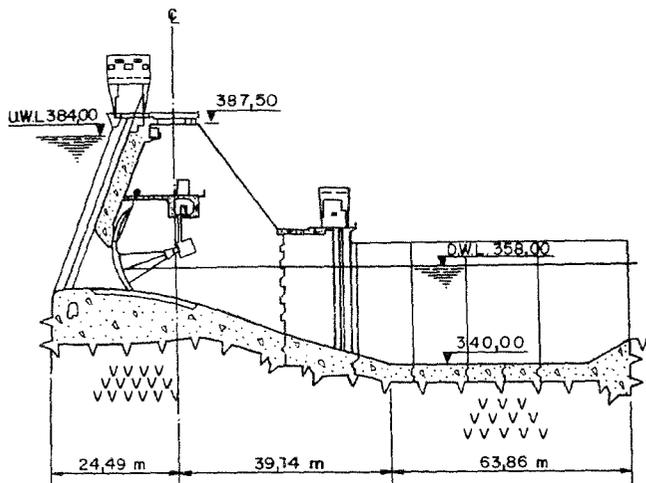
Fig. 2 - Section through bottom outlet and stilling basin.

During one of the aforementioned routine underwater inspections (1977), large amount of salt blocks, iron rebars and scaffolding pipes and bracing components were found, scattered over the stilling basin, near the end sill. Initially, those materials were suspected to have been detached and drawn backward from the protected rock-bottom downstream, by recirculating water.

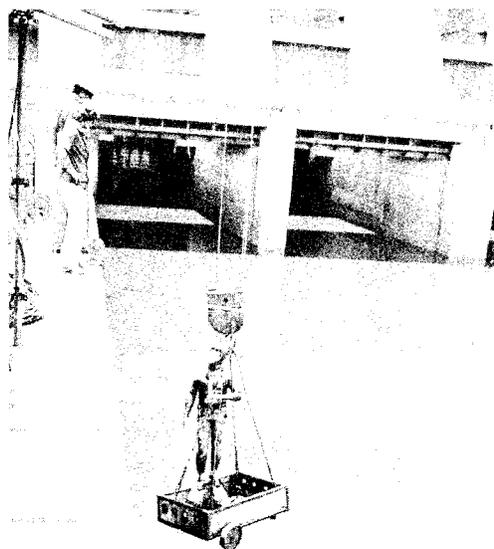
Divers were sent to inspect the upstream slope (22JUL80) and detected slight or no signs of movements in the rip-rapped basalt blocks. In the vicinities (up to 10 m) of the bottom outlets the blocks were clean, without the common ooze cover, found far away to the right. They also searched out, abandoned since construction phases, debris and iron bars similar to those ones discovered at the stilling basin on both prior inspections, and again (JULY80 to DEC80) all materials found in the basin were hauled.

Fig. 5 - Hauling system used by divers.

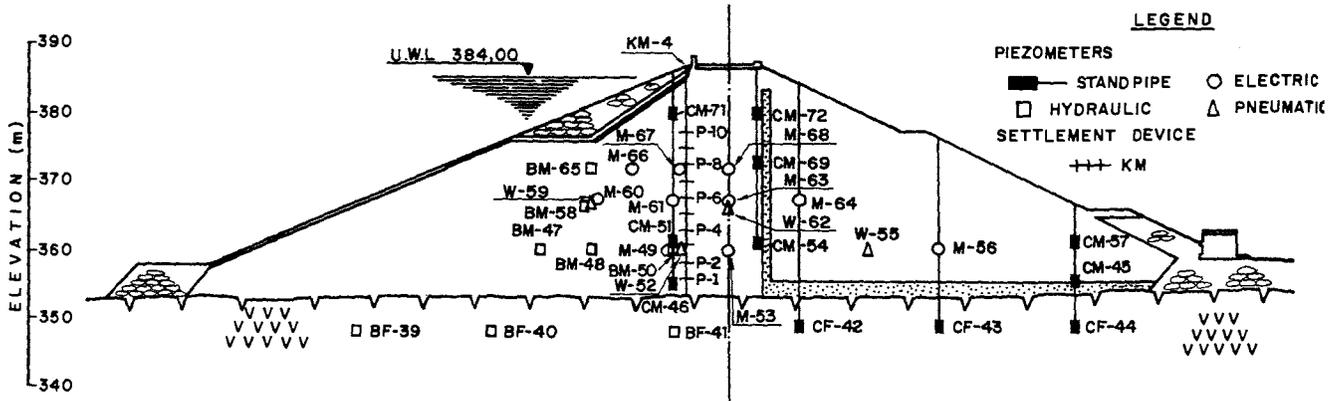
Fig. 7 - Instruments installed in station 165

The main instrumented cross-section is located in the station 165 whereas the wrap-around is spread out between stations 158 and 162. So there was no instrumentation available exactly in the probable affected area. Instruments in station 165 didn't present any alteration at all, when new data were compared with previously registered values. Visual inspection in the upstream rip-rap protection showed that some blocks had slid but perhaps this could have been caused by severe action of high waves over
