Lessons from Recent Collapses of Metal Buildings

By David B. Peraza, P.E.
Senior Associate, LZA Technology, New York, NY

This paper presents case studies of three roof collapses of metal buildings, discusses the most significant features of each case, and summarizes lessons learned that can be used to reduce future failures.

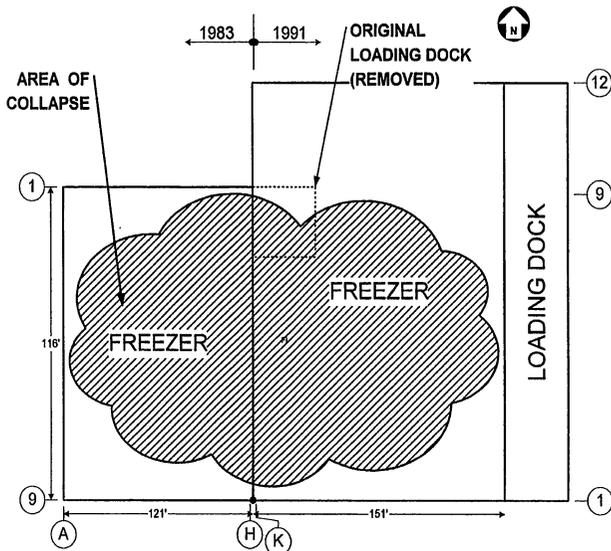
Figure 1: Roof Plan

On March 5, 1994, two attached freezer buildings collapsed under a snow load. The buildings were located near Harrisburg, PA. The buildings were owned by a food distributor and contained racks nearly 30 feet high for frozen food storage. These racks actually prevented the roof from falling to the ground. The claimed loss, primarily for food spoilage, was on the order of \$20 million dollars.

At the time that the 1983 building was designed, it was anticipated that a freezer addition would be built at a later date along one side of the building. The vertical load from the future building was included in the design of the appropriate columns.

In 1991, the small loading dock was dismantled to make way for the freezer addition. Lean-to brackets were welded to each column where the addition would attach. These brackets, and the moments transferred through the brackets, became a focal point of the investigation.

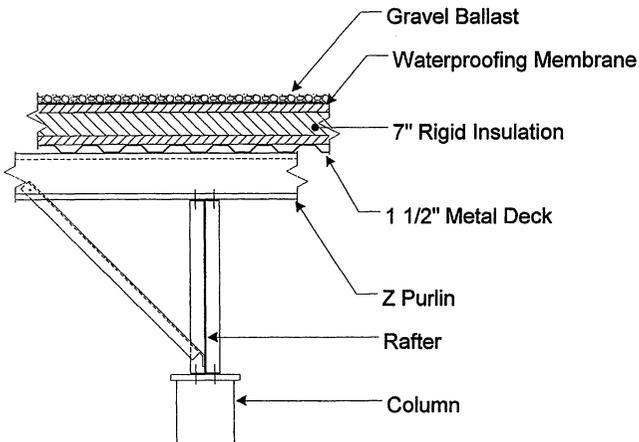
Figure 2: Typical Roof Construction

The 1983 Building measured approximately 121 feet by 155 feet in plan, and had a single slope roof. Its structure typically consisted of steel frames spaced at 19 feet and 20 feet, with one line of intermediate columns. The frames were composed of built-up plate girders, built-up columns, and intermediate round pipe columns. The secondary roof members consisted of 8-inch deep Z purlins spaced at 5 feet on center. Metal deck, 1 1/2" deep, was screwed to the purlins and supported seven inches of insulation and a ballasted roof membrane.

For the 1983 building, the purlins near the end rafters were found to be overstressed 20% to 41% in combined shear and bending. These overstresses occur at the end of the purlin overlaps at the first interior rafter. Similarly, for the 1991 building, the purlins near the end rafters were overstressed as much as 38% in combined shear and bending.

For the 1991 building, widespread instances of web crippling of the purlins was found in the interior bays. Overstresses ranged from 20% to 30% for design loadings, as compared to AISI 1986/89. A check for web crippling could not be found in the design calculations

- Design engineers must be familiar with current codes, and must be thoroughly familiar with the limitations of design software. In this particular case, checks for purlin web crippling and combined shear/bending could not be found in the calculations.

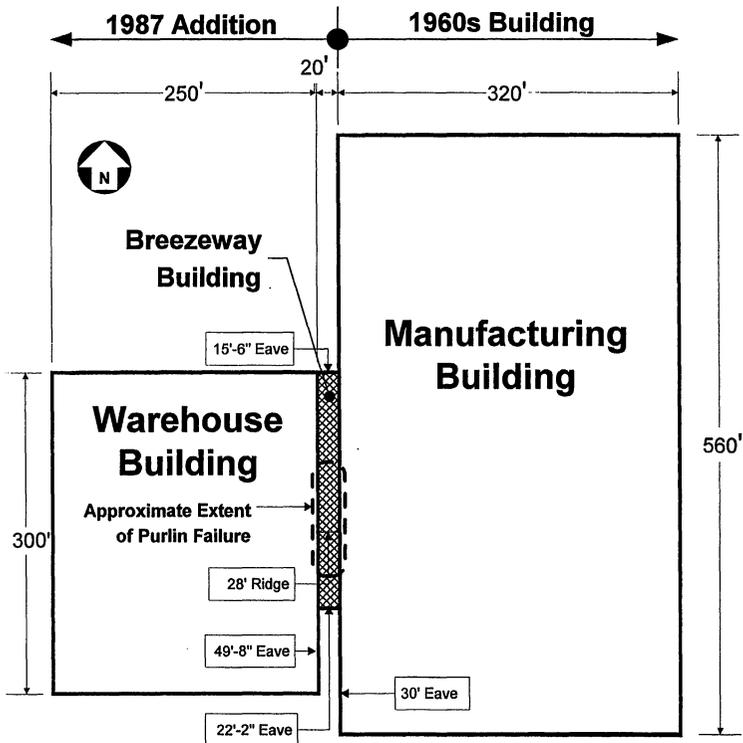
Figure 6: Roof Plan

the Breezeway me was substantially lower than that of the abutting buildings. Figure 6 shows the overall layout of the buildings.

Failure of a portion of the Breezeway roof occurred about a week after the January 1996 blizzard that blanketed the northeast United States. Sometime between the late evening hours of January 14 (Sunday), 1996, and the early morning hours of January 15, the roof purlins, particularly near the ridgeline of the roof, rolled and sagged excessively, although they did not actually collapse to the ground.

In this case, it appears that the failure was caused by a drifted snow load that substantially exceeded the code-mandated values. This is based on the fact that the purlin design was adequate, plus the evidence that the snow loads present exceeded the code design values. Even if the strap bracing had not been installed, the purlins received sufficient incidental bracing from the standing seam roof to safely support the code-required loads. Evidence that the snow load exceeded the BOCA values is provided by meteorological data, published literature, and anecdotal observations by employees of the facility.

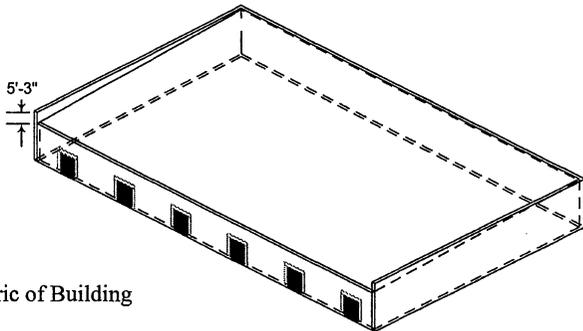
Figure 10: Isometric of Building

This building, which was used primarily for warehouse purposes, was located in Hamilton Township, New Jersey and was erected in early 1990. The building measured 110 by 180 feet. The eave height of this single slope building varied from 16' to 20'7", at a rate of 1/2" per foot. A masonry perimeter infill wall occurred on all sides, with a masonry parapet on three sides and a gutter on the low side. The parapet was about 8" high along the high side of the roof, and about 5'3" at the low side of the roof.

Roof purlins, which were spaced at 5'-3", consisted of 8" Z-shapes with 3 1/2" flanges, made of 12 gage material in the end spans and 14 gage elsewhere. Purlin laps of nearly 5 feet were called for over the rafter frames. Purlins were attached to rafters via fin plates welded to the rafters. Roof decking was a 24 gage standing seam roof system fastened to the purlins using one-piece clips. Erection drawings called for a line of strap bracing at midspan of the purlins, for both top and bottom flanges.

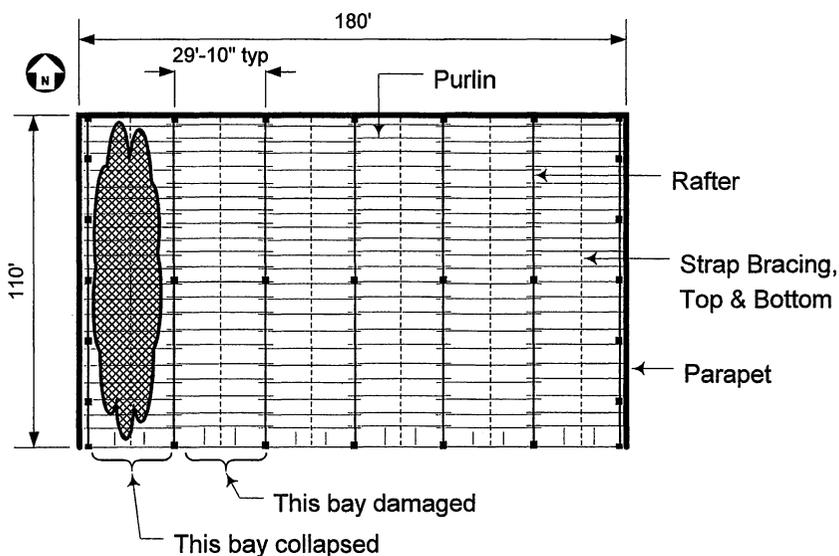
Figure 11: Roof Plan

A partial collapse of the roof occurred in the early morning hours of March 14, 1993 under snow conditions. LZA Technology was retained some years after the collapse by attorneys for the builder.

The engineer for the foundation inspected the building the morning after the collapse. He stated that there were 1.5 to 2 inches of an ice/snow mixture on the roof adjacent to the collapse area.
