# A Field Study and Dynamic Finite Element Analysis of Railway Retaining Structures Damaged by the Hyogoken-Nambu Earthquake (1995)

Yoshinori Nagayama

The seismic damage to embankments and retaining walls caused by the Hyogoken-nambu Earthquake (1995) was reviewed, rather focusing on railway structures. Nearly eight kilometers of damaged retaining structures were divided into five structural types, such as gravity-type walls, leaning-type walls, embankments, geo-textile-reinforced earth walls, and reinforced concrete walls, and into three categories of the damage, such as collapse, tilt, and crack. It was observed that the damage to gravity-type and leaning-type walls was greater than that to embankments, geo-textile-reinforced earth walls, and reinforced concrete walls, when they are lower than five meters. But some leaning-type walls higher than seven meters remained un-collapsed. In a smaller limited section, damage analyses of stone masonry walls of gravity type were carried out including undamaged ones. The percentage of heavy damage to stone masonry walls with slopes was nearly twice larger than that without slopes. Moreover, two-dimensional dynamic non-linear finite elemen

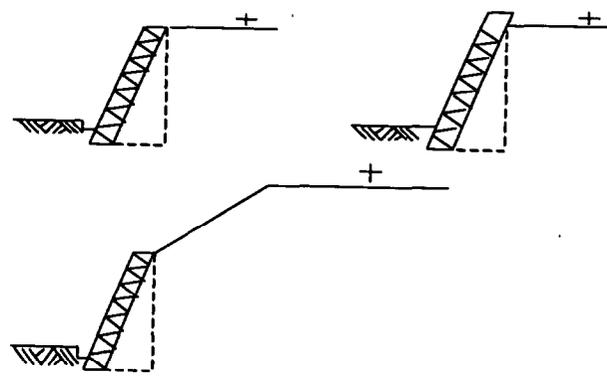
Fig.5. Three structures compared: stone masonry wall (above left), stone masonry wall with protruded crown (above right), and stone masonry wall with slope (below)

In a smaller limited section, all stone masonry retaining structures including non-damaged ones were analyzed, and the damage ratio was calculated. The retaining structures in this section were composed from stone masonry wall, stone masonry wall with protruded crown, and stone masonry wall with slope as shown in Fig.5. Figure 6 shows that the damage ratio of stone masonry wall with slope is twice greater than that without slope. The ratio of collapse in stone masonry wall with protruded crown is nearly twice greater than stone masonry wall. But even if tilted structures are included to the collapsed, the damage ratio with protruded crown does not change so much. From this figure, it is suggested that in the

applied aseismic design of retaining walls with slope, seismic active earth pressure can be estimated to be too small. Figure 7 shows the assumed slope for calculating seismic earth pressure in the applied seismic design. The shaded triangular soil mass over the assumed slope is considered to slide during earthquake, and neglected in the calculation of seismic earth pressure. This underestimation of seismic earth pressure may contribute to the large ratio of collapse. Moreover, some other factors such as slope protection works might accelerate the damage.

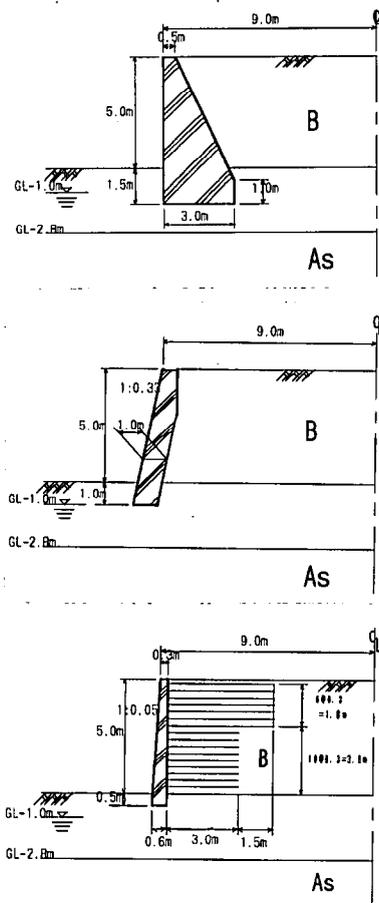
Fig.9. Modeled sections of retaining walls: gravity-type wall (top), leaning-type wall (middle), geo-textile reinforced earth wall (bottom)

Time history response analyses were conducted for a gravity-type wall, a leaning-type wall, and a GRW, each of which has five meters in height, as shown in Fig.9 (Kasai *et al* 1998).

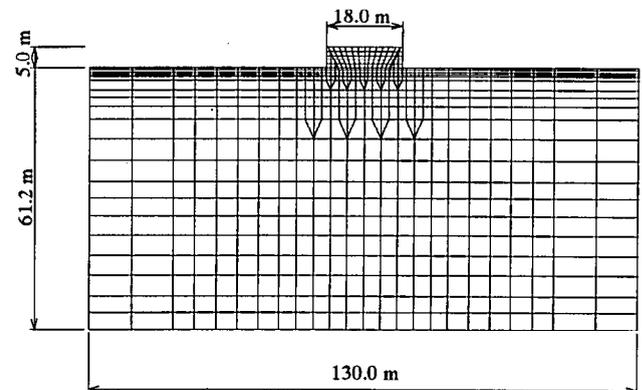
Fig. 10. Finite element model (gravity-type wall)

The two-dimensional finite element model has depth of 61.2 meters and extends 56 meters from the wall location to both boundaries as shown in Fig. 10. The lower boundary faces bedrock. Non-linearity of ground stiffness, de-lamination or sliding at the contact face between backfill and wall is considered in the calculation. Soil properties were obtained at the damaged site of the gravity-type wall. As the aim of the analyses is to find some difference in seismic response among these three retaining structures, the same soil properties are used for analyses. The shear wave velocity is 150 meters per second in the backfill, and 100-540 meters per second in bearing layer increasing from surface to bedrock. Backfill soil and the top five-meters layer of the ground follow the elasto-plastic Mohr-Coulomb's criterion. The angle of internal friction for the cohesionless backfill and the top layer are 42.0 and 35.8 degrees respectively. The soils below this layer and concrete walls are modeled as linear materials. Geo-textile material is modeled as non-symmetrical bi-linear spring that resists tension force only.

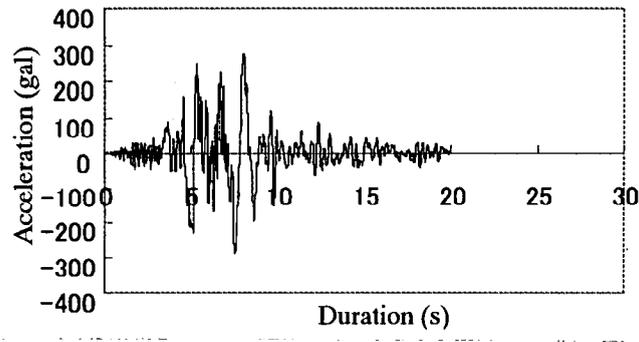
Fig.11. Waveform in acceleration

In order to obtain an input waveform, a pre-calculation was performed. The waveform of earthquake ground motion detected at the location of Kobe University on bedrock surface during the 1995 Hyogoken-Nambu earthquake was applied on the bottom viscous boundary with half space, and a quasi-linear analysis was conducted. The resulting waveform at the upper side of the boundary is used for the present finite element analysis. Figure 11 is the waveform thus obtained.

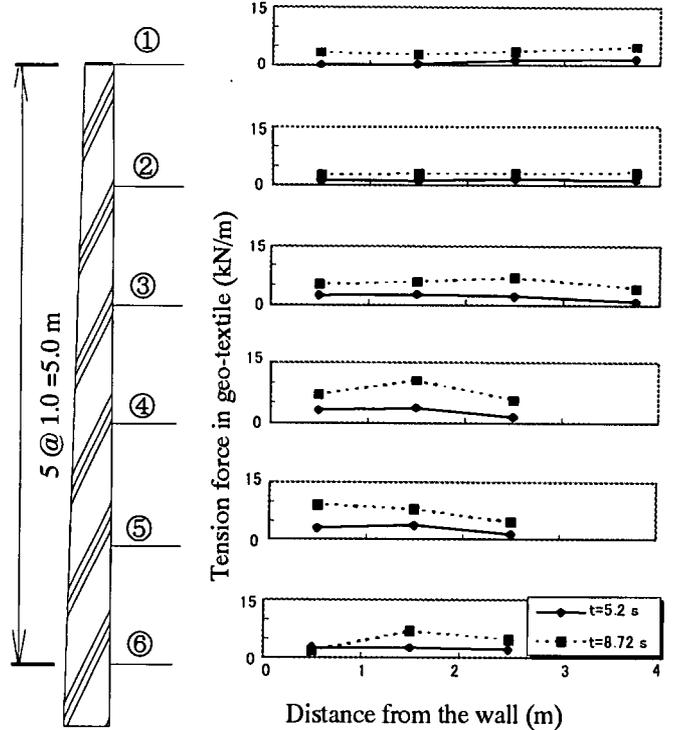
Fig.17. Distribution of tension force in the geo-textile

whether the wall is moving right or left. Therefore, the tension force is not directly caused by the horizontal movement of the wall, but by the settlement of backfill. This tension force suppresses sliding of the wall. Figure 17 shows the distribution of tension force when the whole structure is moving from the left to the right.
