The Role of Geotechnical Factors in Northridge Earthquake Residential Damage

THE ROLE OF GEOTECHNICAL FACTORS IN NORTHRIDGE EARTHQUAKE RESIDENTIAL DAMAGE

On three projects, one a class action law suit and two involving readjustment of insurance claims, we evaluated the impact of the 1994 M_w 6.7 Northridge, California earthquake on over 1,600 residential properties. For each of the properties, we reviewed previous reports on the condition of the site immediately after the earthquake, undertook a site visit to observe current conditions, undertook site-specific geotechnical investigations, as appropriate, and documented our findings on the impact of long-term and earthquake-related geotechnical factors on property damage. We have identified the following significant geotechnical factors that contribute to residential earthquake damage: (a) *hillside sites*; (b) *cut/fill transitions*; (c) *expansive soils*; (d) *liquefied sandy soils*; and (e) *deep soft soils*. This paper summarizes and presents our findings regarding these factors for five representative case histories of residential damage in the Northridge earthquake.

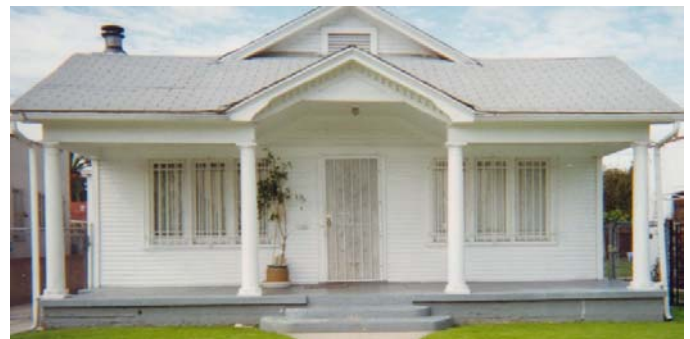
Fig. 1. Typical Single-Story House in the Northridge Earthquake Epicentral Area

Our site visits started in early 1999, approximately five years after the earthquake and were completed in mid 2003. None of the sites inspected were red-tagged (i.e., deemed unsafe to occupy) after the earthquake. Only 15 out of over 1600 sites inspected had been yellow-tagged (i.e., limited entry was allowed). A typical single-story house inspected is shown in Figure 1. A representative hillside site is shown in Figure 2.

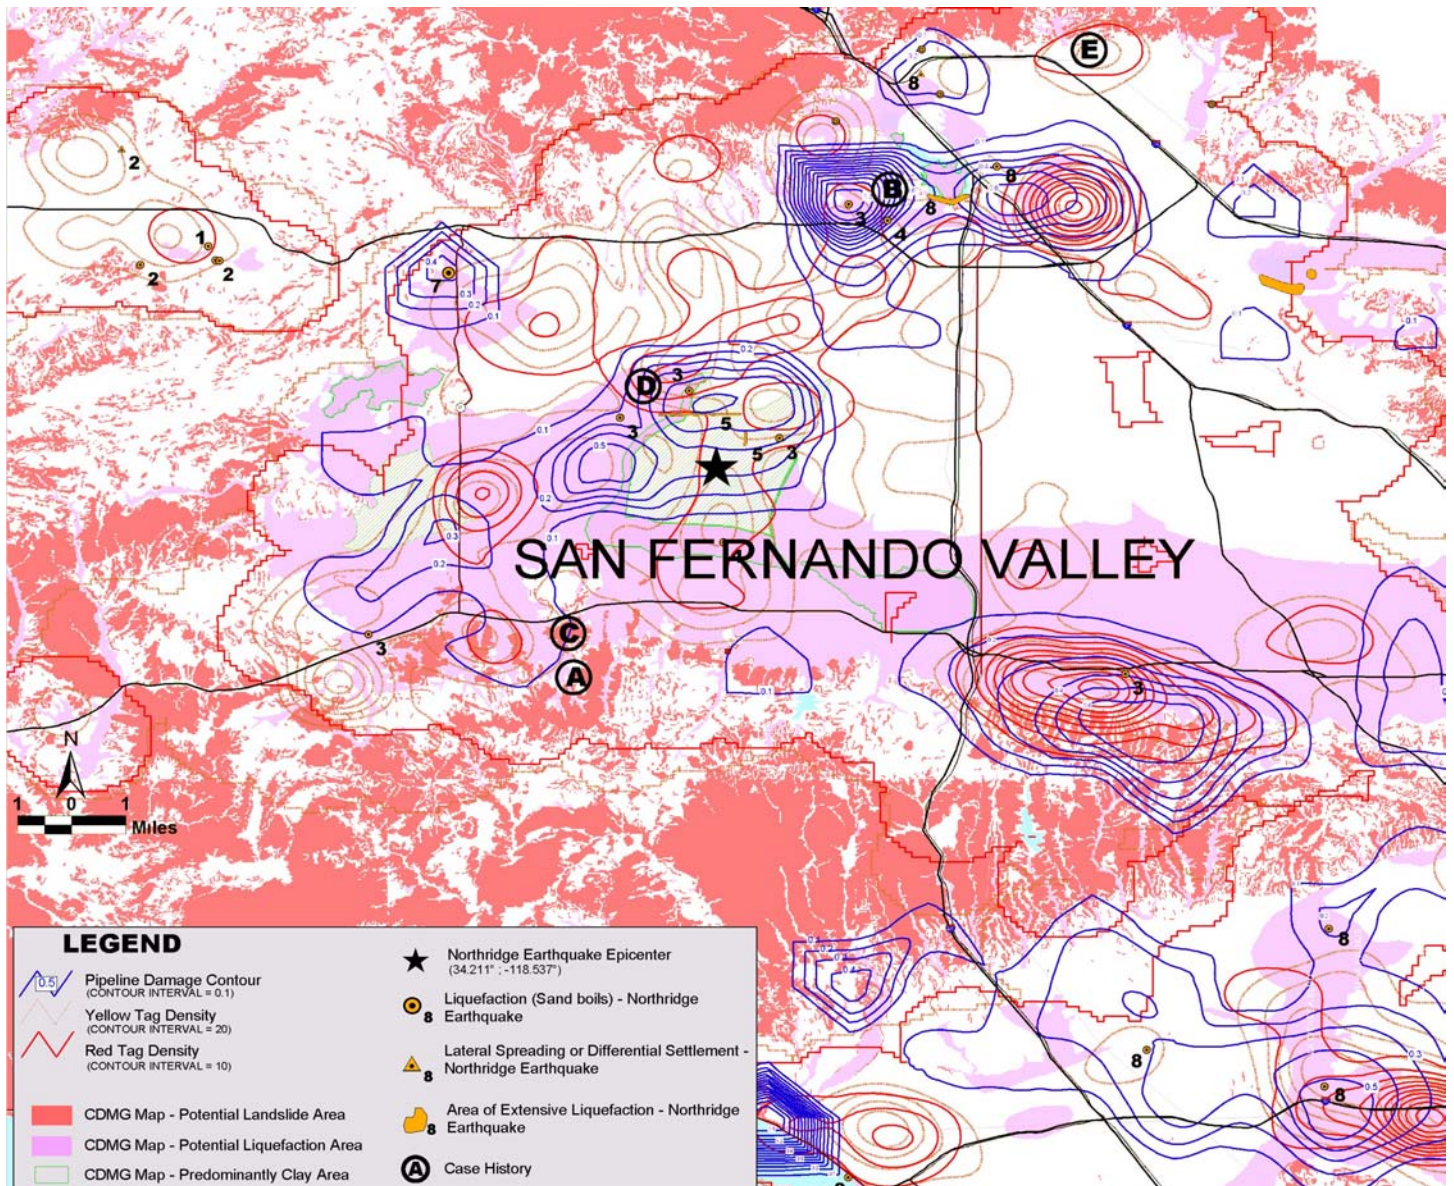
Fig. 3. Partial Presentation of GIS Database Developed for the Project (see also a Color Version of this Figure on CD)

A Geographic Information System (GIS) database was developed for the first project. The database, one layer of which is shown in Figure 3, contained information on regional and local geologic conditions (not shown in Figure 3 for clarity), areas prone to soil liquefaction and landsliding as

established by the California Division of Mines and Geology (CDMG), Peak Horizontal Ground Acceleration (PHGA) contours as established by Stewart et al. (1994) (not shown in Figure 3), peak horizontal ground velocity as established by SAC Joint venture (1995) (not shown in Figure 3), contours of red- and yellow-tagged houses per California Office of Emergency Services (OES, 1994) and the pipeline damage contours as presented by O'Rourke and Toprak (1997). Generic GIS maps, covering a 1.6-km radius of the property, were generated prior to each site visit and distributed to the team members.

weight ranging from 14.6 to 16.5 kN/m³. Boreholes indicate that the local water table is about 5 m below the surface and that the soils to about 20 m are interbedded silty sand and sandy silt. Soil liquefaction-induced sand boils were observed in relative vicinity of the site (see Figure 3). A site-specific soil liquefaction analysis showed that two 1.5-m thick layers at about 10 and 15 m below the ground surface may have liquefied in the earthquake and the estimated site-specific PHGA of 0.62 g. Calculations indicated that up to 74 mm of liquefaction-induced soil settlement could have occurred at the site.
