# Observations and Performance of a Soil Nail Shoring Wall in Seattle Silts and Clays

## OBSERVATIONS AND PERFORMANCE OF A SOIL NAIL SHORING WALL IN SEATTLE SILTS AND CLAYS

### ABSTRACT

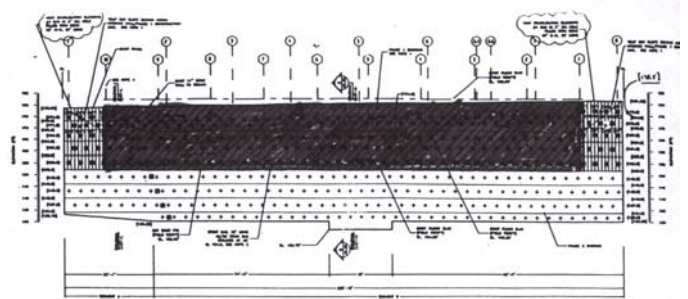
The permitted shoring design for the east wall consisted of five rows of soil nails through the existing basement wall and four rows of soil nails and shotcrete below the existing wall. At the north and south ends of the east wall, there were small sections that consisted of nine rows of soil nails and shotcrete. The typical soil nail spacing was 5 feet on-center horizontally. The maximum depth of excavation was up to 53 feet. An elevation and cross section showing the permitted soil nail wall design for the east wall are shown in Figs. 2 and 3. The darker area shown in the middle of Fig. 2 represents the existing basement wall.

Fig. 2. Elevation view of permitted design for east wall

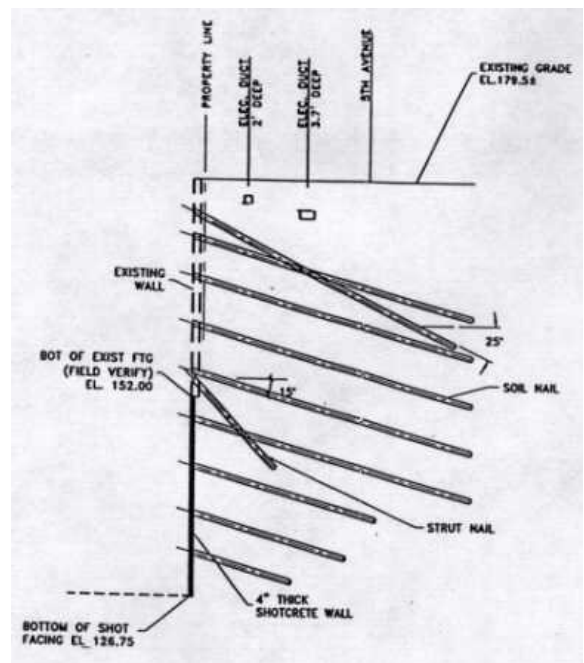
Fig. 3. Cross section of permitted design for east wall
