Observations and Performance of a Soil Nail Shoring Wall in Seattle Silts and Clays

OBSERVATIONS AND PERFORMANCE OF A SOIL NAIL SHORING WALL IN SEATTLE SILTS AND CLAYS

The Seattle Central Library project, which replaced the existing downtown library, consists of a twelve-story building with several below-grade levels. The excavation encompassed an entire city block and had plan dimensions of approximately 250 feet by 240 feet. The original excavation depth was up to 53 feet in height. The excavation was made in highly overconsolidated Seattle silts and clays (Lawton Clay). The Lawton Clay has been documented to exhibit expansive behavior along planes of weakness associated with stress relief upon excavation.

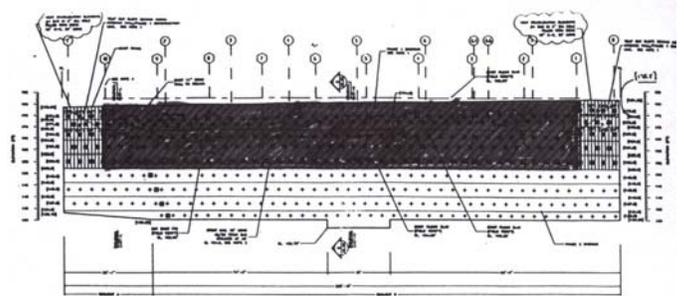
The permitted shoring design for the east wall consisted of five rows of soil nails through the existing basement wall and four rows of soil nails and shotcrete below the existing wall. At the north and south ends of the east wall, there were small sections that consisted of nine rows of soil nails and shotcrete. The typical soil nail spacing was 5 feet on-center horizontally. The maximum depth of excavation was up to 53 feet. An elevation and cross section showing the permitted soil nail wall design for the east wall are shown in Figs. 2 and 3. The darker area shown in the middle of Fig. 2 represents the existing basement wall.

Fig. 2. Elevation view of permitted design for east wall

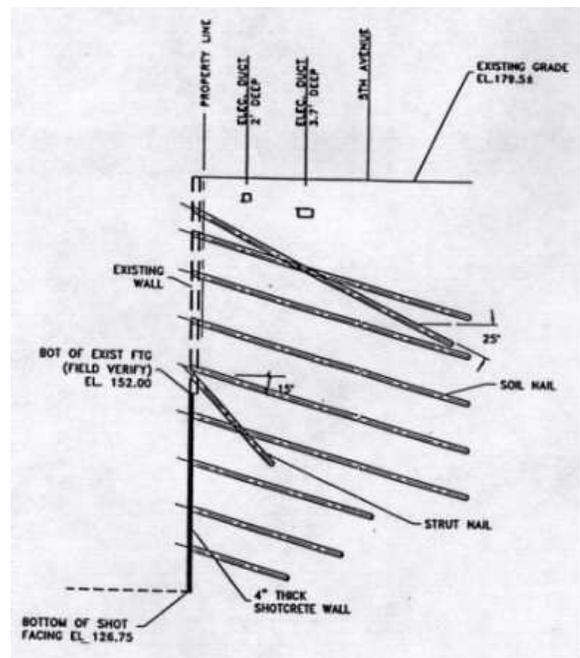
Fig. 3. Cross section of permitted design for east wall
