REPAIR OF THE CHURCH OF LA PURISIMA CONCEPCION OF HUELVA (SPAIN) WITH JET-GROUTING, FOR DAMAGES CAUSED BY THE CONSTRUCTION OF DIAPHRAGM WALLS IN ITS PROXIMITY

The Church of La Purísima Concepción, raised in 1515 as the second parish of Huelva (Spain) has been affected by diverse natural disasters along its history.

The foundation of the church has been repaired using the technology of jet-grouting, with columns of 15 and of 30 meters of depth and 0.75-0.80 m of diameter. Later, it was realized concrete slab to join all the heads of the columns of jet-grouting. Measurements of levelling have been realized to observe the movements of the church structure during the accomplishment of the jet-grouting.

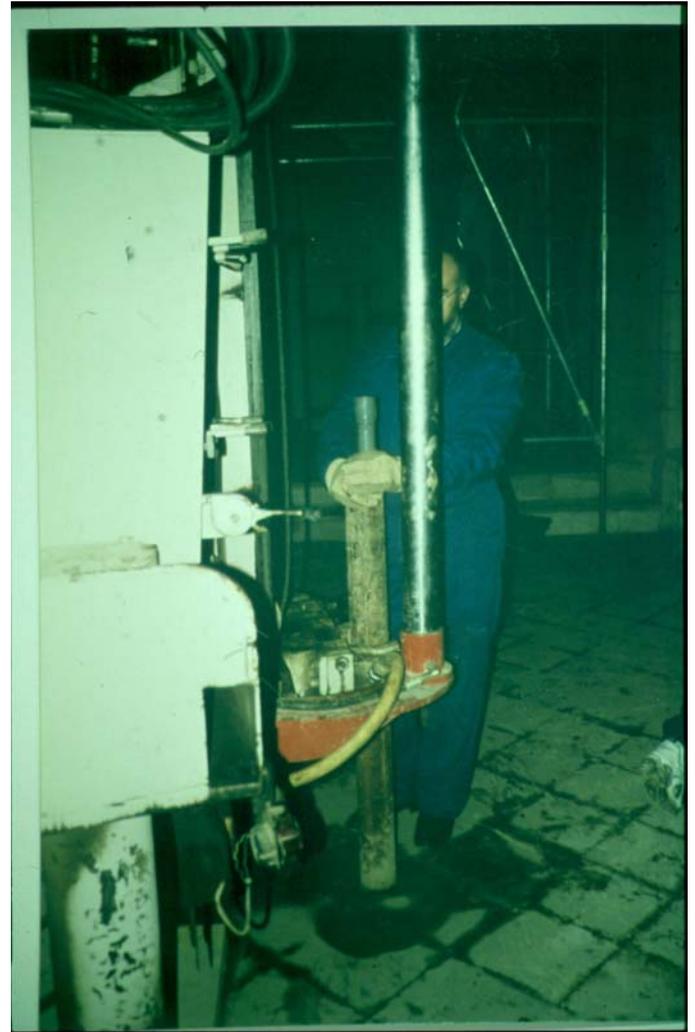
Fig. 2. Bore holes machine working inside the church

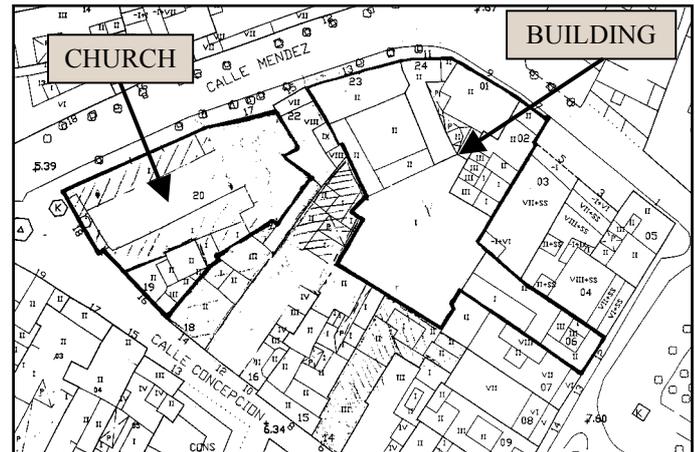
Fig.4. Situation

Because of the movements of the walls there had been differential settlements in the supports of the church, and the parochial buildings, and many cracks appeared in the walls.

The damages caused by the movements of the walls by failures of the provisional struts have been increased by the modifications of the water table, and the changes in the soil parameters.
