Analysis of a Group of Failing Retaining Walls and Remediation Measures

Sami Arsoy
Kocaeli University, Kocaeli, Turkey

ANALYSIS OF A GROUP OF FAILING RETAINING WALLS AND REMEDIATION MEASURES

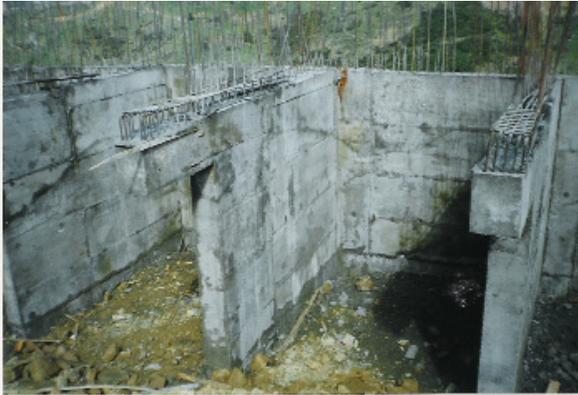
a) Foundation excavation

Foundation soil was graywacke throughout the site as can be seen in Fig. 1.a. No laboratory testing was conducted for the site soils. However, Graywacke is an unweathered rock and it can be described as cemented with usual strength of medium (8000 psi or 50 MPa) to very high (over 32000 psi or 200 MPa) according to Peck et al. (1974).
