Failure of Retaining Structures in Town Lezha and their Consequence in Neighbouring Building

FAILURE OF RETAINING STRUCTURES IN TOWN LEZHA AND THEIR CONSEQUENCE IN NEIGHBOURING BUILDING

Luljeta Bozo

Civil Engineering Faculty
Tirana Polytechnics University, Albania

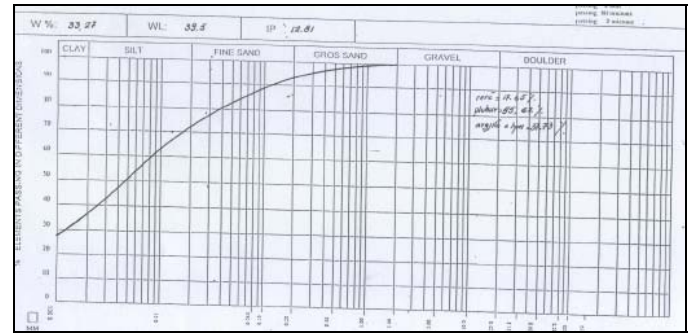
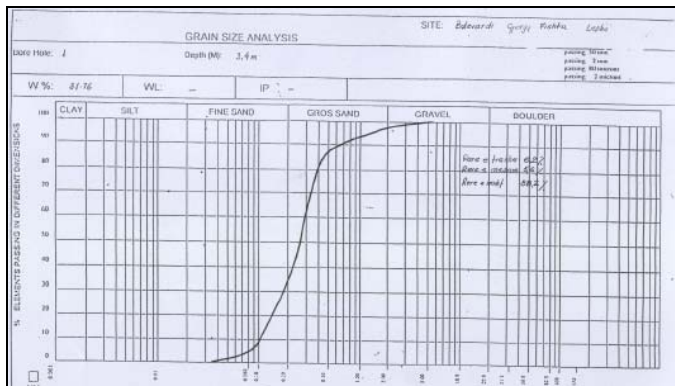
Fig. 4. Sieving and hydrometer tests at borehole nr.1 in depth 3.4m (a1) and 4.2m (a2) and shear box test at borehole nr.1 in depth 3.4m (b1) and 4.2m (b2) and oedometric test at borehole nr.1 in depth 3.4m (c1) and 4.2m (c2).
