Investigating Failure of a Geosynthetic-Reinforced Soil Wall in Black Hawk, Colorado

INVESTIGATING FAILURE OF A GEOSYNTHETIC-REINFORCED SOIL WALL IN BLACK HAWK, COLORADO

Approximately 18 months after construction, an 11-m high rock faced Geosynthetic-Reinforced Soil (GRS) wall was found to suffer from subsidence of about 100 mm on the crest, along with rocks being dislodged from the wall face from time to time. In the ensuing three months after these signs of problems were first detected, the subsidence on the crest of the wall increased to about 250 mm with significant lateral bulging on the wall face. The wall comprised two sides. The problems occurred primarily on one side of the wall; while the other side showed little distress. The entire wall eventually had to be demolished and reconstructed. Prior to reconstruction, a forensic program was undertaken and analyses were performed to examine the causes of failure. This paper describes the geometry and properties of the wall, the events leading to failure of the wall, and the post-failure analysis. It was concluded that the failure likely stemmed from two causes: (1) poor compaction of the fill in harsh winter weather during wh

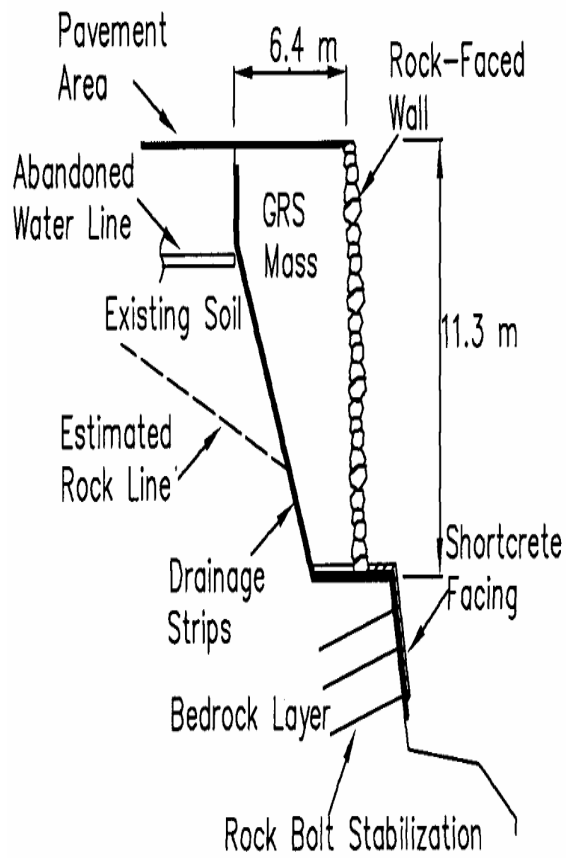
Fig. 3. Side view of the wall configuration.

reinforcement was a polypropylene woven geotextile. The reinforcement length was 6.4 m at the top and gradually reduced with depth to accommodate the sloping rock cut behind the reinforced soil zone (see Figure 3). The front edge of each reinforcement sheet was sandwiched between vertically aligned rocks at the wall face to form a frictional connection between the reinforcement layer and facing rocks.

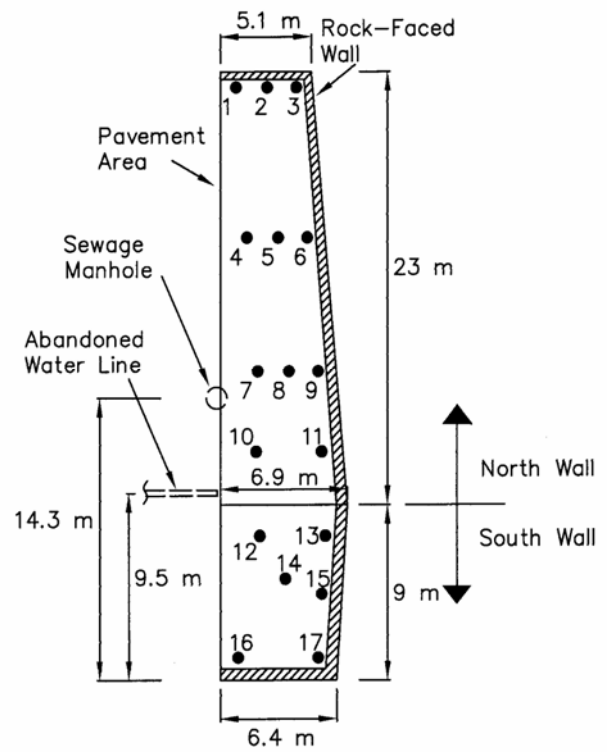
Fig. 4. Plan view of the wall configuration.

The settlement at different locations of the paved area (Pts. 1 to 17 in Figure 4) on the crest was measured. The survey measurement was taken on May 12, June 5, and August 21, 1998. The elevations recorded on May 12, 1998, approximately one year after initial wall distress was detected, were used as the reference for the subsequent settlement measurements on June 5 and August 21, 1998. The settlements of the pavement area measured between May 12 and June 5, 1998 (over 25-day period) and between June 5 and August 21, 1998 (over 45-day period) are listed in Table 1. From May 12 to June 5, 1998, the largest settlements in the North and South walls were 240 mm (at Pt.6) and 3 mm (at Pt.12), respectively. Between June 5 and August 21, 1998, the largest settlements in the North and South walls were 125 mm (at Pt.11) and 27 mm (at Pt.12), respectively. Note that the largest settlements all occurred adjacent to the wall face.

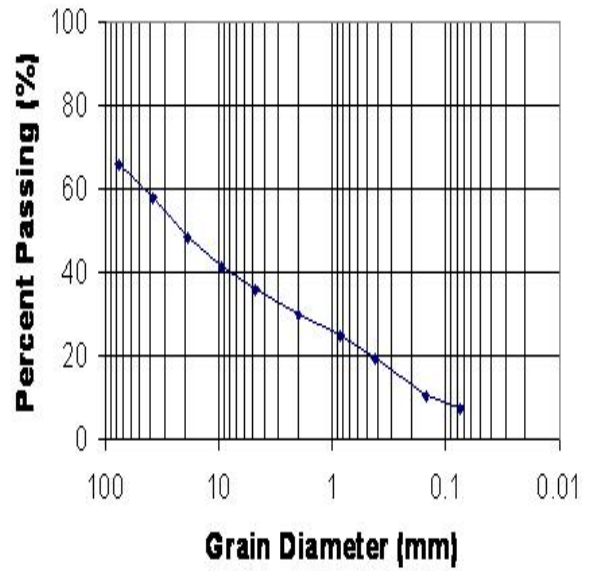
Fig. 5. A Gradation Curve of the Soil

The backfill was a gravelly silt and gravelly sand, classified as GP-GM. The soil contained 20% to 50% of oversized particles (retained on the 19-mm sieve) and has about 7% of fines (passing the 0.075 mm sieve). A gradation curve of the soil is shown in Figure 5. The maximum dry unit weight and optimum moisture content for the minus 19-mm portion of the soil are 20.63 kN/m³ and 8.8 %, respectively, per ASTM D1557 method C. The coefficient of permeability for the compacted gravelly soil is judged to be on the order of 10⁻³ cm/sec.

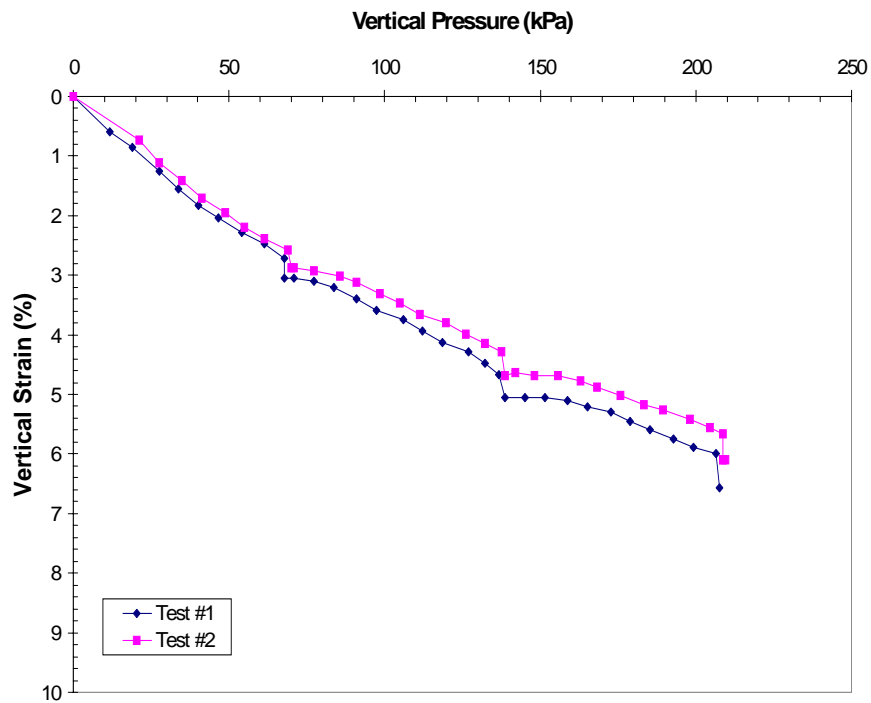
Fig. 10. Repeatability of the Large-Size One-Dimensional Compression Tests

Repeatability of the test procedure was first examined by comparing the results of Tests #1 and #2, conducted under identical initial density and moisture content. Figure 10 shows the applied pressure versus vertical strain relationships (referred to as “the compression curves”) of Tests #1 and #2 (85% R.C., w=5.8%). The compression curves of Tests #1 and #2 are very similar with the maximum difference in vertical strain being 0.47% occurred at 207 kPa. The repeatability of the test procedure is considered satisfactory.

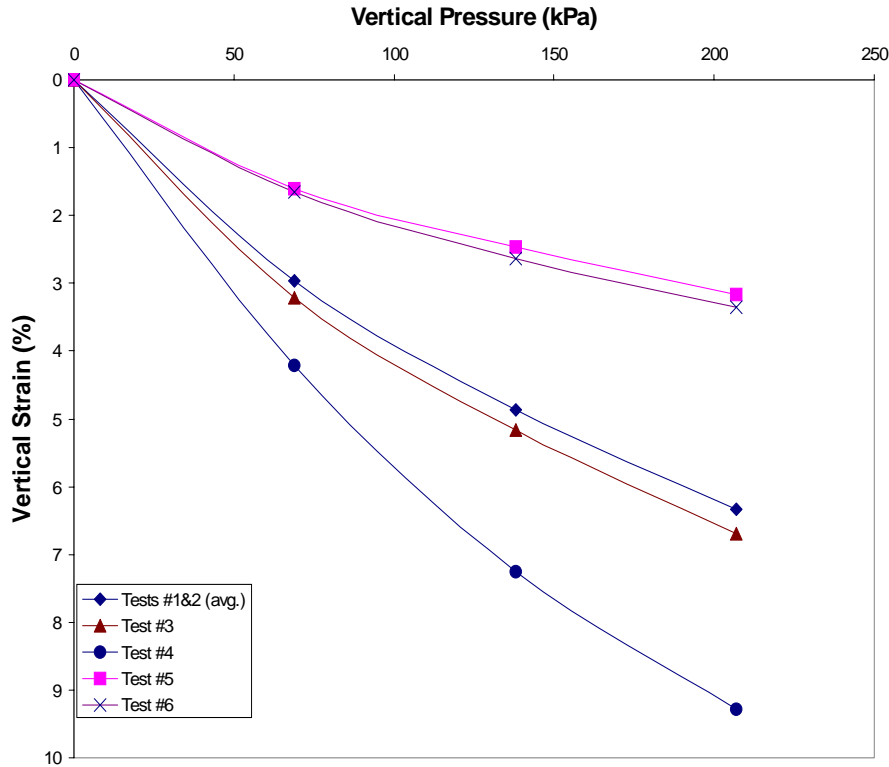
Fig. 11. Compression Curves at Different Water Contents

Figure 11 shows the compression curves of the 85% R.C. and 95% R.C. specimens at the different water contents. The vertical strains that occurred after the vertical pressure (69, 138, and 207 kPa) was applied for one hour were used to plot the compression curve. The vertical strains of the 95% R.C. specimens at water contents of -3% and +3% of OMC were, respectively, 1.60% and 1.66% at 69 kPa, 2.47% and 2.63% at 138 kPa, and 3.16% and 3.36% at 207 kPa. These results indicate that for the soil compacted to 95% relative compaction, the compression induced by wetting (water content changed from -3% to +3% of OMC) was fairly small.

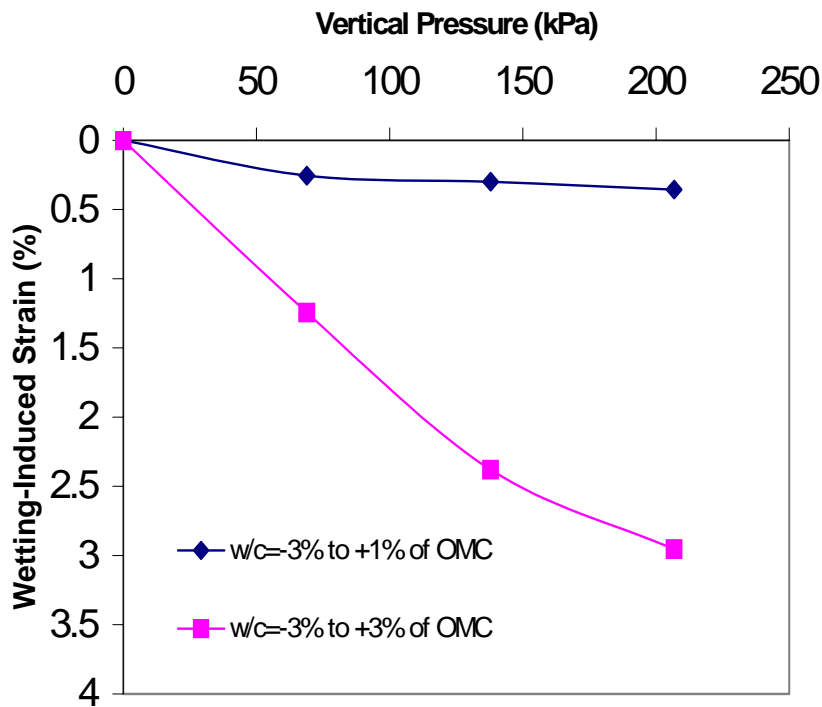
Fig. 12. Wetting-Induced Strain versus Vertical Pressure of the 85% R.C. Specimen

From Figure 11, the wetting-induced strain (ϵ_{wet}) of the 85% R.C. specimens at 69, 138, and 207 kPa was calculated. Figure 12 shows the relationships of wetting-induced strain versus vertical pressure of the 85% R.C. specimens as water
