# Failure of Two High Embankments at Soft Soil Sites

## **FAILURE OF TWO HIGH EMBANKMENTS AT SOFT SOIL SITES**

Two highway bridge approaches, about 10 and 12 m in height, near Calcutta, India constructed with mechanically stabilized earth failed recently. These embankments were founded on soft and compressible, fine-grained soils of the intertidal flats and backswamps of the Ganges delta. One of these embankments, which failed in the final stages of its construction, was constructed after foundation soils were strengthened with preloading and prefabricated vertical drain installation and the other second embankment that failed within a month of its opening for traffic was constructed on unimproved ground. Fortunately, direct collateral damage from these incidents was small. Available geotechnical data indicated that design inadequacy was the main cause of these failures. Using pre- and post- consolidation shear strengths the embankments were redesigned. Reconstruction involved PVD installation at the second site and construction of stabilizing berms at both locations. The facilities are now operational and appear to be performing satisfactorily. Details of the failures, post fail

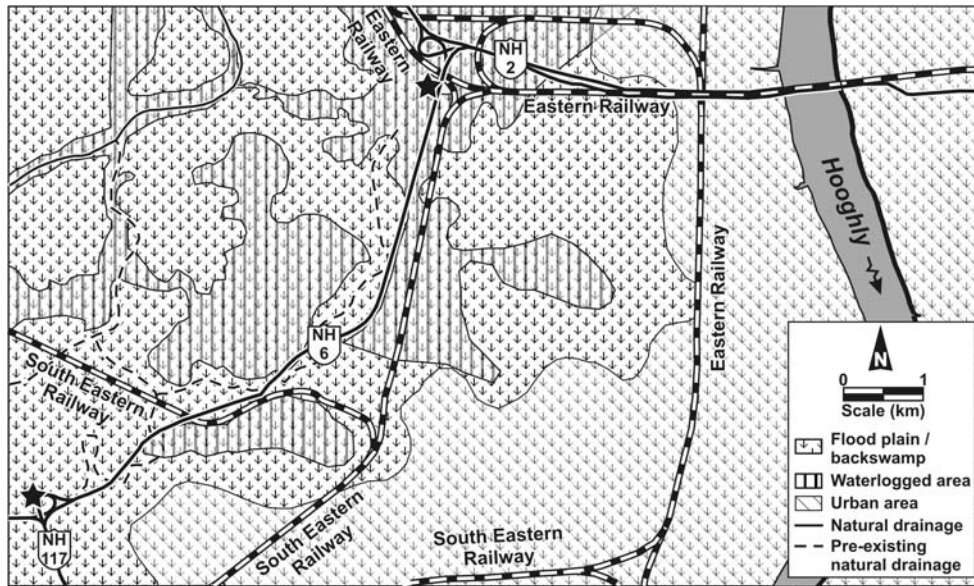
Two highway embankments constructed with mechanically stabilized earth failed recently near Kolkata (Calcutta) of southern part of West Bengal state, India (Fig. 1). The sites are located within the intertidal flats and backswamps of the Hooghly, a major distributary of the Ganges (Fig. 2). One of these sites, KM 18 site, remain waterlogged throughout the year, and the other, KM 26 site, also remains waterlogged over prolonged periods. Both the embankments were retained by mechanically stabilized earth (MSE) walls constructed with compacted river sand reinforced with galvanized steel reinforcements.

Fig. 2. Geological and geomorphological setting.
