Ground Deformations Observed After 23.10.2011 M_w 7.2 VAN Earthquake (Turkey)

GROUND DEFORMATIONS OBSERVED AFTER 23.10.2011 M_w 7.2 VAN EARTHQUAKE (TURKEY)

A destructive earthquake with a moment magnitude of 7.2 occurred in the north of the Van province (Turkey) on 23rd October 2011 at 13:41 local time and caused approximately 600 deaths and more than 4000 injuries. Many damaging aftershocks were recorded for more than a month after the main shock including a triggered earthquake (M_w 5.6) located in the southern district of Van, namely Edremit, on November 9th, 2011 which caused additional damage and casualties. After the M_w 7.2 Van earthquake, earthquake-induced ground deformations such as liquefaction and lateral spreading were extensively observed around the shores of Lake Van and in the floodplains of rivers. The Karasu River floodplain, which is one of the major streams in the region, severely suffered from liquefaction and lateral spreading. In this study, a brief overview of the M_w 7.2 Van earthquake as well as earthquake-induced ground deformations is presented. Then, the results of field reconnaissance on liquefaction and lateral spreading features observed in the Kar

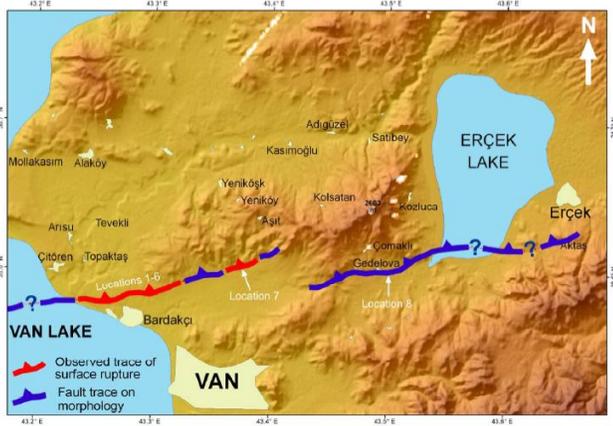
The causative fault that ruptured during the M_w 7.2 Van earthquake is located about 10 km to the north of the city center (Figure 2). No significant surface rupture was observed during the field studies carried out by the authors or other investigators just after the earthquake. However, small scale traces of compressional deformations up to 5-10 cm were measured at several locations along the fault line especially in brittle structures (Figure 3). The signs of compressional deformations point out a thrust fault with the upper plate thrusting southward. The city center of Van is placed on the footwall side of the thrust fault whilst heavily damaged Ercis district is on the hanging wall side. The fault ruptured during the Van earthquake is classified as a blind fault since no obvious sign of surface rupture presents (Alan et al., 2011, Ozkaymak et al., 2011). A fault is identified as a blind fault when the rupture does not reach all the way up to the ground surface and so no clear evidence of fault rupture can be observed (Groshong, 1999; Gates and Ritchie, 2007).

Fig. 2. Trace of the causative fault ruptured during M_w 7.2 Van earthquake (Akyuz et al., 2011)
