The Loma Prieta Earthquake: Implications of Structural Damage

S.A. Mahin

Professor of Civil Engineering, University of California, Berkeley

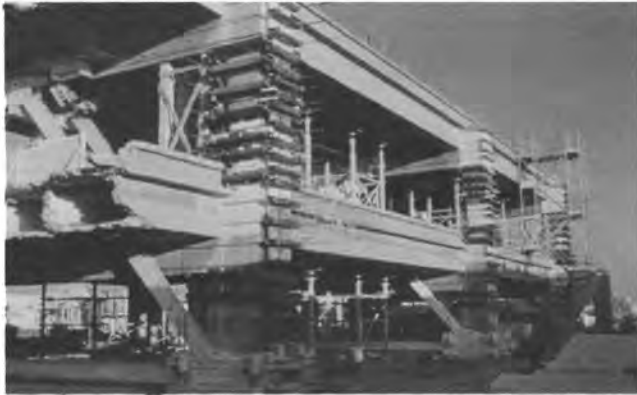
Fig. 26 Cypress Street Test Structure

The need for rapid retrofit of the damaged double deck freeways in San Francisco led to a series of field tests on undamaged portions of the Cypress Street Viaduct. These tests consisted of forced vibration studies to determine the dynamic characteristics of the structure and static lateral load tests in the transverse direction to determine force and deformation capacities. Tests were performed on a relatively unmodified segment of the structure, as well as on the same segment after it was retrofit. The three bents used in the tests are shown in Fig. 26. The results of these tests have been reported by Moehle and Mahin (1990).

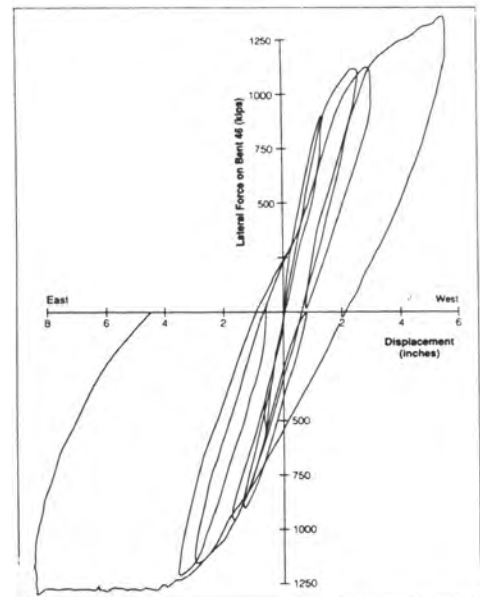
Fig. 27 Hysteretic Plots for Retrofit Viaduct
