## Phase 1 Inspection Report: National Dam Safety Program. Mississippi - Kaskaskia - St. Louis Basin. Cadet Mine Tailings Dam, Washington County, Missouri

CADET MINE TAILINGS DAM  
WASHINGTON COUNTY, MISSOURI  
MO 30715

## PHASE 1 INSPECTION REPORT NATIONAL DAM SAFETY PROGRAM

FEBRUARY 1980

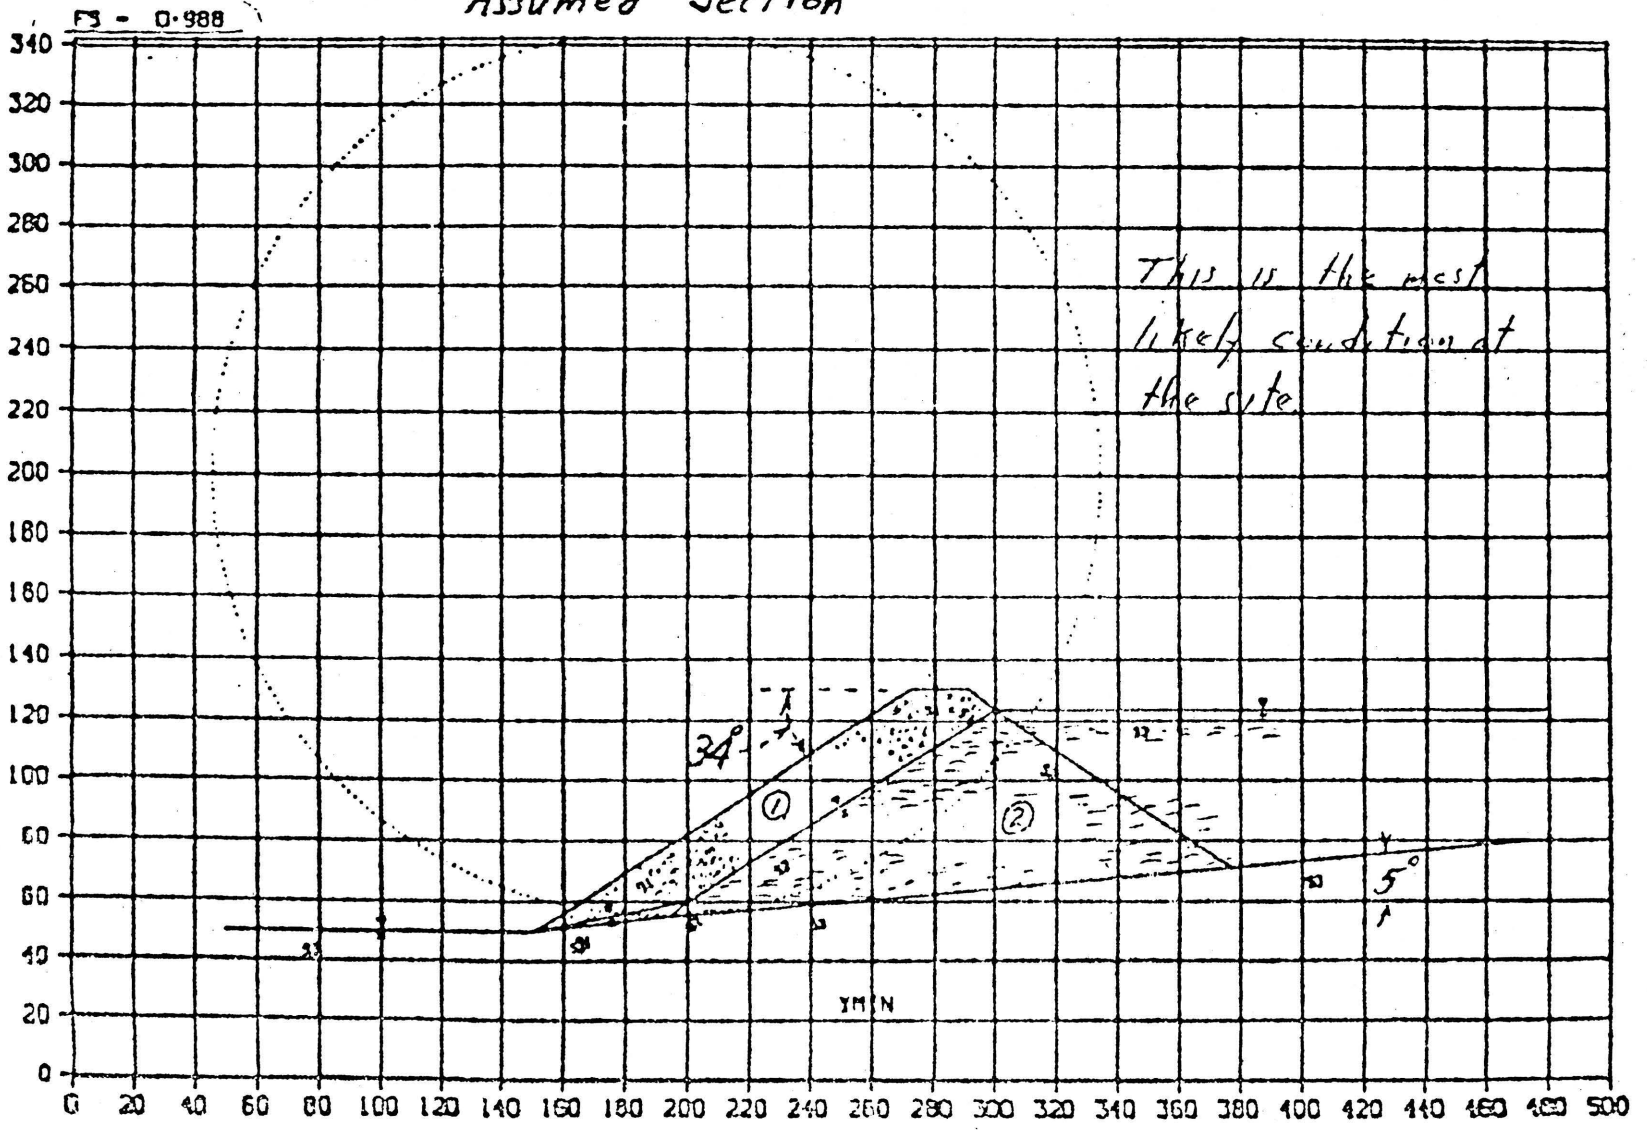
Assumed Section

②  $W = 68^\circ$   $\phi = 21^\circ$   $C = 1 \text{ psi}$

Values based on tests of materials at Dresser #4.

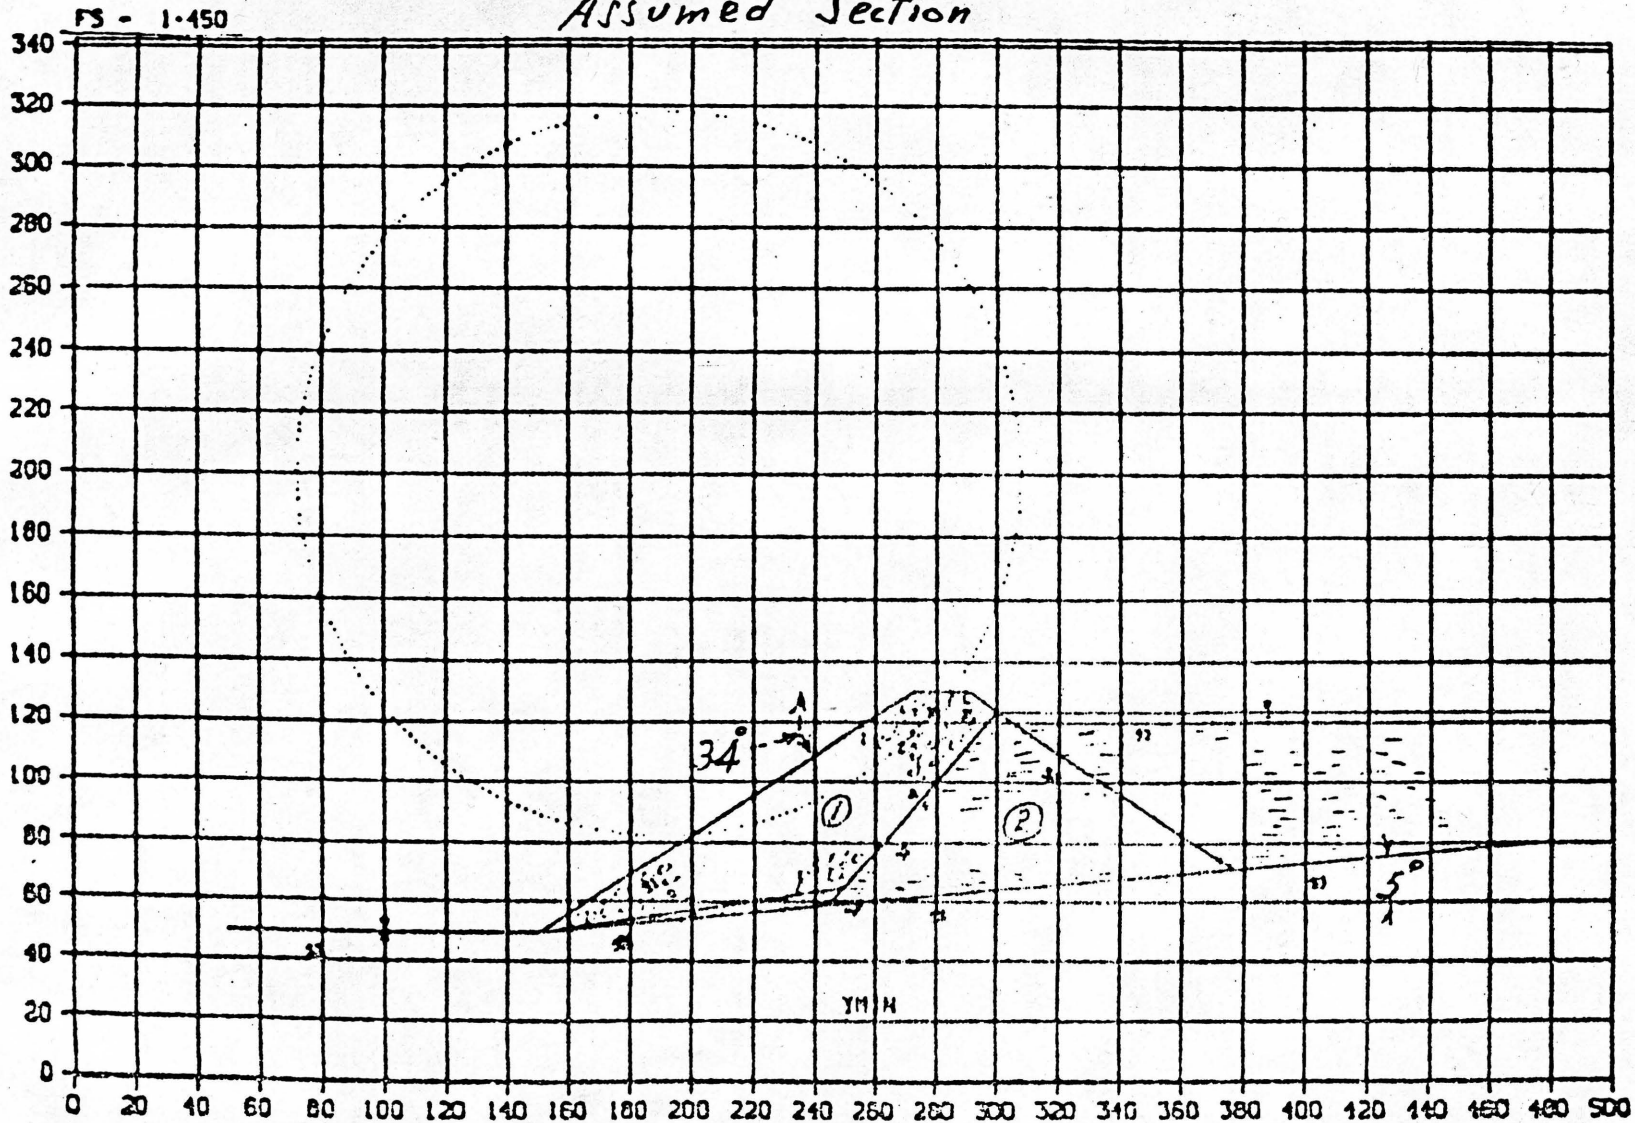
Assumed Section

Static condition
