## Phase 1 Inspection Report: National Dam Safety Program. Mississippi - Kaskaskia - St. Louis Basin. Carden Lake Dam, Crawford County, Missouri

CARDEN LAKE DAM

MO 30987

## PHASE 1 INSPECTION REPORT NATIONAL DAM SAFETY PROGRAM

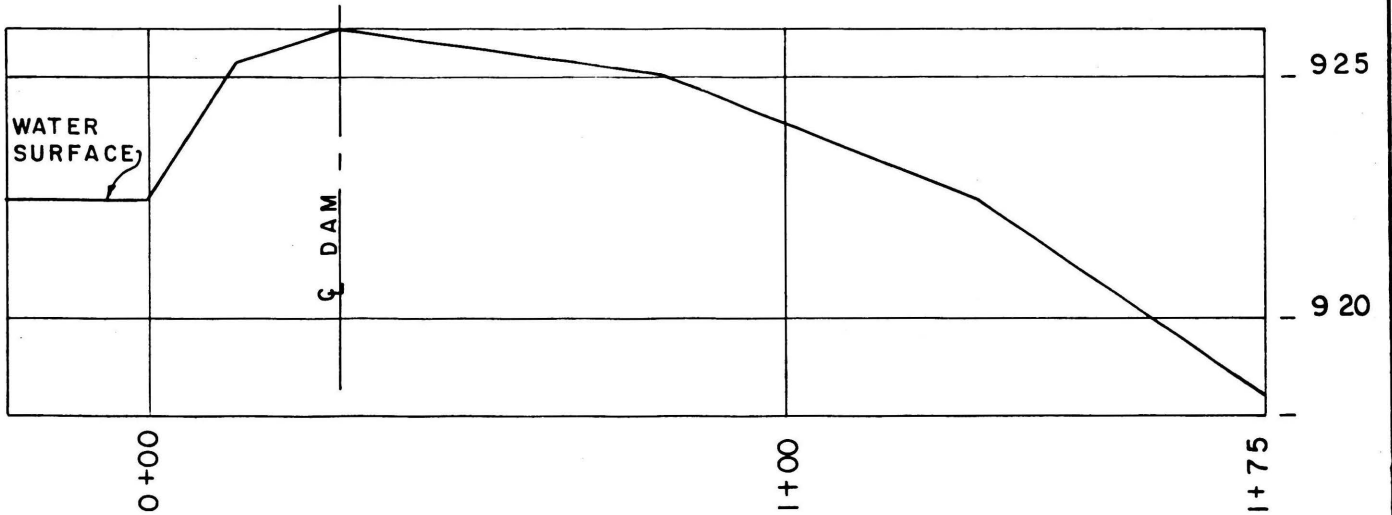
PROFILE OF SPILLWAY AT STA. 6 + 30

Carden Lake Dam is an earth fill structure approximately 35 ft high and 550 ft long at the crest. In this report, right and left orientation is based on looking in the downstream direction. The appurtenant works consist of an earth cut swale in the left abutment and an 8 in. drawdown pipe under the center of the dam with a valve on the downstream end. The outlet of the drawdown pipe could not be found during the inspection visit. The owner indicated that the outlet has been buried with soil for years (slopewash from the dam). Sheet 3 of Appendix A shows a plan, profile, and typical section of the embankment. Sheet 4 of Appendix A shows a section and profile of the spillway.
