**Phase 1 Inspection Report: National Dam Safety Program.  
Mississippi - Kaskaskia - St. Louis Basin. Lac Marseilles Dam, St.  
Francois County, Missouri**

Woodward-Clyde Consultants, Chicago, Illinois

LAC MARSEILLES DAM  
ST. FRANCOIS COUNTY, MISSOURI  
MO 30282

## PHASE 1 INSPECTION REPORT NATIONAL DAM SAFETY INSPECTION

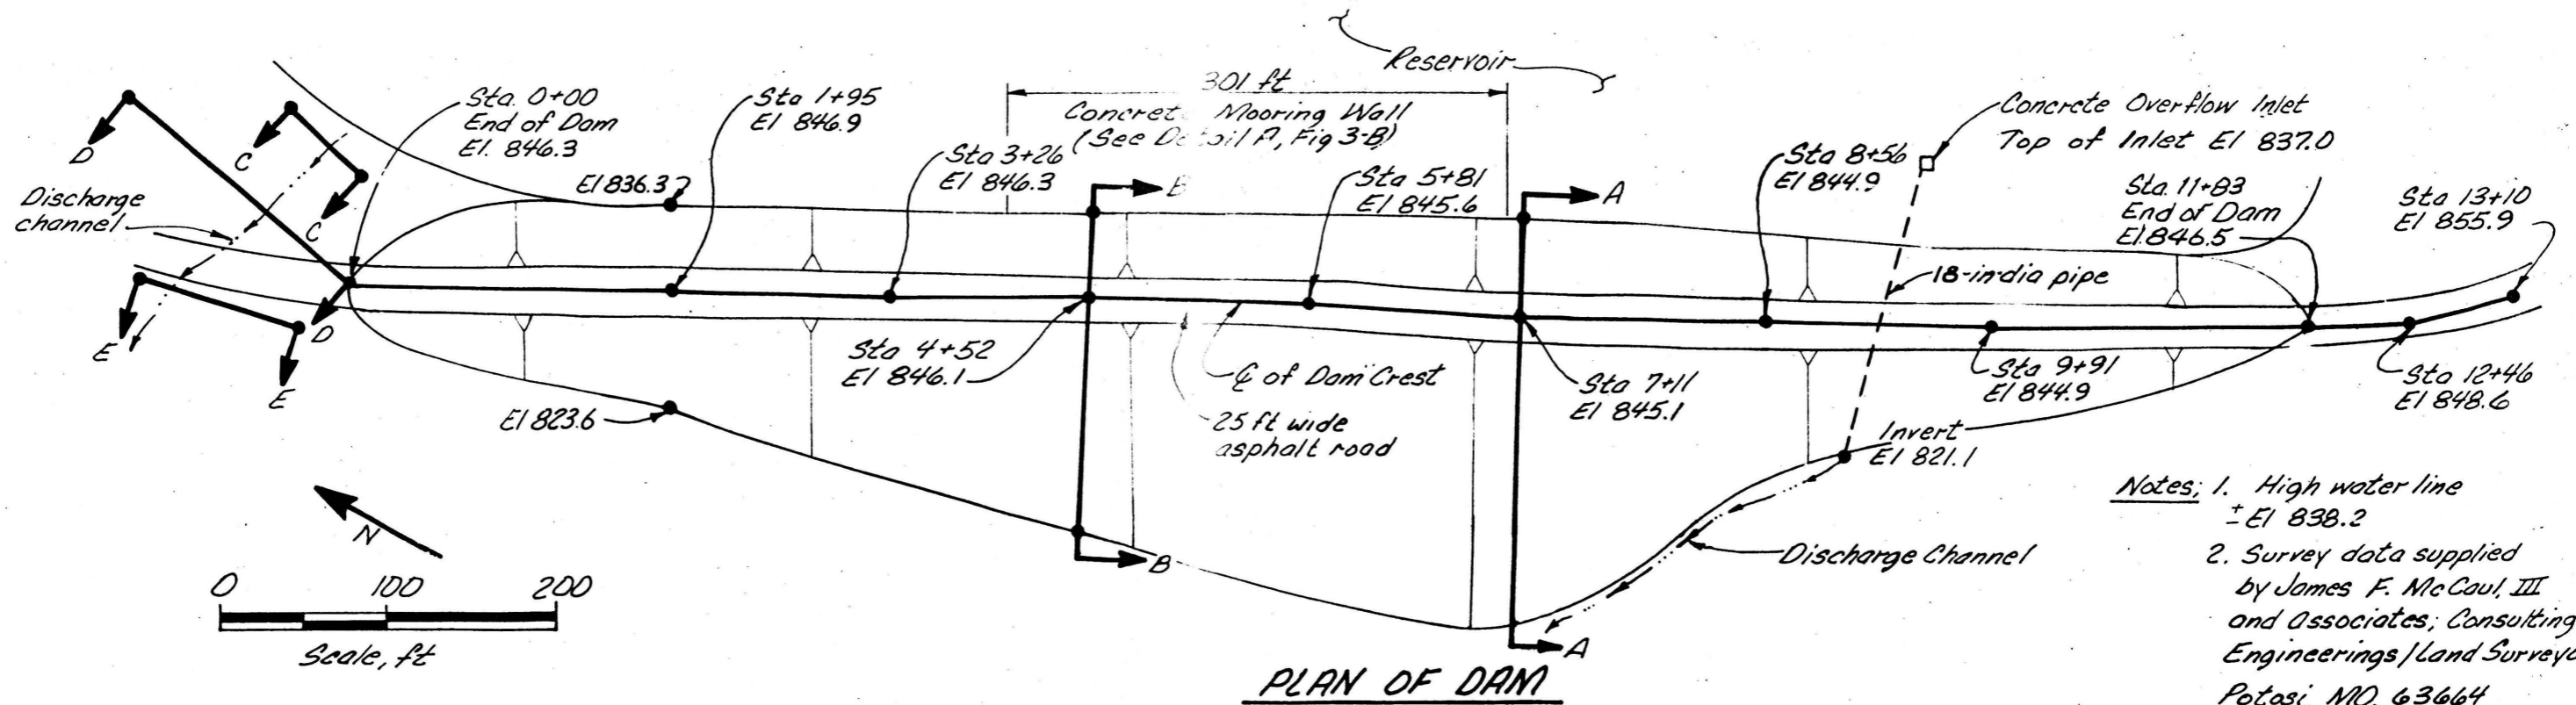
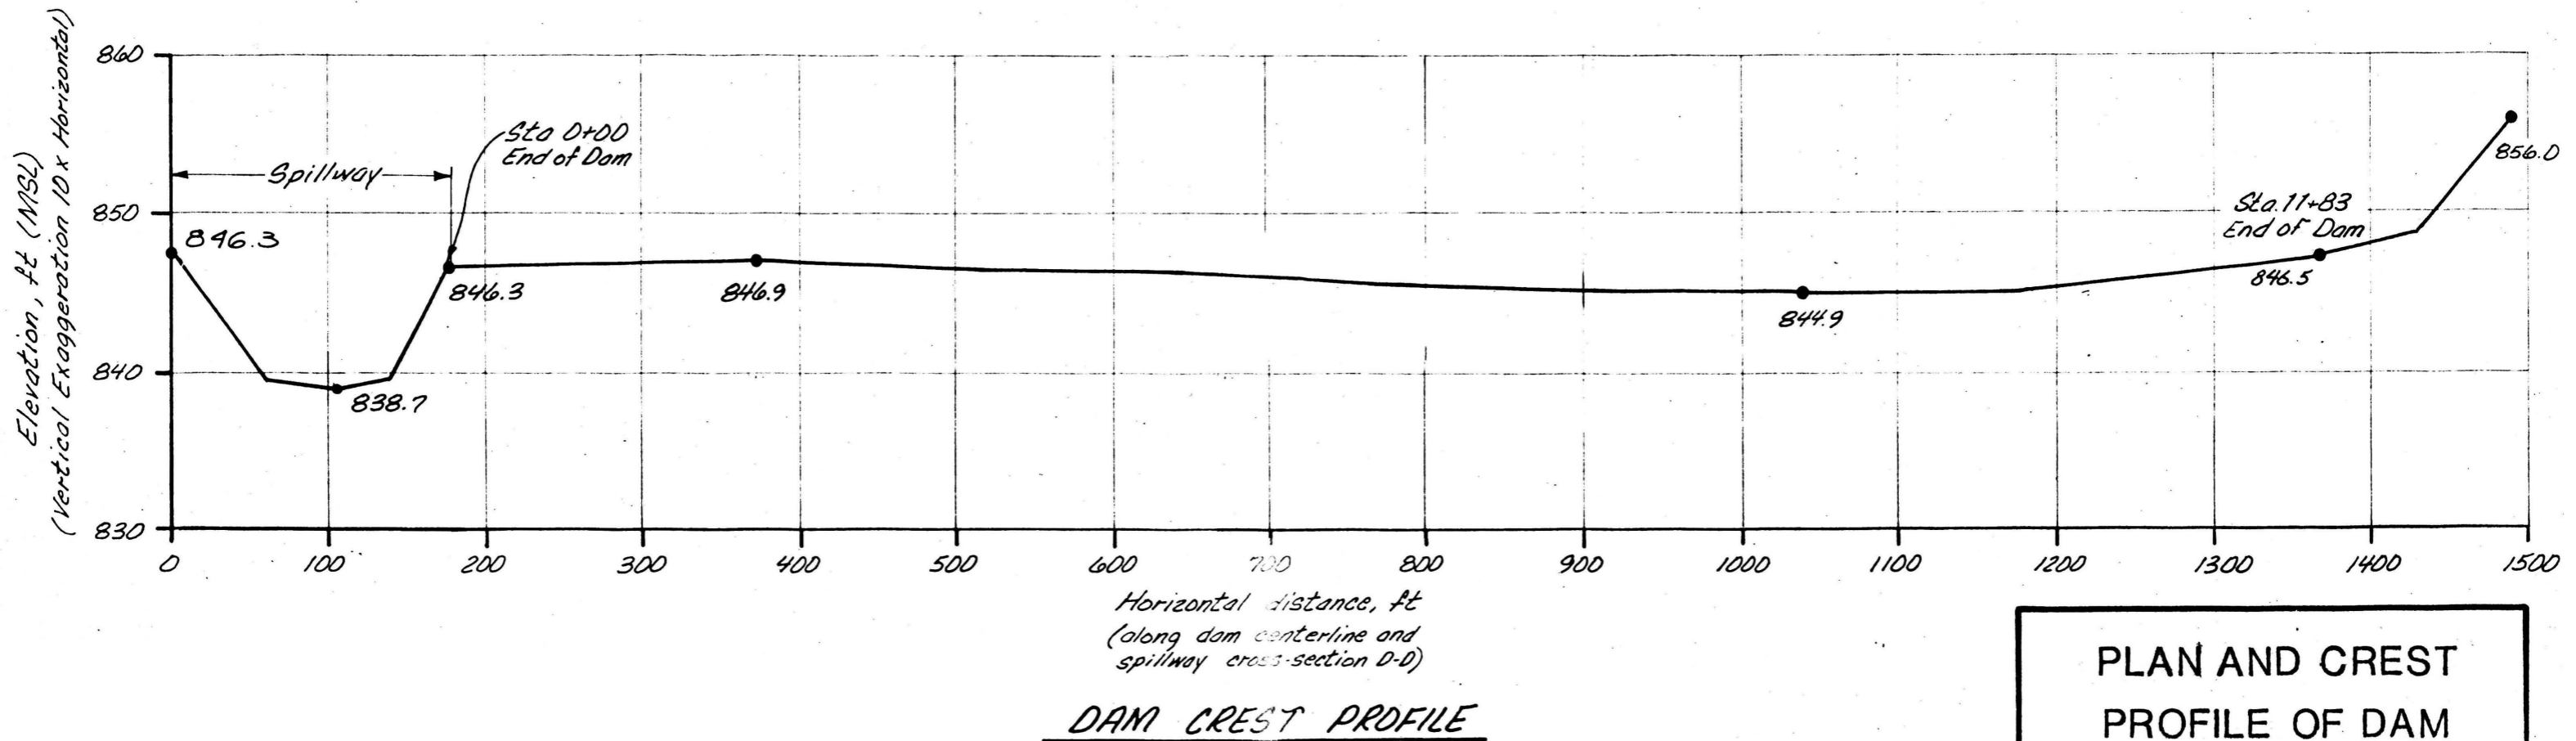
Fig. 3-A

- a. **Description of dam and appurtenances.** Lac Marseilles Dam is an earth and rockfill dam impounding a lake for recreational purposes within the surrounding residential development. The dam crest varies in elevation from 844.9 to 846.5 ft, and is capped by a paved asphalt roadway (Fig. 3A). The spillway is an uncontrolled, roughly trapezoidal excavation in natural soil and bedrock in the right (north) abutment. The spillway crest is also covered by the asphalt roadway. Discharge through the spillway is directed away from the toe of the dam and into the downstream drainage way of the adjacent Lac Capri. An intake tower for a pipe outlet facility is located near the left abutment. It consists of a square concrete inlet tower constructed in the lake and an 18-in. diameter iron pipe crossing through the embankment and discharging into a channel near the junction of the left abutment and the embankment. The gate for this outlet is located at the tower.
