**Phase 1 Inspection Report: National Dam Safety Program.
Mississippi - Kaskaskia - St. Louis Basin. Little Indian Creek Dam,
Washington County, Missouri**

LITTLE INDIAN CREEK DAM
WASHINGTON COUNTY, MISSOURI
MO. 30718

PHASE 1 INSPECTION REPORT NATIONAL DAM SAFETY INSPECTION

SEPTEMBER 1980

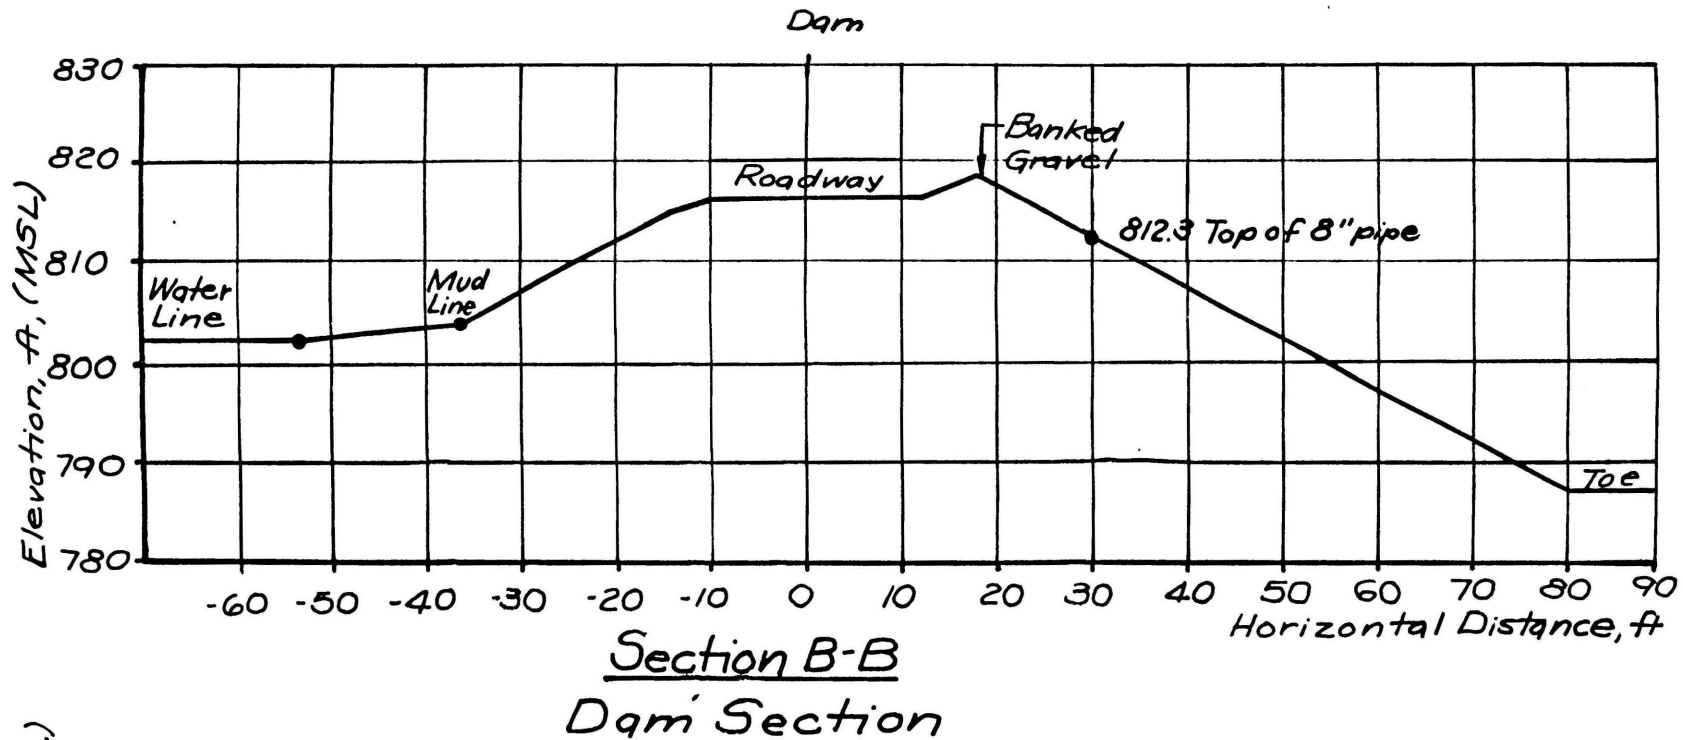
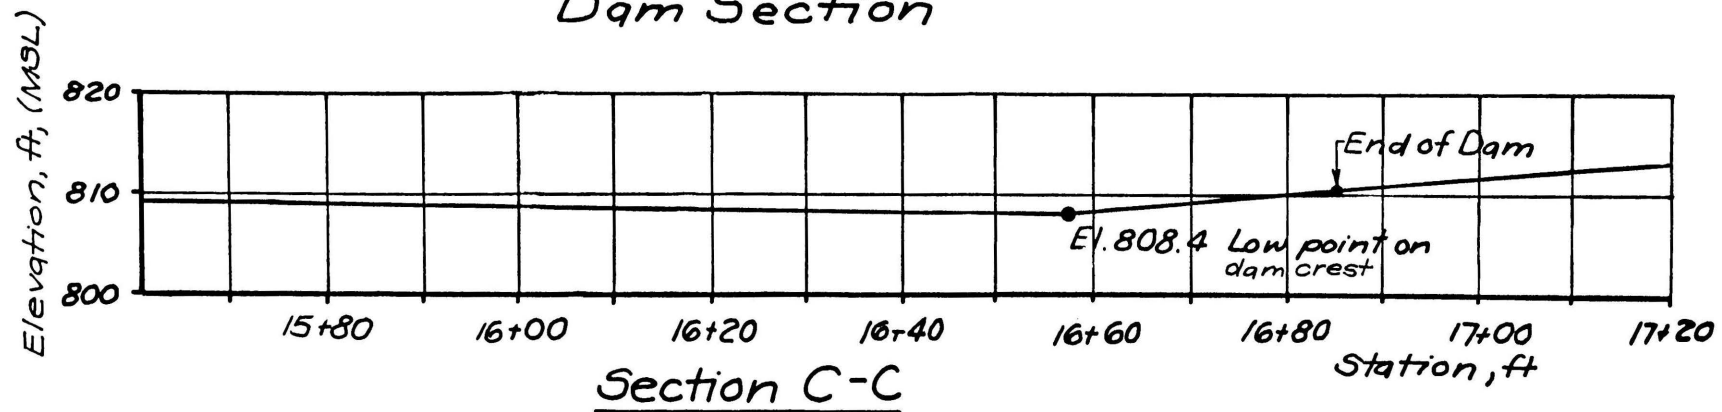
SECTION OF DAM AND CREST PROFILE	
LITTLE INDIAN CREEK DAM	
MO 30718	Fig. 3 B

2. **Overflow pipe.** A 8 in. pipe is buried in the dam, about 4 ft below the dam crest as shown in Fig. 3B and Photo 5. There are no controls on the pipe. The pipe is above the elevation where overtopping of the dam crest near the north abutment would occur, and is therefore of no value prior to overtopping.
